Cedar Swamp Covered Bridge

COVERED BRIDGE STUDY

FEATURE CROSSED
OTTER CREEK

DATE
3-31-93

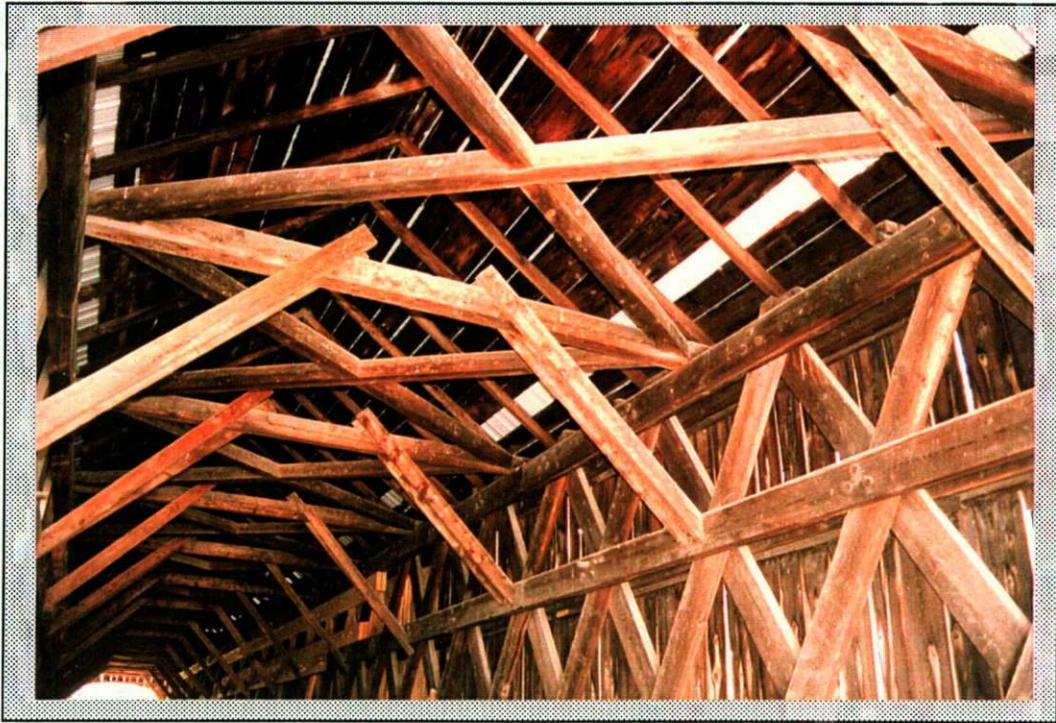
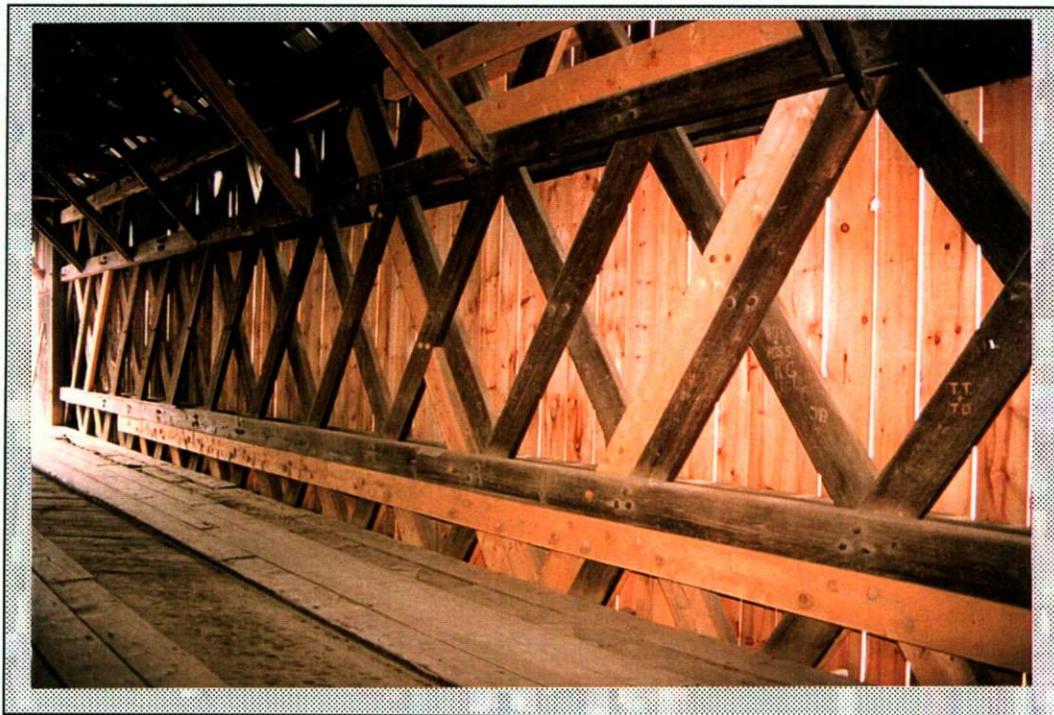
FIGURE 7

- Some wear and rot in runner planks.
- Bullet holes in metal roof.
- Several floor beams tipped.
- Spalled and cracked backwall at Abutment 2.

A thorough discussion about the condition of the structure is contained in the VAOT Bridge Inspection Report, presented in Appendix B. Pertinent bridge dimensions are shown on Figure 6. Photos of relevant portions of the structure are presented in Figures 7 and 8.

- Replace runner planks.
- Repair metal roof.
- Repair floor beams.
- Repair backwall at Abutment 1.
- Provide guide rail on each approach for compliance with VAOT standards.
- Install new signs to replace missing or damaged signs indicating "One Lane Bridge", vehicle weight limits, and vertical clearance in accordance with VAOT standard and the Manual of Uniform Traffic Control Devices (MUTCD).

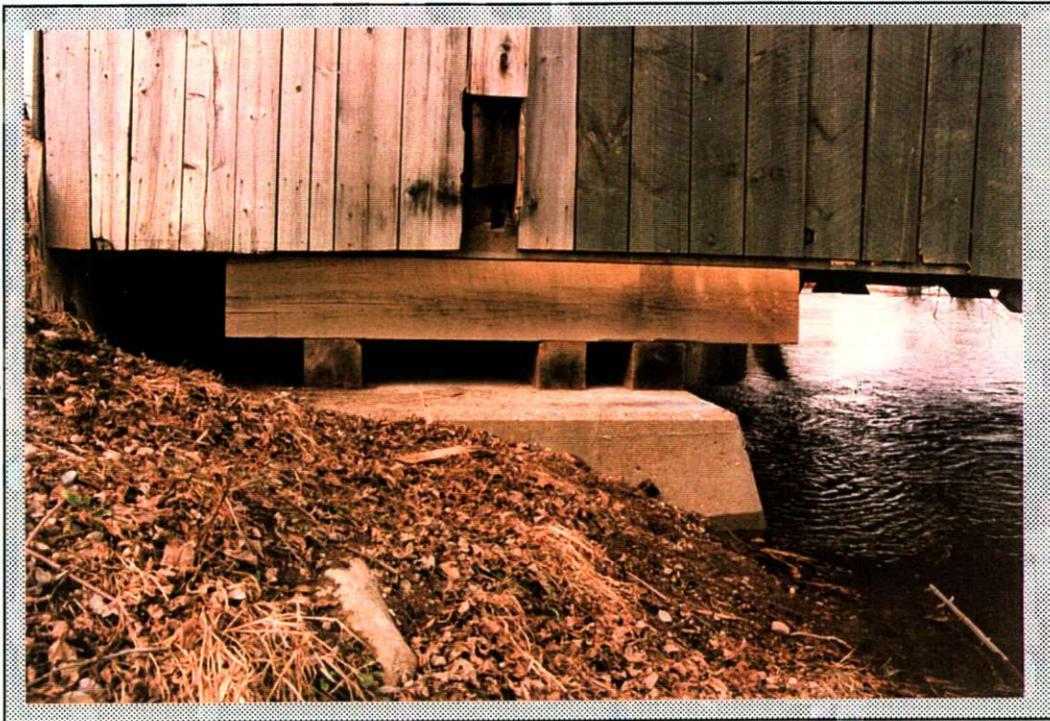
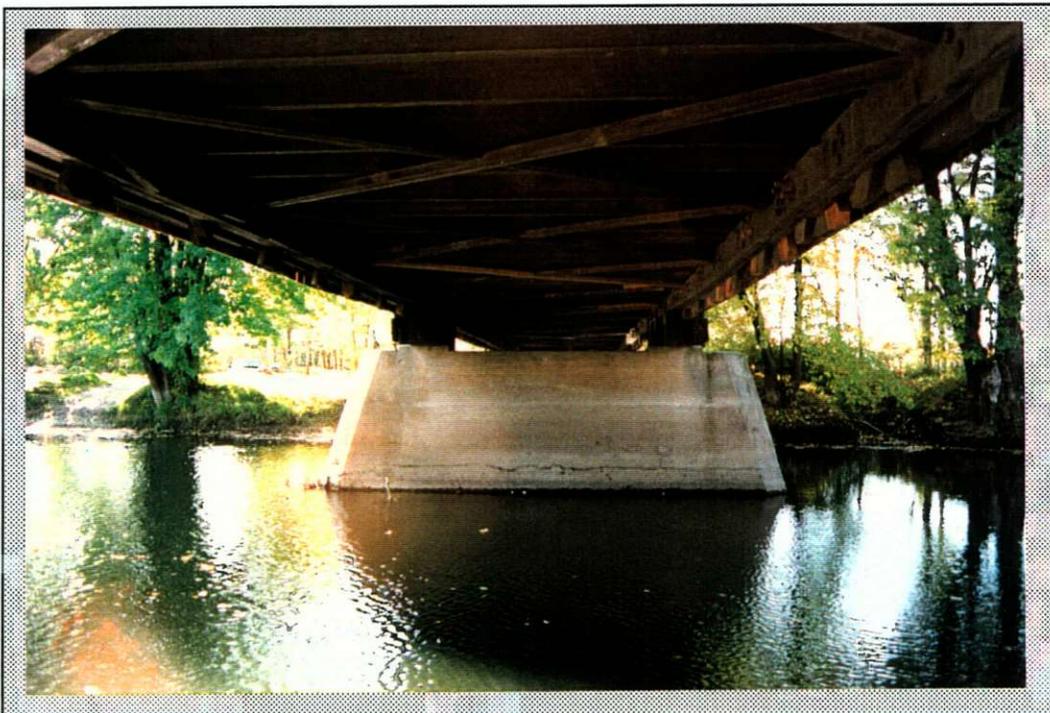
FIGURE 8

ABUTMENTS MINOR CRACKS
 WINGS NONE AS SUCH
 CONC CAPS CONC. PADS UNDER BRGS. @ ABUT #1
 BACKWALLS CRACKS & SPALLS - ABUT #1 ESPECIALLY
 UNDERMINING NONE - 10' DEEP @ PIER
 SPALLING NONE ON BACKWALLS
 SETTLEMENT NONE ?
 PILES NONE SEEN
 PIER(S) MINOR CRACKS & SPALLS
 FOOTING NONE SEEN
 ON LEDGE ABUT #1 NO ABUT #2 NO PIER(S) NO
 REMARKS _____
