STATE OF VERMONT
Division for Historic Preservation
Montpelier, VT 05602

HISTORIC SITES & STRUCTURES SURVEY
District Complex Survey Form

COUNTY: Chittenden
TOWN: Bolton
LOCATION: Nebraska Road, Bolton
NAME OF DISTRICT: Stevens Mill Historic District
TYPE OF DISTRICT: Residential
PHYSICAL CONDITION OF STRUCTURES: Excellent % Good 75 % Fair 25 % Poor %
LEVEL OF SIGNIFICANCE: Local <input checked="" type="checkbox"/> State <input checked="" type="checkbox"/> National <input type="checkbox"/>
THEMES:

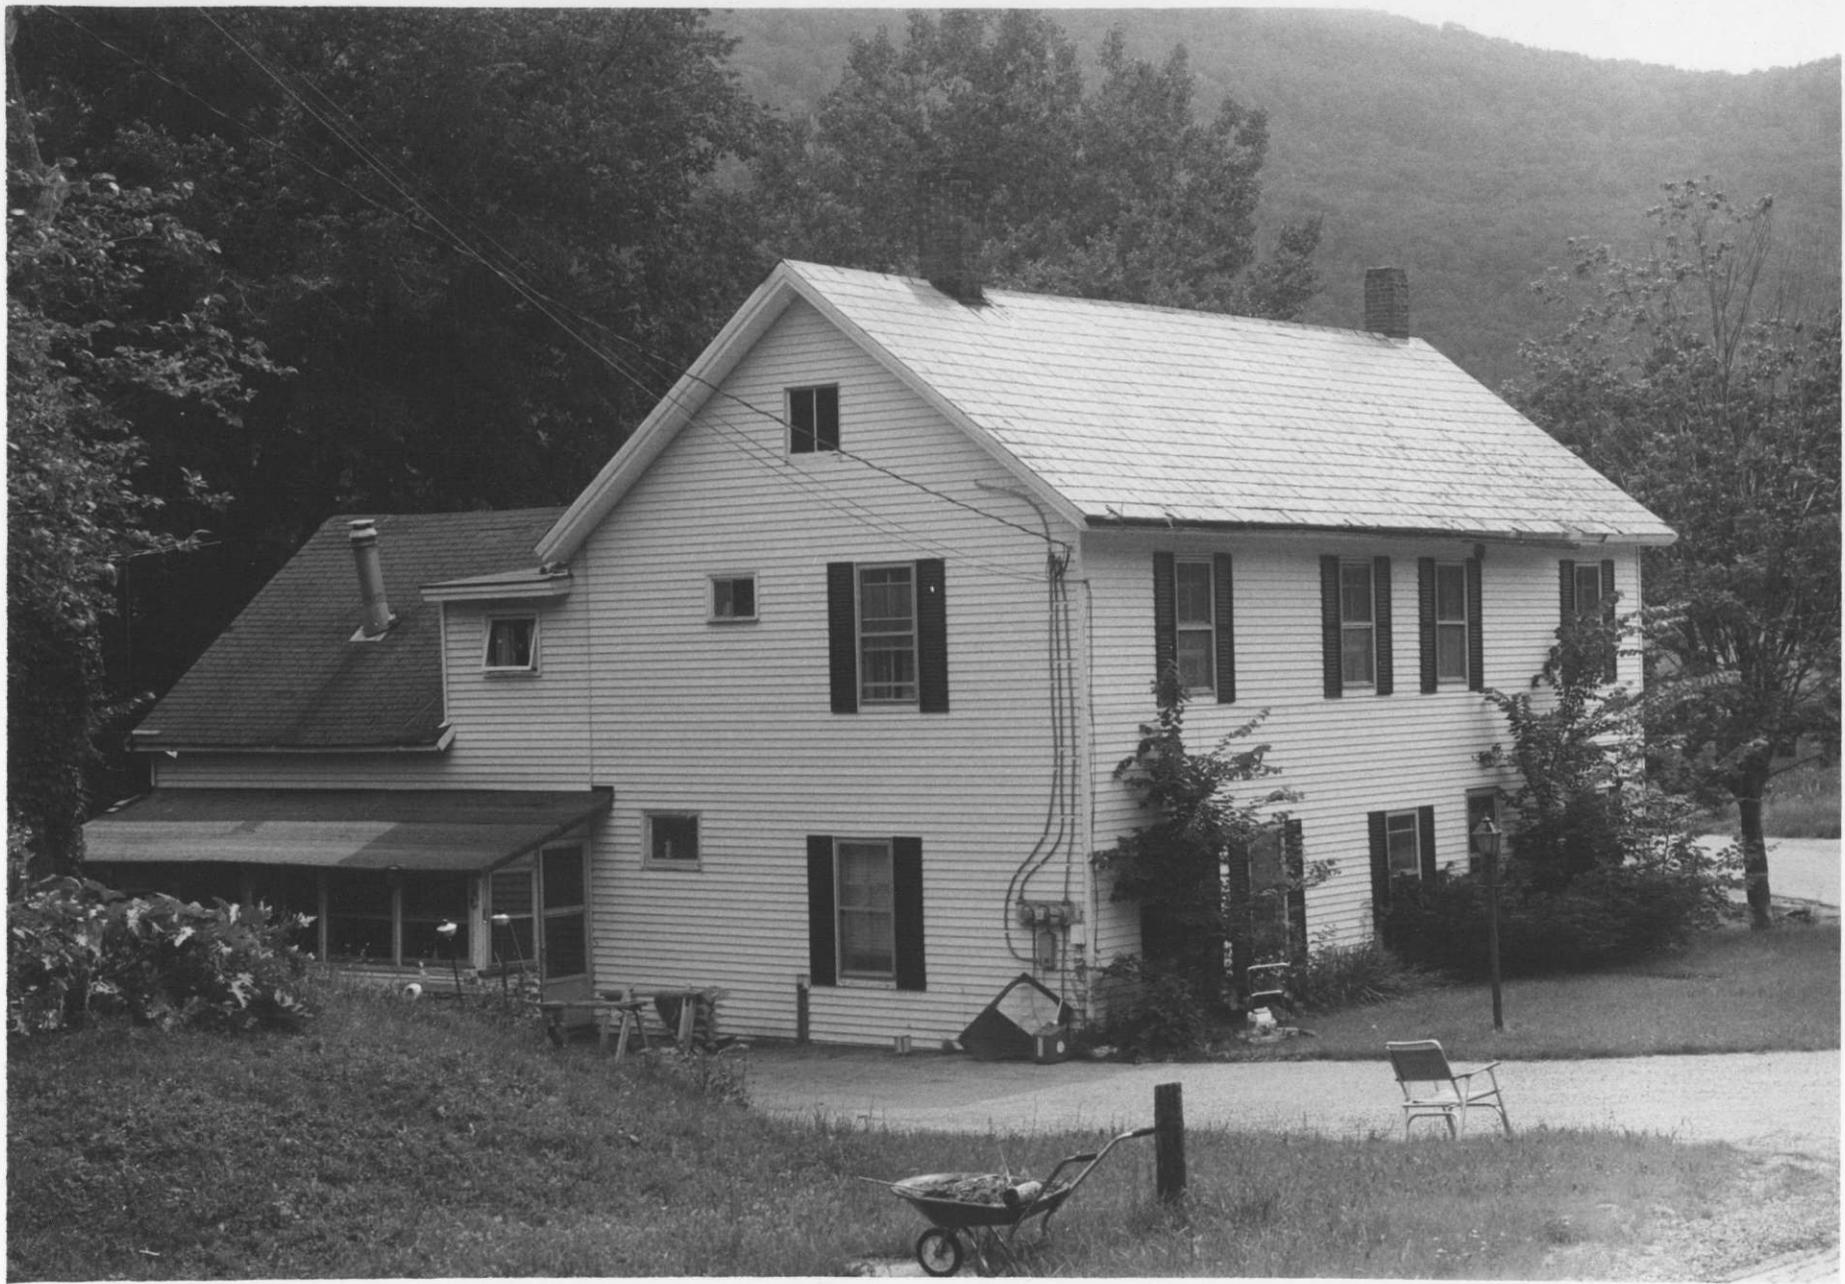
CO. Chittenden TOWN Balton DATE July 1976
SUBJECT Large Apartment House (Havers Mill) VIEW SE
FILE # 76-A-194 CREDIT Adelle Crance

Of the four houses in the district, C. P. Stevens owned the two along the brook. He lived in a portion of the largest one and rented out rooms in the rest of the house.

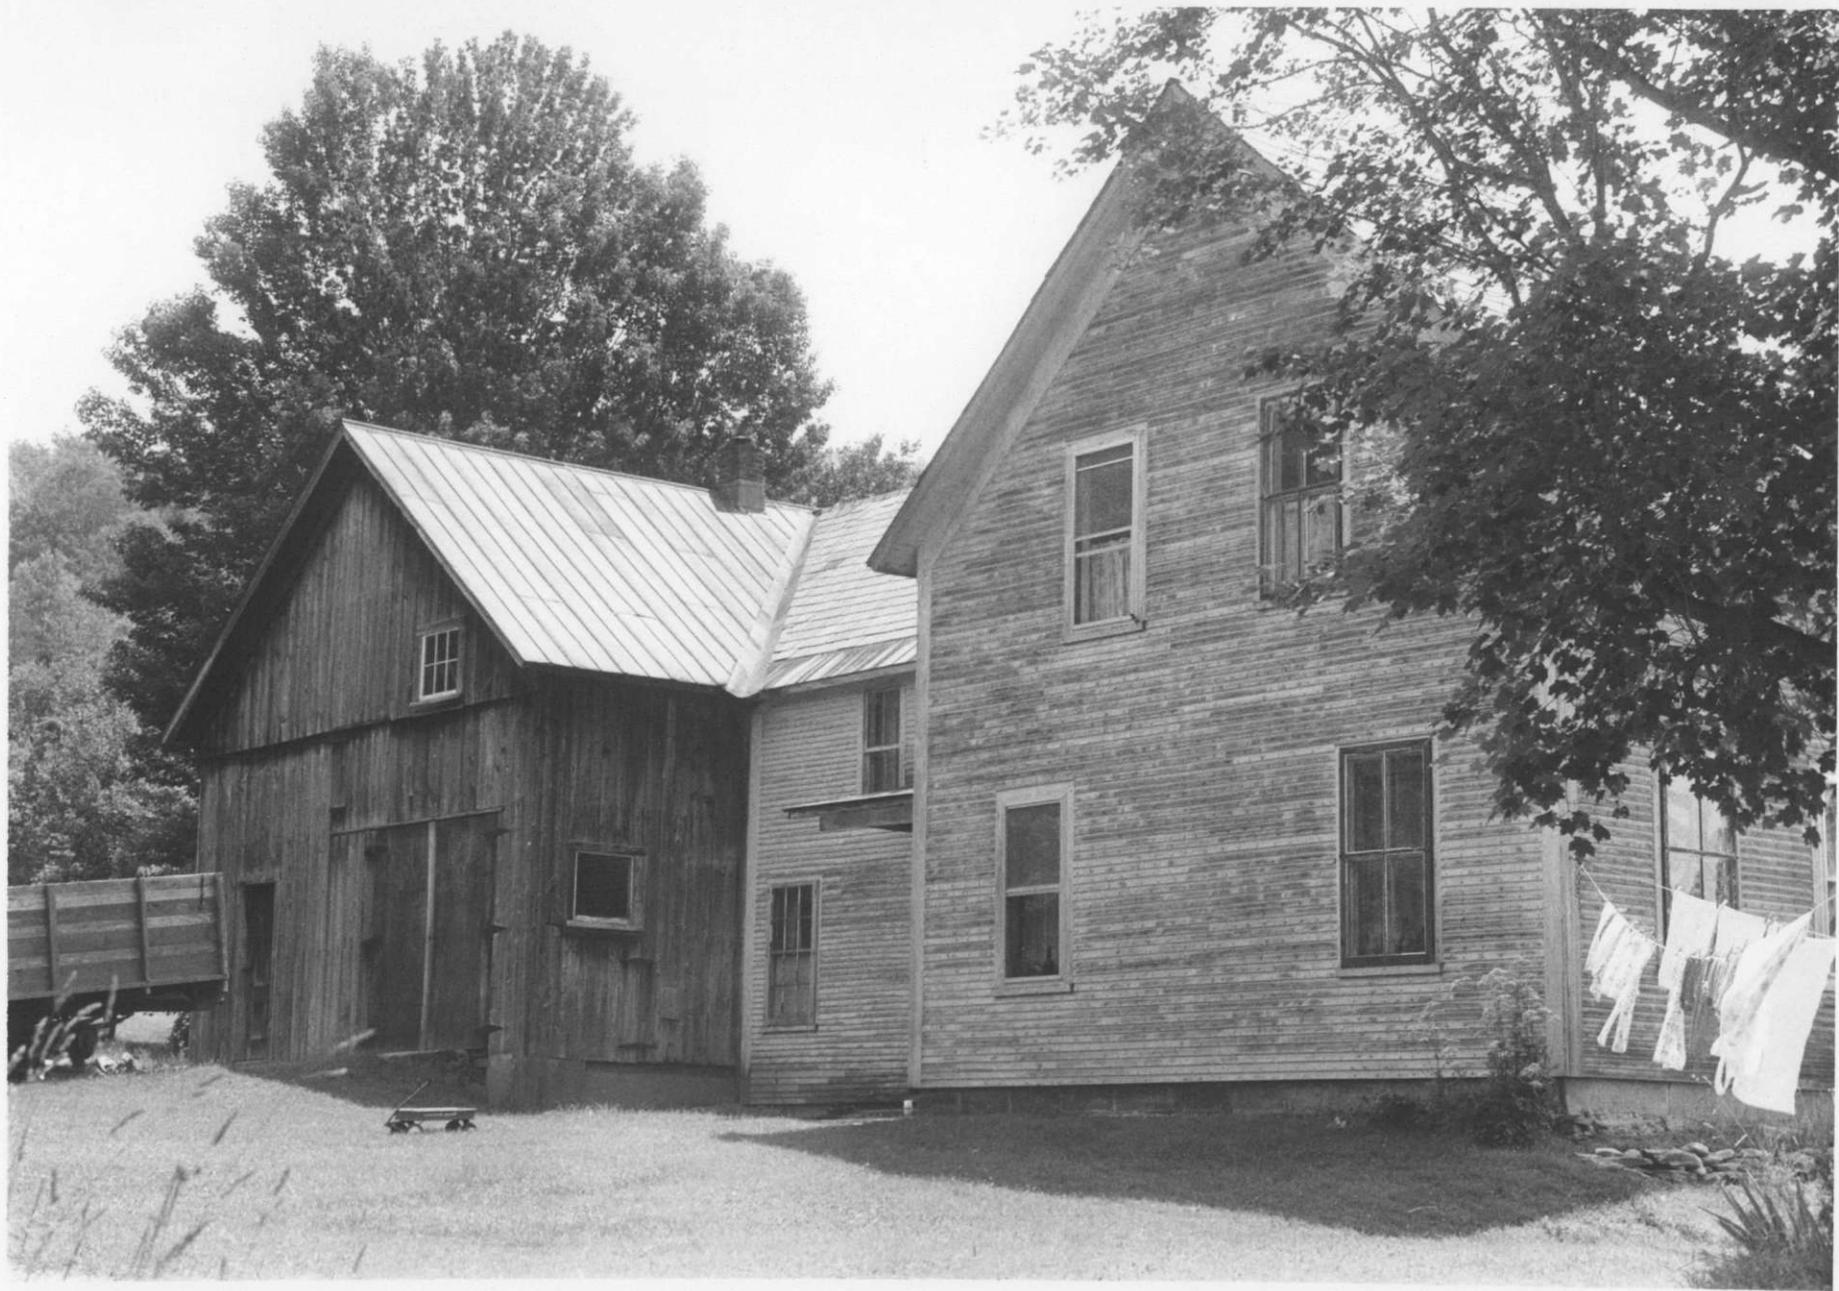
CO. Chittenden TOWN West Bolton DATE July 1976
SUBJECT Sandus Residence VIEW S
FILE # 76-A-193 CREDIT Adelle Craver

This house has a front gable, ell section, and an attached barn. The barn was built first, ca. 1870 and the house added later. The foundation is of fieldstone slabs scored to look like cut blocks. The interior contains a handmade newel post, banister and balusters carved by the builder.

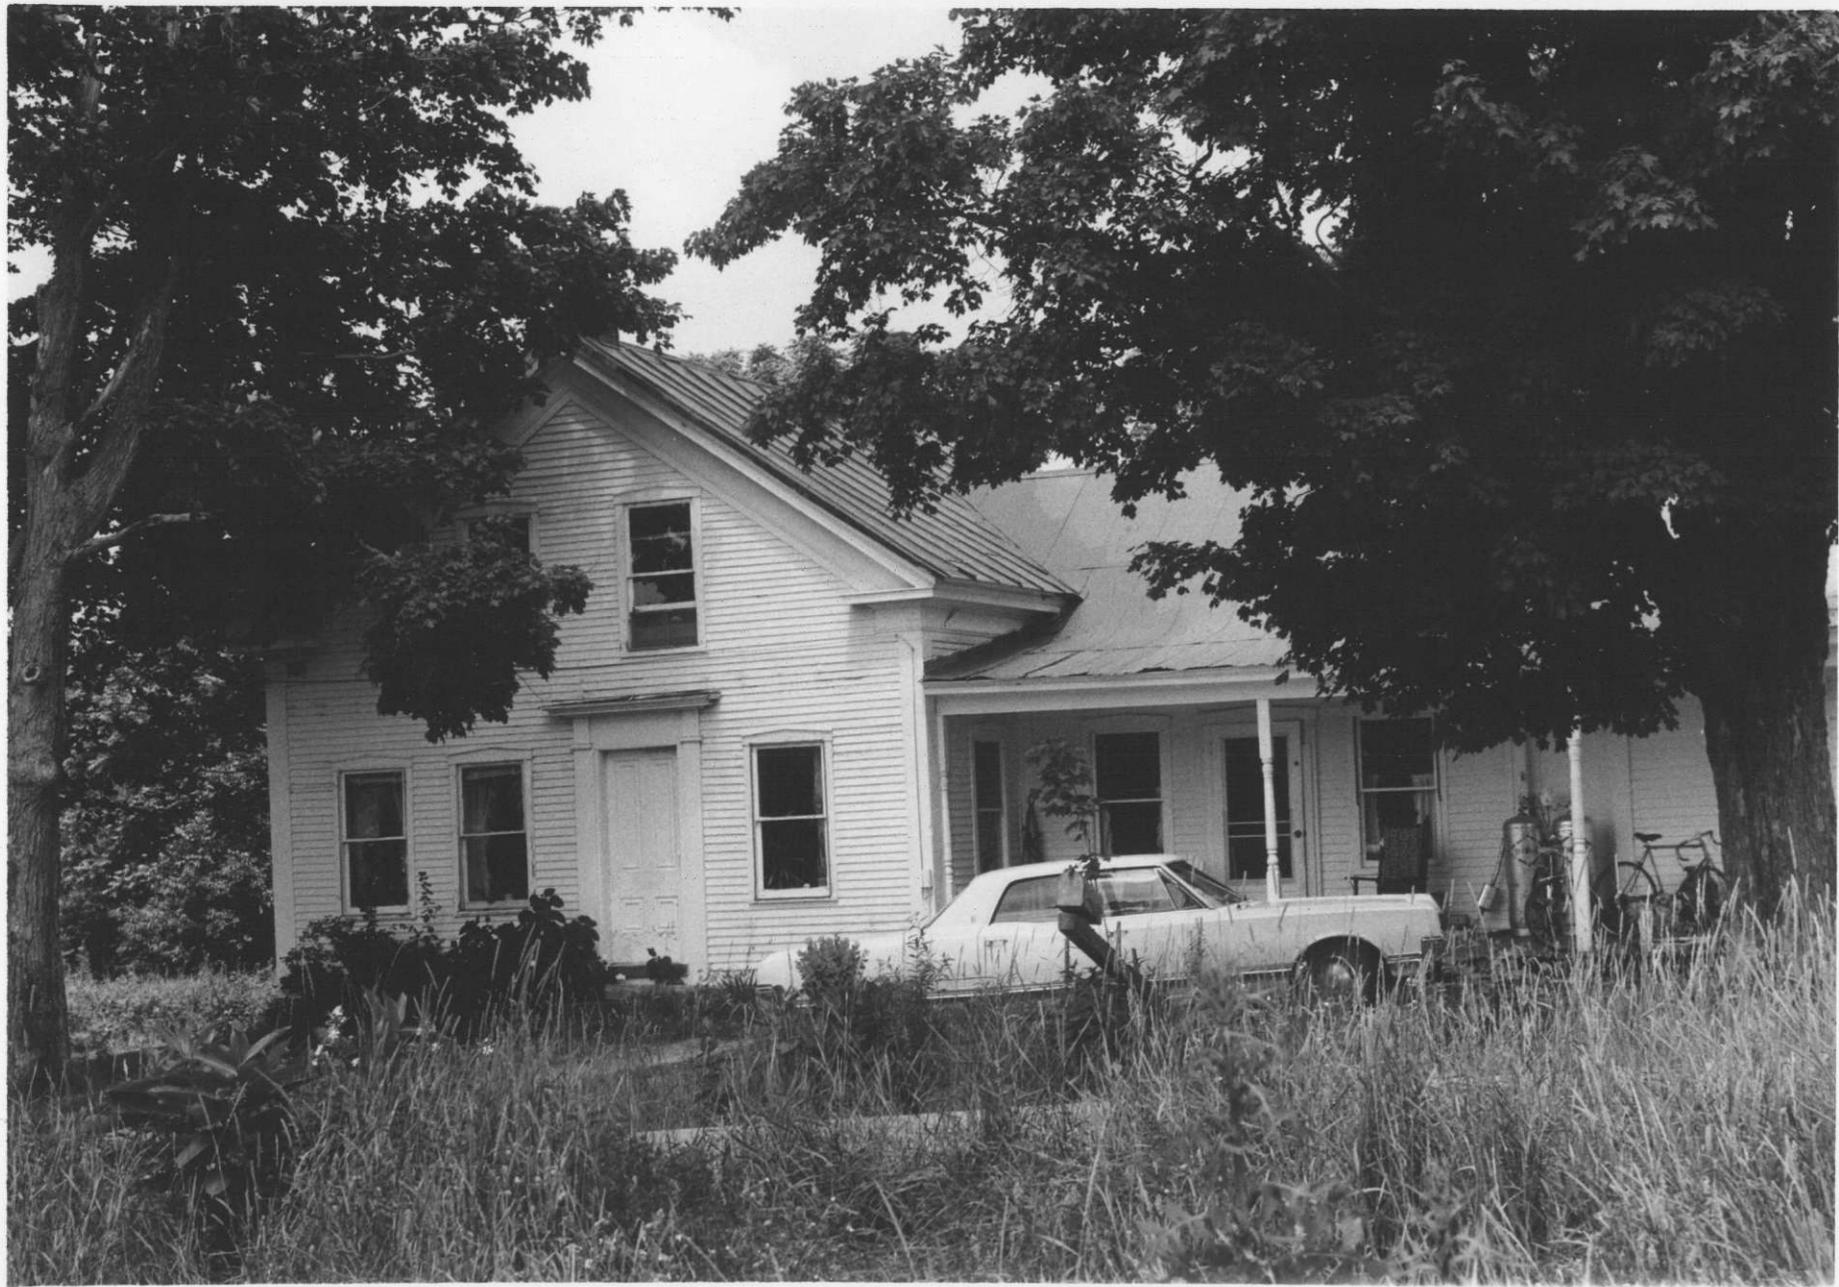
CO Chittenden TOWN Balton DATE July 76
SUBJECT The White House (Phillip's whole farm) VIEW N
FILE # 76-A-194 CREDIT Adelle Croner

This house has a front gable orientation, a wide frieze, partial cornice returns, and peaked window heads which would indicate Greek Revival style, but it has a Federal doorway with pilasters "en rissault" which would indicate earlier origins.

Possibly the oldest house in West Bolton, it still retains its Federal style doorway with cap moulded lintel and pilasters "en rissault." From the 1850's through the 1880's, this was the Fay farm, run first by Orange L. Fay and then by his widow Caroline. Before Fay the land was owned by Antoin Lancor.

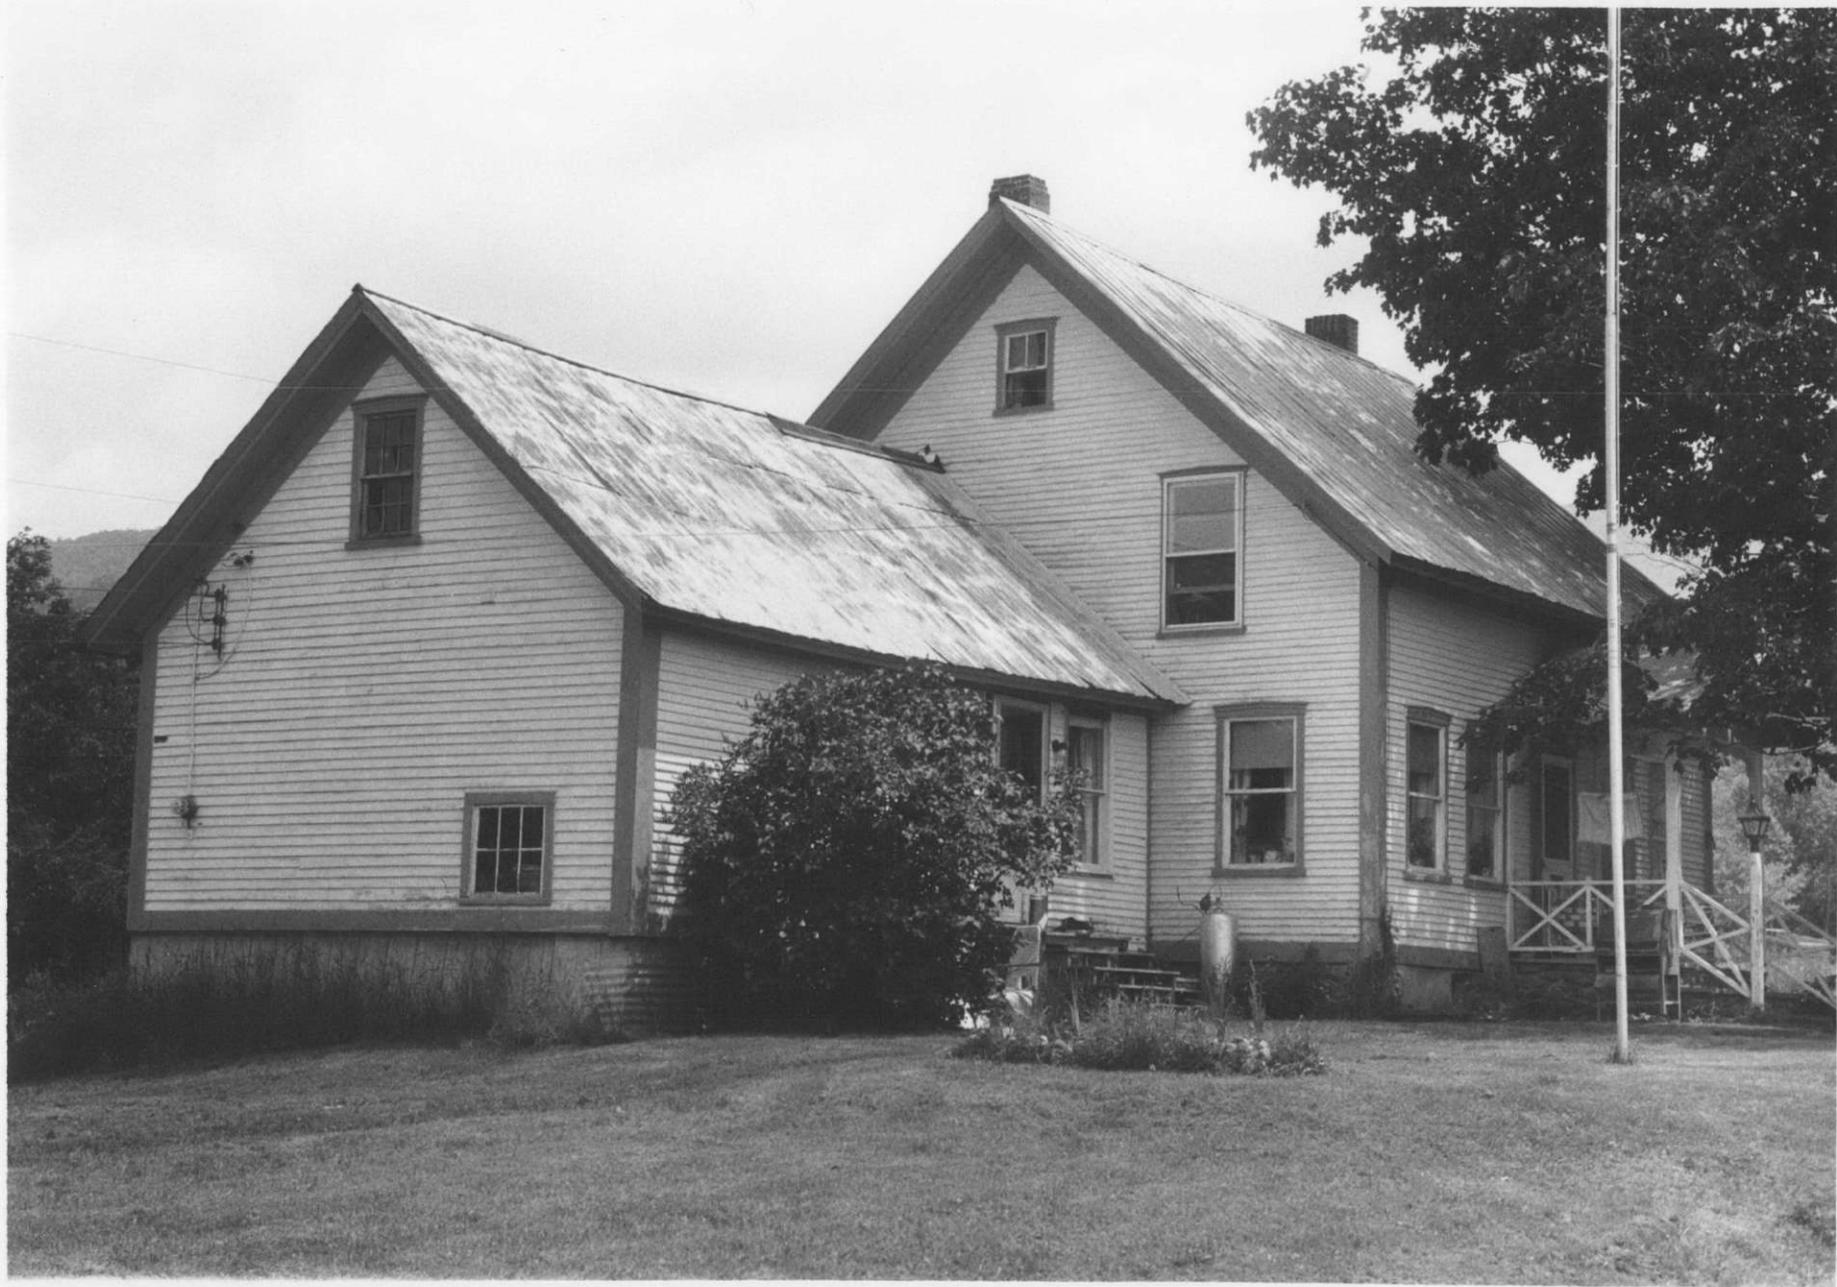
CO. Chittenden TOWN Belton DATE July, '76
SUBJECT Strata Residence VIEW E
FILE # 76-A-194 CREDIT Adelle Cramer

This house has a fieldstone foundation, plain window surrounds with peaked window heads, a projecting cornice, a wide frieze, corner boards and a projecting entrance porch. Window heads on the side window are plain.

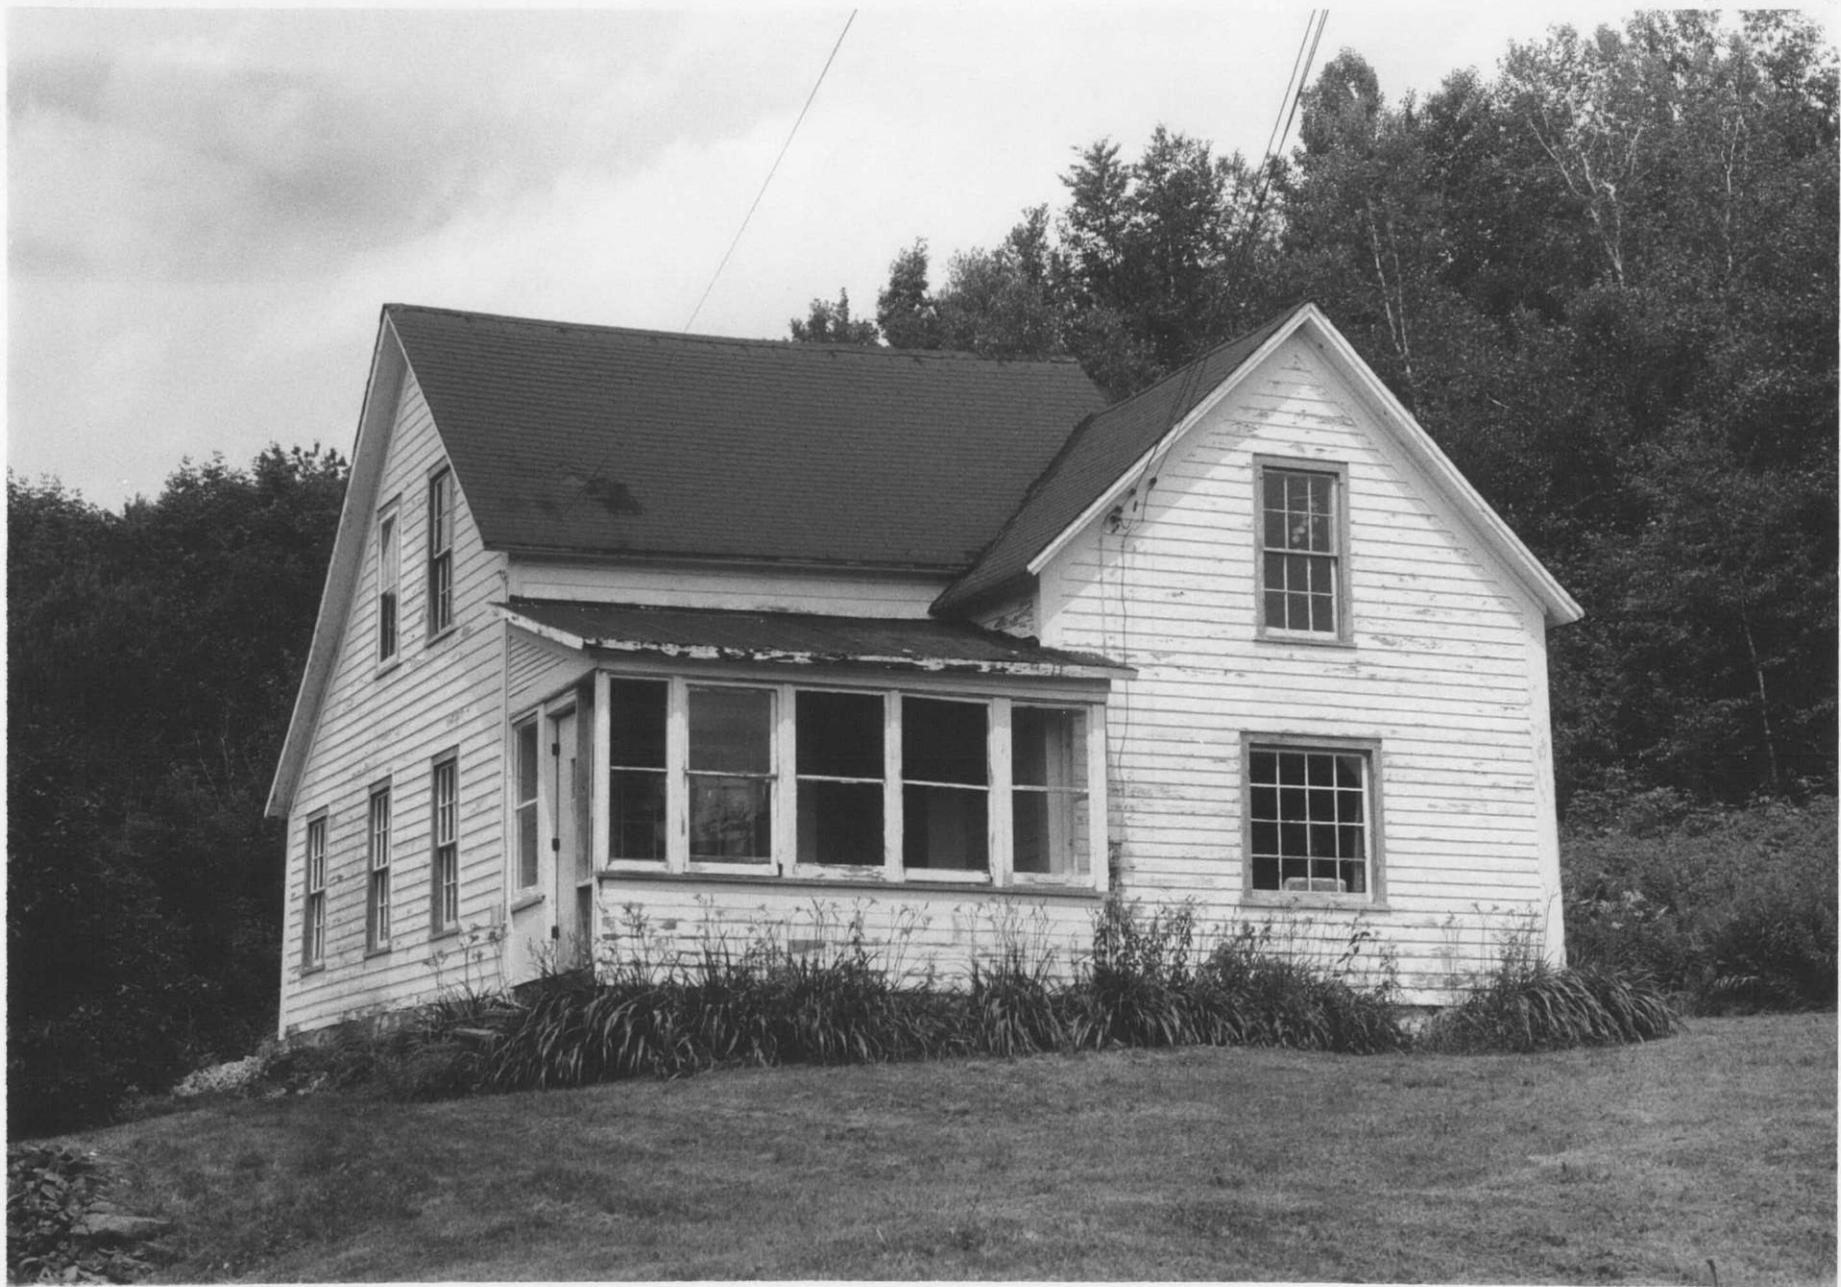
CO. Chittenden TOWN Balton DATE July/76
SUBJECT Mullen Residence VIEW N
FILE # 76-A-194 CREDIT Adèle Cramer

The original house is now the front-gabled section. It has a fieldstone foundation, hand-hewn beams and floor joists made from undressed, half-logs. A 9 over 6 window lights the rear gable end. Around 1900, another house from West Bolton was attached to the original section. 6 over 6 window sashes added in the 1940's, replaced 2 over 2 sashes and a Queen Anne sash window was removed from the front gable and replaced with the present multi-paned picture window.
