Hamilton, John, Farmstead  
Bridport, Addison County, Vermont

# National Register of Historic Places Registration Form

historic name Hamilton, John, Farmstead

United States Department of the Interior  
National Park ServiceNational Register of Historic Places  
Continuation SheetSection number 7 Page 1Hamilton, John, Farmstead  
Bridport, Addison County, VT

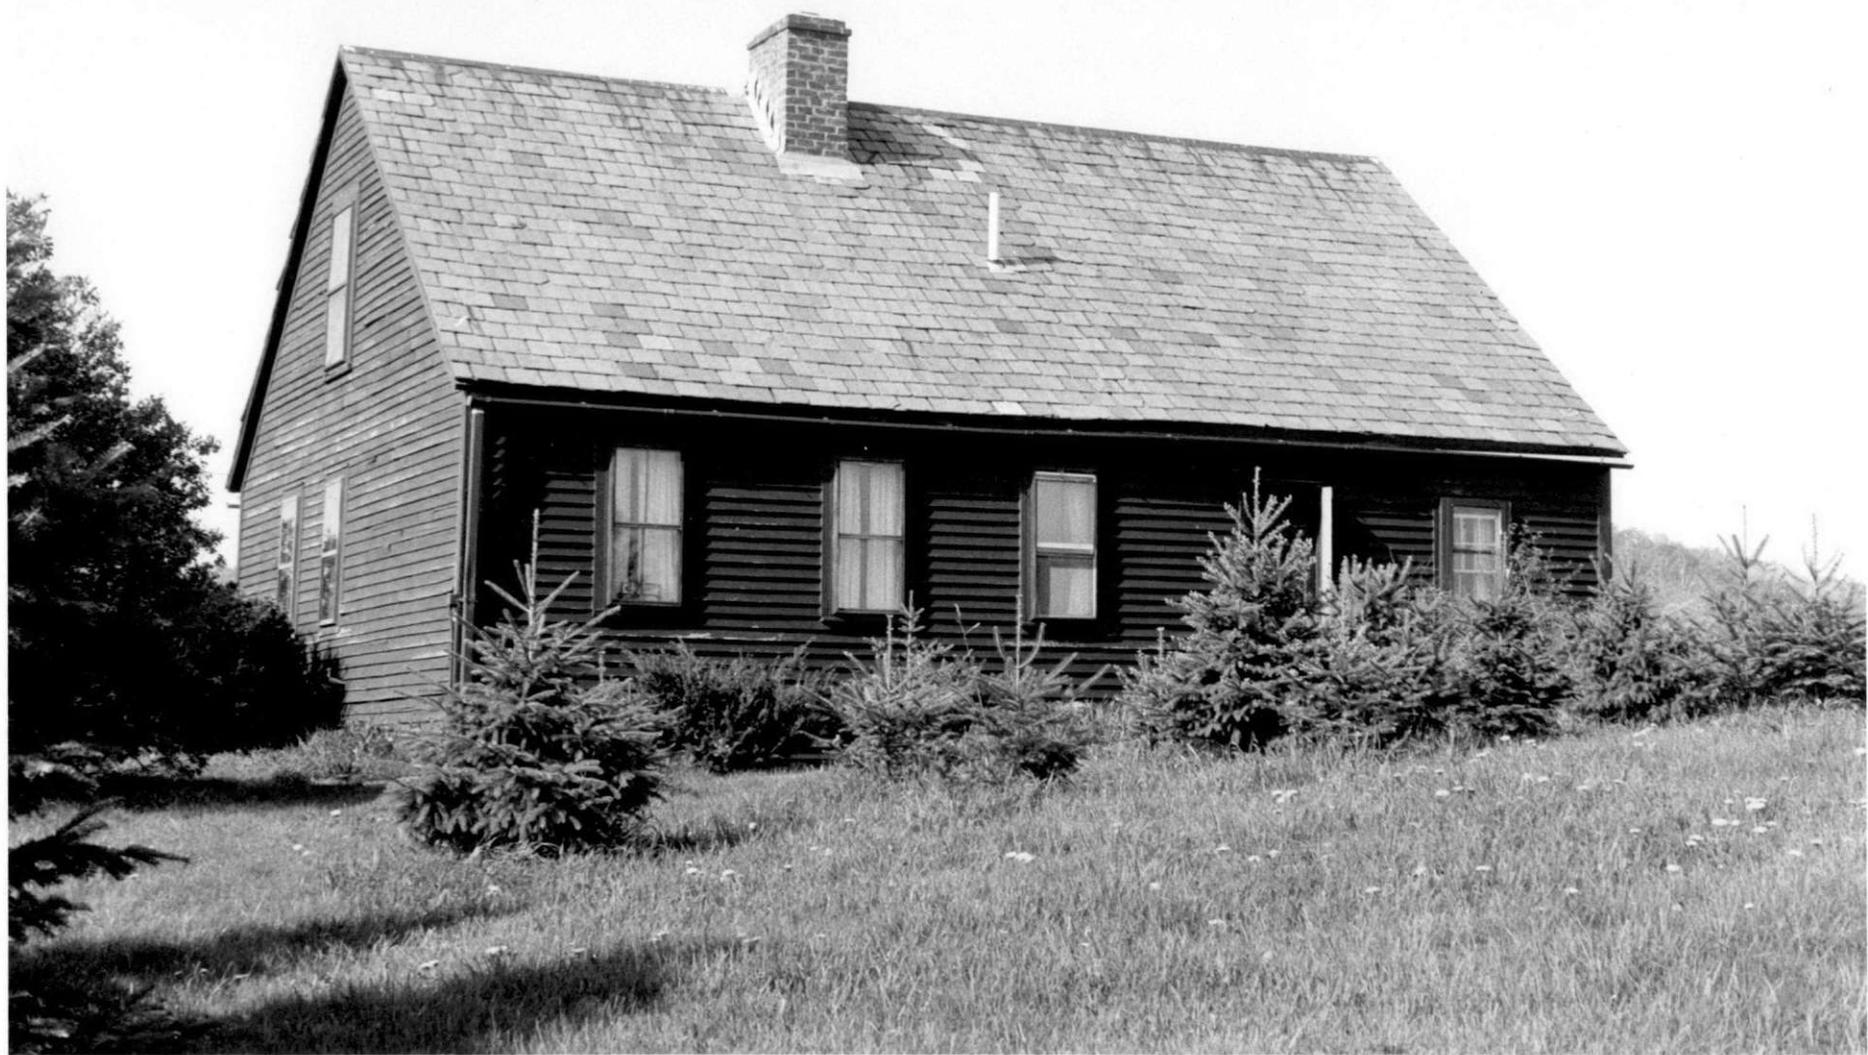
92-61

Hamilton, John, Farmstead  
Bridport, Addison Co., Vermont  
Credit: Elsa Gilbertson  
Date: May 1992  
Negative: VT Div. Hist. Pres.  
View looking S, bldg #1  
Photo 2

**1 Farmhouse, 1804**

The Cape Cod farmhouse is a one and half story, five bays long by two bays wide, post and beam frame structure covered with clapboards, resting on a concrete foundation and topped with slate shingles. An ell approximately forty feet long, created from a c 1840 addition and a c 1890 carriage house, extends to the south from the Cape Cod, also rests on a concrete foundation and is capped with slate shingle roof.

The original Cape Cod portion of the house was built in two sections. First John Hamilton built a small three bay by two bay Cape Cod with large hand-hewn beams. Around 1820, the owner expanded the Cape Cod to its present configuration of five bays by three bays with smaller hand-hewn beams. An ell extending to the south was added c 1840 while a carriage house containing a tool shed, further elongated the ell to its present dimensions about 1890. To unify the exterior appearance the current owner replaced the wooden shingles and covered all the components with slate shingles.

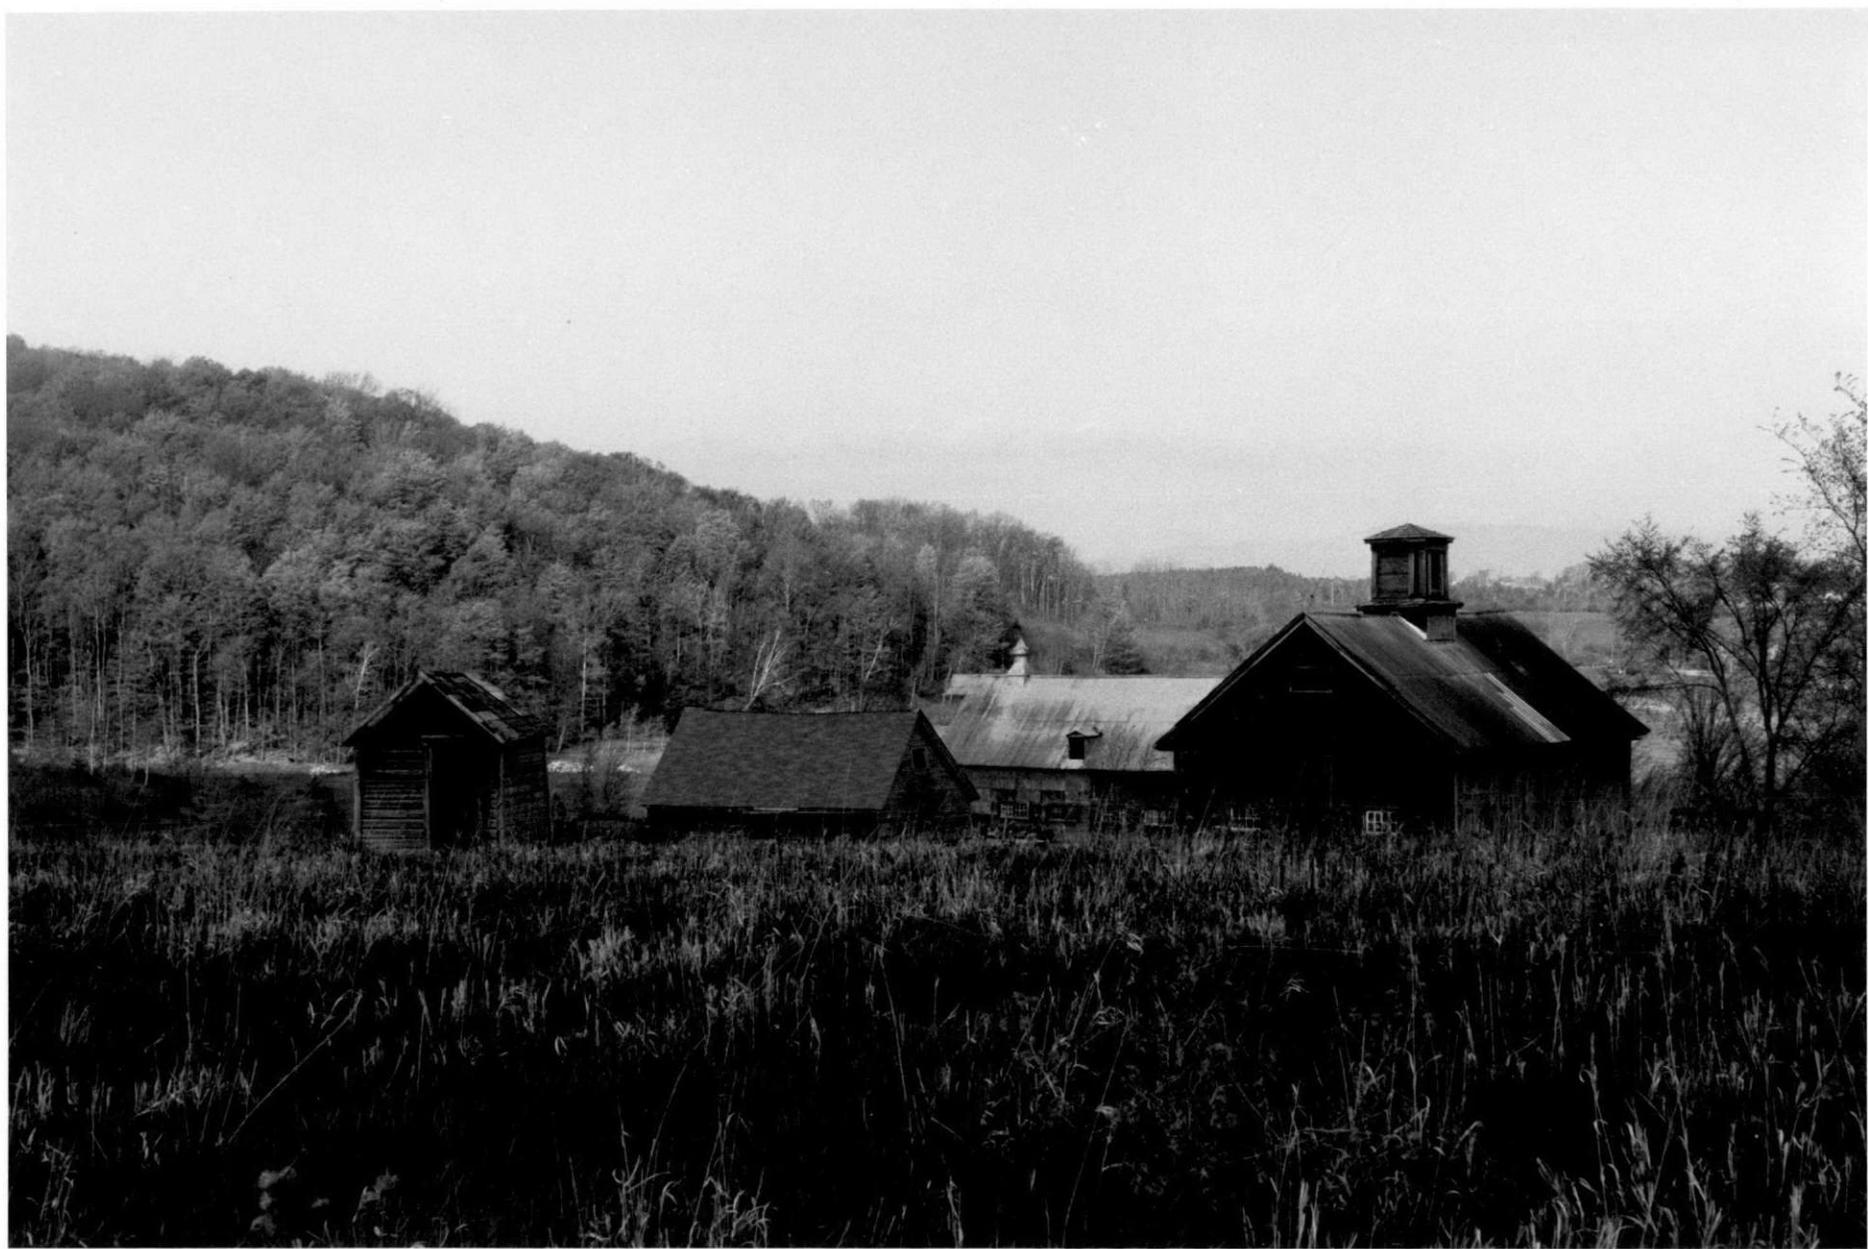
92-61

+  
Hamilton, John, Farmstead  
Bridport, Addison Co., Vermont  
Credit: Elsa Gilbertson  
Date: May 1992  
Negative: VT Div. Hist. Pres.  
View looking W, shed, #s3,2,4  
Photo 1

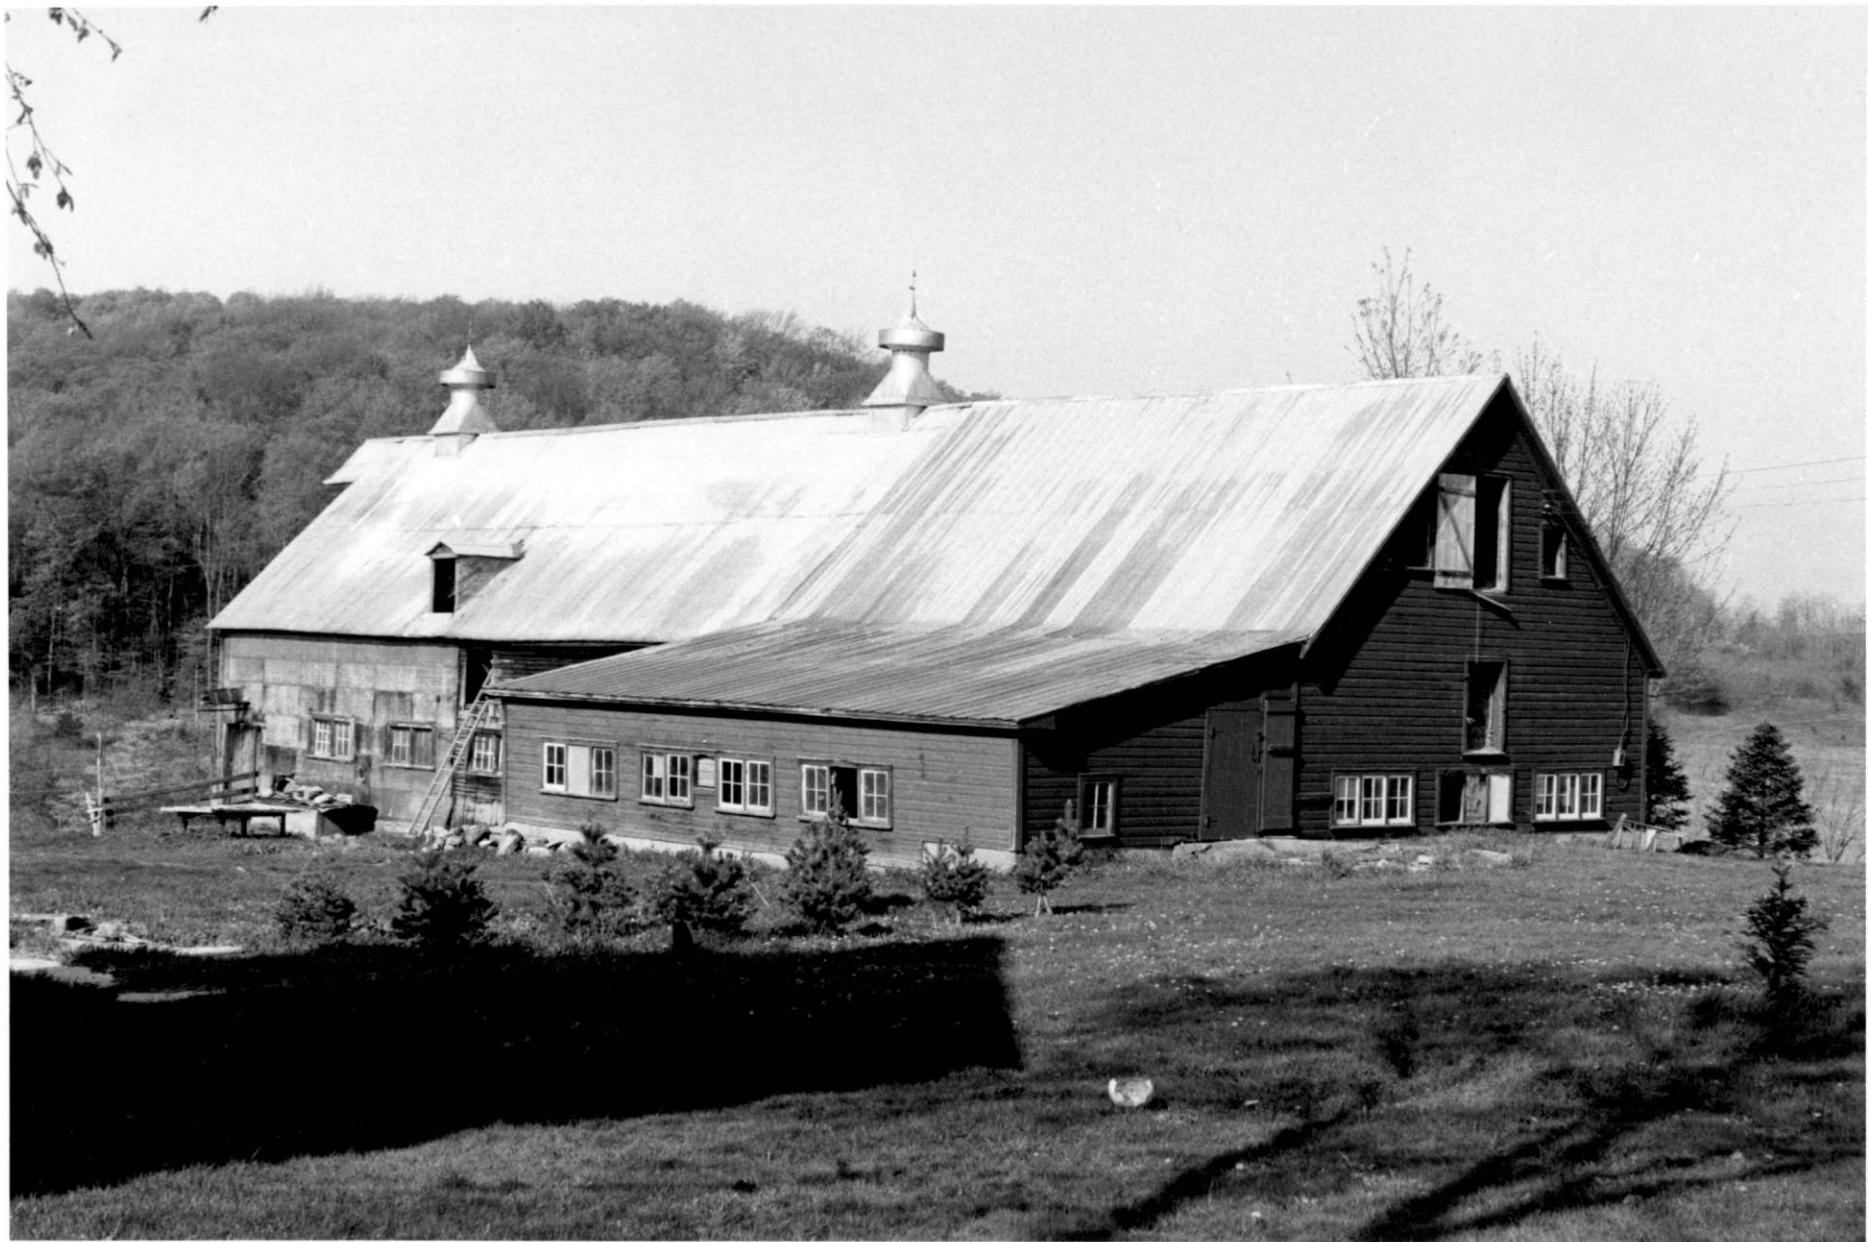
92-6

Hamilton, John, Farmstead  
Bridport, Addison Co., Vermont  
Credit: Elsa Gilbertson  
Date: May 1992  
Negative: VT Div. Hist. Pres.  
View looking SW, bldg #2  
Photo 4

**2 Ground Level Stable Barn, c 1900/c 1940**

Built in the early 1900s by Maxime St George for his dairy operation, the southern section is the oldest part of the current structure. Expanding in the early years of World War II, Kenneth St George built the northern portion. Located approximately twenty-five feet south of the farmhouse sits the dairy barn today, a one and a half story rectangular structure used to house the dairy cows and pigs of the St George family. Situated on the bank of a hill, the concrete foundation and floor support a wooden frame with both metal and clapboard siding while the entire entity is covered by a corrugated sheet-metal gable roof. The two round metal air ventilators on the roof ridge and bands of stable windows on the north and east sides indicate dairy purposes. From the 1940s addition, a small attached milkhouse extends to the west while the two pig sties extend to the east.

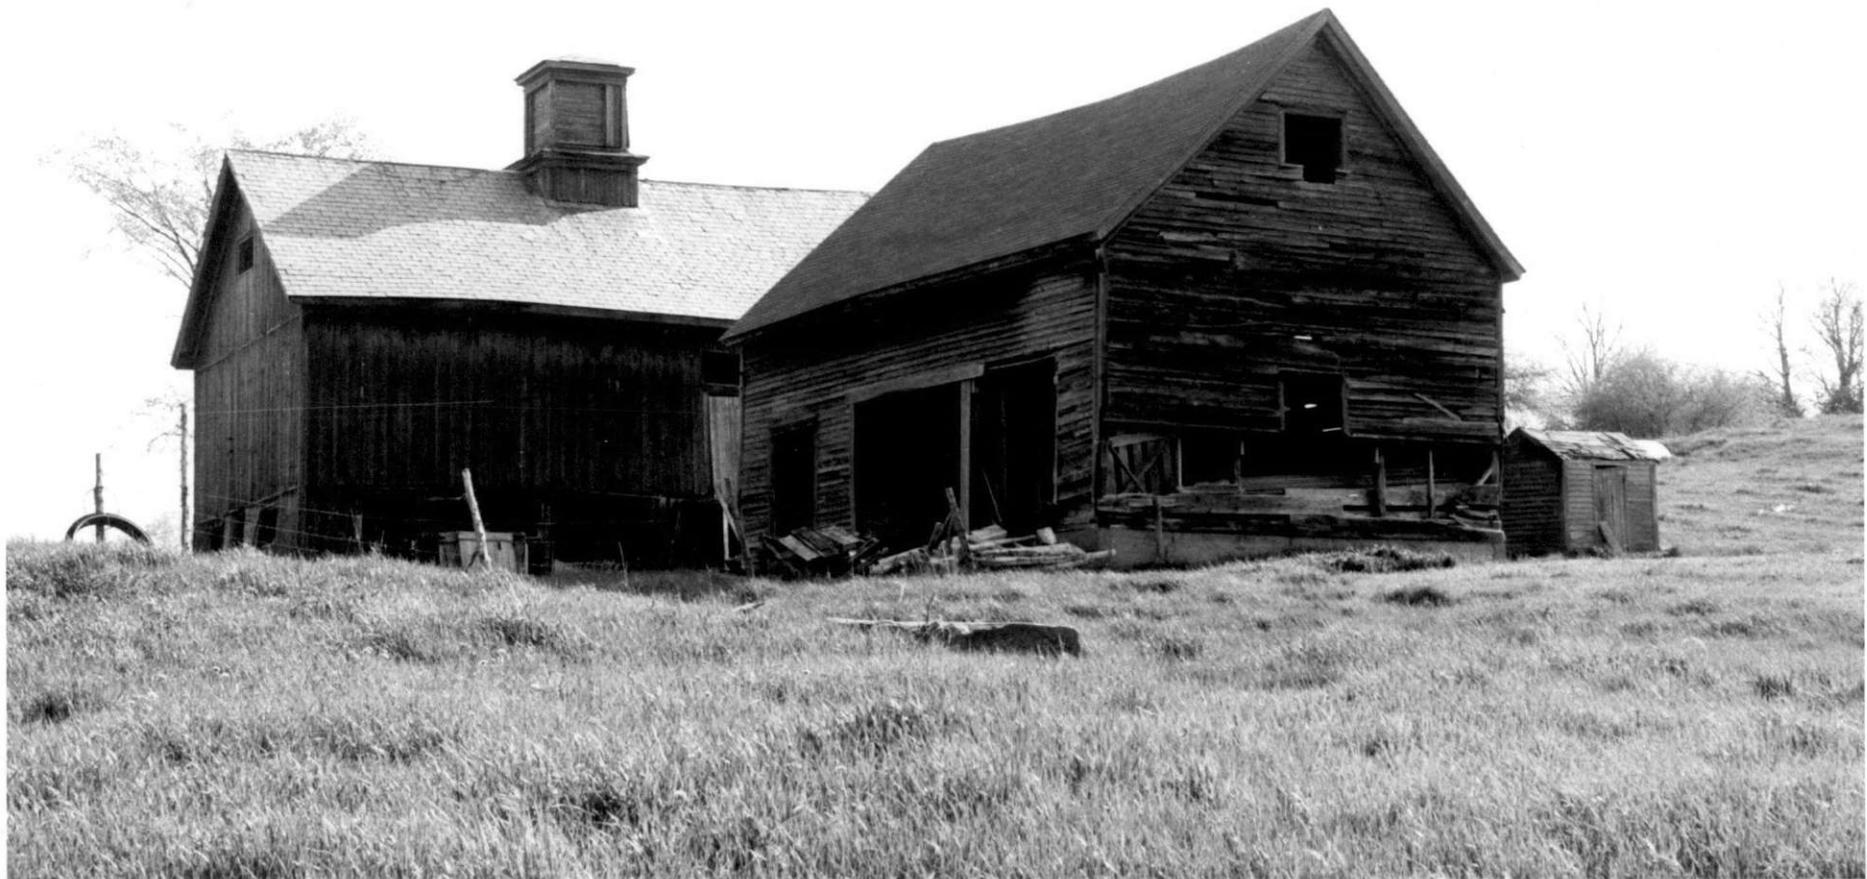
92-61

Hamilton, John.  
~~Witherell Farm~~  
<sup>2nd part</sup>  
Shoreham, Addison Co., Vermont  
Credit: Elsa Gilbertson  
Date: May 1992  
Negative: VT Div. Hist. Pres.  
View looking N, bldgs. #4, 3  
Photo 6

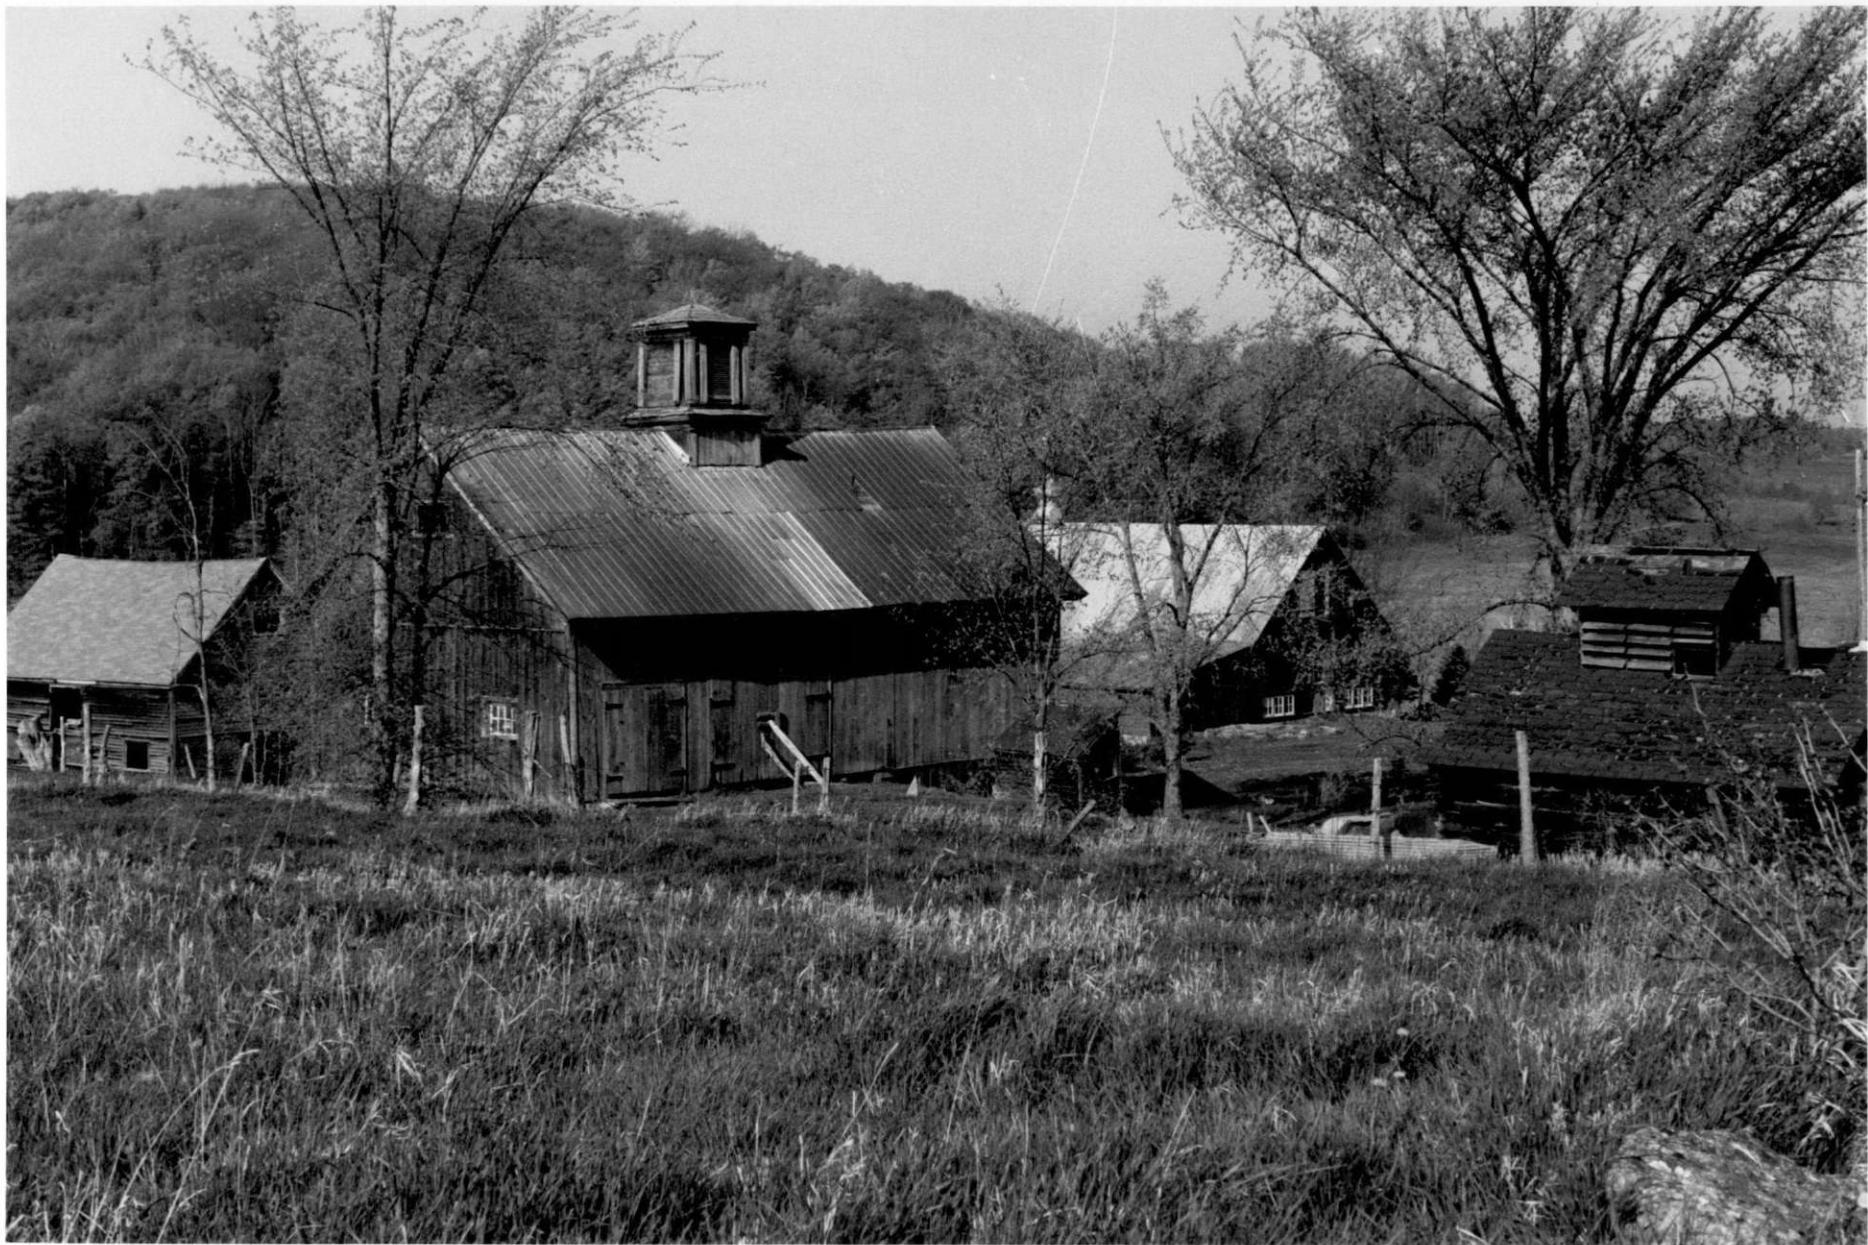
92-61

Hamilton, John, Farmstead  
Bridport, Addison Co., Vermont  
Credit: Elsa Gilbertson  
Date: May 1992  
Negative: VT Div. Hist. Pres.  
View looking SW, #s 3,4,2,9  
Photo 7

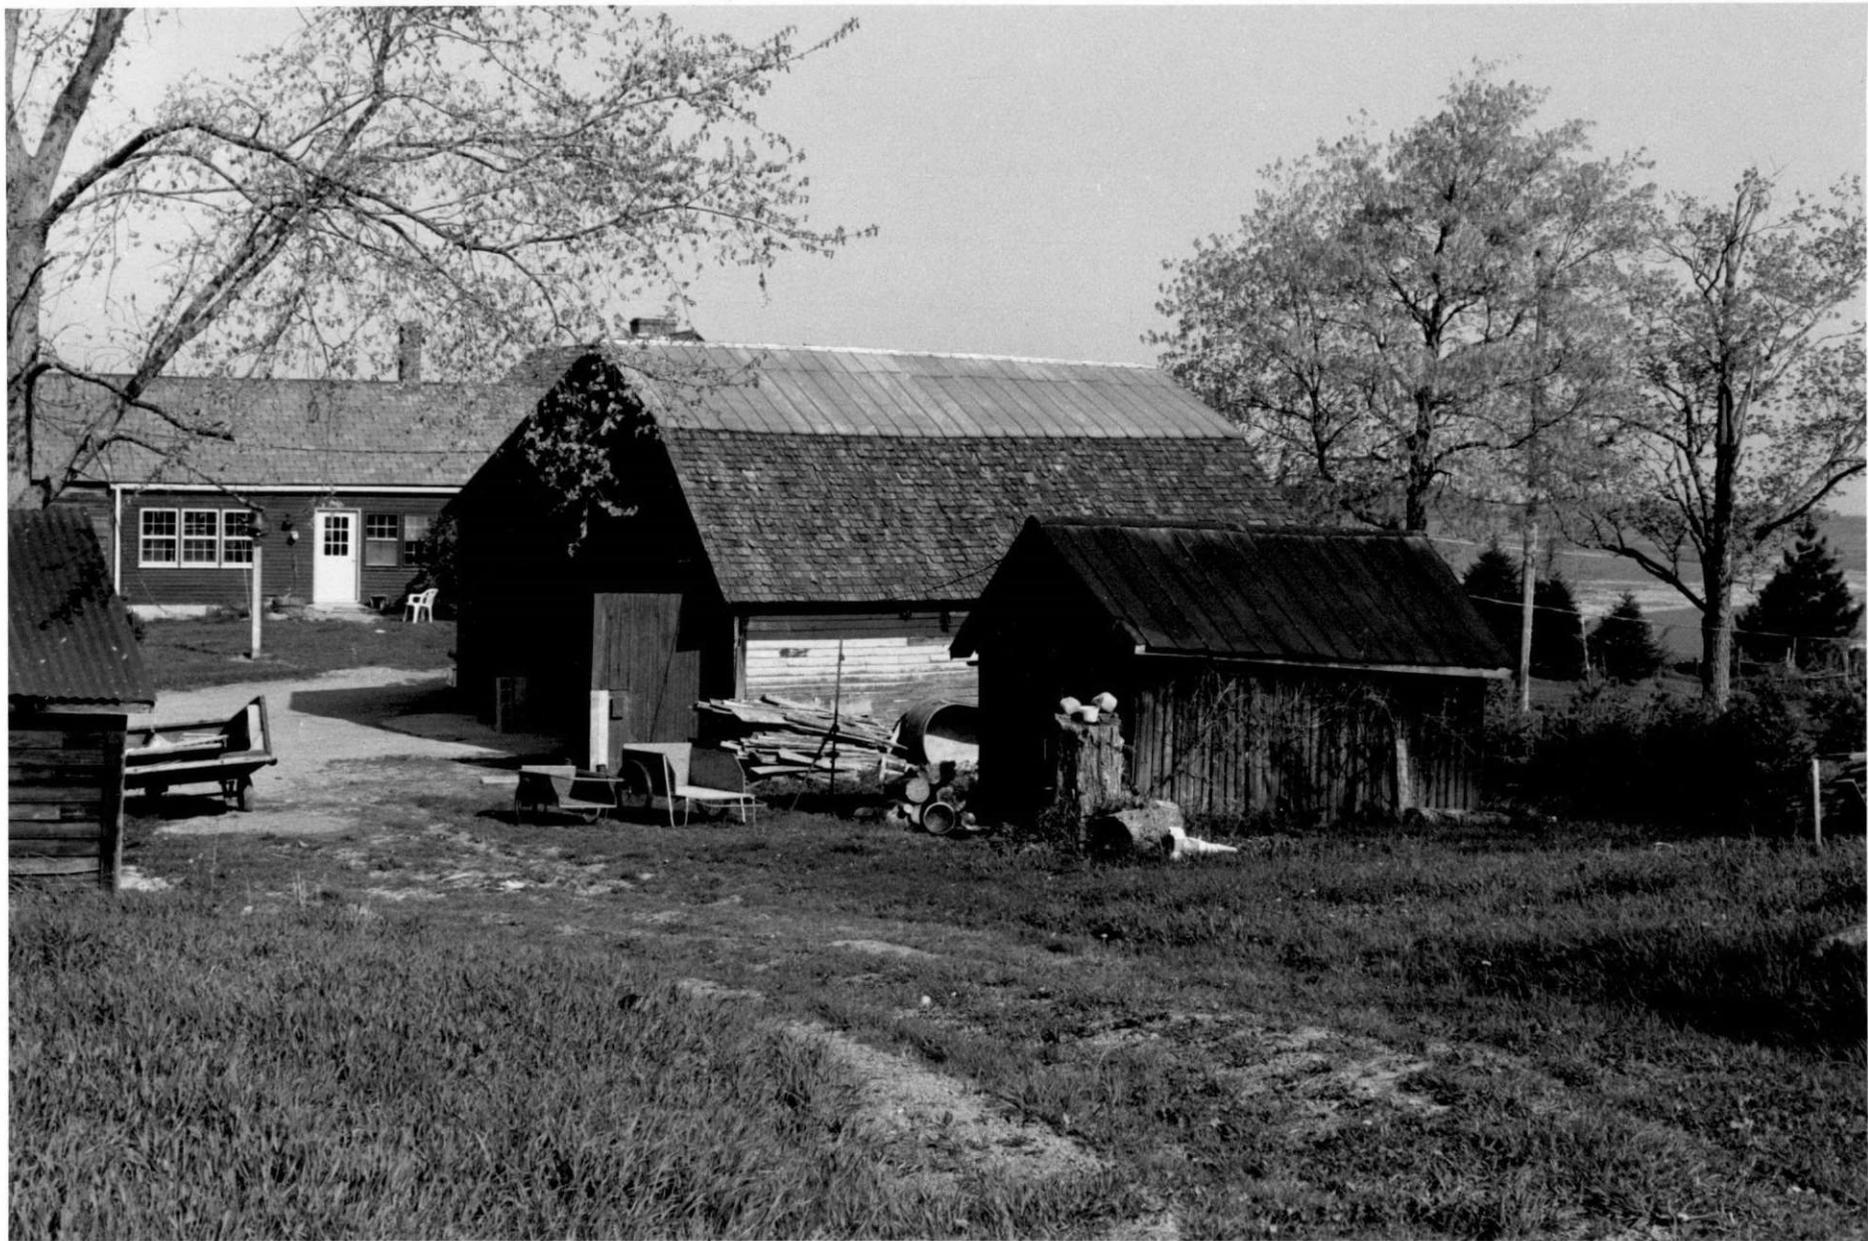
9261

Hamilton, John, Farmstead  
Bridport, Addison Co., Vermont  
Credit: Elsa Gilbertson  
Date: May 1992  
Negative: VT Div. Hist. Pres.  
View looking WNW, #s 1, 7, 8  
Photo 8

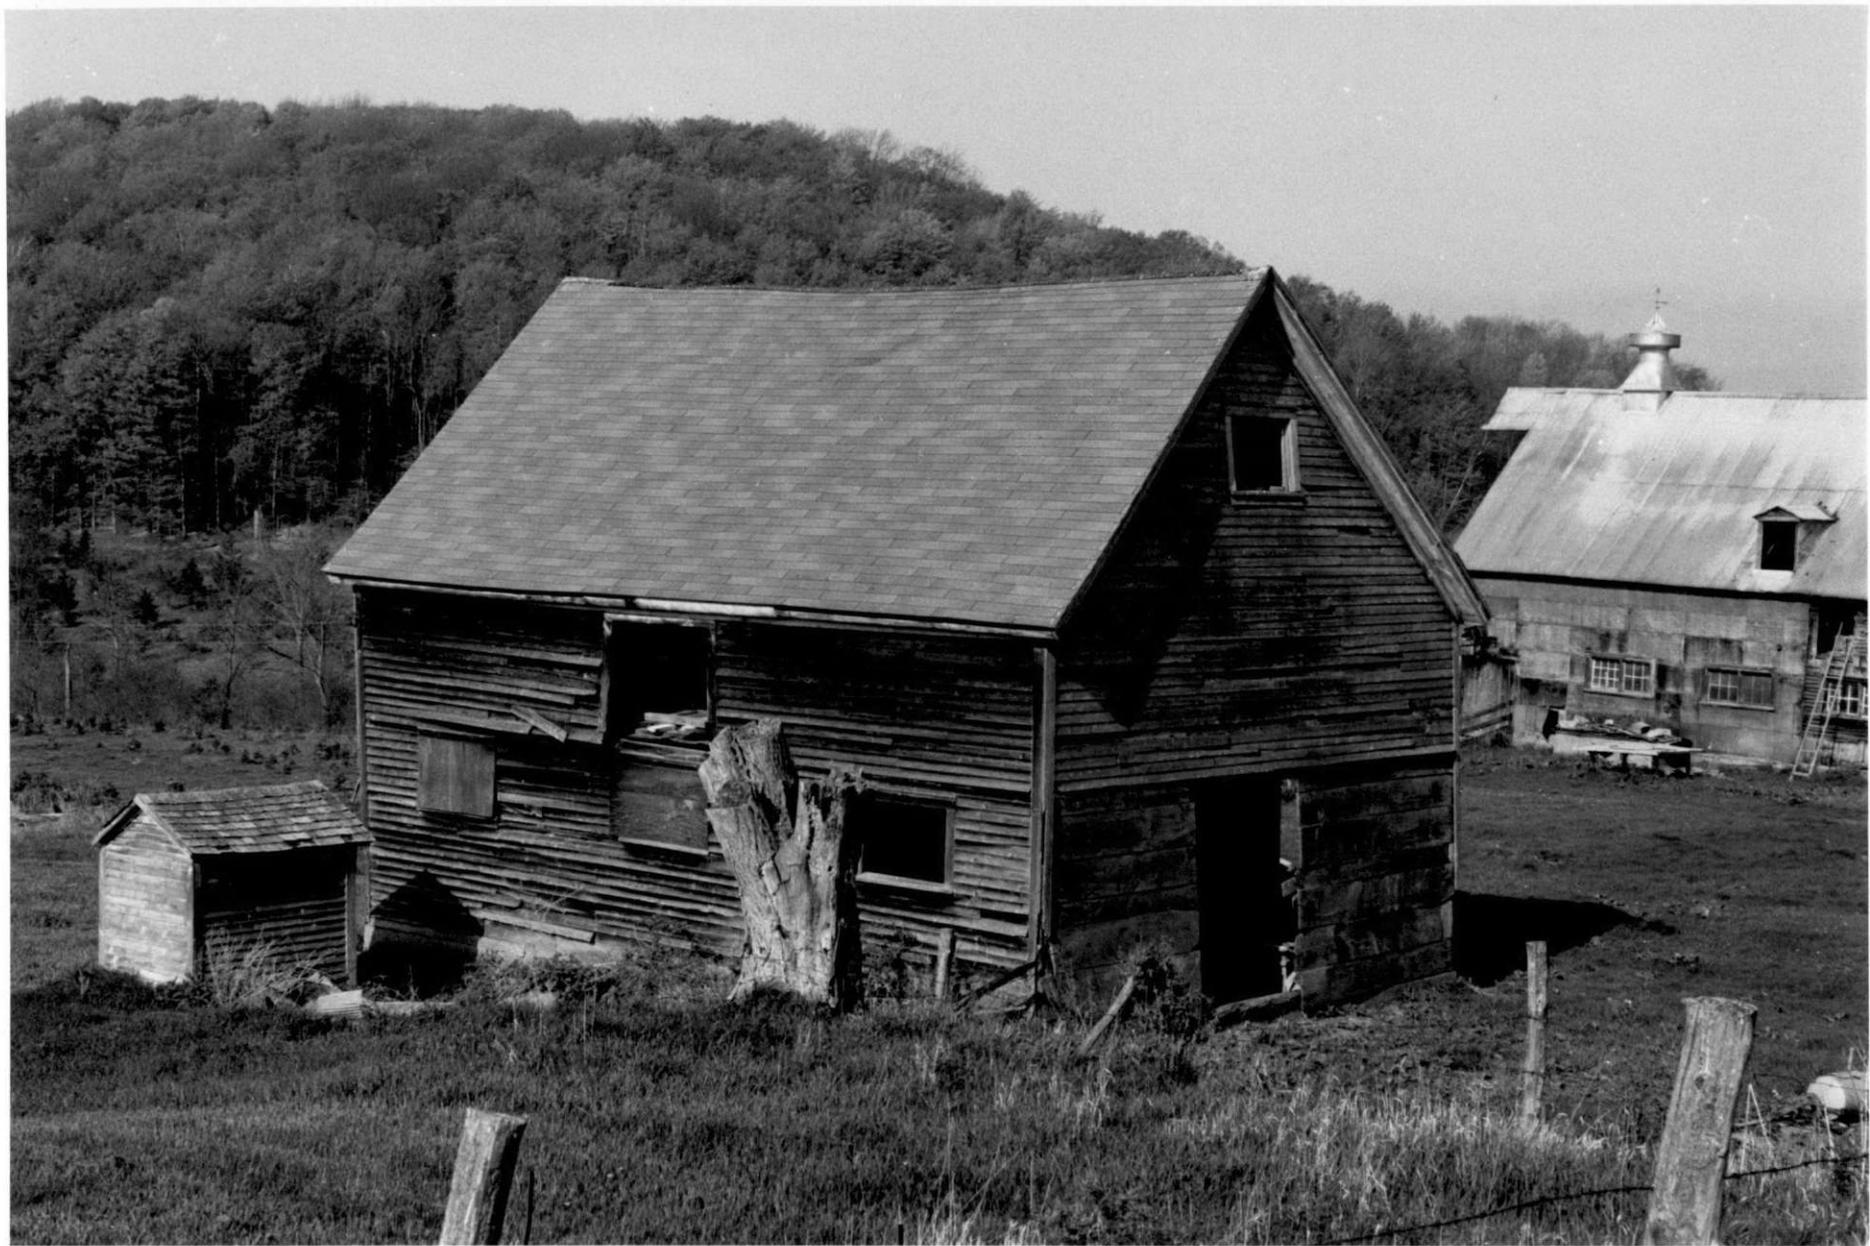
92-61

Hamilton, John, Farmstead  
Bridport, Addison Co., Vermont  
Credit: Elsa Gilbertson  
Date: May 1992  
Negative: VT Div. Hist. Pres.  
View looking SW, #s 10,3,2  
Photo 9

### 10 Privy, c 1890

Located approximately 25 feet south of the c 1890 Bank barn, the 6'5" x 5'5" rectangular privy, has a frame of 4" square hand hewn beams and is sheathed with weather boards while the gable roof is covered first by wooden shingles and second by composition shingles. It was found on the southern side of the farmhouse at the time of purchase but was moved to its present location by the owners in 1969. Like other farm structures the privies were also moved around the farmstead.
