NATIONAL REGISTER OF HISTORIC PLACES
INVENTORY -- NOMINATION FORM

Wilmington Village Historic District

The buildings and structures included in the Wilmington Historic District are as follows (numbers refer to the enclosed sketchmap):

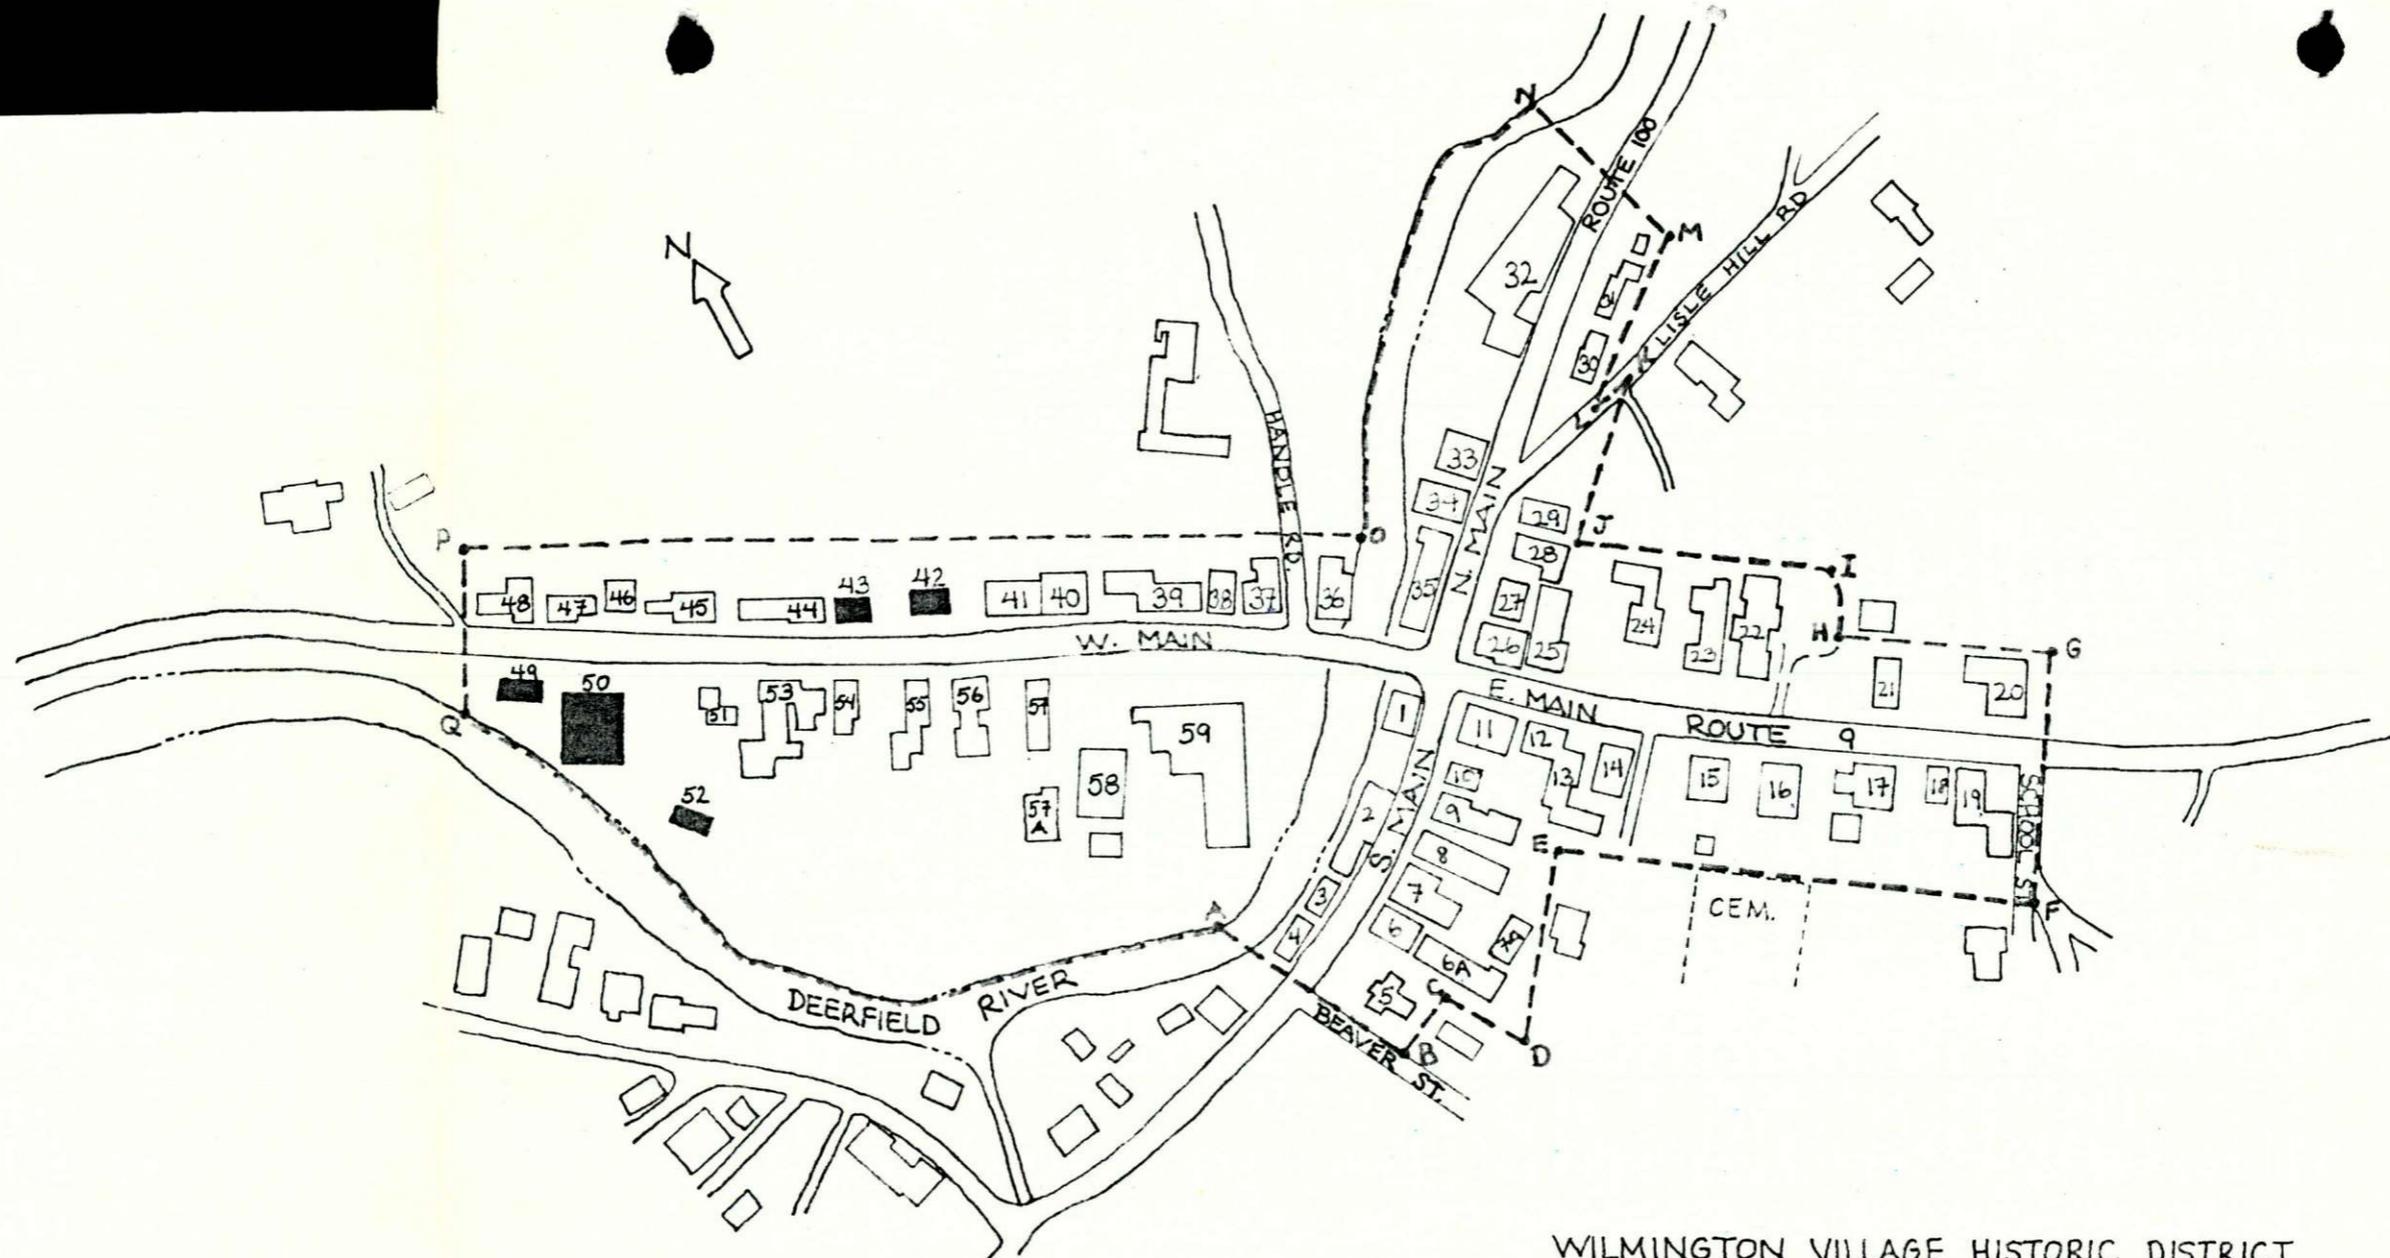
WILMINGTON VILLAGE HISTORIC DISTRICT
 WILMINGTON, VERMONT

■ = INTRUSION

- - - = DISTRICT BOUNDARY

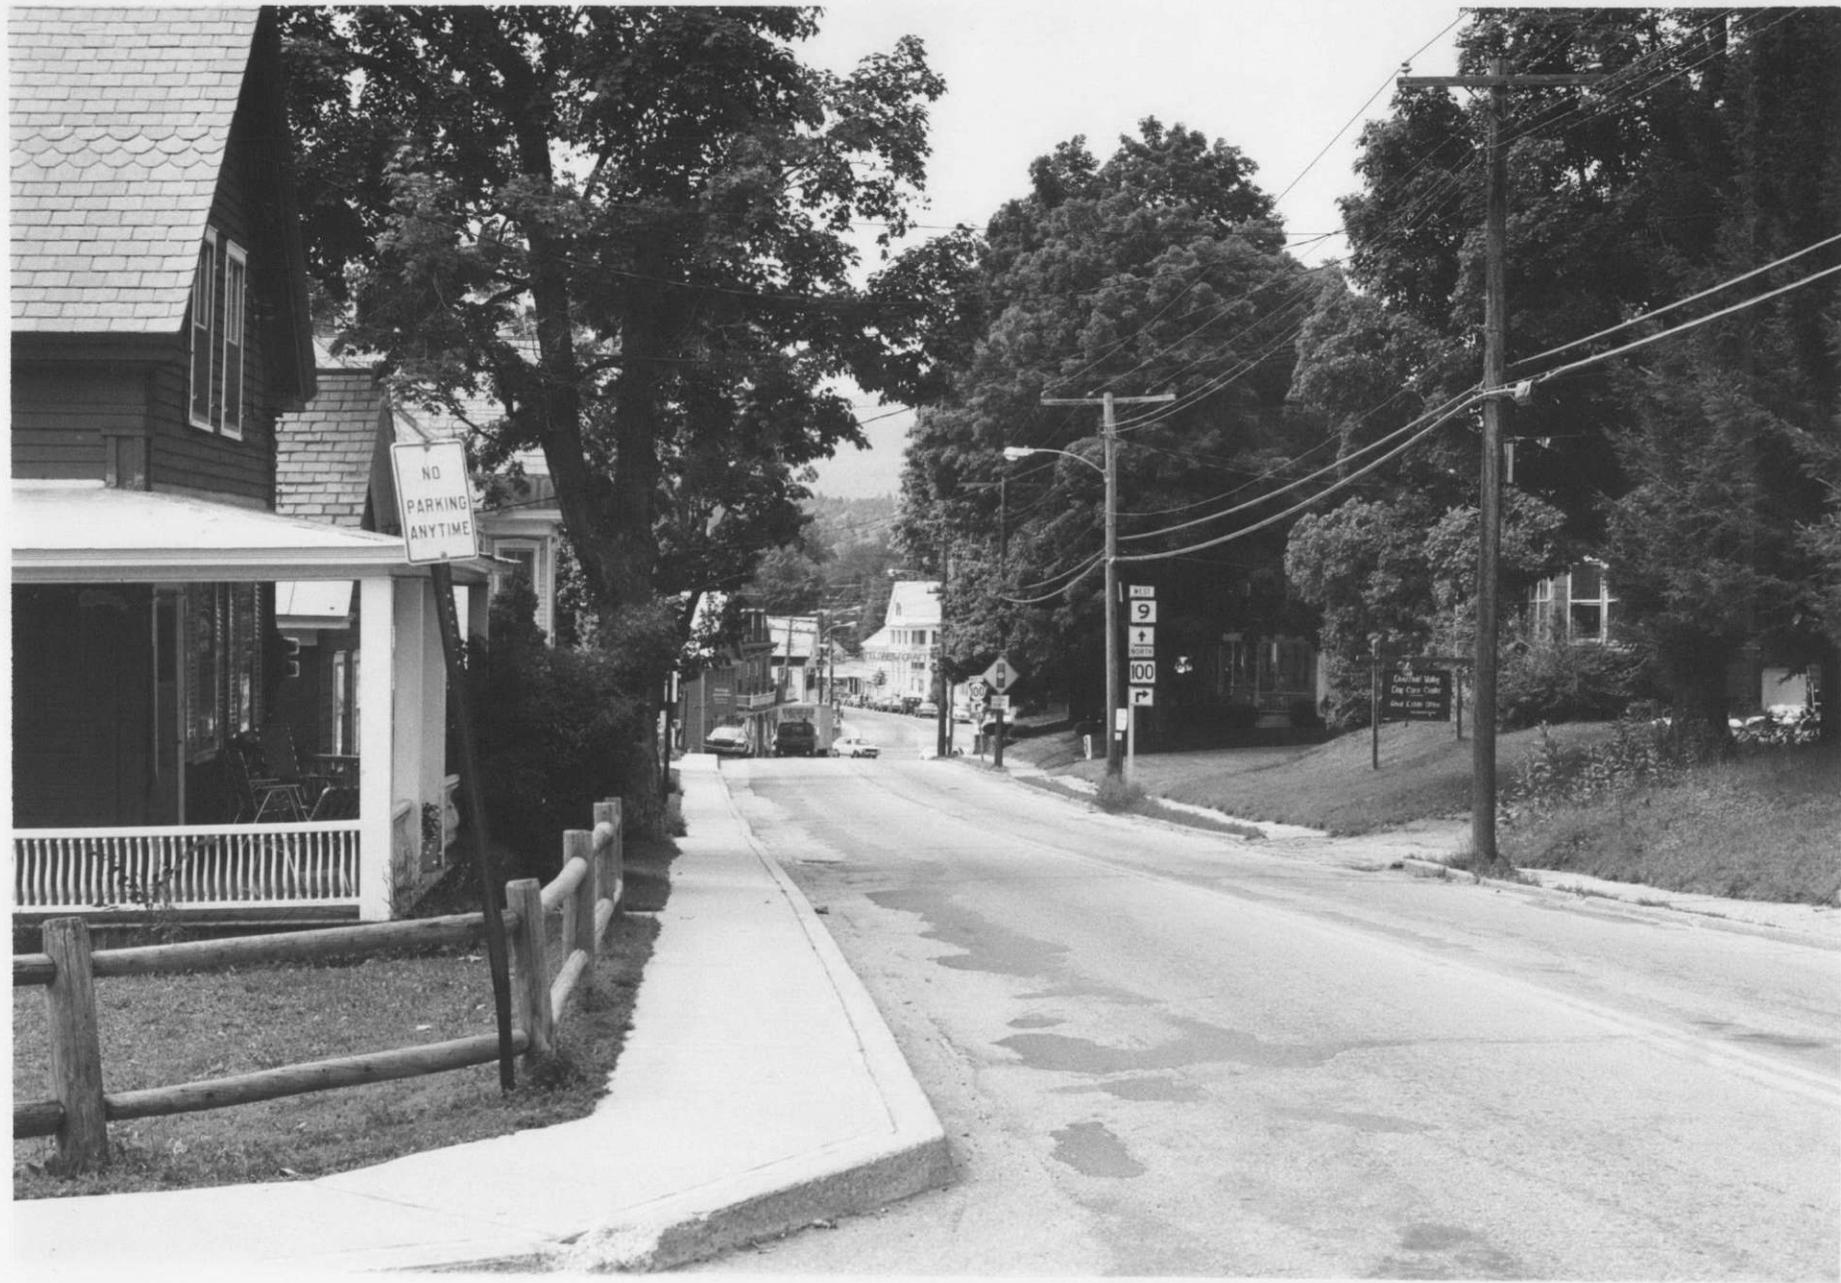
Wilmington Village Historic District
Wilmington, VT
Credit: Charles H. Ashton
Date: ~~January 1980~~ July 1979
Negative filed at Vermont Division for
Historic Preservation
Description: Eastern boundary of district
looking towards village center, East Main
Photograph 1 Street looking west.

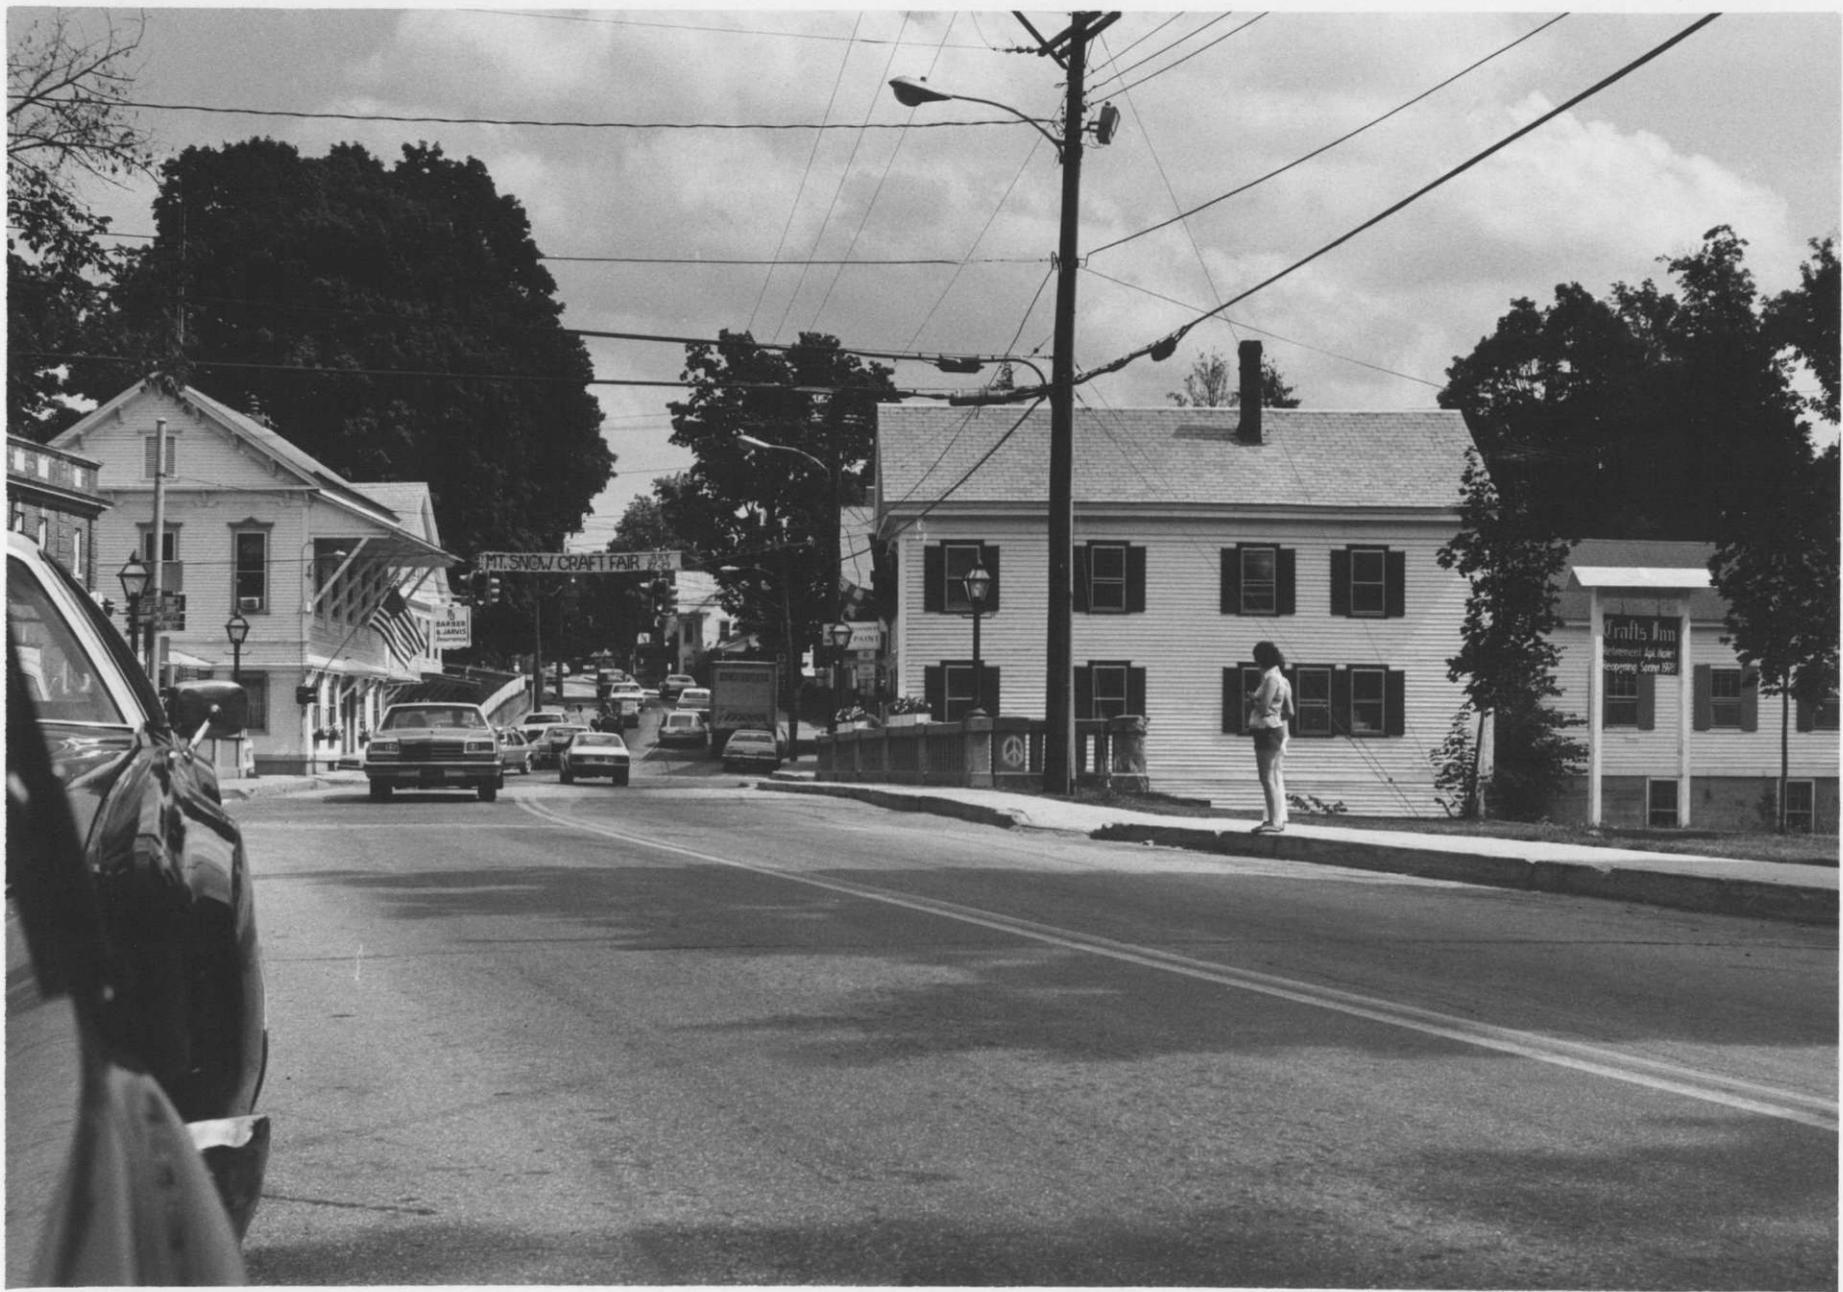
Photograph 2

Description: Village center, West Main St.
looking east on Route 9.

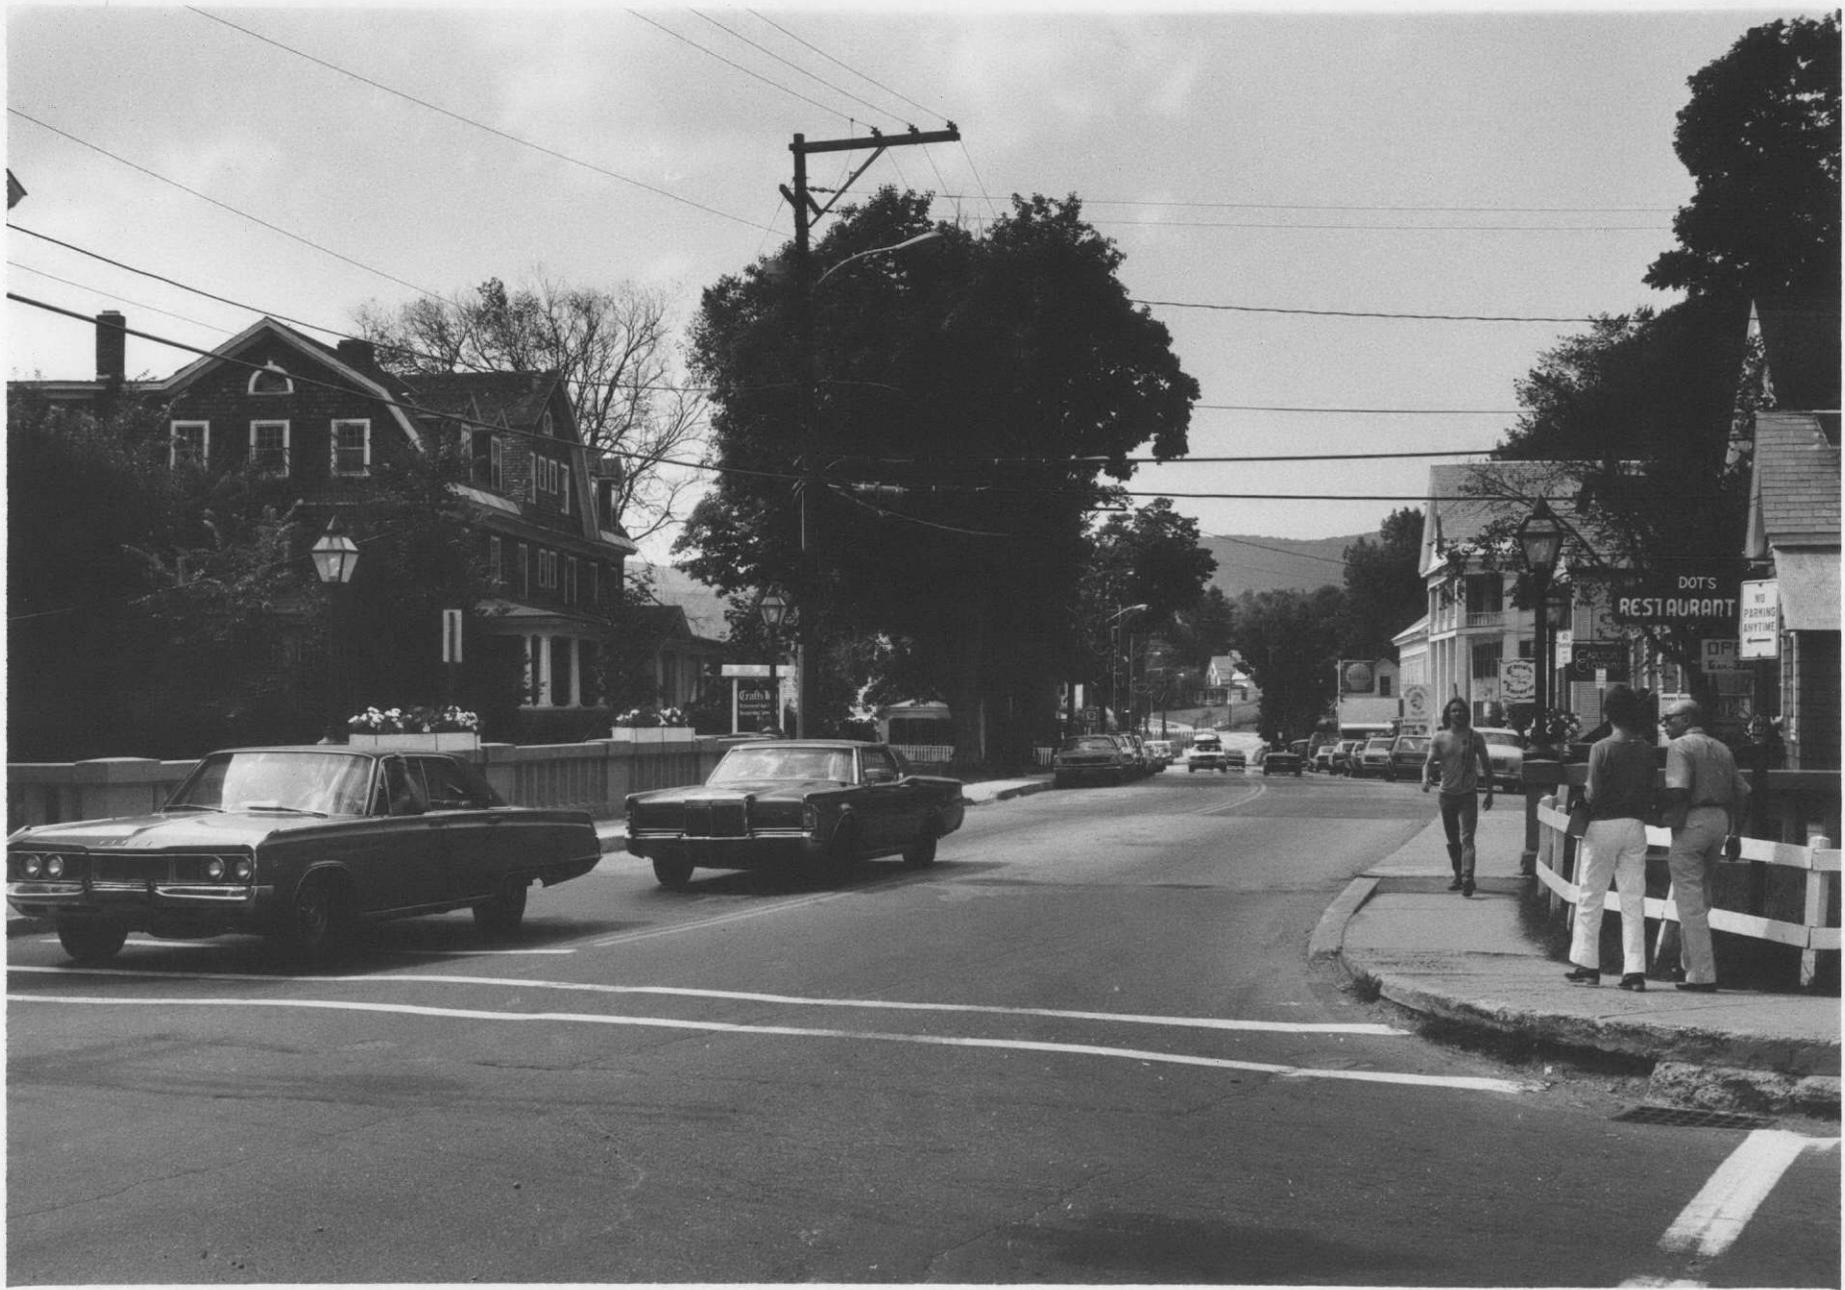
Photograph 3

Description: West Main Street looking west
from Route 100.

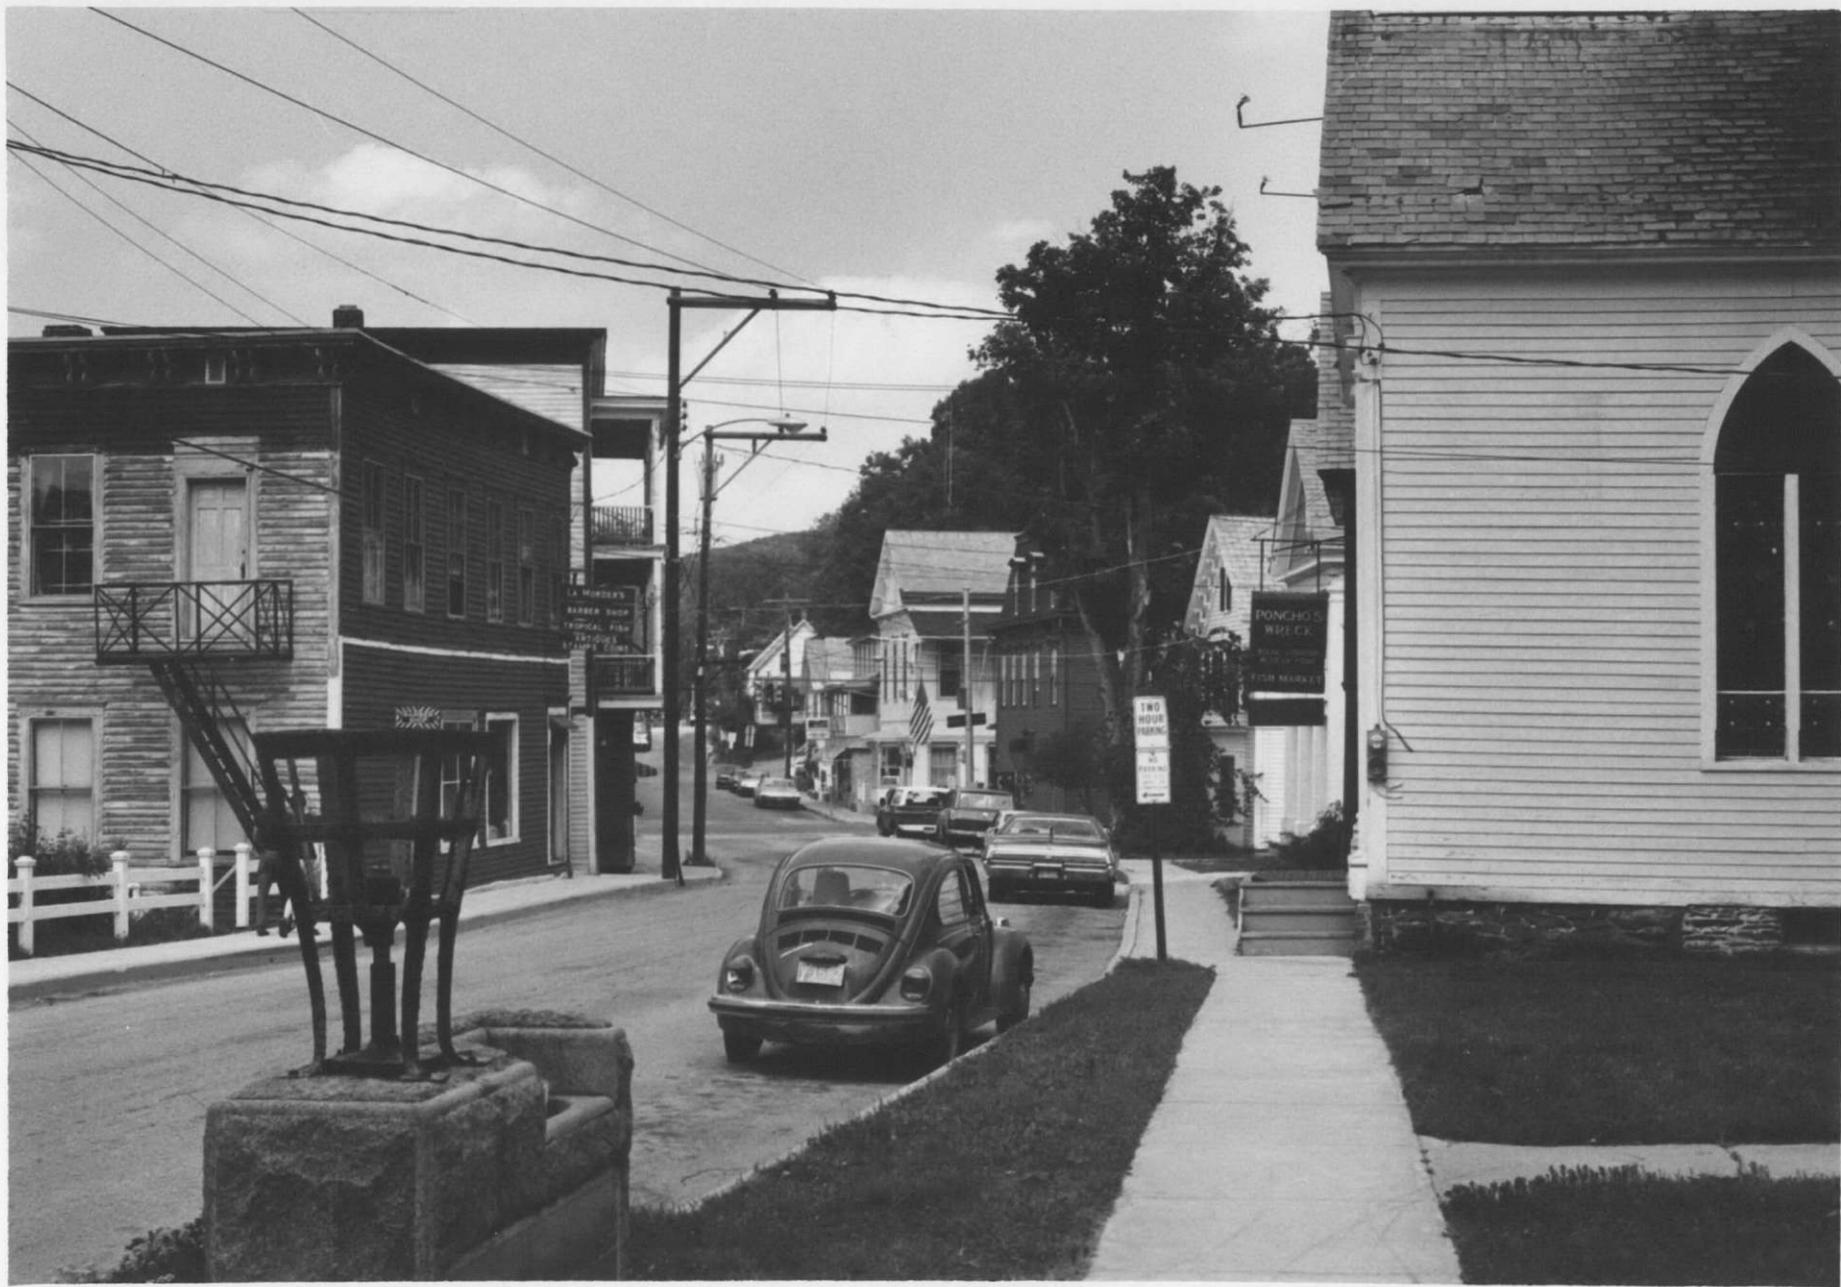
Photograph 4

Description: South Main Street looking north
on Route 100. #4 on left.

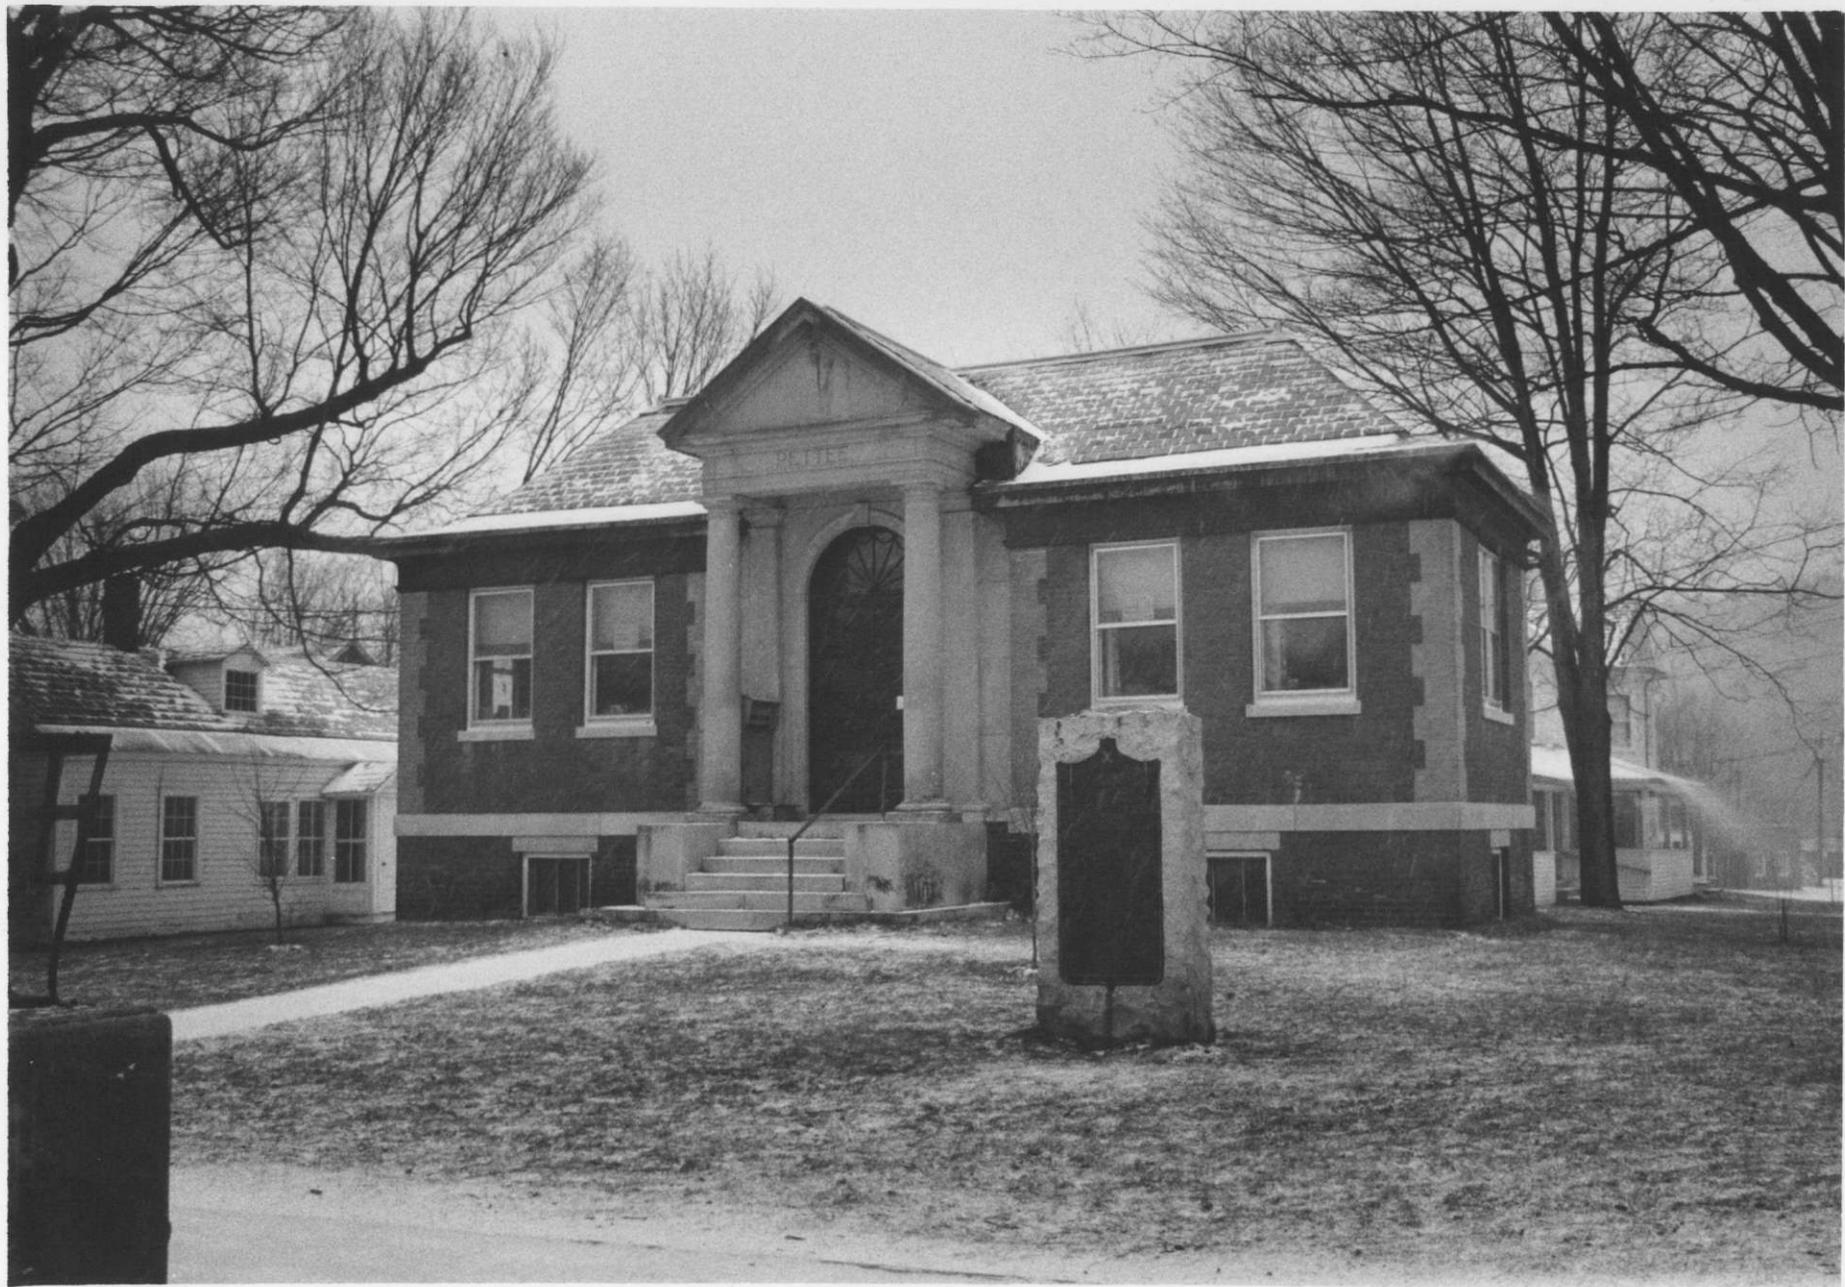
6A. The 1½-story structure situated behind the church appears early, perhaps c. 1800, and may have been built in two stages. The building essentially looks like two capes connected together because each bay of the long building has an entrance and a center brick chimney. The spacing of bays is uneven; windows are double-hung sash with 6/6 lights and there is a gabled dormer on the western half. No eaves overhang, the siding is clapboard, and the roof has slate tiles. There are three storage sheds attached. One has clapboard siding, another board and batten, and the one on the far end has novelty siding and a shed roof.

Wilmington Village Historic District
Wilmington, VT
Credit: Margaret DeLaittre
Date: January 1980
Negative filed at Vermont Division for
Historic Preservation
Description: Pettee Library #5, & #6A on left
View west from South Main Street.
Photograph 5

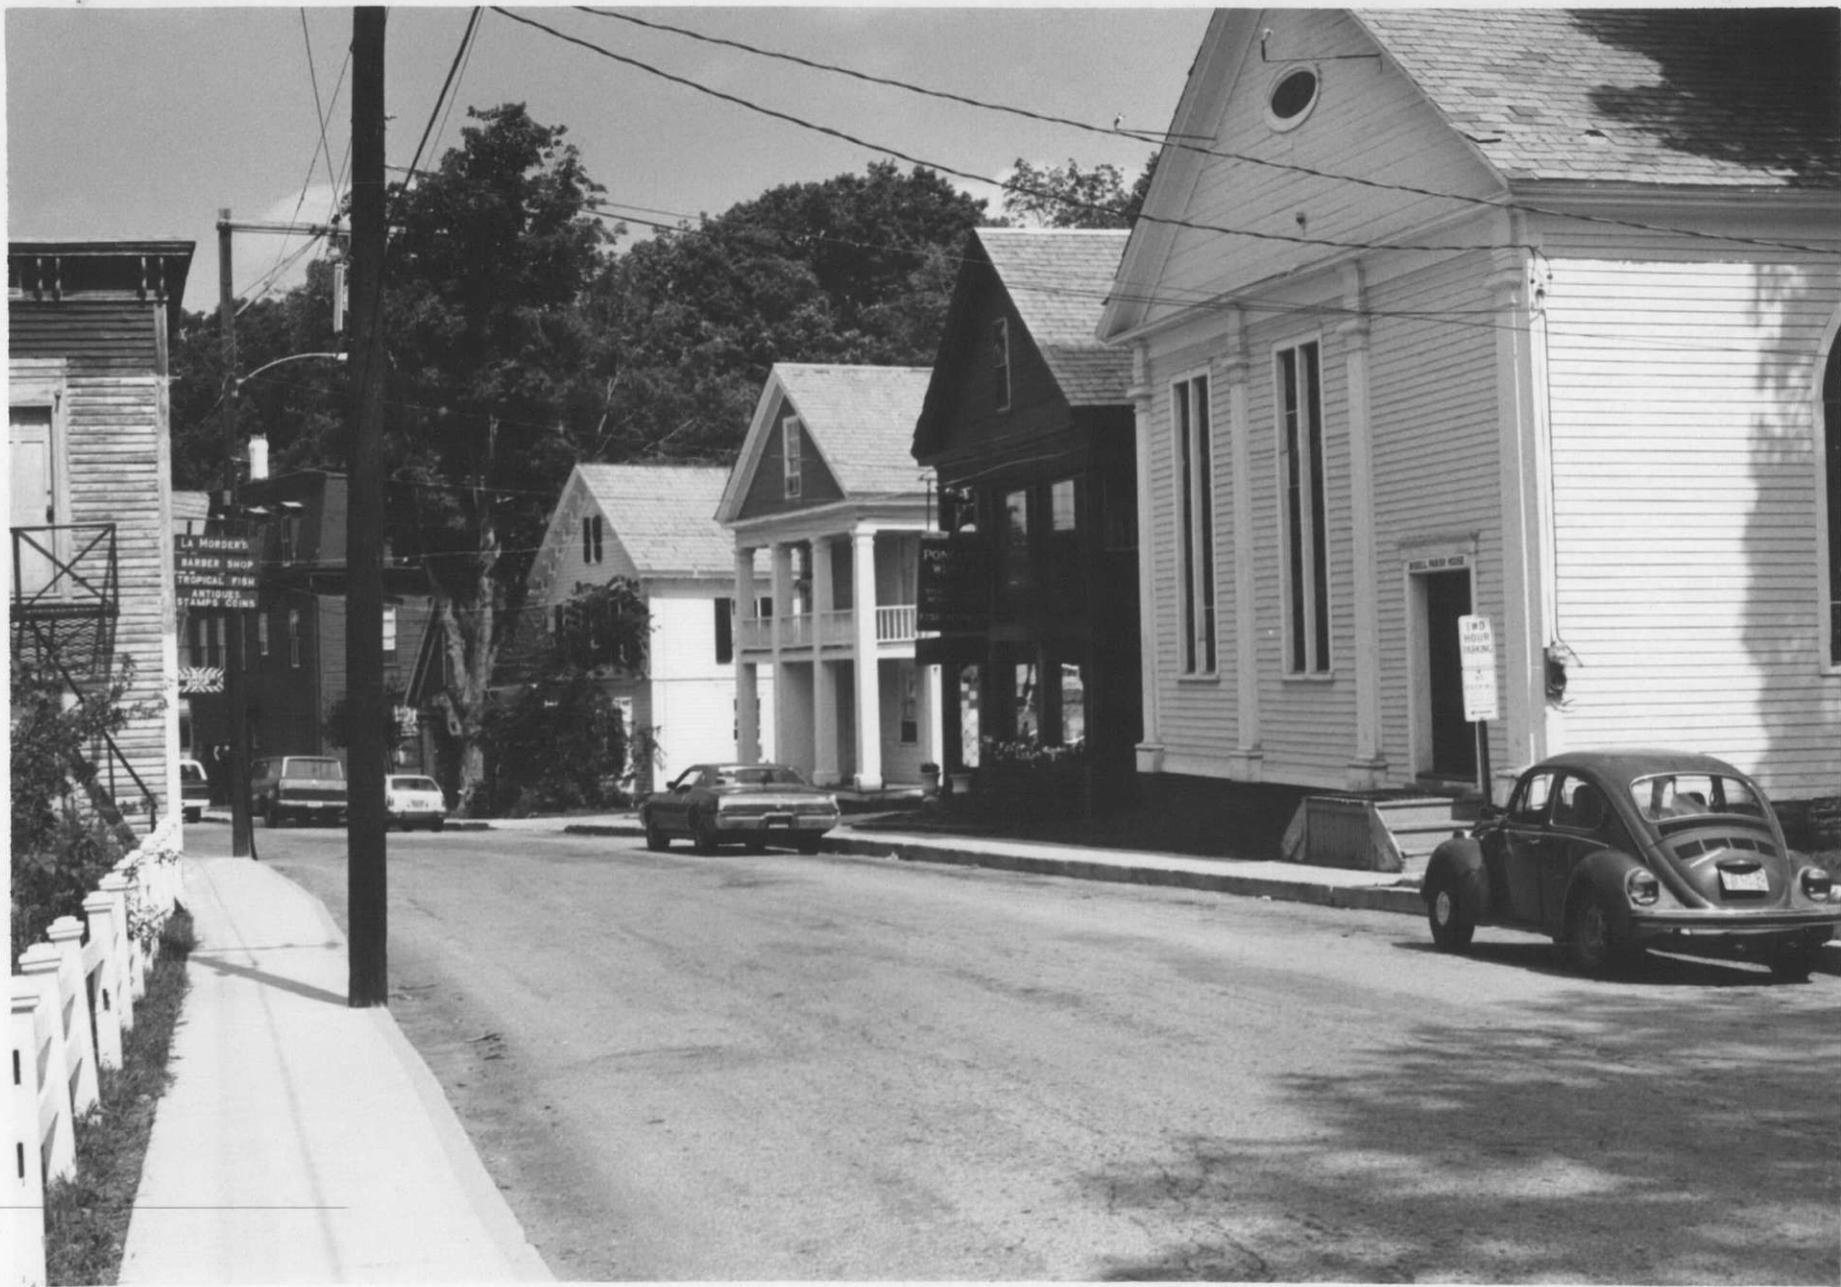
Description: R to L: Bldgs. #6, #7, #8, #9,
View is west side of South Main Street look-
Photograph 6 ing North.

6. Bissell Parish House, 1835, originally Universalist Church: The Bissell Parish House, an excellent example of provincial Greek Revival architecture, was constructed in 1835 and originally served as a Universalist Church. Greek Revival features are

7. Poncho's Wreck, c. 1854: This is a 2½-story, Greek Revival, clapboarded structure which was radically altered in 1971-72. While the gable front pediment remains intact with an entablature returning across the gable end, the 2-story, three-bay, portico has been enclosed with large picture windows and modern doorways on both floors on the left side. The facade behind the enclosed portico has been destroyed. Doric pilasters and uneven fenestration define the side elevations. The rear wing of two stories was originally part of a larger barn; it now serves as the restaurant kitchen and has a one-story, cinder block lean-to addition which was added in 1971.

8. Long House, c. 1850: Greek Revival temple-front house with 2-story recessed portico supported by four square Doric columns resting on plinths. Entrances on left side of both stories also have the Doric order in pilasters surrounding the doorways (second floor of portico is a porch with balustrade). The gable pediment has a window with 2/2 lights and a molded cornice which fully returns across the front supported by a frieze. There are Doric pilasters at the four corners of the front section. Center chimney. The roof is sheathed in asphalt shingles; the sides have asbestos shingles.

9. McCarty & Rifkin Building, c. 1855: Frame, gable front, 2½-story structure with clapboard siding and two additions in rear. The original front section has 3 x 3 bays. The entrance on left side of facade has a Queen Anne style porch supported

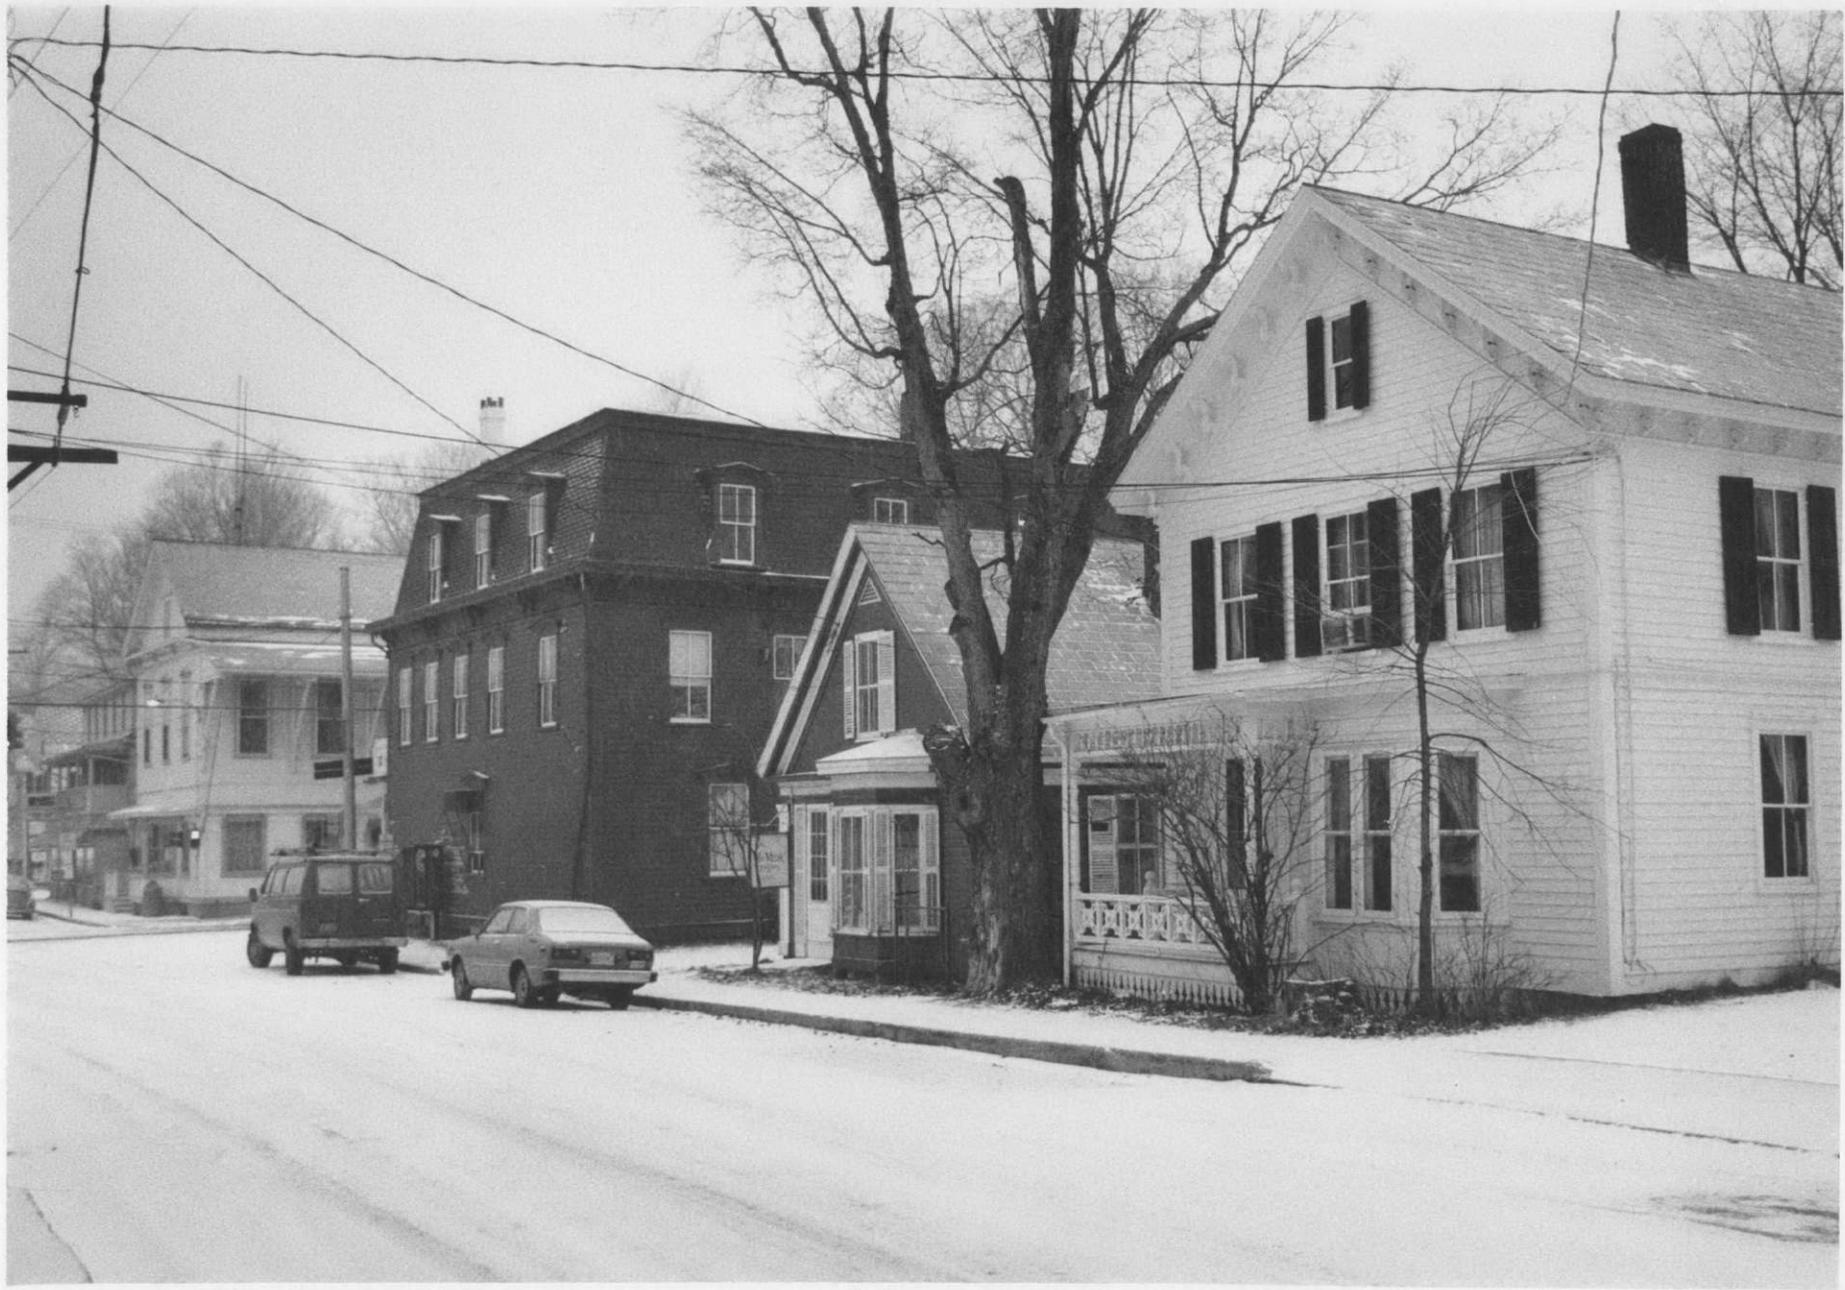
Photograph 7

Description: R to L: Bldgs #9, 10, 11. View
west side of South Main St. looking north.

10. Mr. Mark Gallery, c. 1840: This is a small, 1½-story, Greek Revival structure with a gable roof and clapboard siding. A full entablature with molded cornice is in the gable pediment and surrounds all sides of the building. There are Doric pilasters at the corners. The door on the left and the bay window on the right are not original. The addition in the rear conforms in style and in decorative detail to the main block of the house.

11. O. O. Ware Store, 1880: A 3-story frame structure with clapboard siding, the first floor has always been used for commercial purposes and the second floor for tenements; the third floor was once a Masonic Hall. Though the building is French Empire in style because of the mansard roof, the plain entablature reflects the Italianate style because of the paired, scrolled brackets with drops which support the molded cornice. Windows have 2/2 lights and pedimented lintels. There is uneven spacing of bays on the first floor while that of the second and third floors is even. There are three entrances on the first floor; the main door is double-leaf and flanked by large display windows. A one-story porch extends the length of the north side and has posts with scroll brackets. The top of the porch serves the second floor and has a balustrade.
