NATIONAL REGISTER OF HISTORIC PLACES
INVENTORY -- NOMINATION FORM

Wilmington Village Historic District

The buildings and structures included in the Wilmington Historic District are as follows (numbers refer to the enclosed sketchmap):

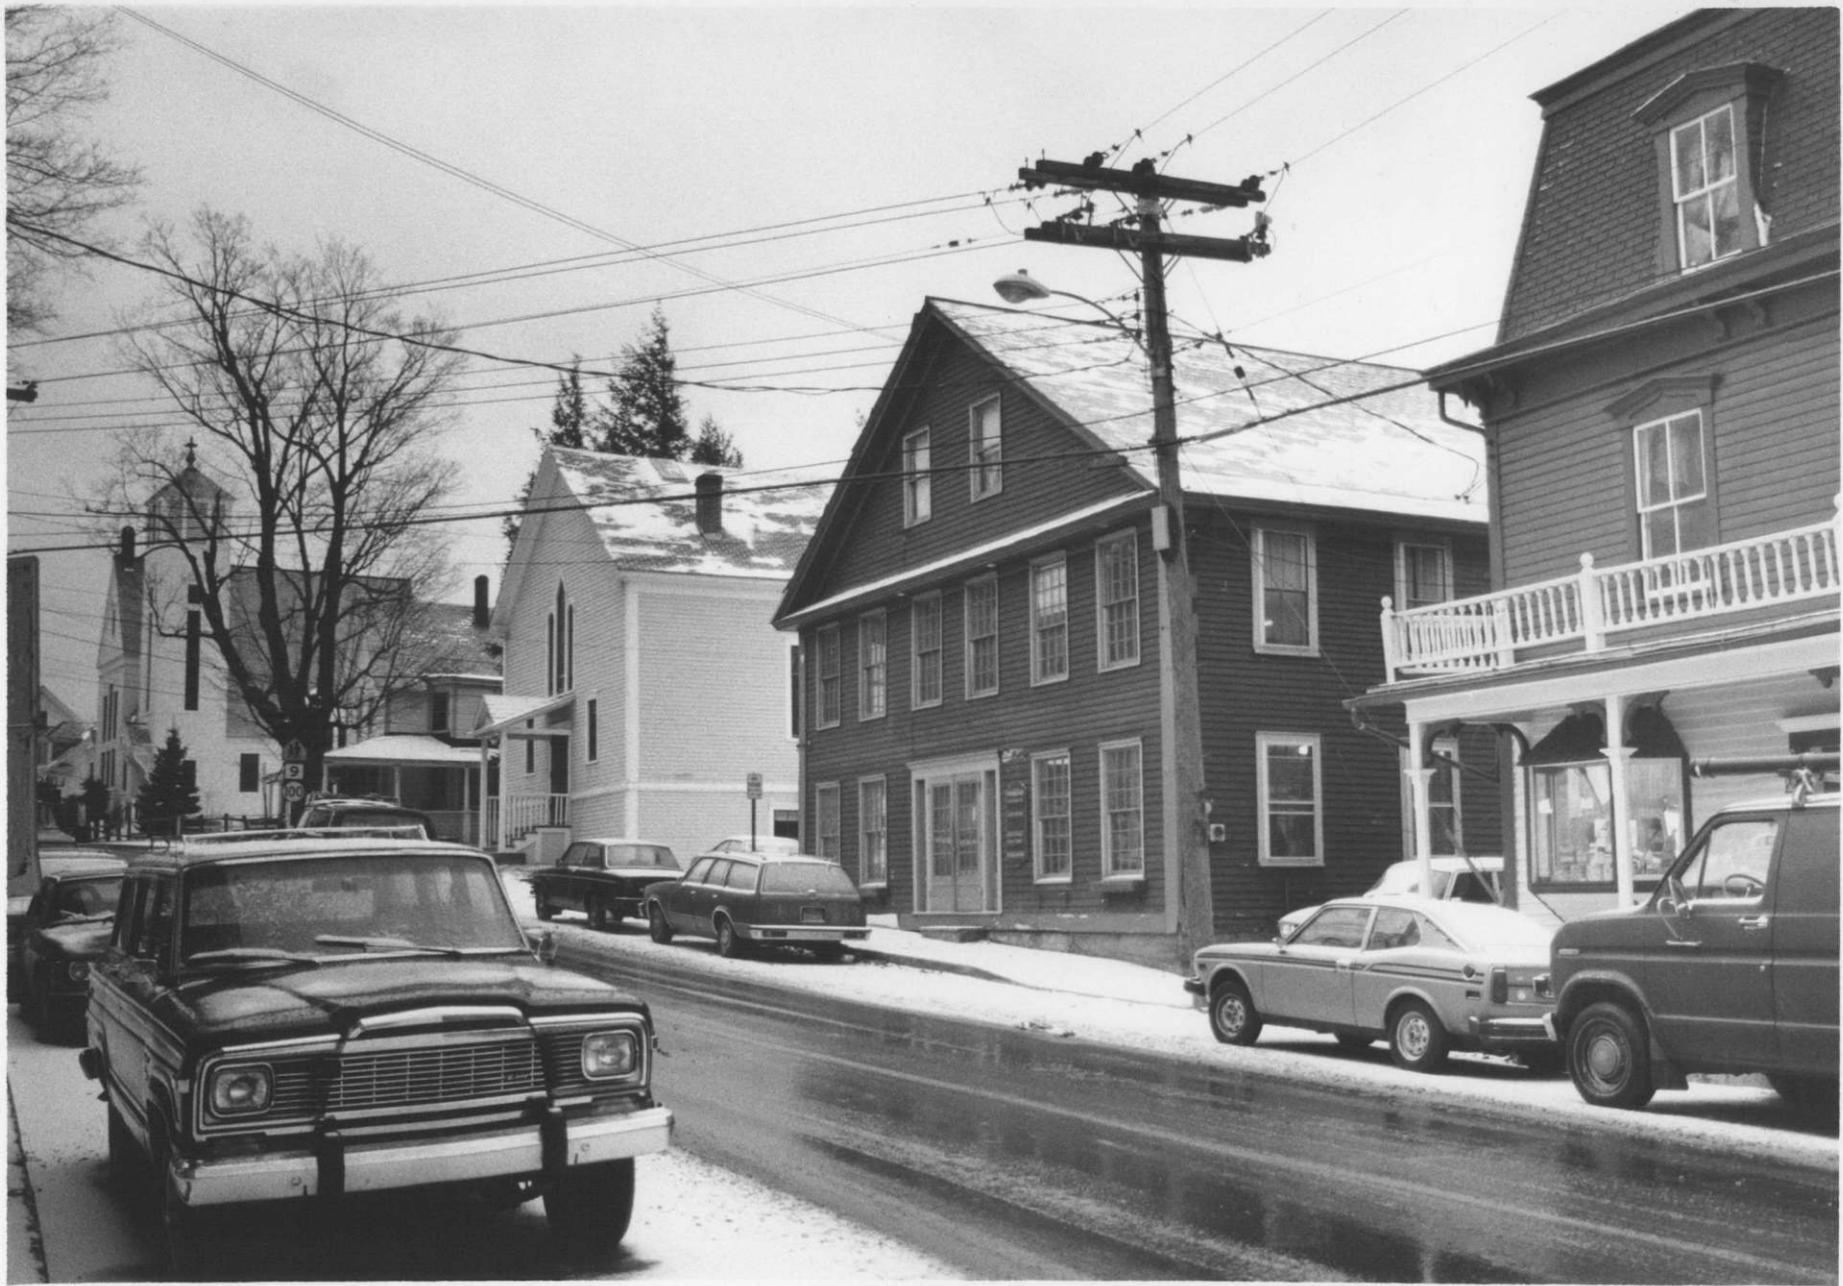
Wilmington Village Historic District
Wilmington, VT
Credit: Margaret DeLaittre
Date: January 1980
Negative filed at Vermont Division for
Historic Preservation
Description: R to L: Bldgs #11 (corner), 12,
14, 15, 16. View south side of West Main St.
Photograph 8 looking west.

14. Masonic Hall, c. 1890: Basically a plain frame structure of 1½ stories with a high basement, the Masonic Hall has a gable front with a molded cornice returning at the ends. Corner boards support a plain entablature which extends across the west and east elevations. The double-door entrance is sheltered by a shed-roof porch which has a cross gable pediment. A stained-glass window on each side of the doorway has a pedimented lintel. The centrally located stained-glass window over the doorway is Palladian in nature having three divisions with the larger central panel having a pedimented top while the flanking panels are round-headed. A wooden water-table surrounds the building delineating the basement and first floor. Stained-glass windows on the first floor side elevations have pedimented lintels; the windows in the basement floor have clear 2/2 lights. The side entrance on the west elevation is sheltered by a hood.

16. Congregational Church, 1883: Built in 1883 at a cost of \$4,500 to replace an earlier church which burned the preceeding year, this church exemplifies the Queen Anne style and is one of the finer structures in the district.

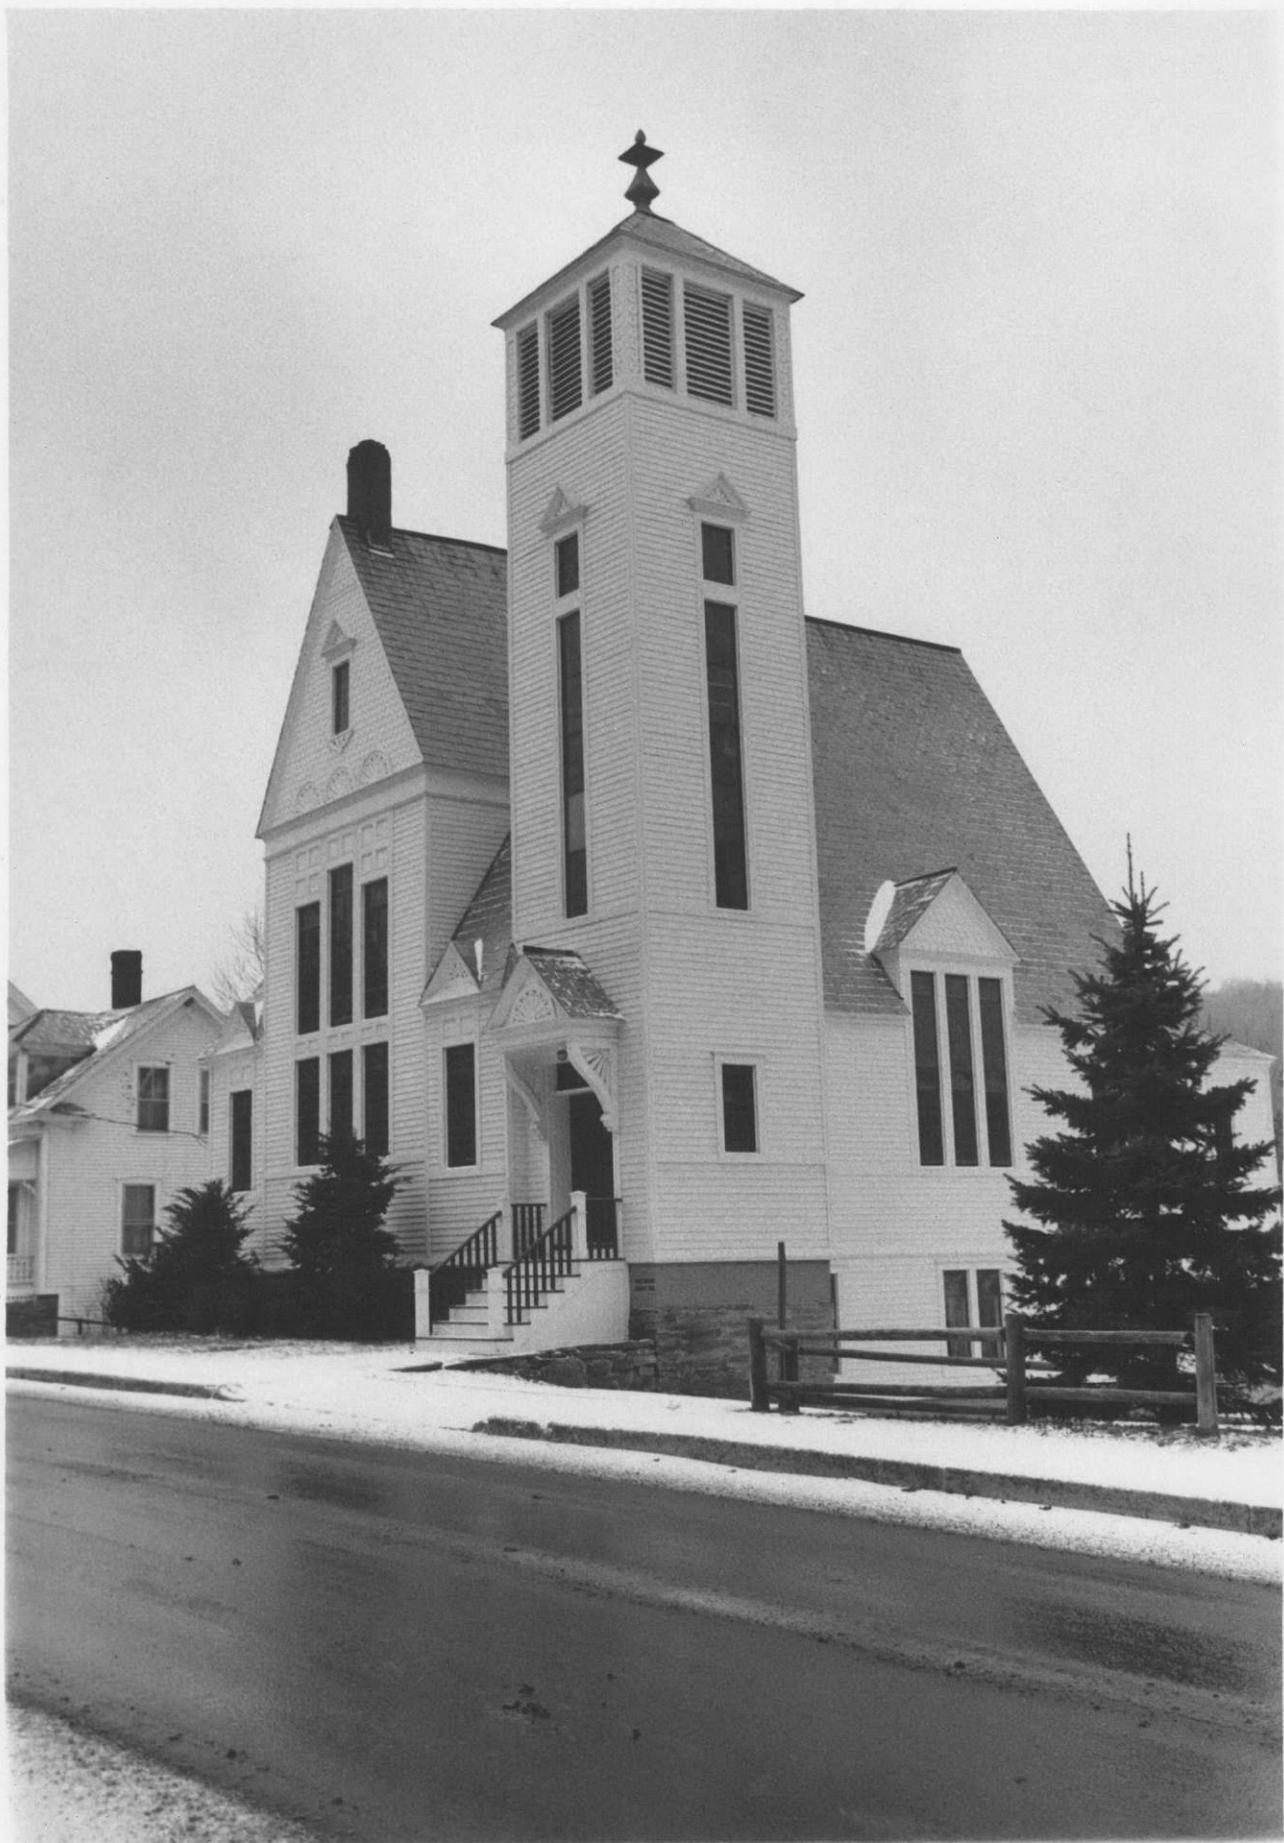
Wilmington Village Historic District
Wilmington, VT
Credit: Margaret DeLaittre
Date: January 1980
Negative filed at Vermont Division for
Historic Preservation
Description: Congregational Church, #16. View
south side of West Main Street looking west.
Photograph 9

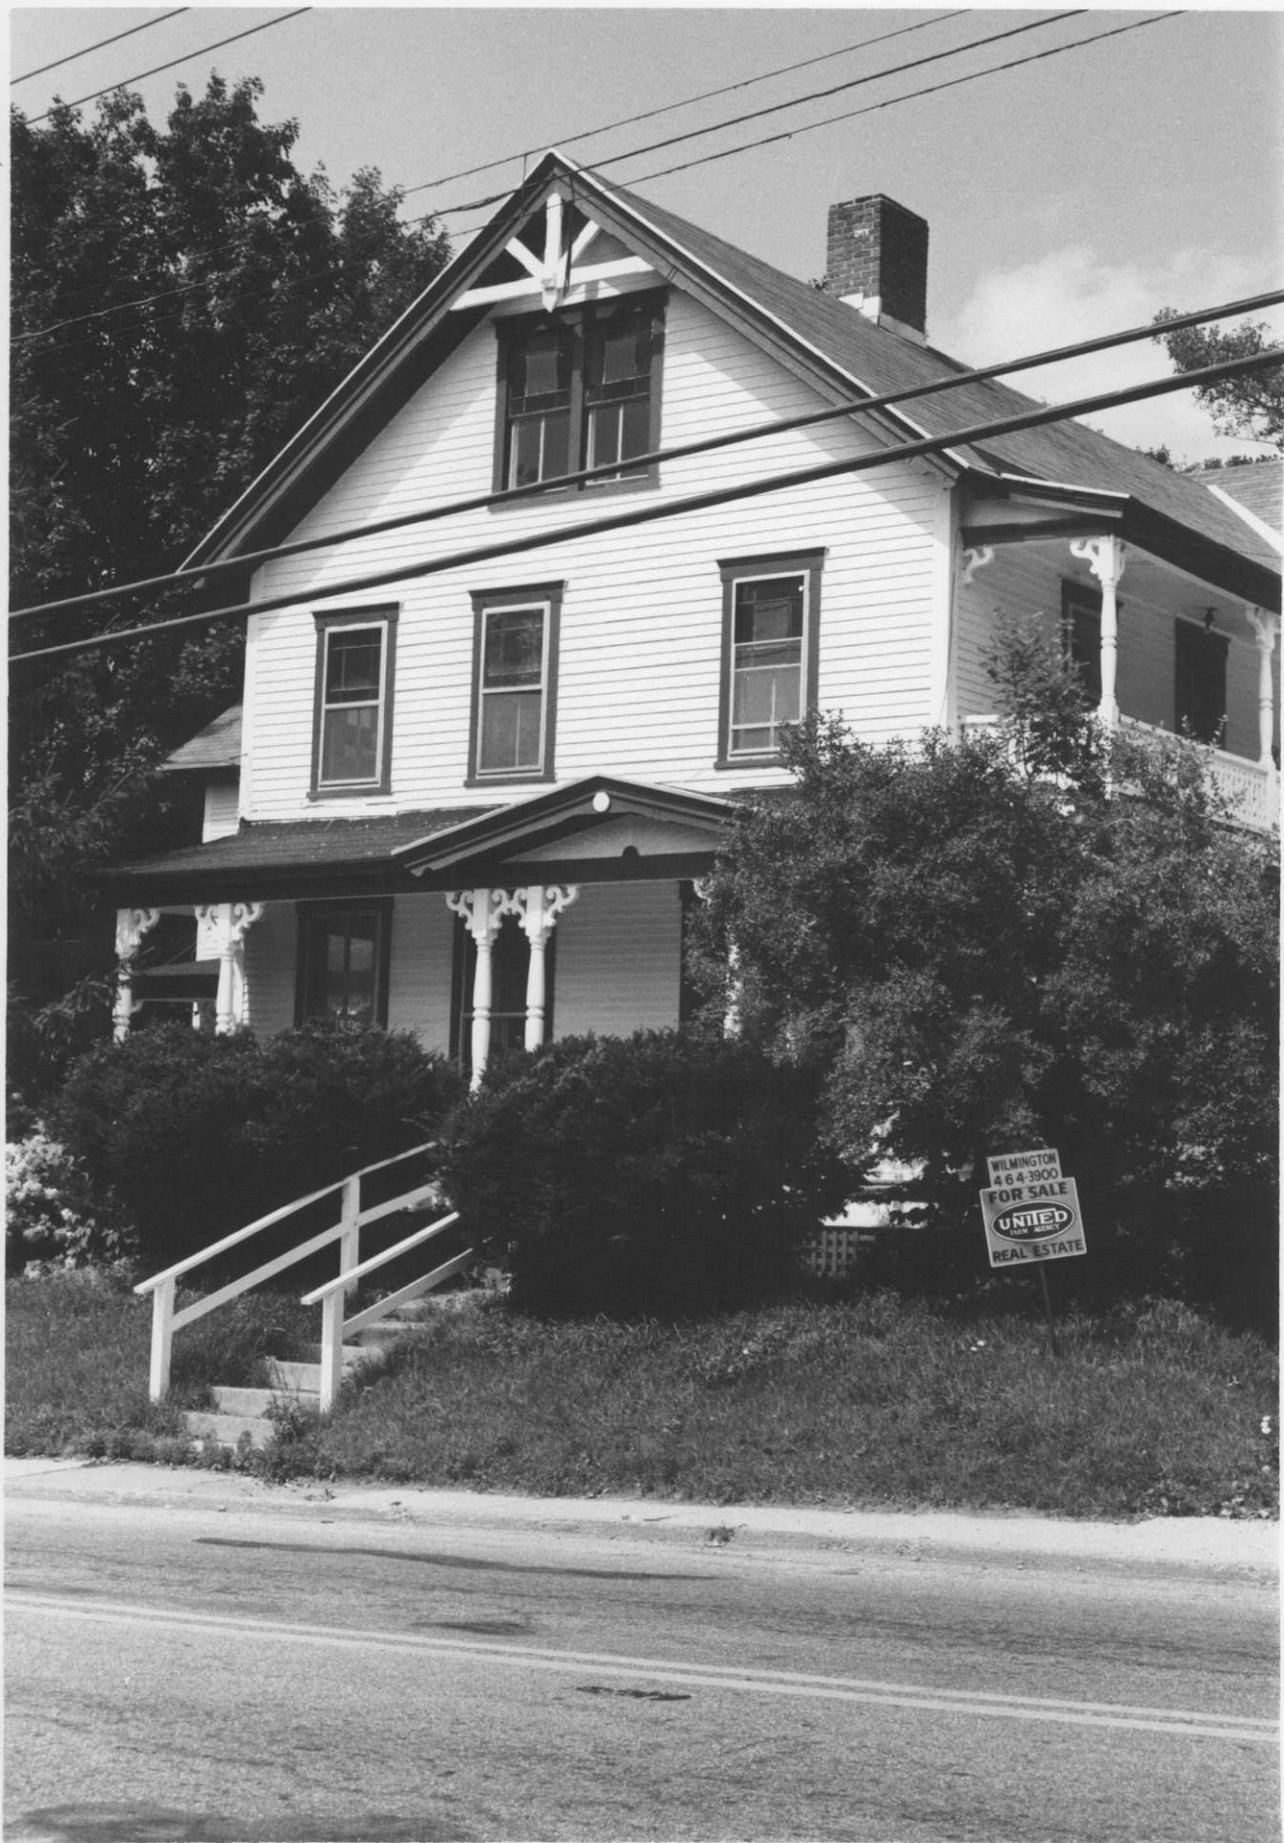
Description: Building #20. View north side of
West Main Street looking northeast,
Photograph 10

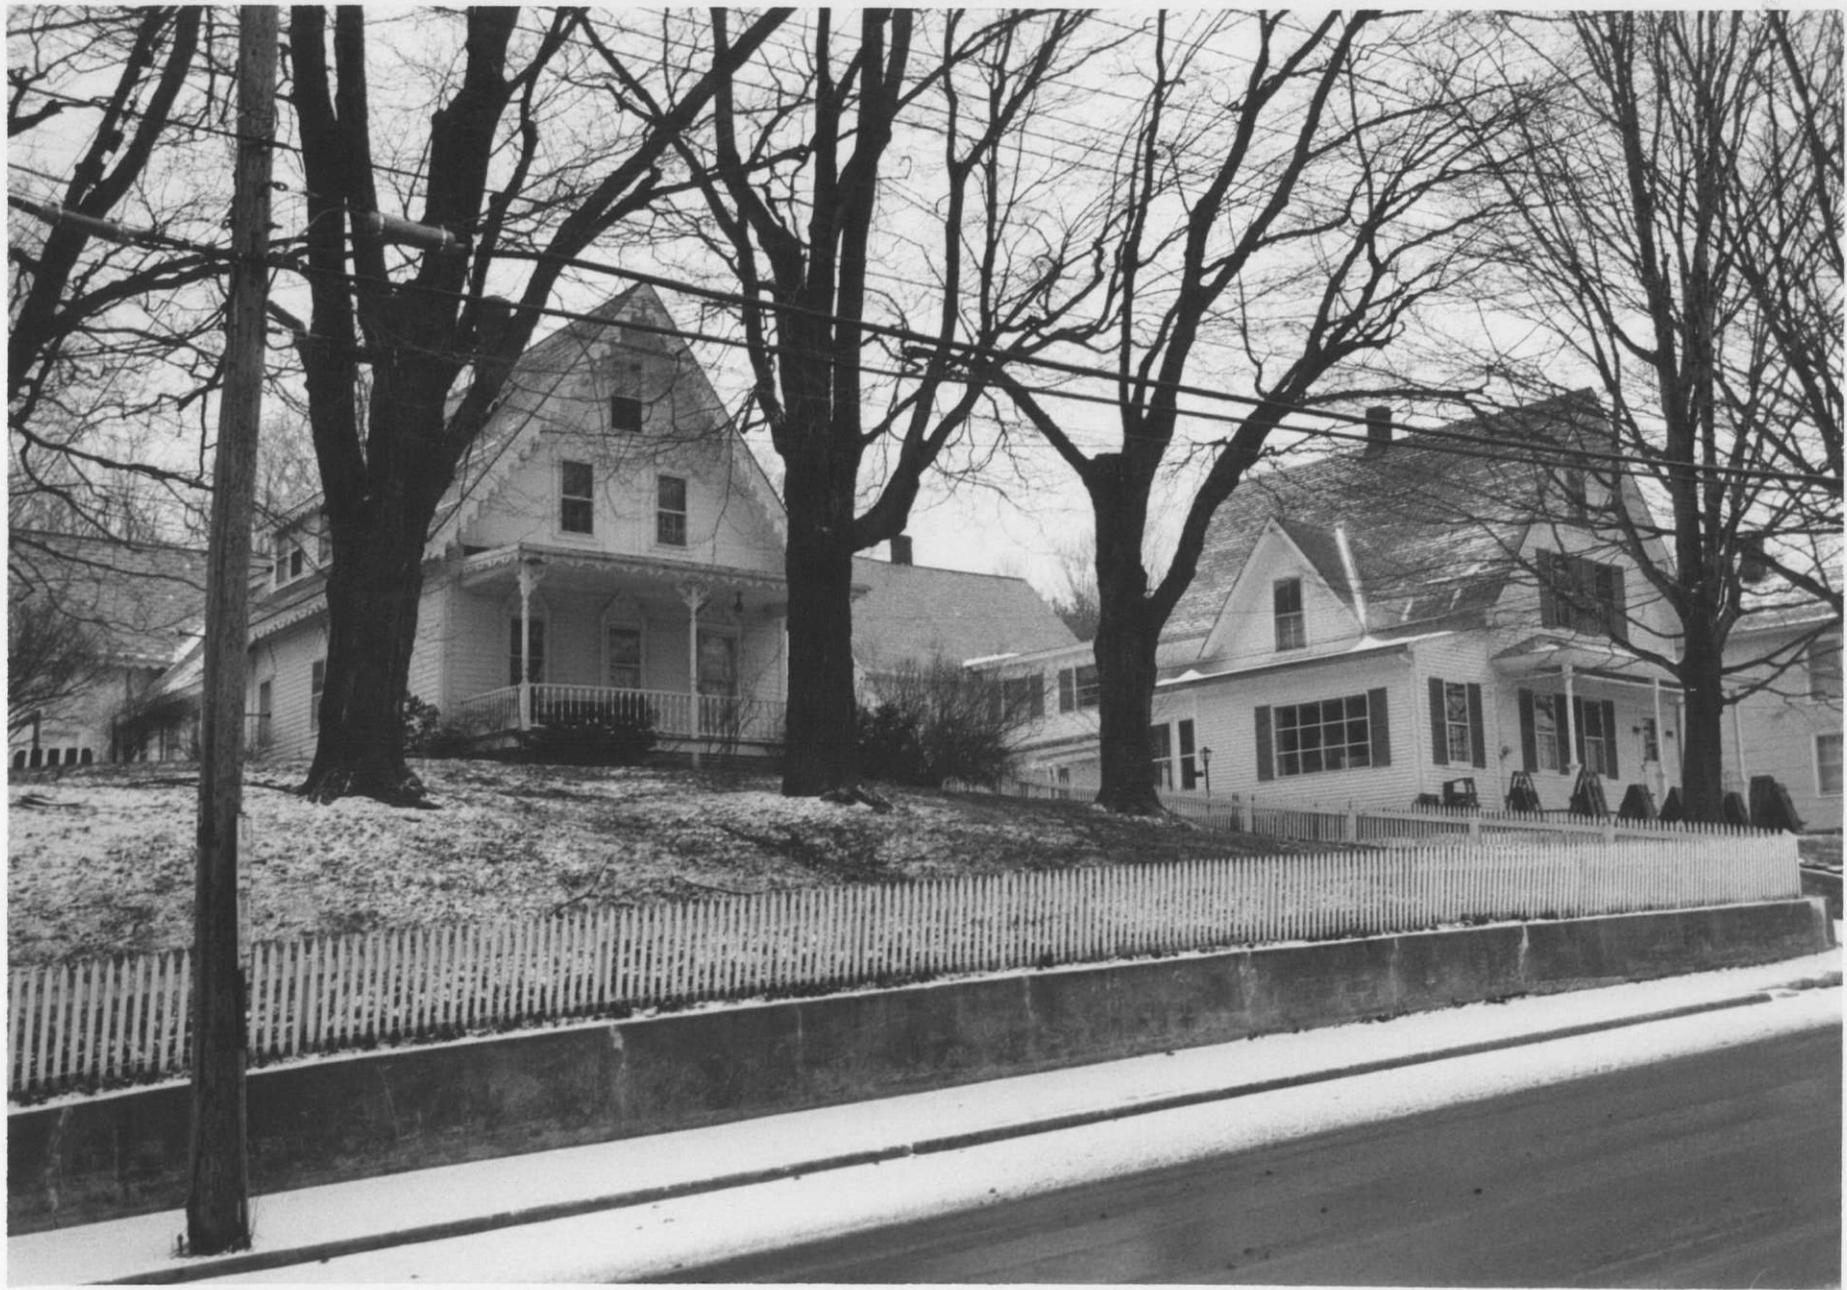
Description: Building #24 & 23. View north
side of West Main Street looking northwest.
Photograph 11

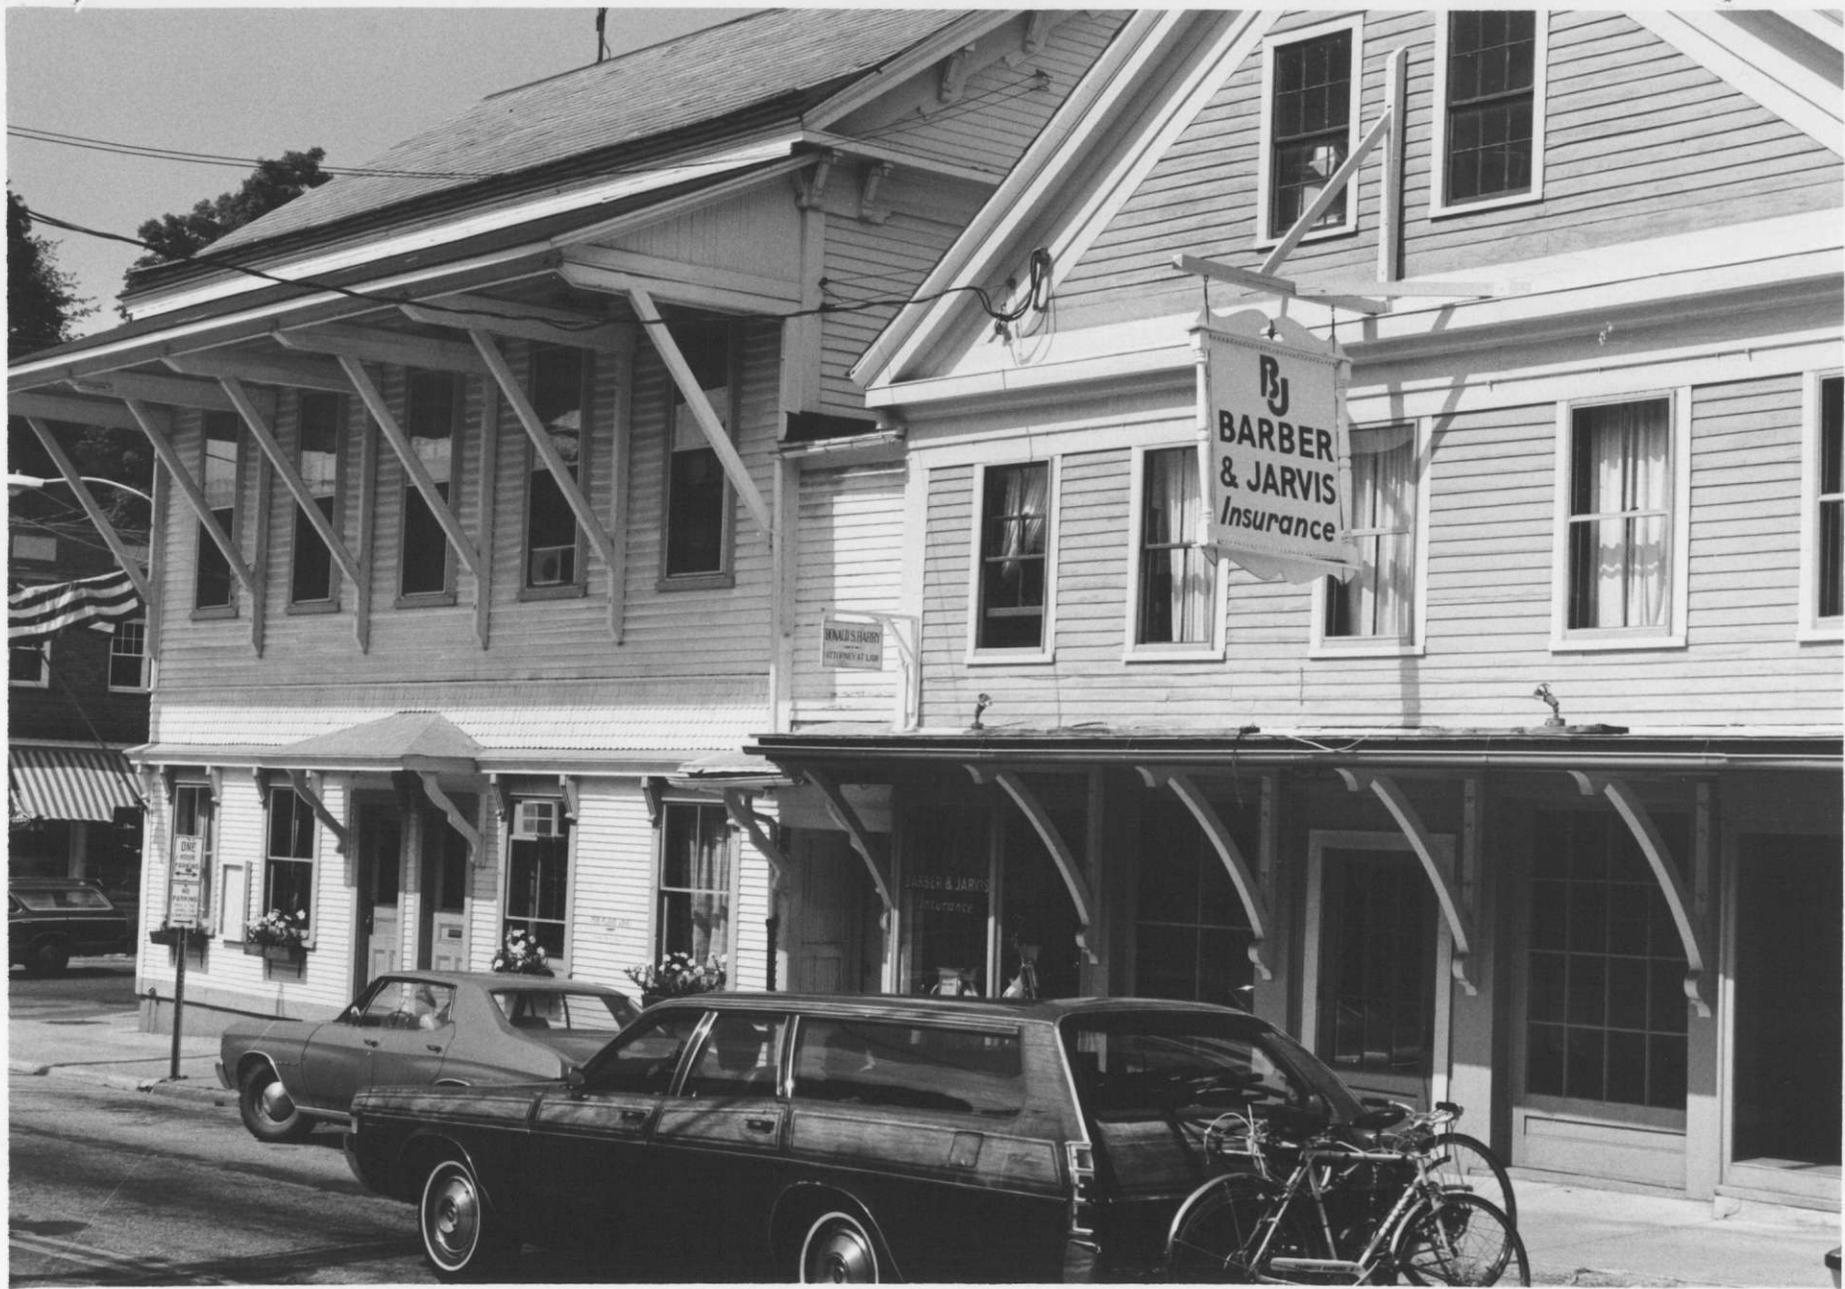
Description: L to R: Town office bldg. #26,
Barber & Jarvis Bldg. #25. View north side of
Photograph 12 West Main St. looking northeast

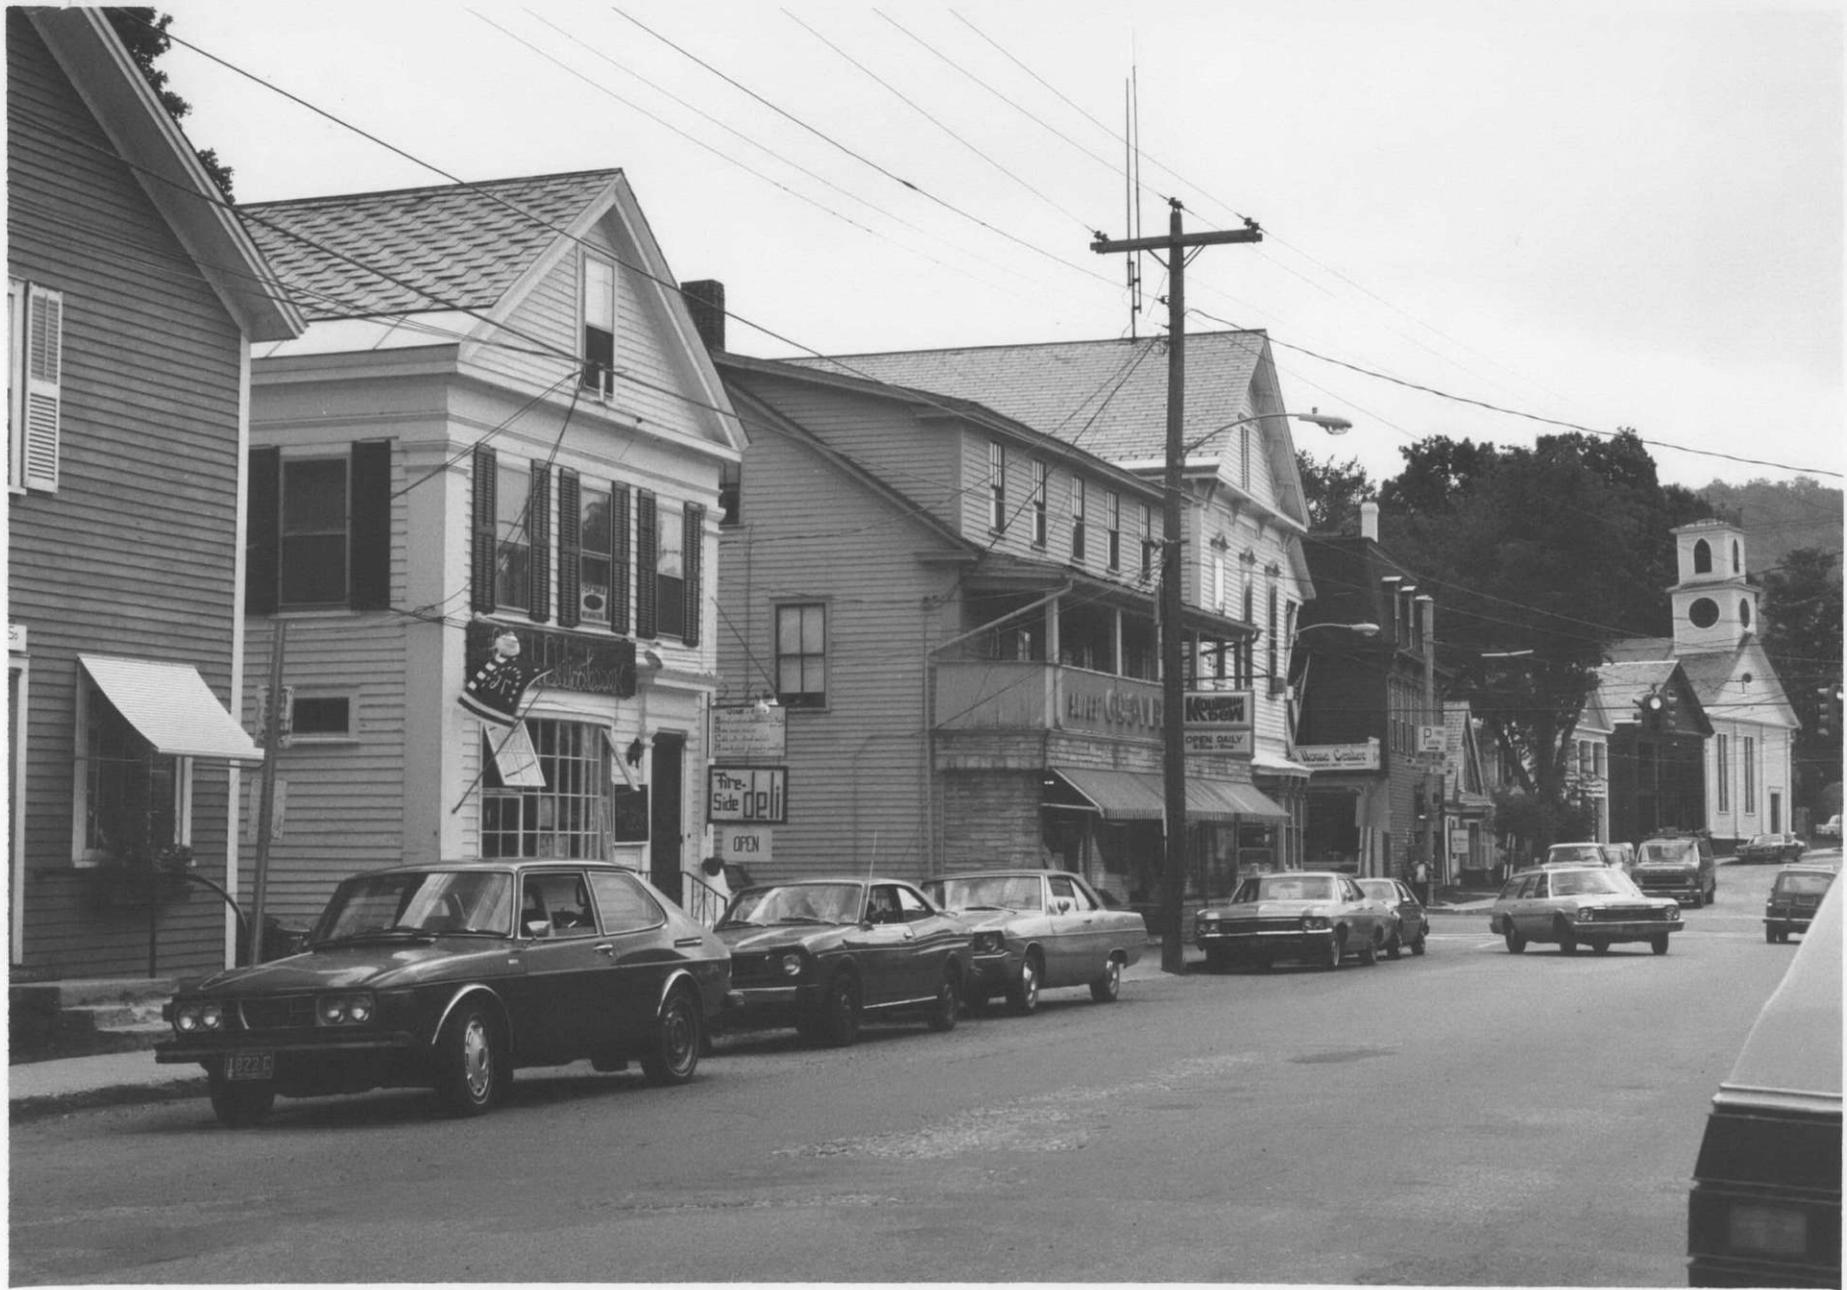
Wilmington Village Historic District
Wilmington, VT
Credit: Charles H. Ashton
Date: ~~January 1980~~ JULY 1979
Negative filed at Vermont Division for
Historic Preservation
Description: L to R: Bldgs. #29 (corner), 28,
27, 26. View west side of North Main St. look-
ing southwest.

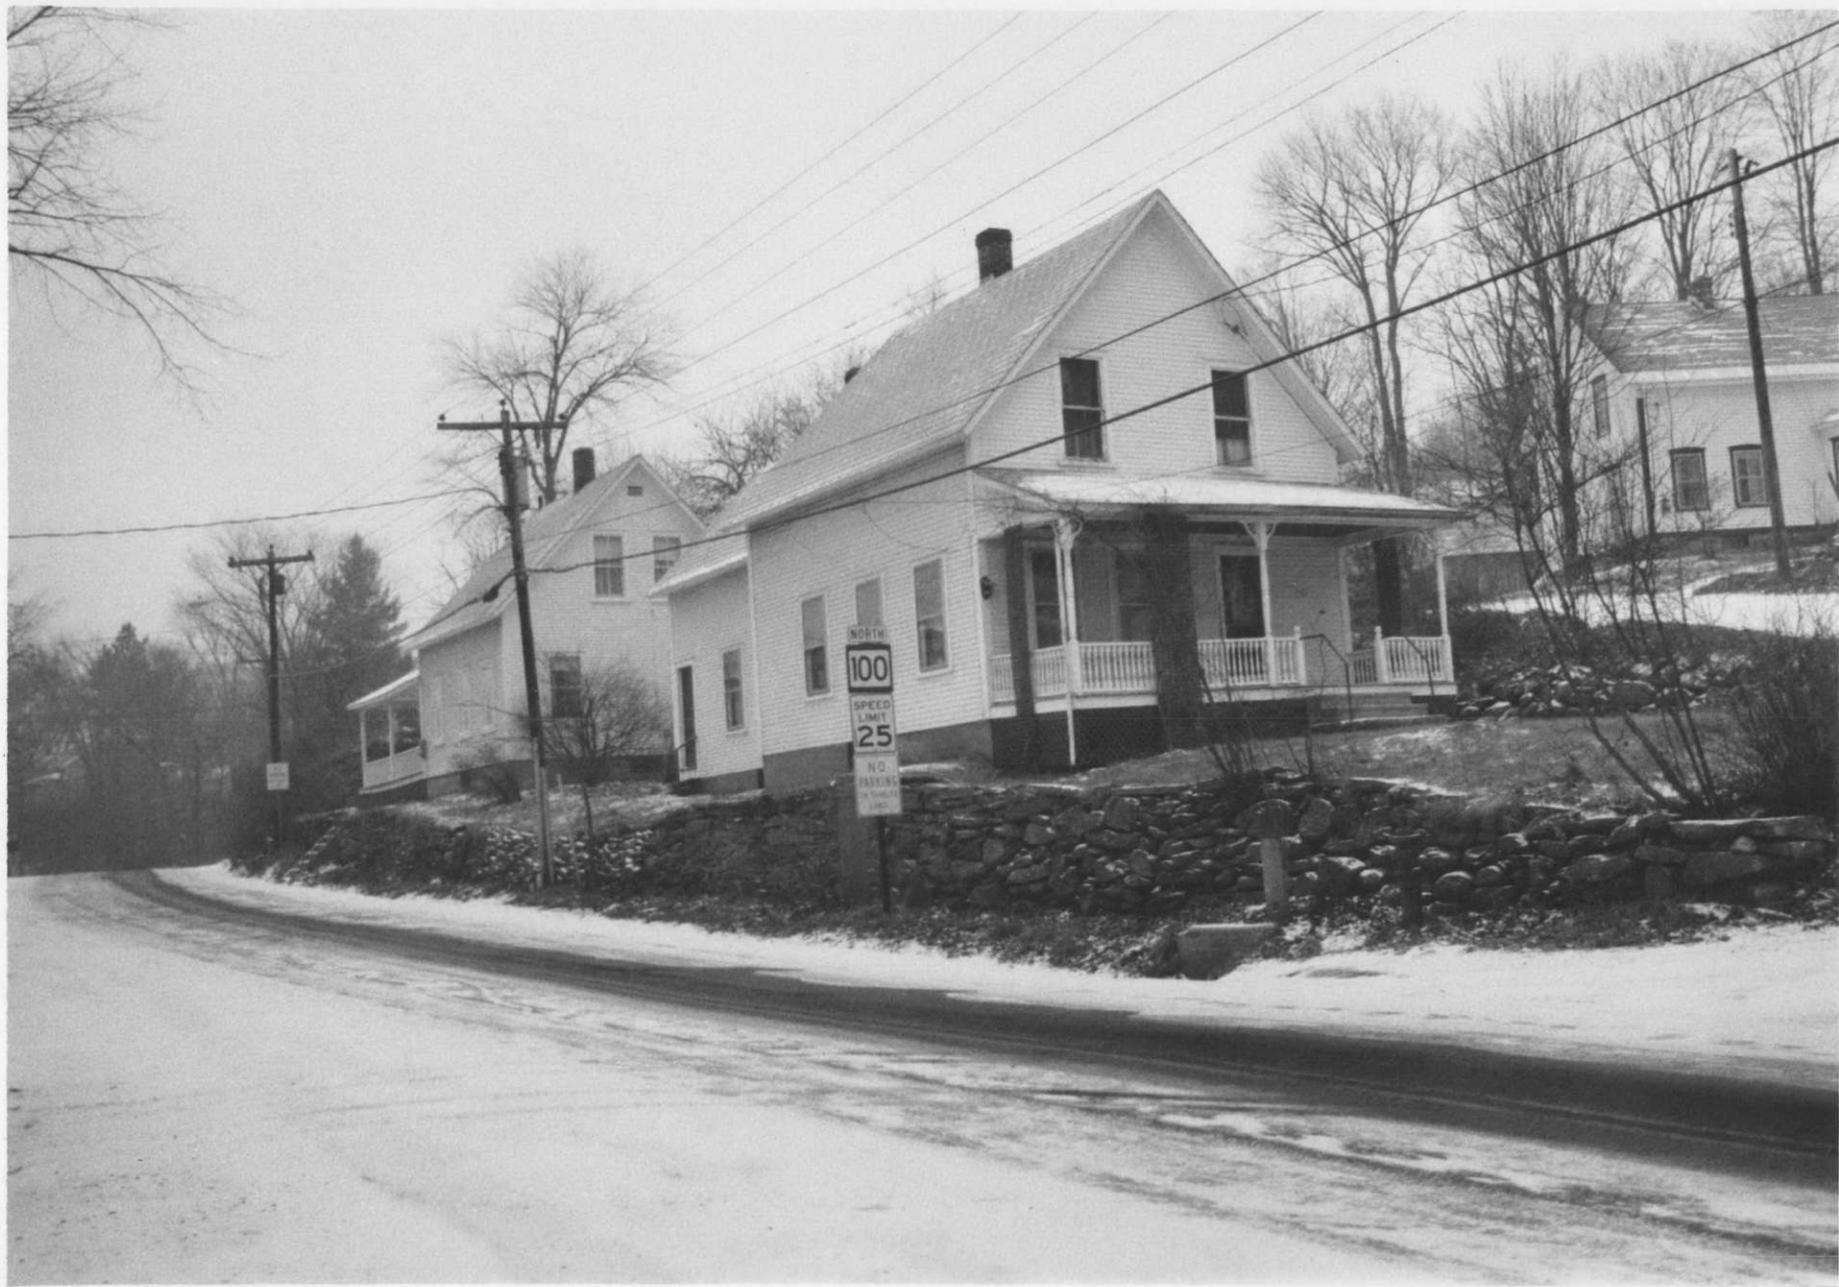
Photograph 14.

Description: R to L: Bldgs #30, 31. View west
side of North Main Street looking northwest.

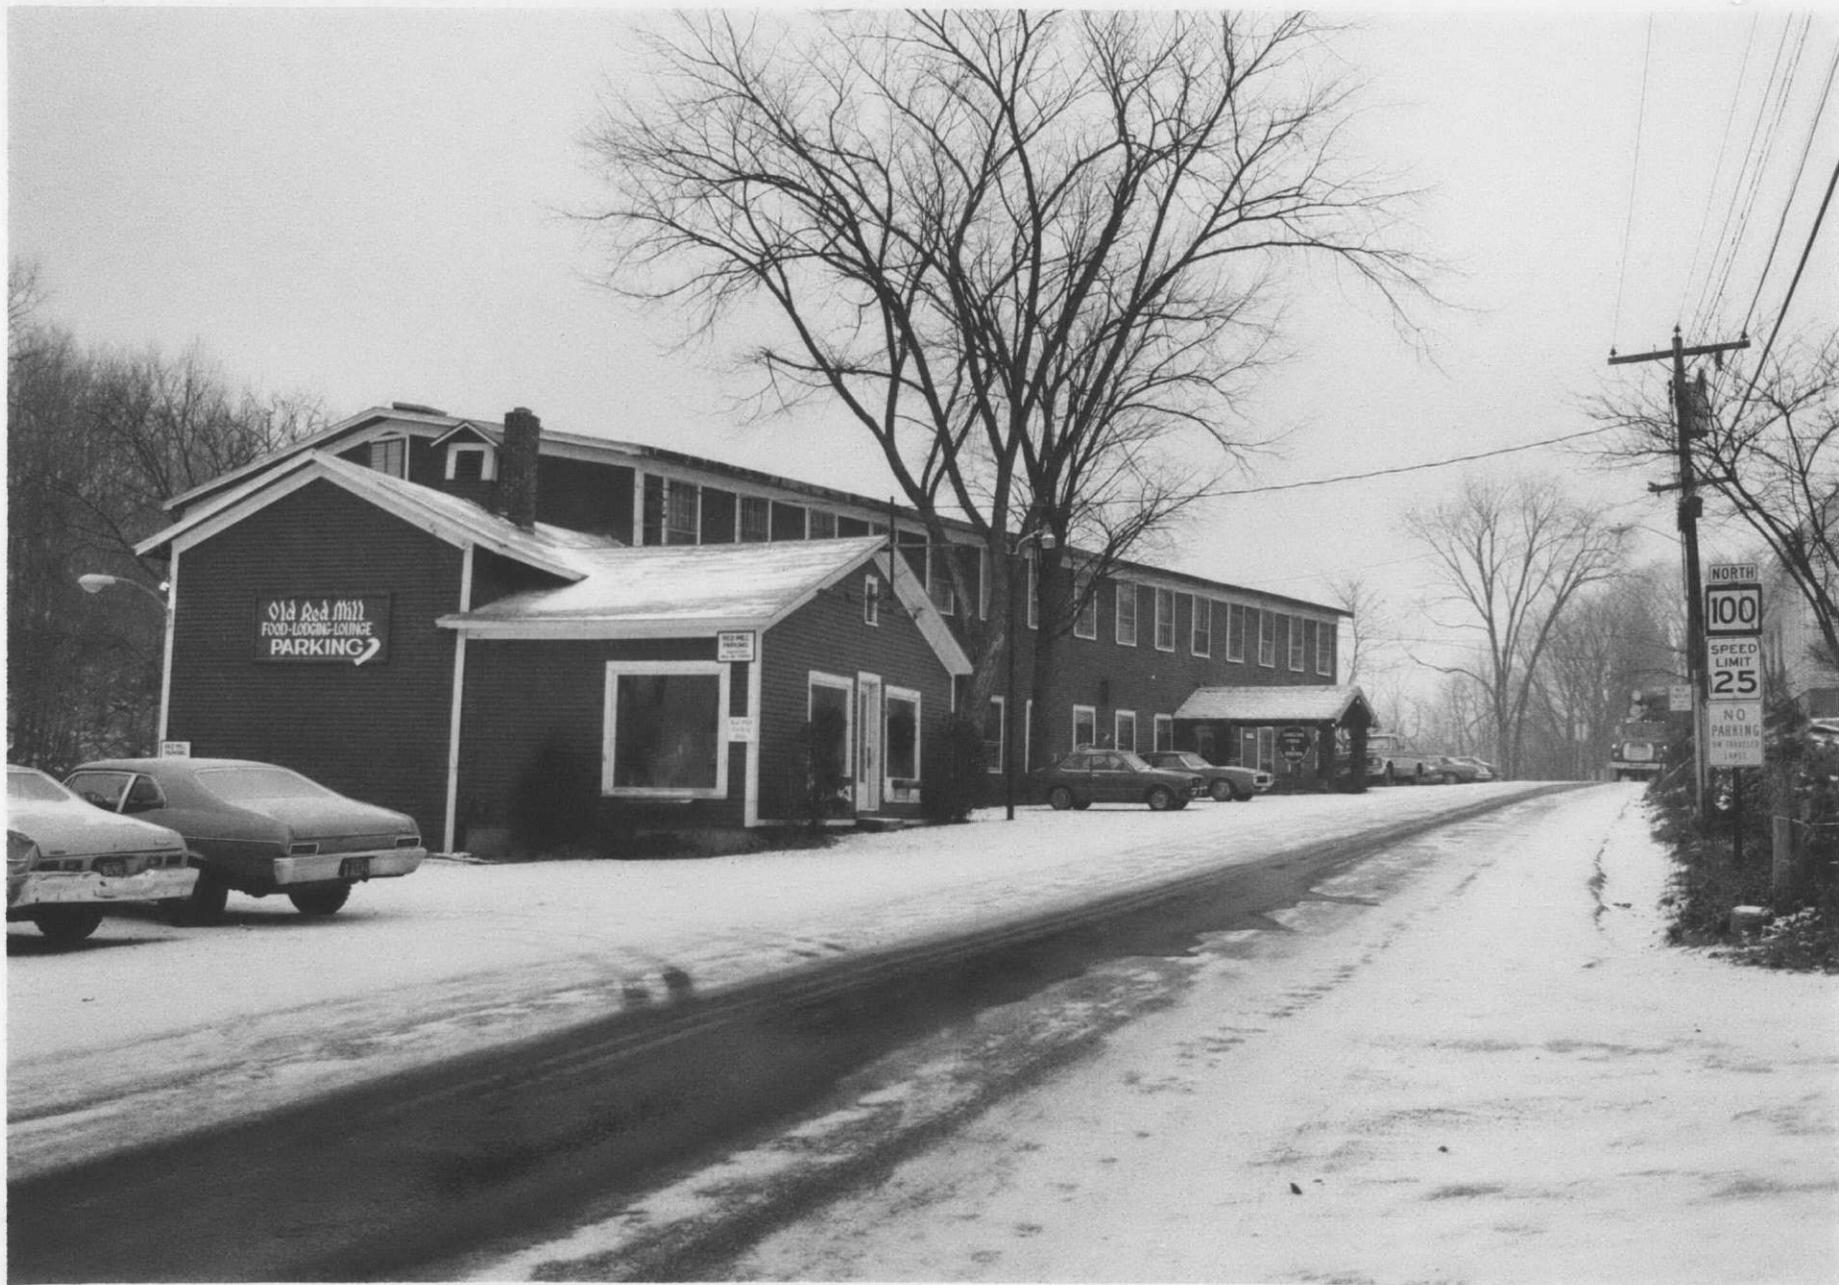
Photograph 15

Description: The Old Red Mill, #32. View east
side of North Main Street looking northeast.

32. Old Red Mill, 1828, 1902-03, vernacular utilitarian: Originally built in 1828 by Richard Waste, this structure has had numerous functions beginning as a gristmill, then sawmill, and since the 1930's, as a restaurant and inn. Located in the area once known as Mill Hollow, this mill building was one of several constructed to take advantage of the water power provided by the Deerfield River. Changing owners many times throughout its history, the works of the mill were also changed and updated. Wooden water wheels were replaced by metal ones and eventually turbines were installed. Around 1901-02, while owned by the Readsboro Chair Company, the mill building burned and was partially rebuilt in 1902-03. Today some of the mill works remain intact on the main floor and some of the braced framing can still be seen.

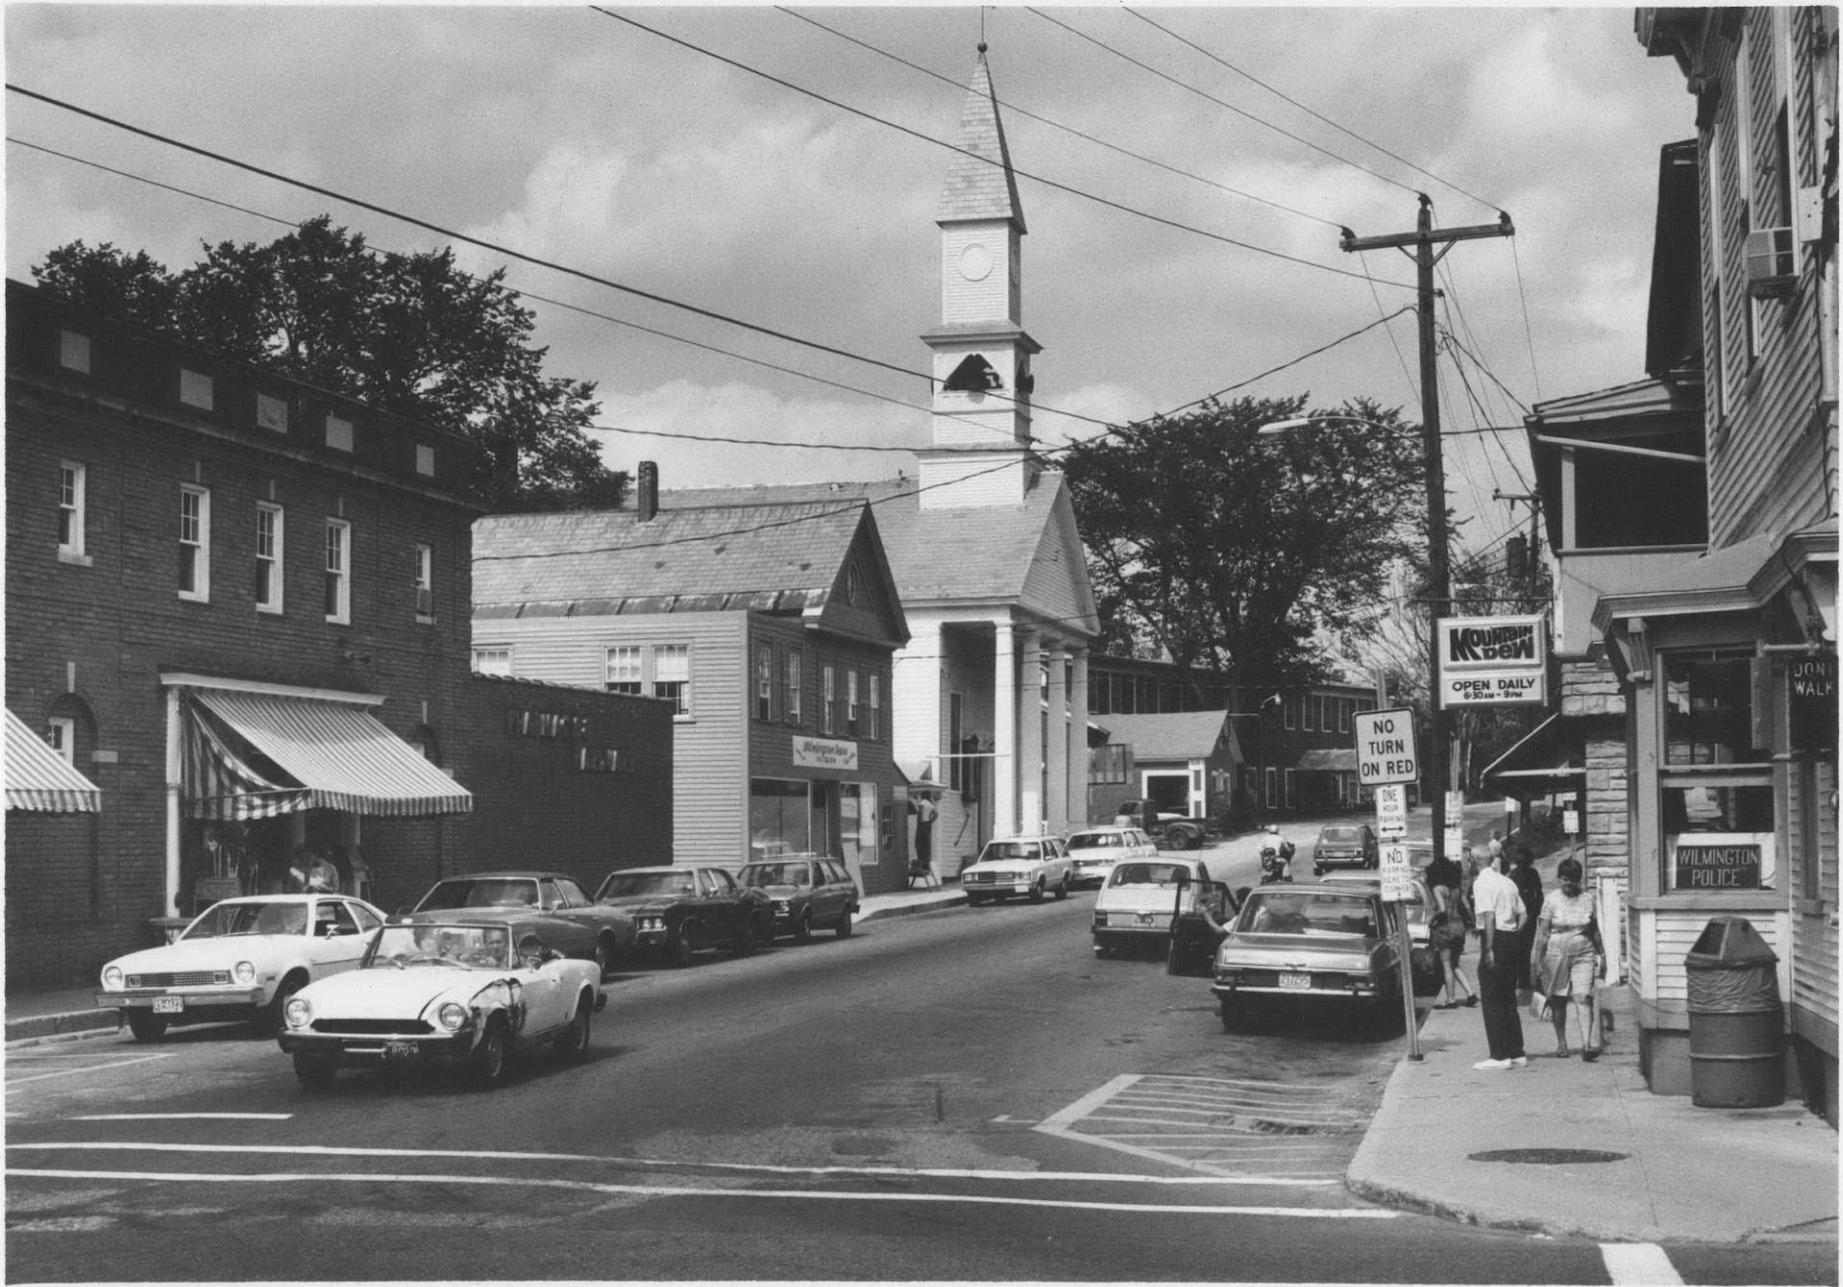
Description: L to R: Bldgs. #35, 34, 33, on
east side of North Main St. looking NE from
Photograph 16 intersection of Rts. 9 & 100.

33. Wilmington Baptist Church, 1833, Greek Revival: Originally organized in 1806, the Baptists of Wilmington erected this frame church in 1833. The temple-front has a two-story, three-bay portico supported by tapered Doric columns. Doric pilasters are placed behind the columns at the corners and an entablature with molded cornice surrounds the building. The central entrance has double doors and a panelled surround. Within this surround are two crosses, also applied, each flanking the doorway. The three large windows on left and right elevations and the two on front elevation have stained glass.

35. Parmalee & Howe Drugstore, 1930: Though a relatively modern structure, this store also serves an important role in the Wilmington Historic District as one of the four corner buildings at the intersection of Routes 9 and 100. Built in 1930, this building replaced an earlier structure which burned in 1928. The Parmalee drugstore was originally established on this site around the time of the Civil War.
