NATIONAL REGISTER OF HISTORIC PLACES
INVENTORY -- NOMINATION FORM

Wilmington Village Historic District

The buildings and structures included in the Wilmington Historic District are as follows (numbers refer to the enclosed sketchmap):

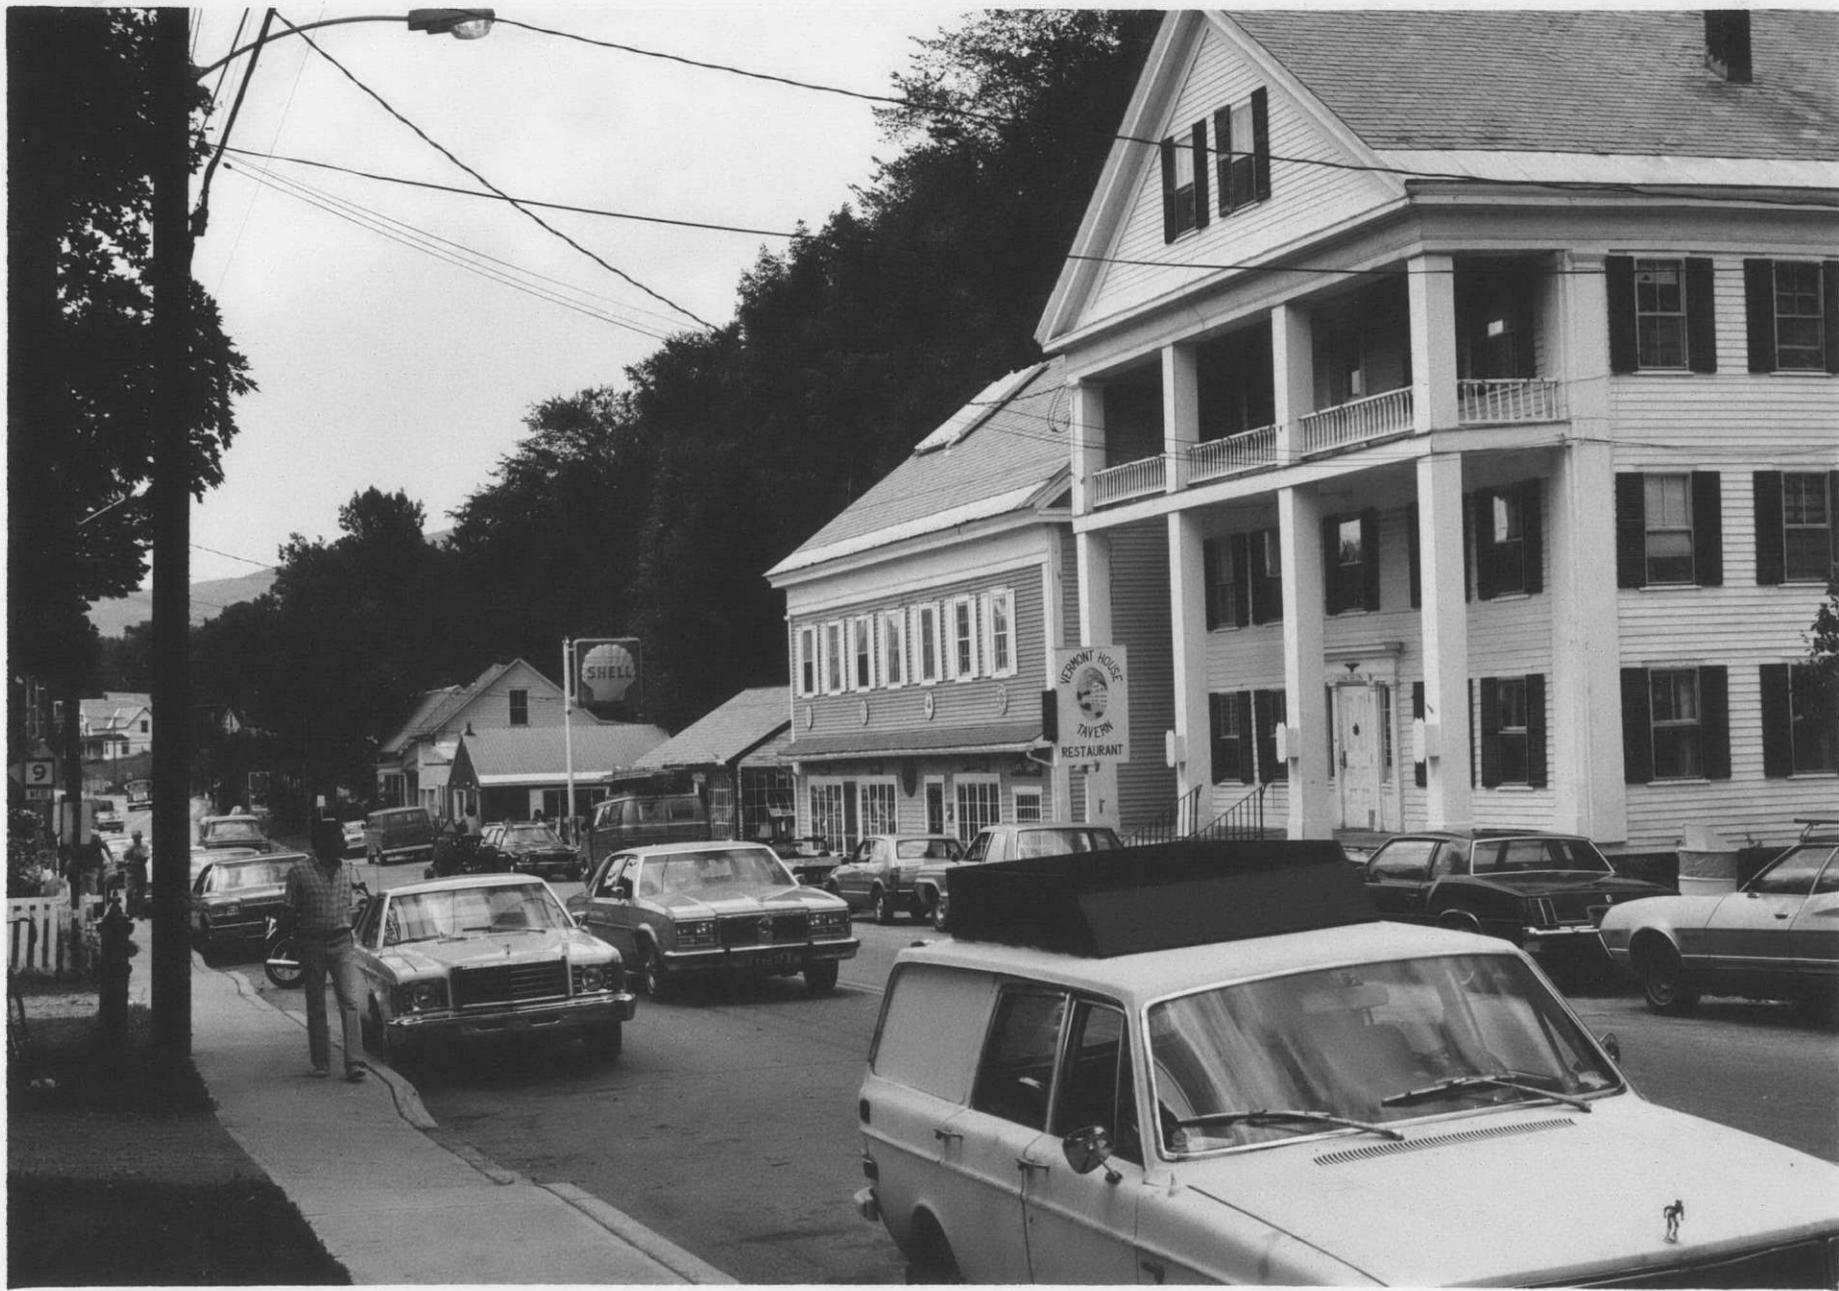
Wilmington Village Historic District
Wilmington, VT
Credit: Charles H. Ashton
Date: ~~January 1980~~ JULY 1979
Negative filed at Vermont Division for
Historic Preservation
Description: West Main St. looking NW. R to L:
Bldgs. #40 and 41.
Photograph 17

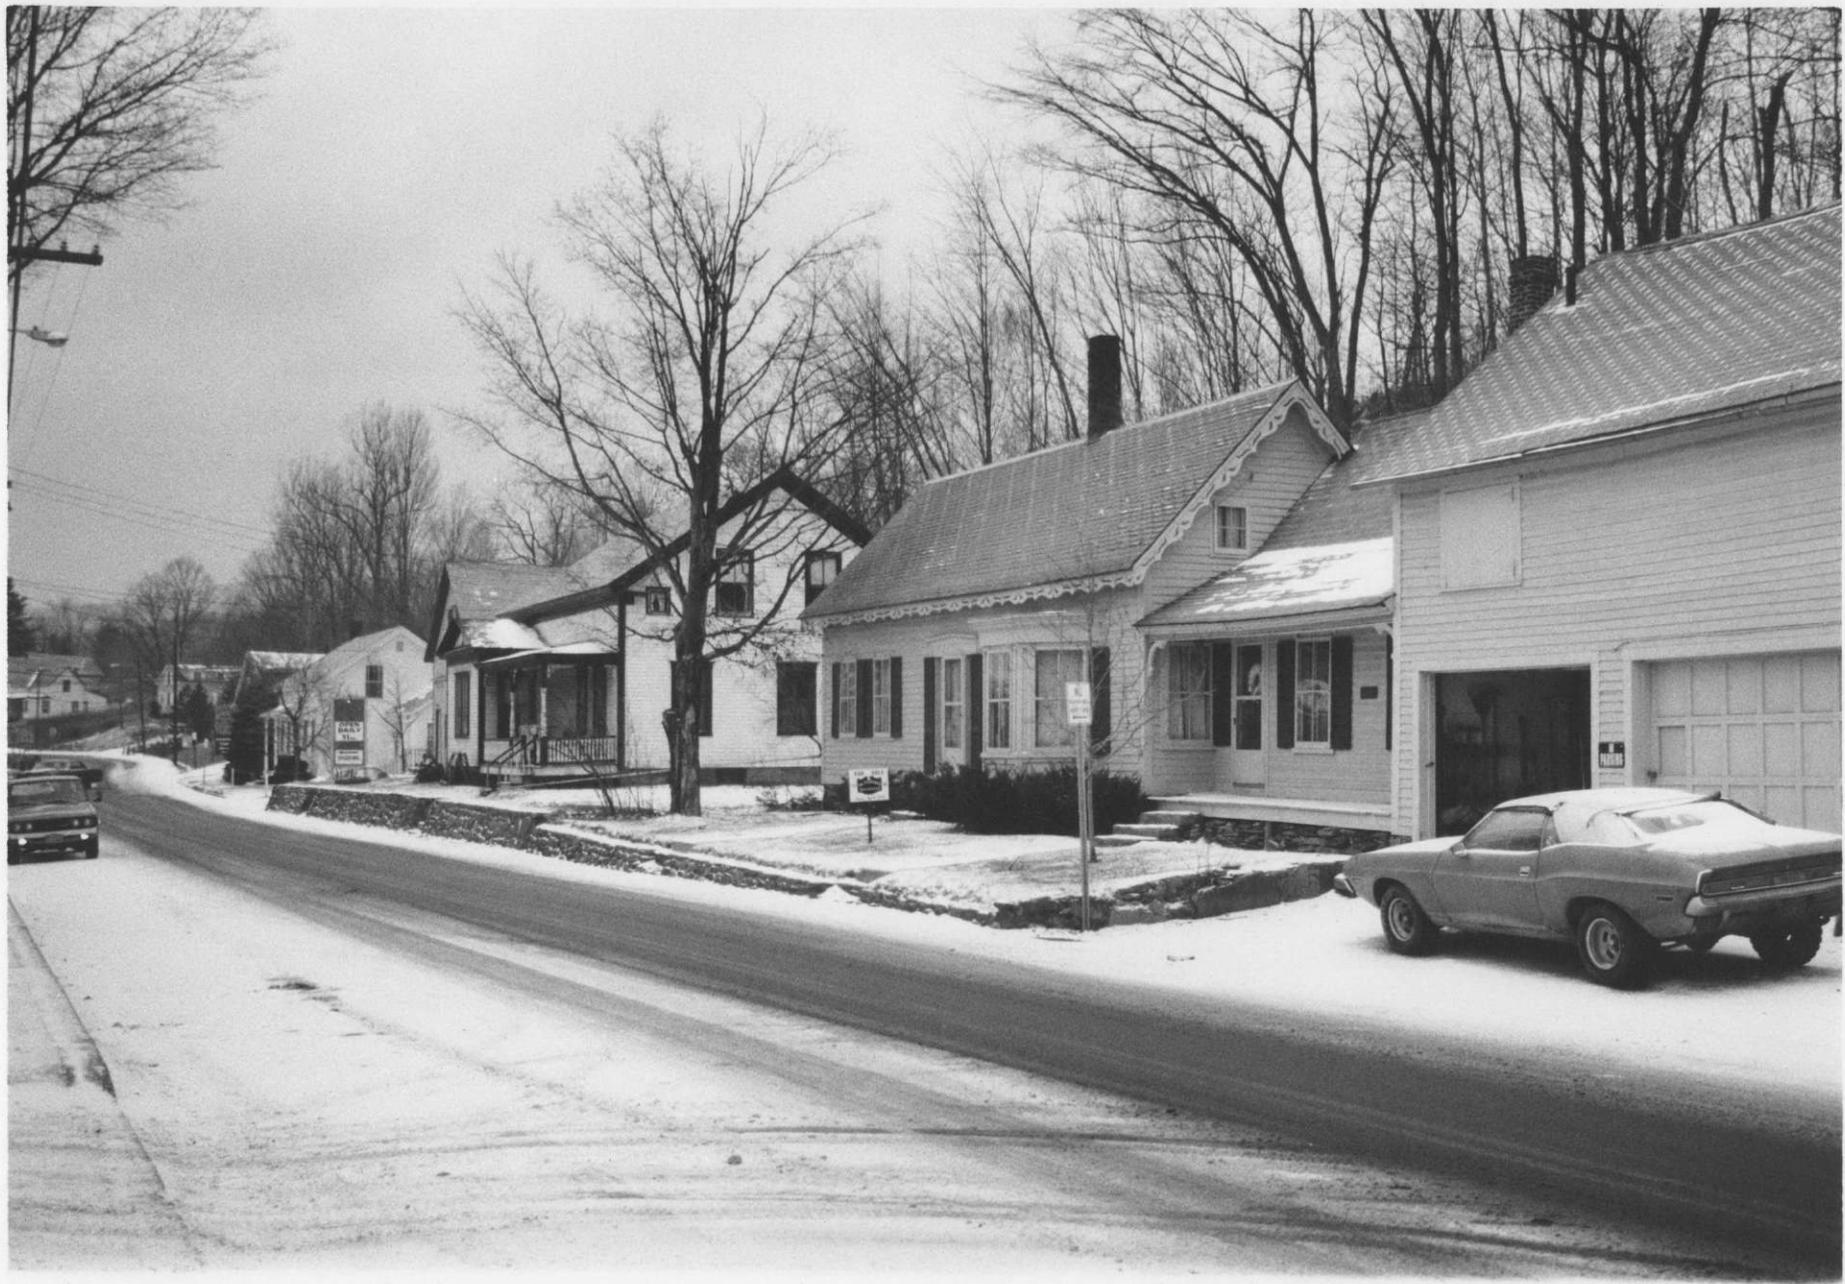
Photograph 18

Description: R to L, Bldgs. #44 & 45. View N
side of West Main St. looking NW.

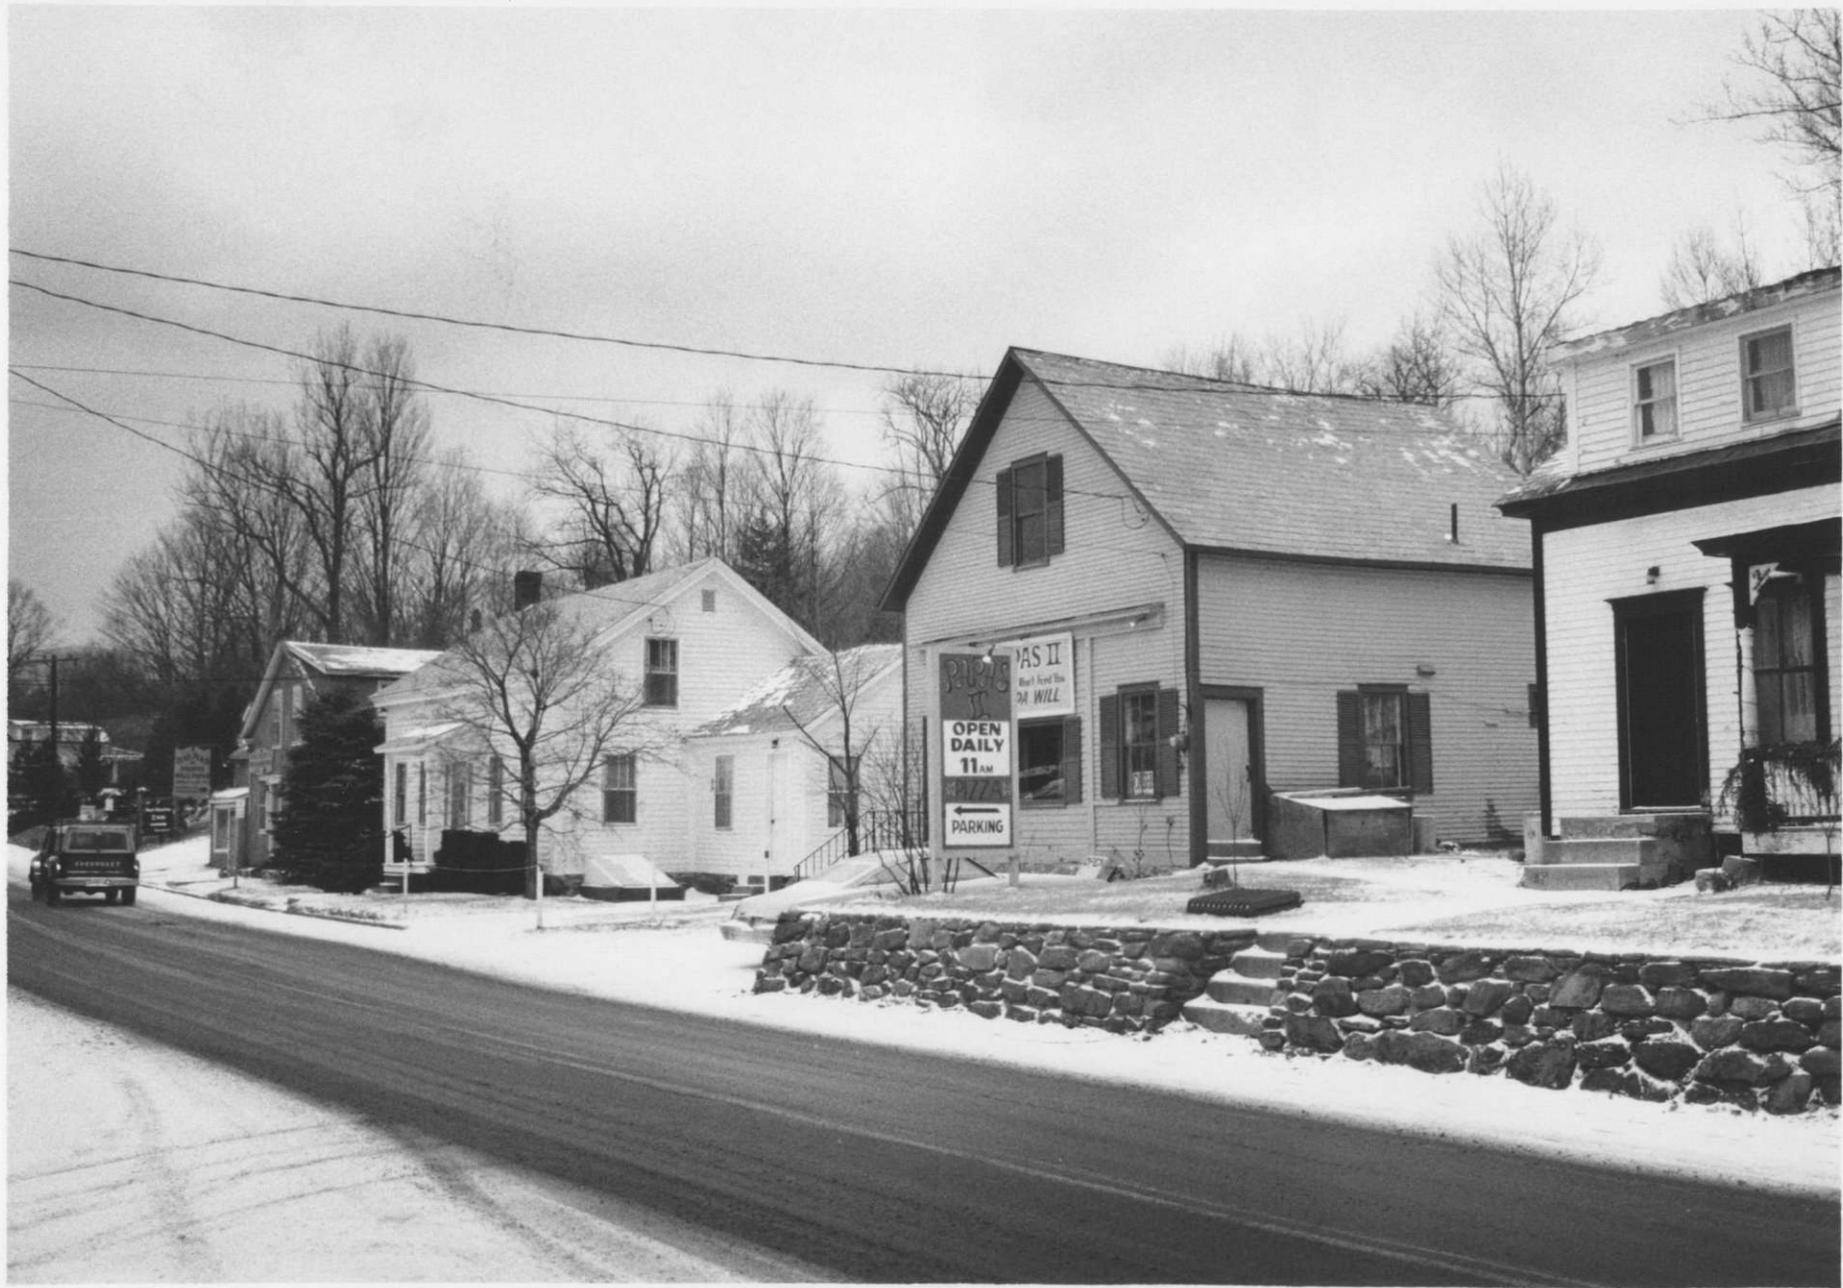
Wilmington Village Historic District
Wilmington, VT
Credit: Margaret DeLaittre
Date: January 1980
Negative filed at Vermont Division for
Historic Preservation
Description: R to L: Bldgs. #46, 47, 48. View
north side of West Main St. looking NW.
Photograph 19

48. Bauman Company, c. 1840, vernacular, Greek Revival: The original portion is a 1½-story, gable-front structure with a molded cornice which returns at the gable ends. There are two windows in the gable peak which have 2/2 lights and plain surrounds. The left of center doorway has fluted pilasters and cornice and is a modern replacement. The rear wing and left side ell additions are also modern and are 1½ stories. The left side ell has gabled dormers while the rear wing continues the row of shed-dormer windows which are also on the main block of the house. The ell has two entrances: one door has a new metal hood while the other entrance, also sheltered, is flanked by a display window. The entire building is sheathed in board and batten siding and the roof has slate tiles.

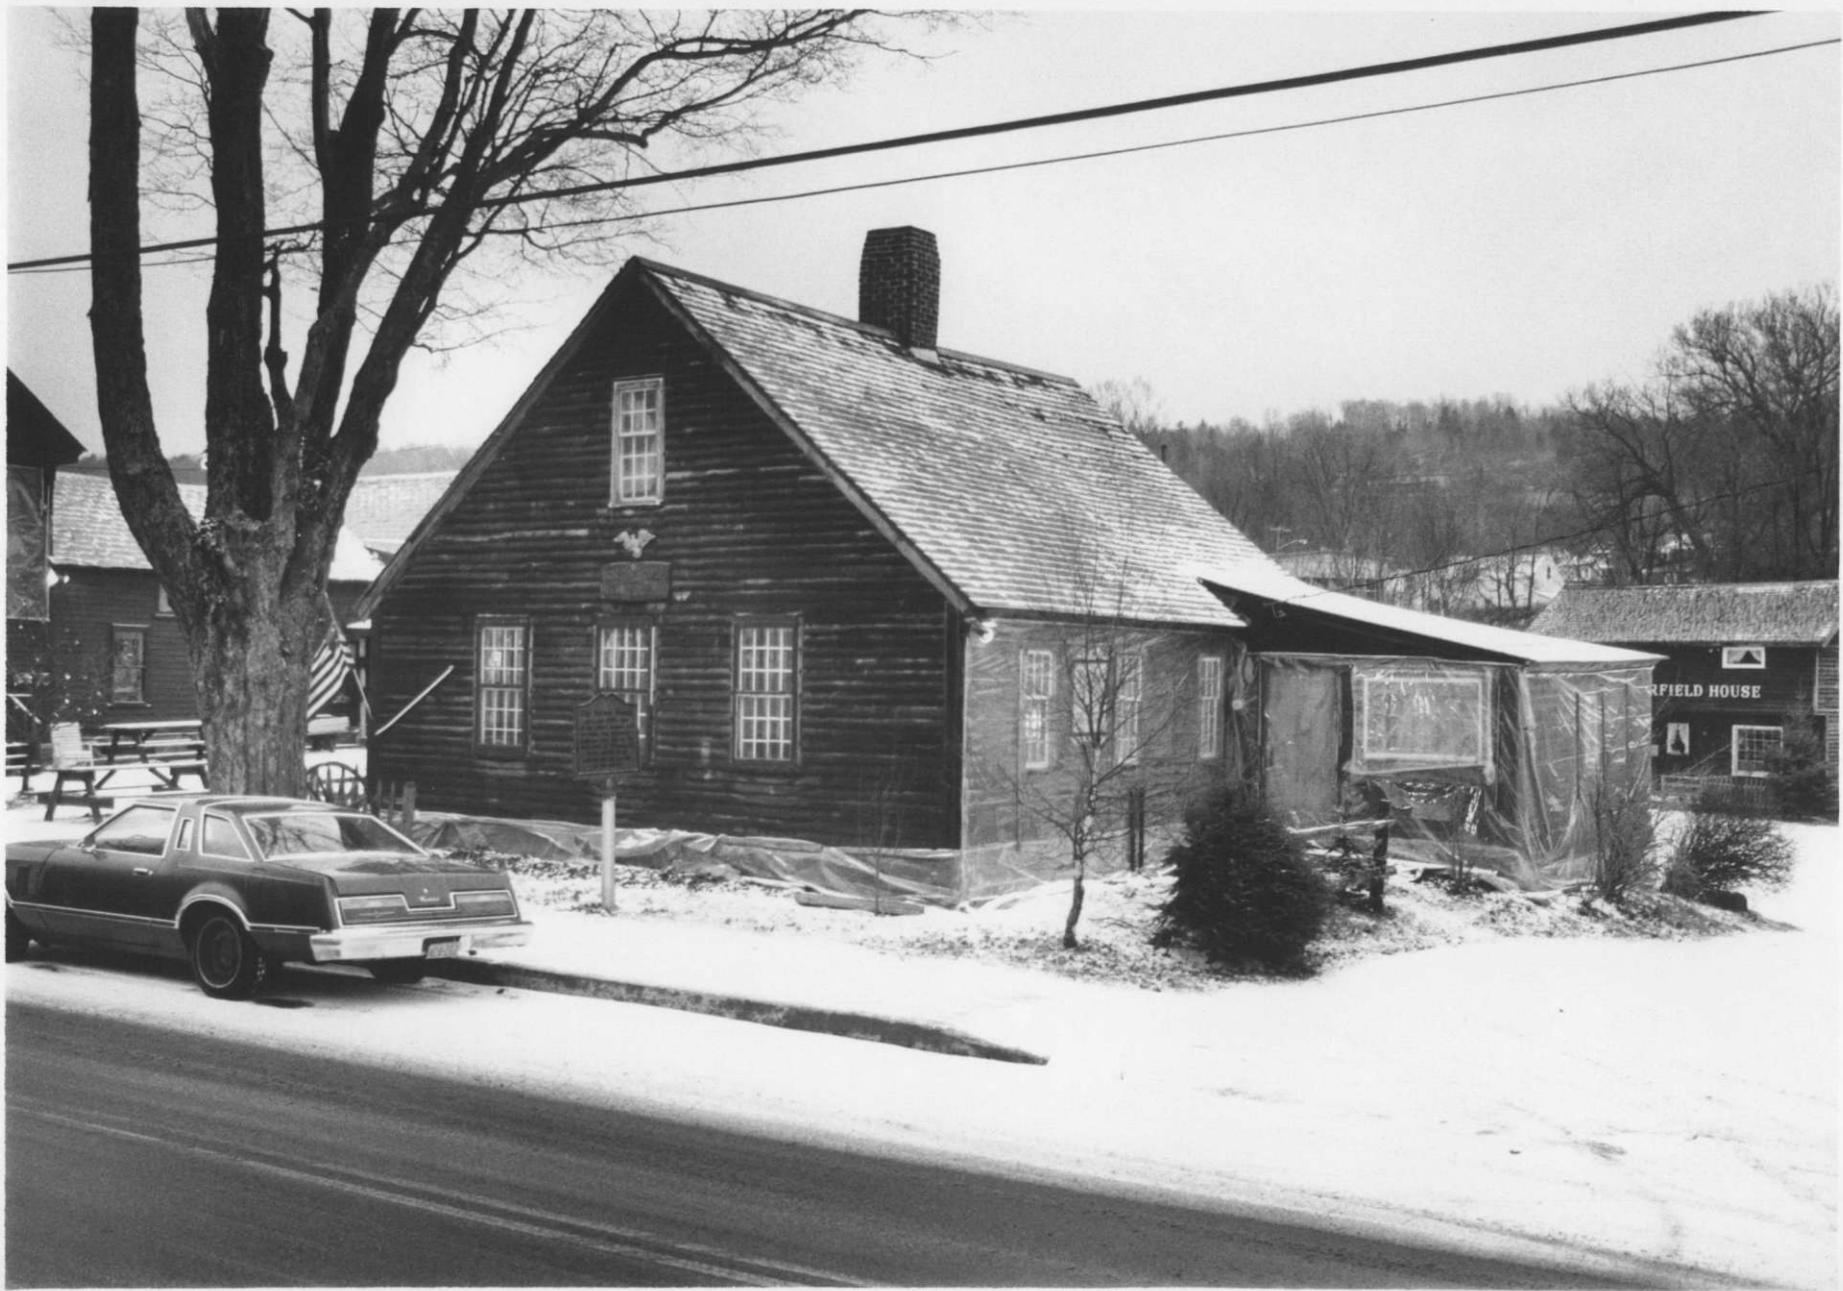
Photograph 20

Description: Norton House, #51. South side
of West Main Street looking southeast.
