HISTORIC SITES & STRUCTURES SURVEY
District Complex Survey Form

COUNTY	Addison
TOWN	Addison
LOCATION	Stickle Road off Route 22A
NAME OF DISTRICT	
TYPE OF DISTRICT	
PHYSICAL CONDITION OF STRUCTURES	Excellent 30% Good % Fair 50% Poor 20%
LEVEL OF SIGNIFICANCE	Local <input checked="" type="checkbox"/> State <input type="checkbox"/> National <input type="checkbox"/>
THEMES

SURVEY NUMBER	0101-2
NEGATIVE FILE NUMBER(S)	77-A-138
UTM REFERENCES	Zone/Easting/Northing A 18/635350/4876850 B C D
U.S.G.S. QUAD MAP	Port Henry, N.Y. -VT
COMPLEX INFORMATION ONLY	
COMMON NAME	Stickle Farm
PRESENT FORMAL NAME	
ORIGINAL FORMAL NAME	
TYPE OF COMPLEX	Agricultural
TYPES OF STRUCTURES	Barns, house, Blacksmith shop, Privy
PRESENT USE	Dairy farm
ORIGINAL USE	Diverse Agricultural
ARCHITECT/ENGINEER	
BUILDER/CONTRACTOR	
ACCESSIBILITY TO PUBLIC	Yes <input type="checkbox"/> No <input checked="" type="checkbox"/> Restricted <input type="checkbox"/>

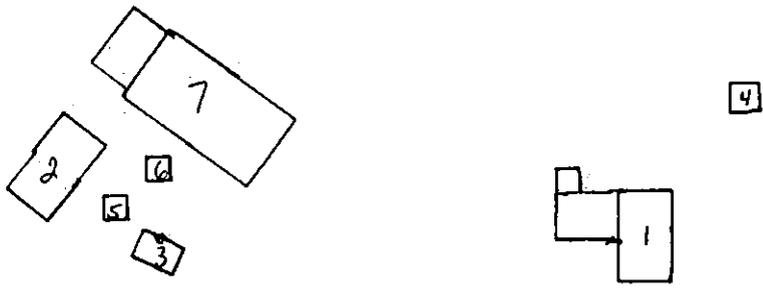
MAP (1 Indicate NORTH in circle 2 Represent each structure as an open box 3 Number each structure inside of its box)

Access to Route 22A

Coextensive with the boundary of the farm on the West side of route 22A

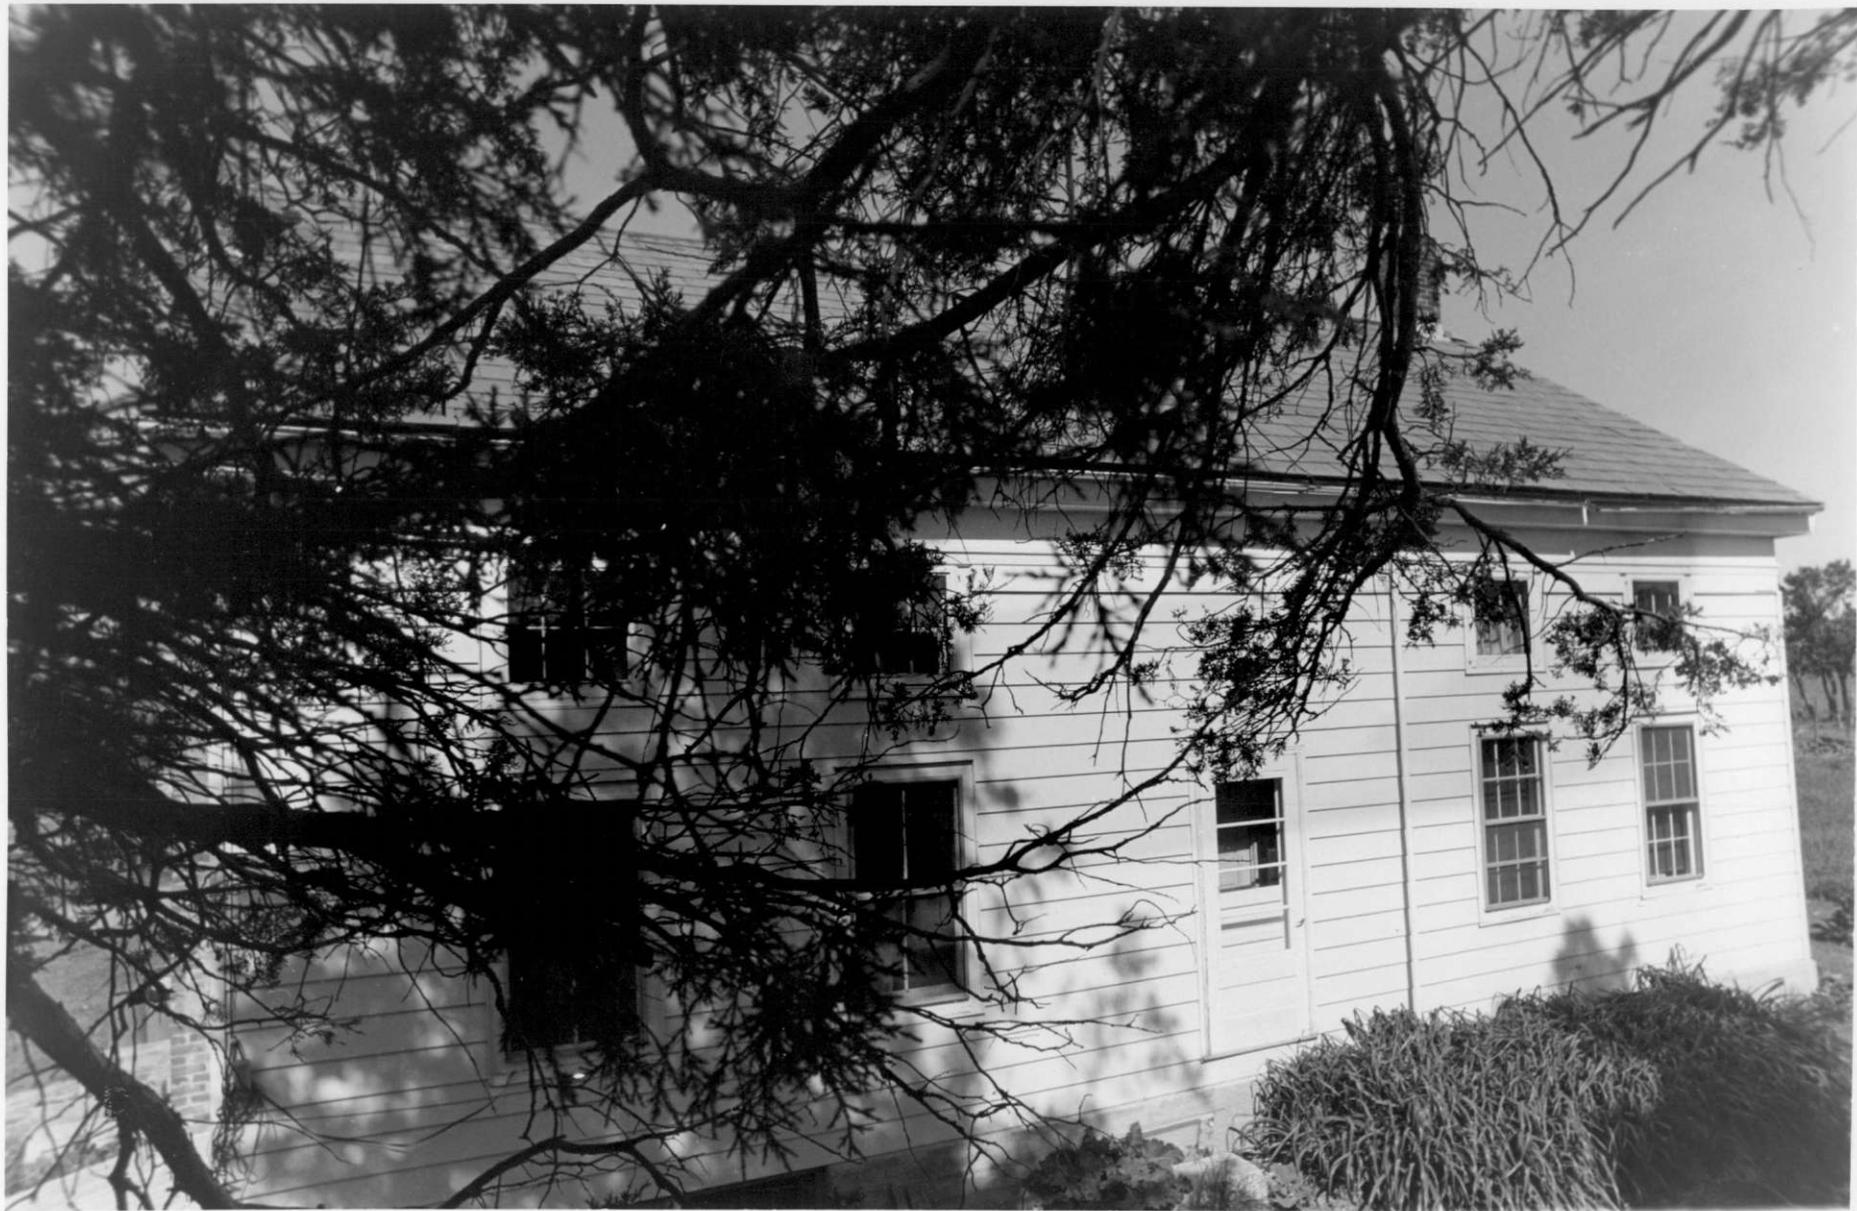
OUTSTANDING COMPONENTS OF DISTRICT <input type="checkbox"/>		COMPLEX <input checked="" type="checkbox"/>
(Include individual survey number ONLY if surveyed individually)		
MAP NUMBER: 1	DATE BUILT: c.1805/	SURVEY NUMBER: 0101-2
FUNCTIONAL TYPE: house	1856	NEGATIVE FILE NUMBER: 77-A-138
COMMON NAME: Stickle farm	OWNER: Alta Brileya	
DESCRIPTION: Mixed saltbox and Greek Revival cottage The newer Greek Revival front was built perpendicular to the original saltbox. The saltbox measures approximately 27' X 24'. While its original character is obliterated by misuse, aluminum siding and the added structure, its proportions, fenestration and roof line give clear evidence of its original appearance (See 0101-52 for discussion of the Addison saltbox type). The wide entablature and gable returns of the 5 X 2 bay 1 1/2 story Greek Revival front indicate that under the layers of aluminum is a good example of early Greek Revival cottage architecture. Some of the window sashes are original and all of the slate on both roofs, but it is amazing to what extent aluminum siding has destroyed the integrity of the house. Noteworthy are the

eyebrow windows on the facade Frontispiece and entablature were
obliterated when fitting the aluminum siding

Vt. Div. for Historic Preservation
Addison Co. Town of Addison 6/77
Stickle-Brileya Farm, house W
77-A-138 W. N. Hosley

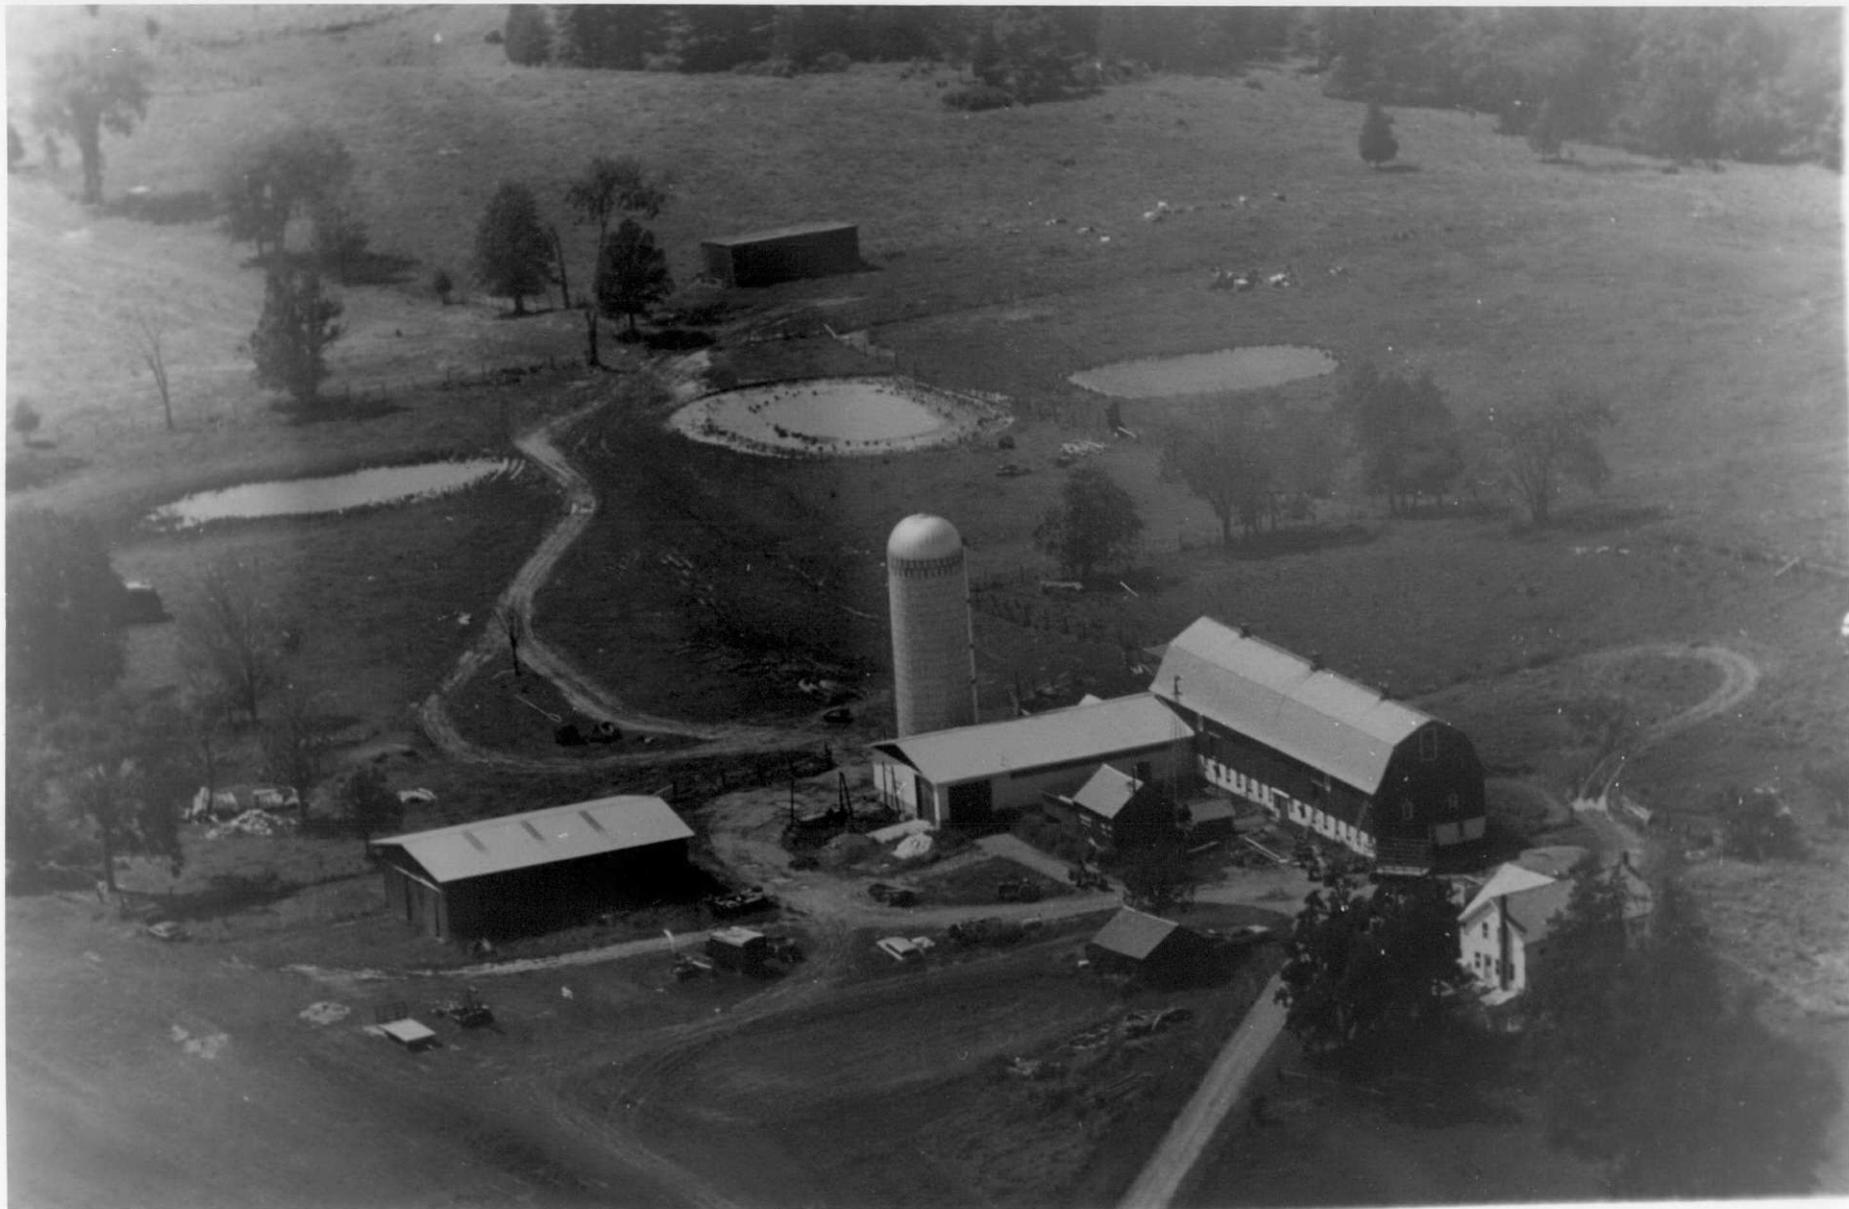
0101-2

Vt. Div. for Historic Preservation
Addison Co. Town of Addison 6/77
Stickle-Brileya Farm, aerial
77-A-138 W.N. Hosley
