DIFFERENCES IN SITE NUMBERS USED IN PUBLISHED TOWN HISTORY AND VERMONT HISTORIC SITES & STRUCTURES SURVEY

BRIDPORT

**THE HISTORIC ARCHITECTURE
OF ADDISON COUNTY**
*Including a listing of
the Vermont State Register of Historic Places*

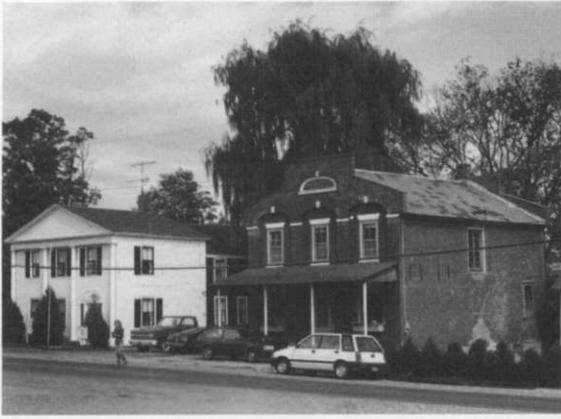
By 1826 Bridport village was a prosperous place, benefiting from trade along the Fair Haven to Vergennes stage road and a road from Middlebury to Lake Champlain. In that year Paris Fletcher built his brick store (A26, 1826) at the main intersection in the village and added an ornate Federal style addition to his home (A25) next door.

With the rise in canal-bound traffic, trade in the village increased significantly. Merchant Paris Fletcher had a Federal style brick store (A26, 1826) built which resembled brick structures in Woodstock, from where he had emigrated in 1810. At about the same time Fletcher constructed an ornate Federal style addition to the front of his home (A25, c.1825). With its monumental portico, full entablature, and semi-circular entrance fan, this house reflected Fletcher's stature as a successful merchant. In 1826 another merchant, Matthew Chambers, also added a Federal style front to his older, saltbox type house (A33). Both Chambers' and Fletcher's homes bear pediments filled with flushboard above enriched Doric entablatures. By 1845

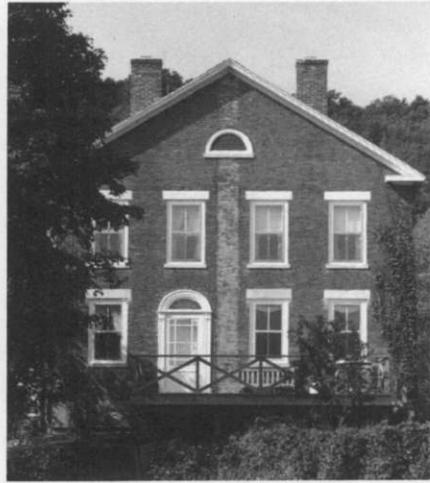
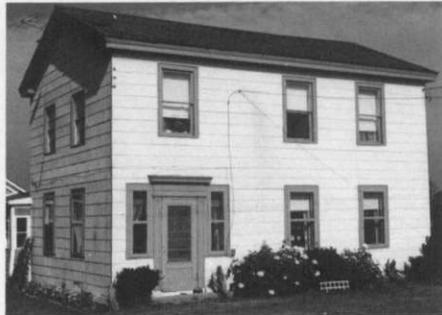
Bridport has a wealth of houses from the first third of the nineteenth century, ranging from sophisticated Federal style houses, such as a brick home (58, c.1825) with gable and entry fanlights, to modest vernacular types, such as this half I-house (82, c.1825), with an entry with paneled pilasters, entablature, and sidelights.

The general prosperity of the wool-growing years is illustrated by the many stylish homes constructed in Bridport between 1820 and 1840. While most farmers had frame houses built, a few opted for more expensive brick. A member of the Pratt family had a stately brick home (58, c.1828) built in the late-Federal style. A semi-circular, entrance fanlight set above pilasters ornamented by starbursts graces this house. Hiram Smith's Greek Revival style house (1, c.1835) is noteworthy for its impressive, modillion cornice and muntin-interlaced gable window. The bricks for this house may have been fired on the farm, which Smith's grandfather established in 1770. Another house (78, c.1845) is an interesting variation of the Greek Revival style with its pavilion with ells plan, panelled corner pilasters, and elaborate entrance entablature.

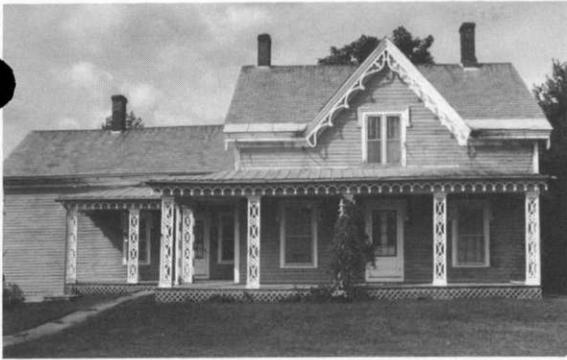
Farmer and stock dealer Orin W. Pratt remodeled this house (A18, c.1840) about 1870 as his village home. It is an excellent example of the Gothic Revival style, with Gothic wall dormers, bargeboard, and a porch with posts filled by delicate tracery designs.

A18 House, c.1870

Gothic Revival style, gable roof, 1 1/2 stories.
Features: label lintels, bargeboard, Gothic wall dormer, Gothic Revival porch, distinctive door.

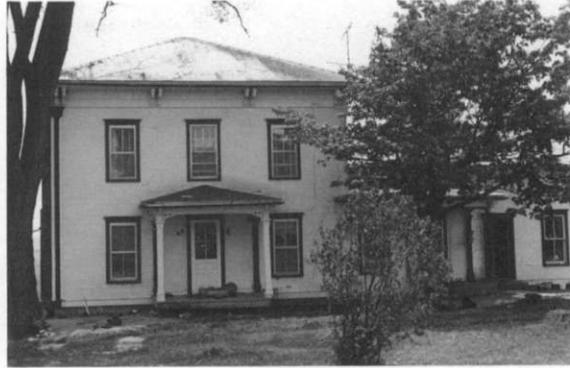
After the Civil War, many Vermont farmers who remodeled or constructed new homes did so using Italianate style forms and decoration. Two-story, cube-shaped, hipped-roof houses, large enough for a farm family and help, were popular in both Bridport and Addison, and in many ways presaged the popular Four-square house form of the twentieth century. This example (15a, c.1880) has an attached kitchen ell and Italianate style porches, cornice brackets, and corner pilasters.

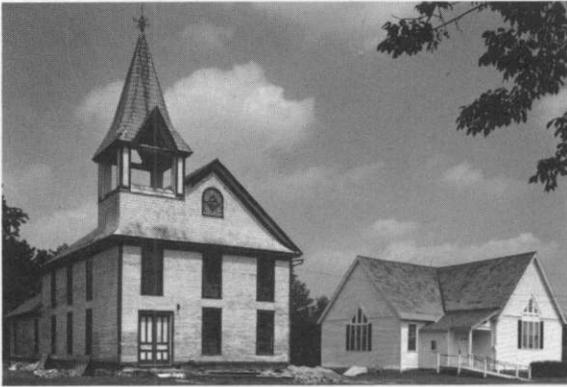
A fire in February, 1891, destroyed the 1821 Bridport Methodist Church, which also served the local Masonic society. The same year both groups built new Queen Anne style structures. The Masonic Hall (A9), with its distinctive corner belfry tower, was designed by Vergennes architect Charles LeBoeuf. The Methodist church (A10), which has had its original interior corner tower removed, was designed by Middlebury architect Clinton Smith.

Although the population of Bridport declined to 1,018 in 1890, Bridport village, as the center of a successful agricultural town, experienced a spurt of growth, when three new buildings were erected on the north side of the green in 1891. A Masonic Hall (A9) and a new vestry (A6) for the Congregational church went up, as well as a new Methodist church (A10). Both the Masonic Hall and Methodist Church exhibit characteristics of the Queen Anne style: the hall with its shingled, pent gable and asymmetrical tower, and the church with its shingling and divided stained-glass windows.

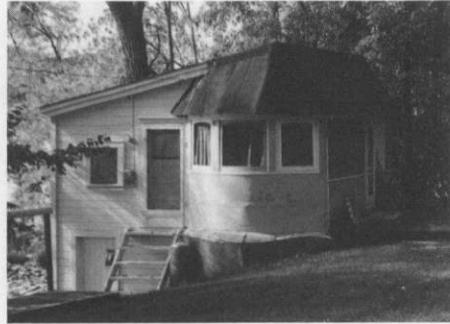
Ervin Huestis began operating the ferry from Bridport to Crown Point, New York, in 1933. Not long after, he moved a trolley car from Ticonderoga, New York, across the lake, converted it to this camp (113), and stayed in it during foul weather.

Beginning just prior to World War II, a number of residents constructed modest summer camps along the lakeshore. The most unusual of these is a converted trolley car (113) that Ervin Huestis, the last ferry operator, floated across the lake from Crown Point in the 1930s. Apparently he stayed in it when foul weather delayed the running of the ferry. Also at the ferry landing in West Bridport is a more typical frame camp (114, c.1940). It was built inside the foundation of a large, nineteenth century icehouse, where ice cut from the lake in winter was stored and sold throughout the year, probably by the owner of the ferry and store there.

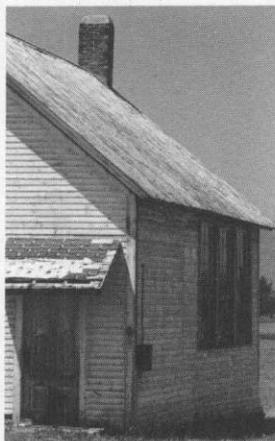
8 School, c.1880

Gable roof, 1½ stories.
Features: bank of windows.

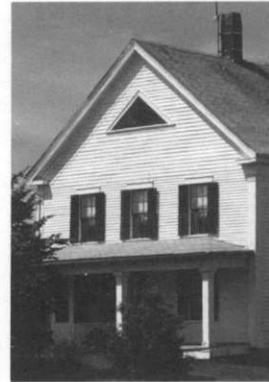
42 (Farm)

a. House, c.1830/c.1850

Greek Revival style, sidehall plan, 1½ stories.
Features: Greek Revival porch, triangular gable fan, corner pilasters.
b. Barn, c.1880
c. Barn, c.1880
d. Milkhouse, c.1910
e. Ground Stable Barn, c.1880/c.1920
Gambrel roof.
Features: hoist, rafter tails.
f. Shed, c.1880

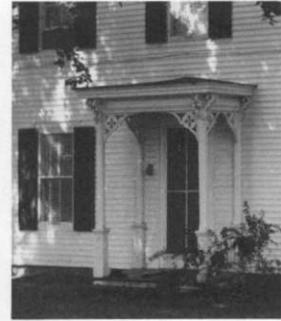
48 (Farm)

a. House, 1869

Architect/builder: John T. Lamos.
Italianate style, hip roof, 2 stories.
Features: Italianate porch, cornice brackets, belvedere, distinctive door, enriched frieze.
b. Granary, c.1900
c. Carriage Barn, c.1910
d. Ground Stable Barn, c.1915/c.1974
Gambrel roof.
Features: hoist.

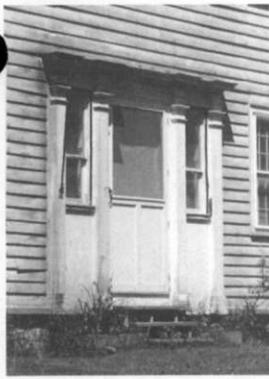
84 House, c.1810

Federal style, Georgian plan. Features: cornice caps, enriched entablature, sidelights, entry pilasters, distinctive interior, porch, carriage bays.

early architectural refinement rare in Bridport. Other Federal style houses of this period were fitted with details ranging from a simple entrance entablature and panelled door (10, c.1810) to entries with pilasters and sidelights (84, c.1810).

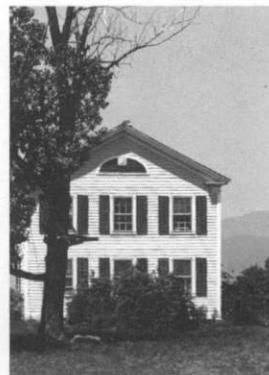
104 House, c.1800/1828

Architect/builder: Zenas Myrick. Vernacular-Federal style, Georgian plan. Features: distinctive interior, gable fan. Related: barn.

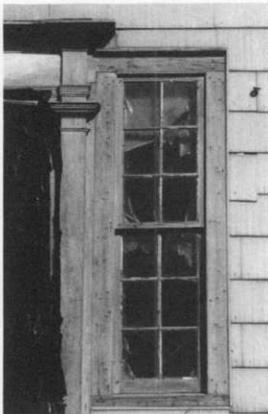
117 Lapham Farm

- a. House, c.1800
Vernacular-Federal style,
Georgian plan.
Features: sidelights, entry
entablature, entry pediment.
- b. Barn, c.1860
Features: hoist, polychrome slate.
- c. Barn, c.1910

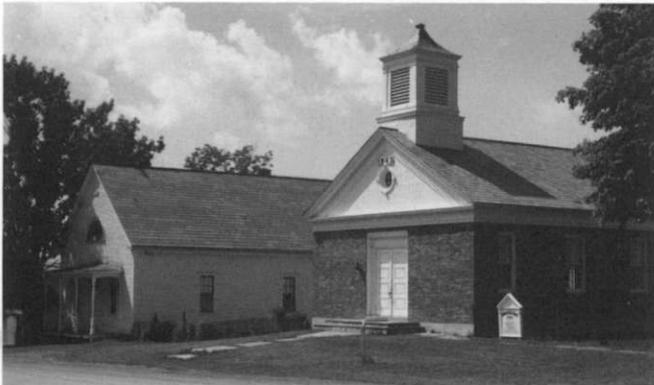
(A6, 1891; A7, 1941-43)

With many early homes and a number of later public buildings, Bridport village retains a wide range of distinguished structures from the nineteenth century when it served as the town center for a prosperous agricultural community.

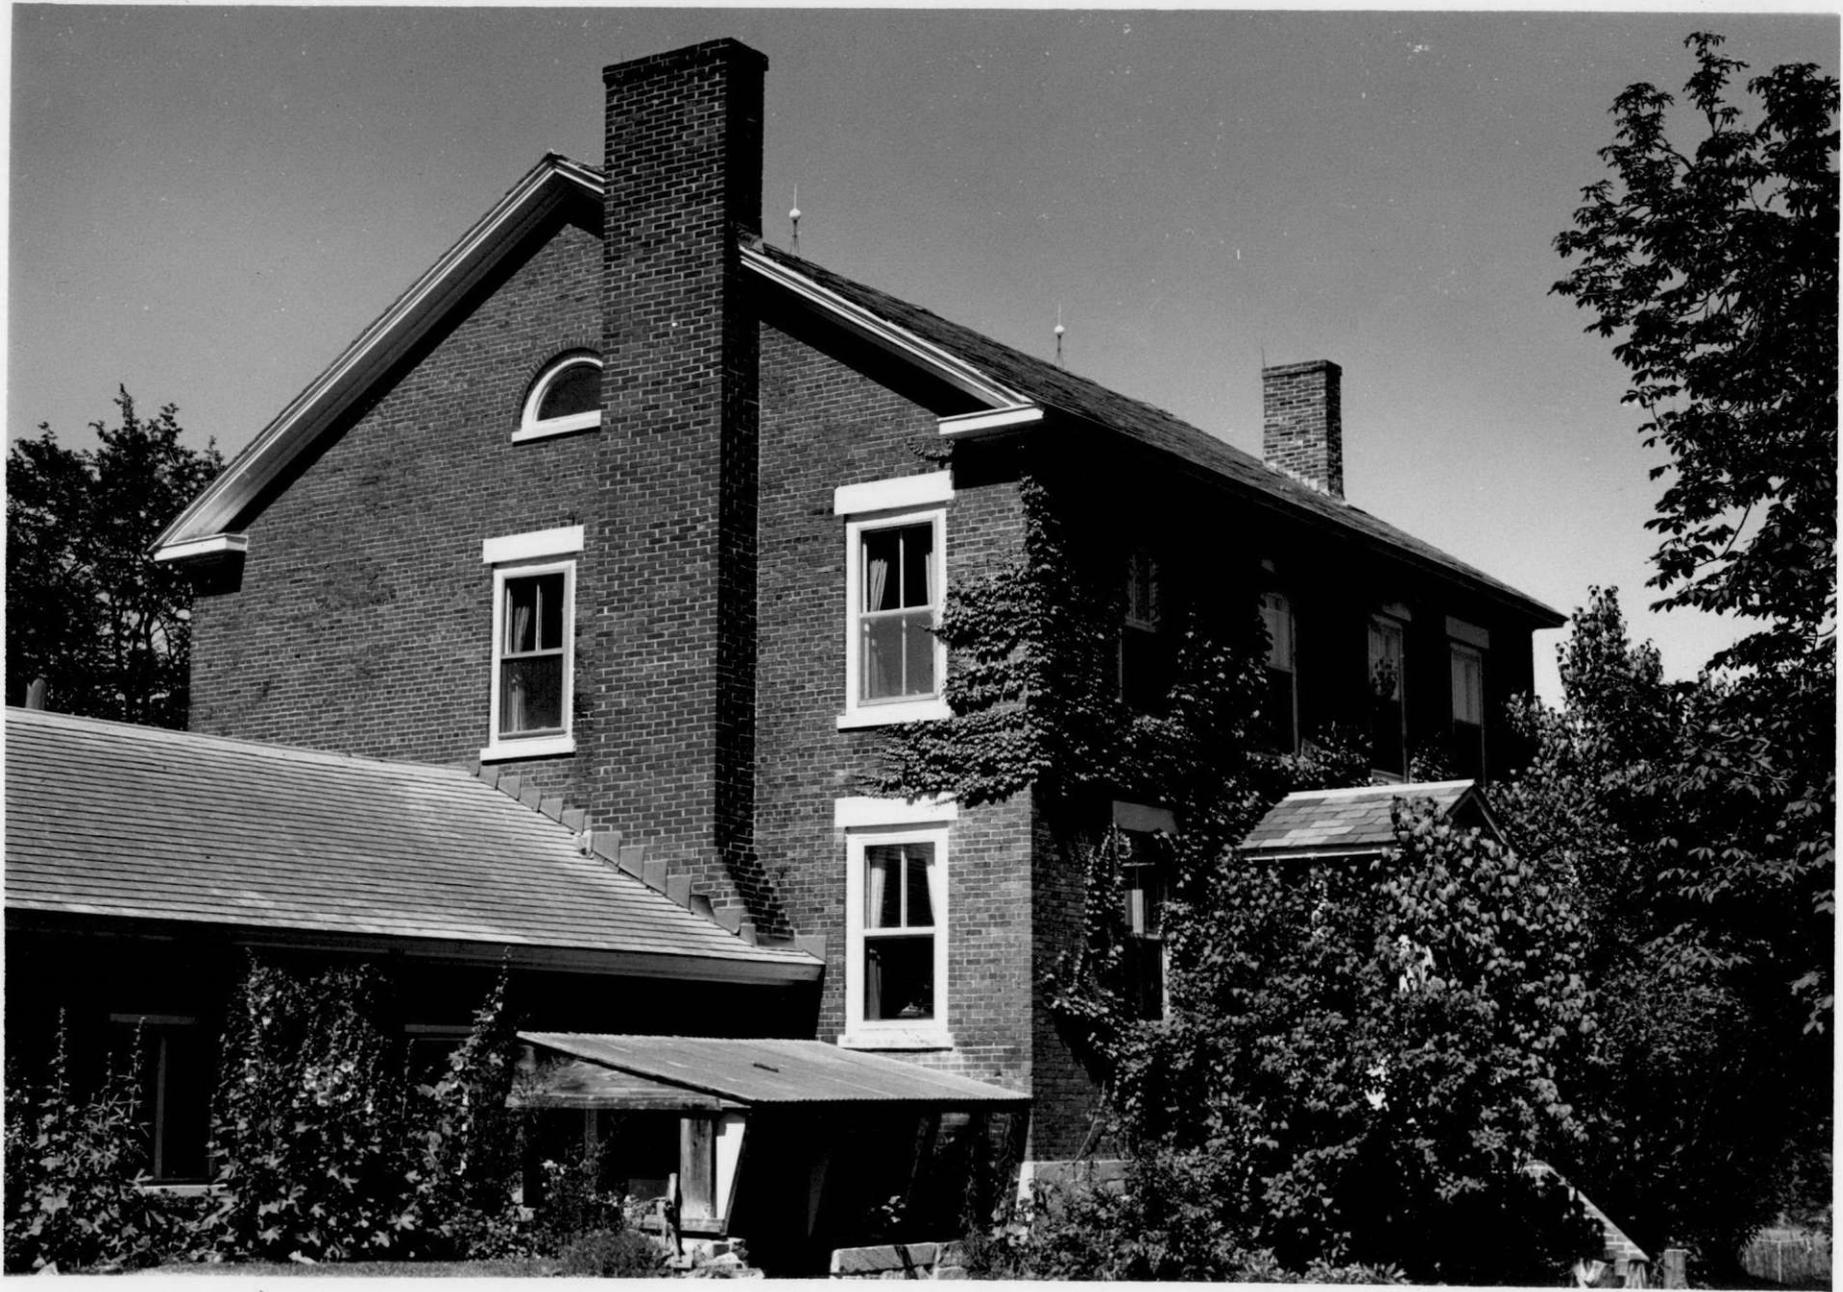
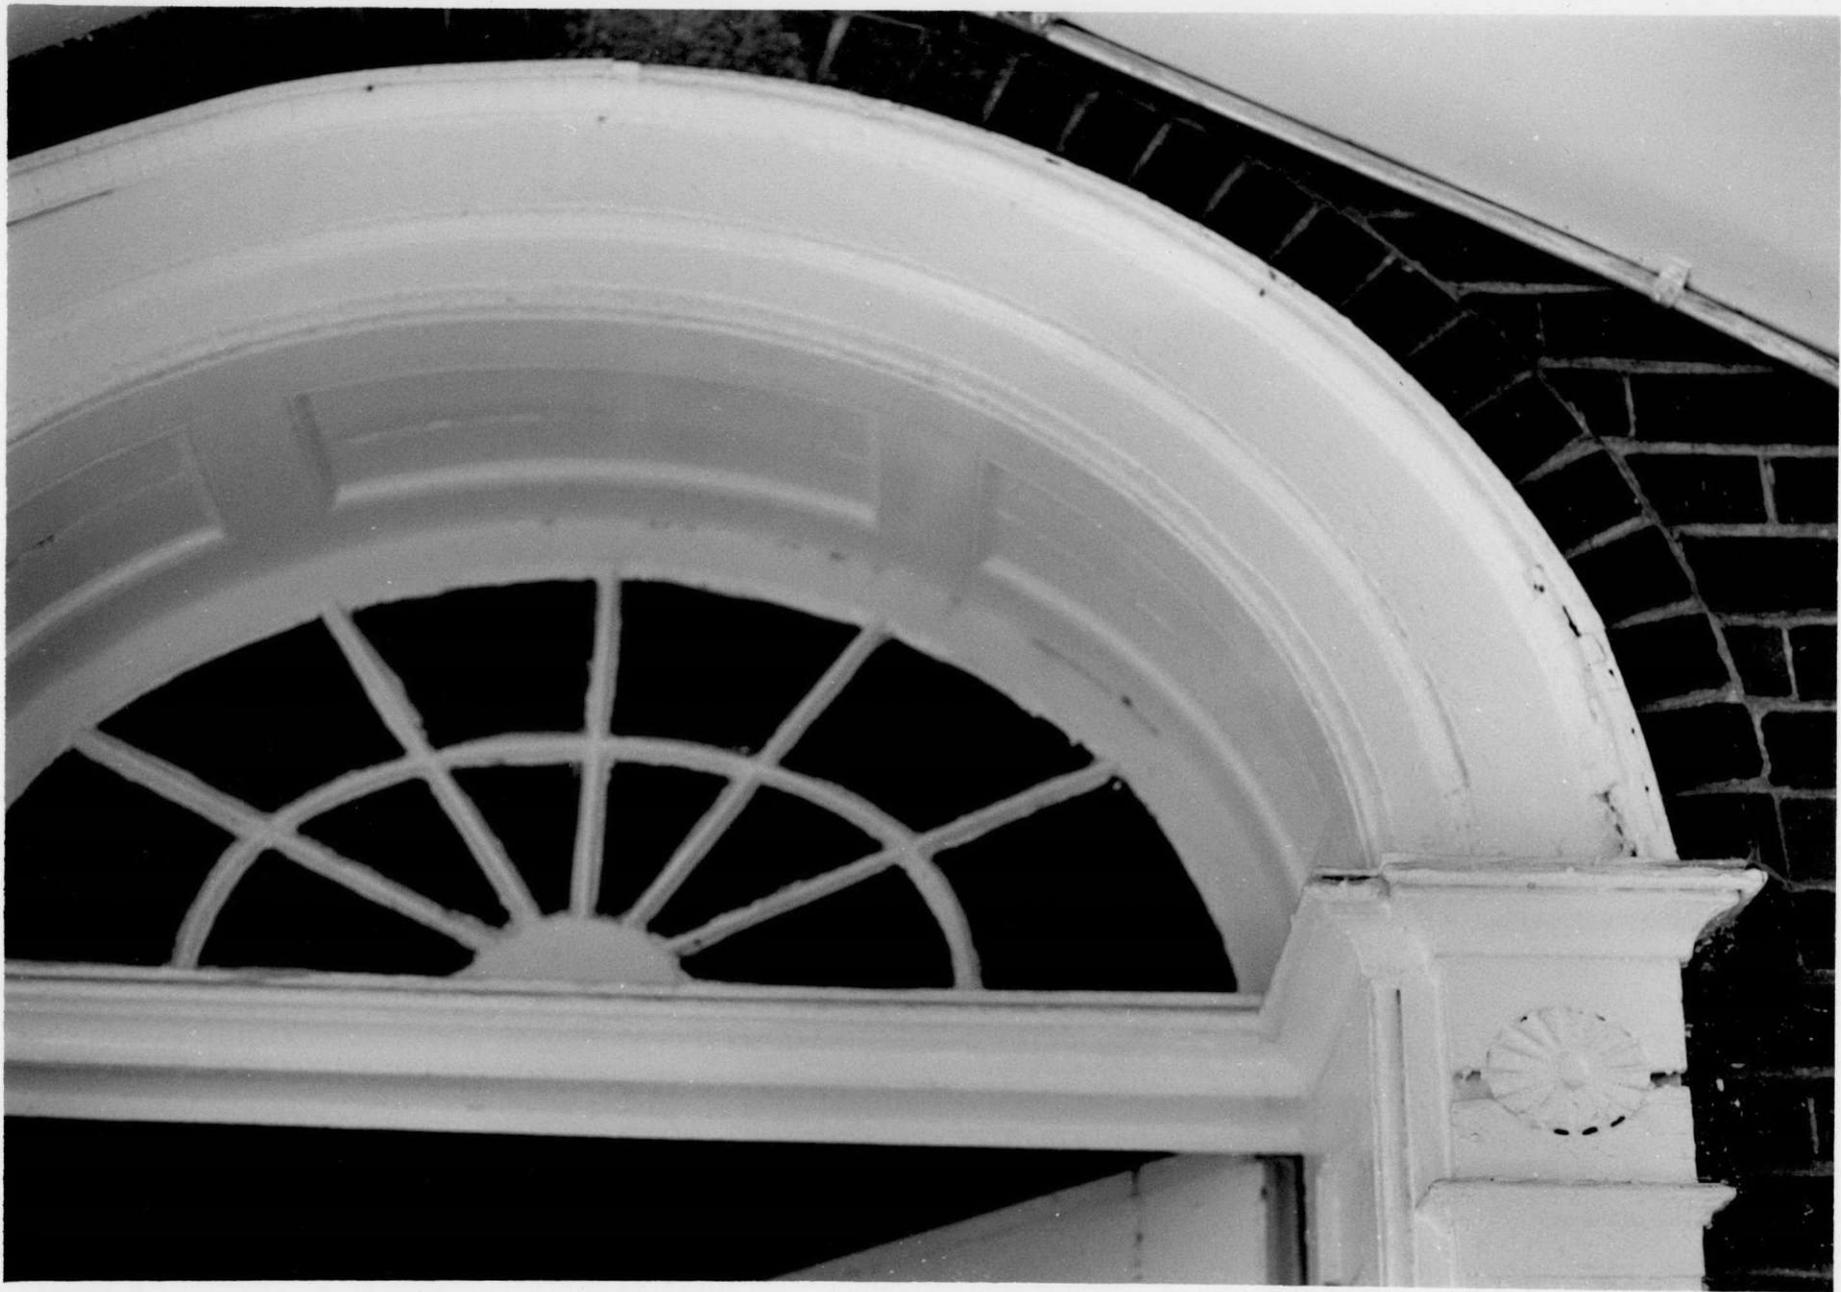
SURVEY NUMBER:	0102-6
NEGATIVE FILE NUMBER:	77-A-147
UTM REFERENCES	Zone/Easting/Northing
	18 639430 4875040
U S G S QUAD MAP	Port Henry N.Y. - Vt.
PRESENT FORMAL NAME	
ORIGINAL FORMAL NAME	
PRESENT USE.	domestic dwelling
ORIGINAL USE.	farmhouse
ARCHITECT/ENGINEER	
BUILDER/CONTRACTOR	
PHYSICAL CONDITION OF STRUCTURE	Excellent <input type="checkbox"/> Good <input checked="" type="checkbox"/> Fair <input type="checkbox"/> Poor <input type="checkbox"/>
THEME.	
STYLE:	Federal-Greek Revival Transitional
DATE BUILT	c 1828

This transitional brick house has some interesting details that were common to the building vocabulary of this part of Addison County. Particularly noteworthy is the semi-circular fanlight with ornamental starbursts. Similar elements are found on other houses in Bridport, Weybridge and Middlebury. It is a motif used in some of the domestic designs of Middlebury architect Lavius Fillmore (1767-1852)

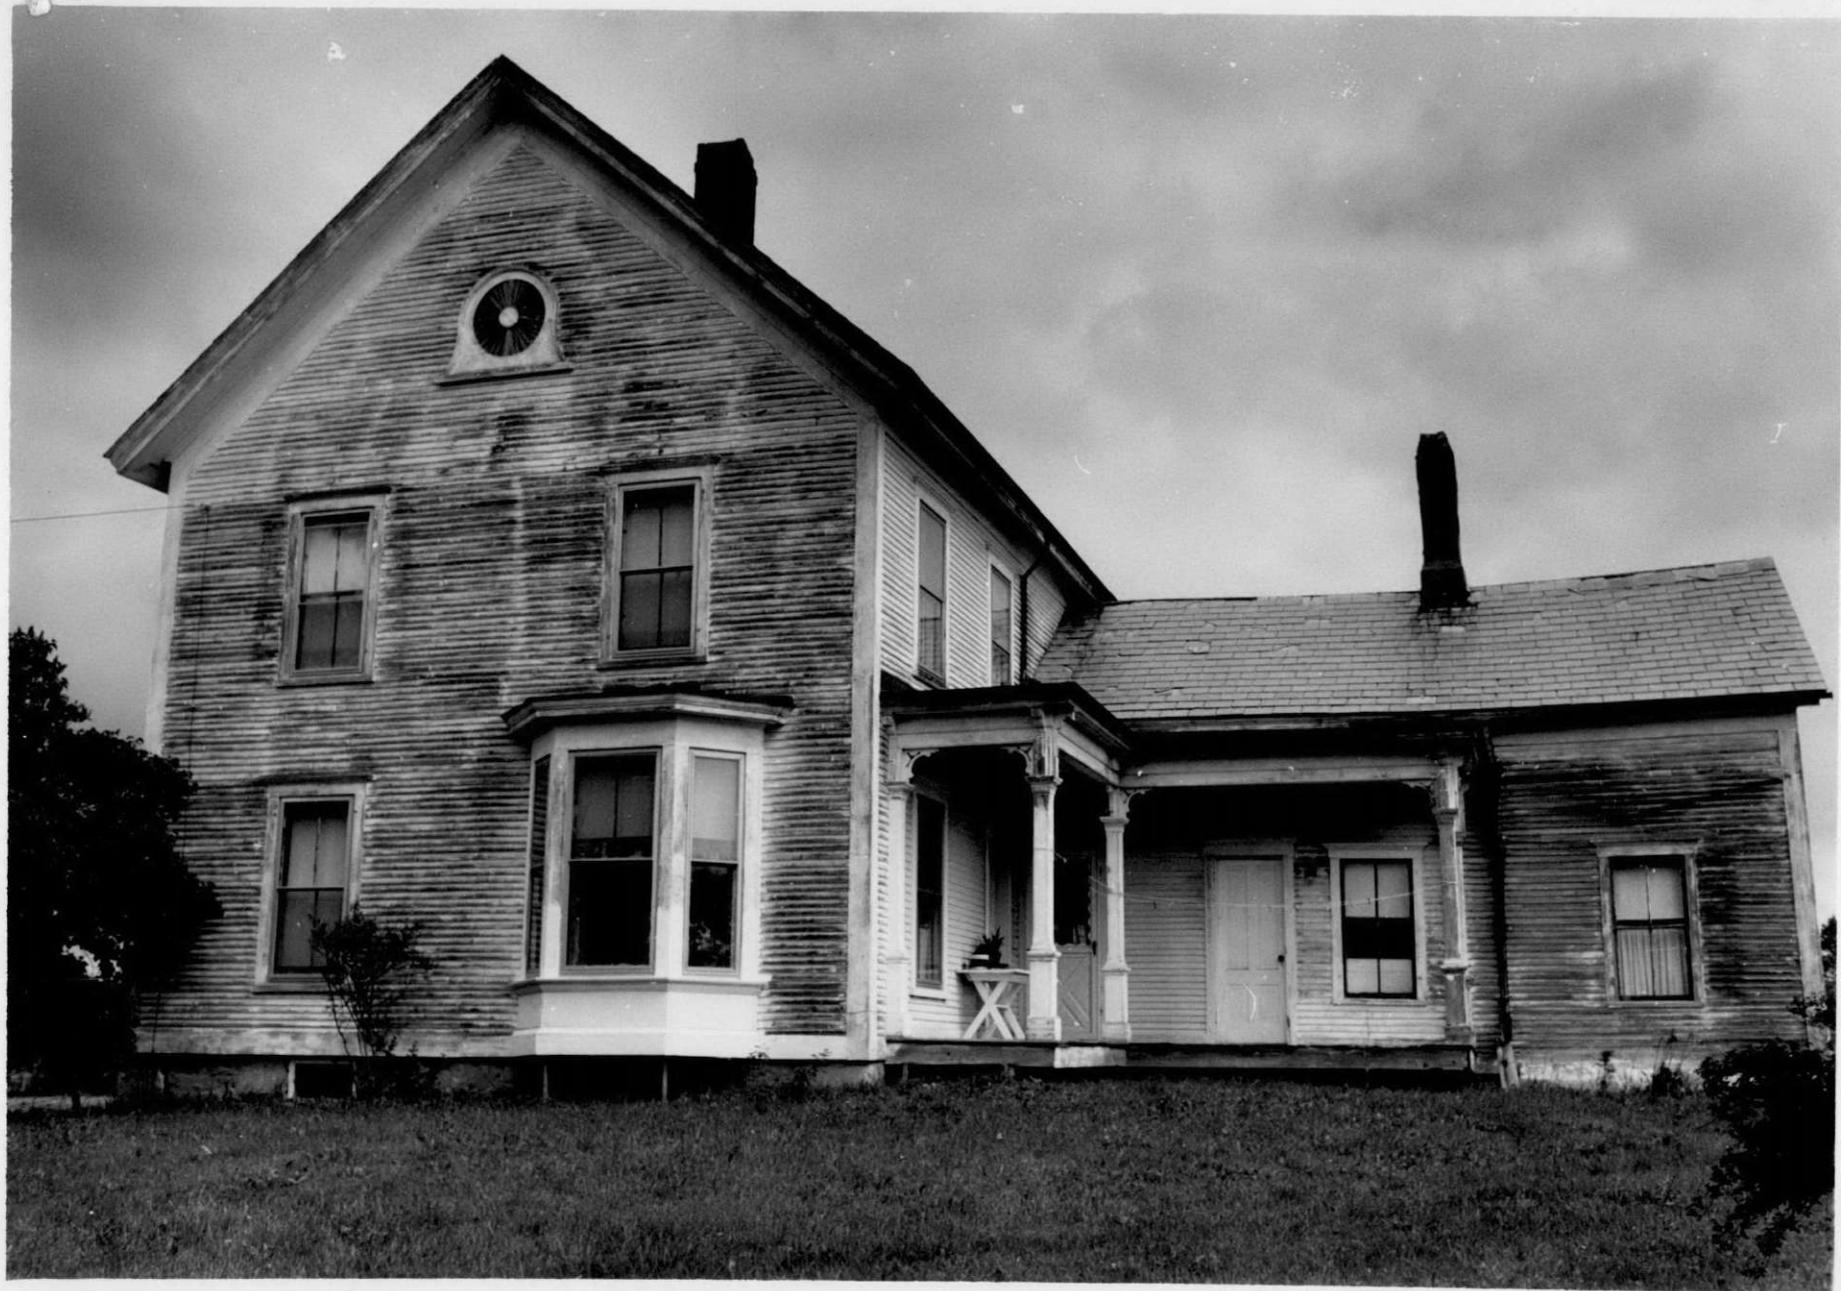
0102-9

DESCRIPTION: 2-1/2 story clapboard sided; steeply pitched slate shingle clad wide eaved roof with simple frieze line. Gable has a (flayed based)? louvered ocular window; window caps are molded. Porches are probably later with chamfered posts with pedestals and capitals; corner brackets. The house is of a type found elsewhere in Bridport.

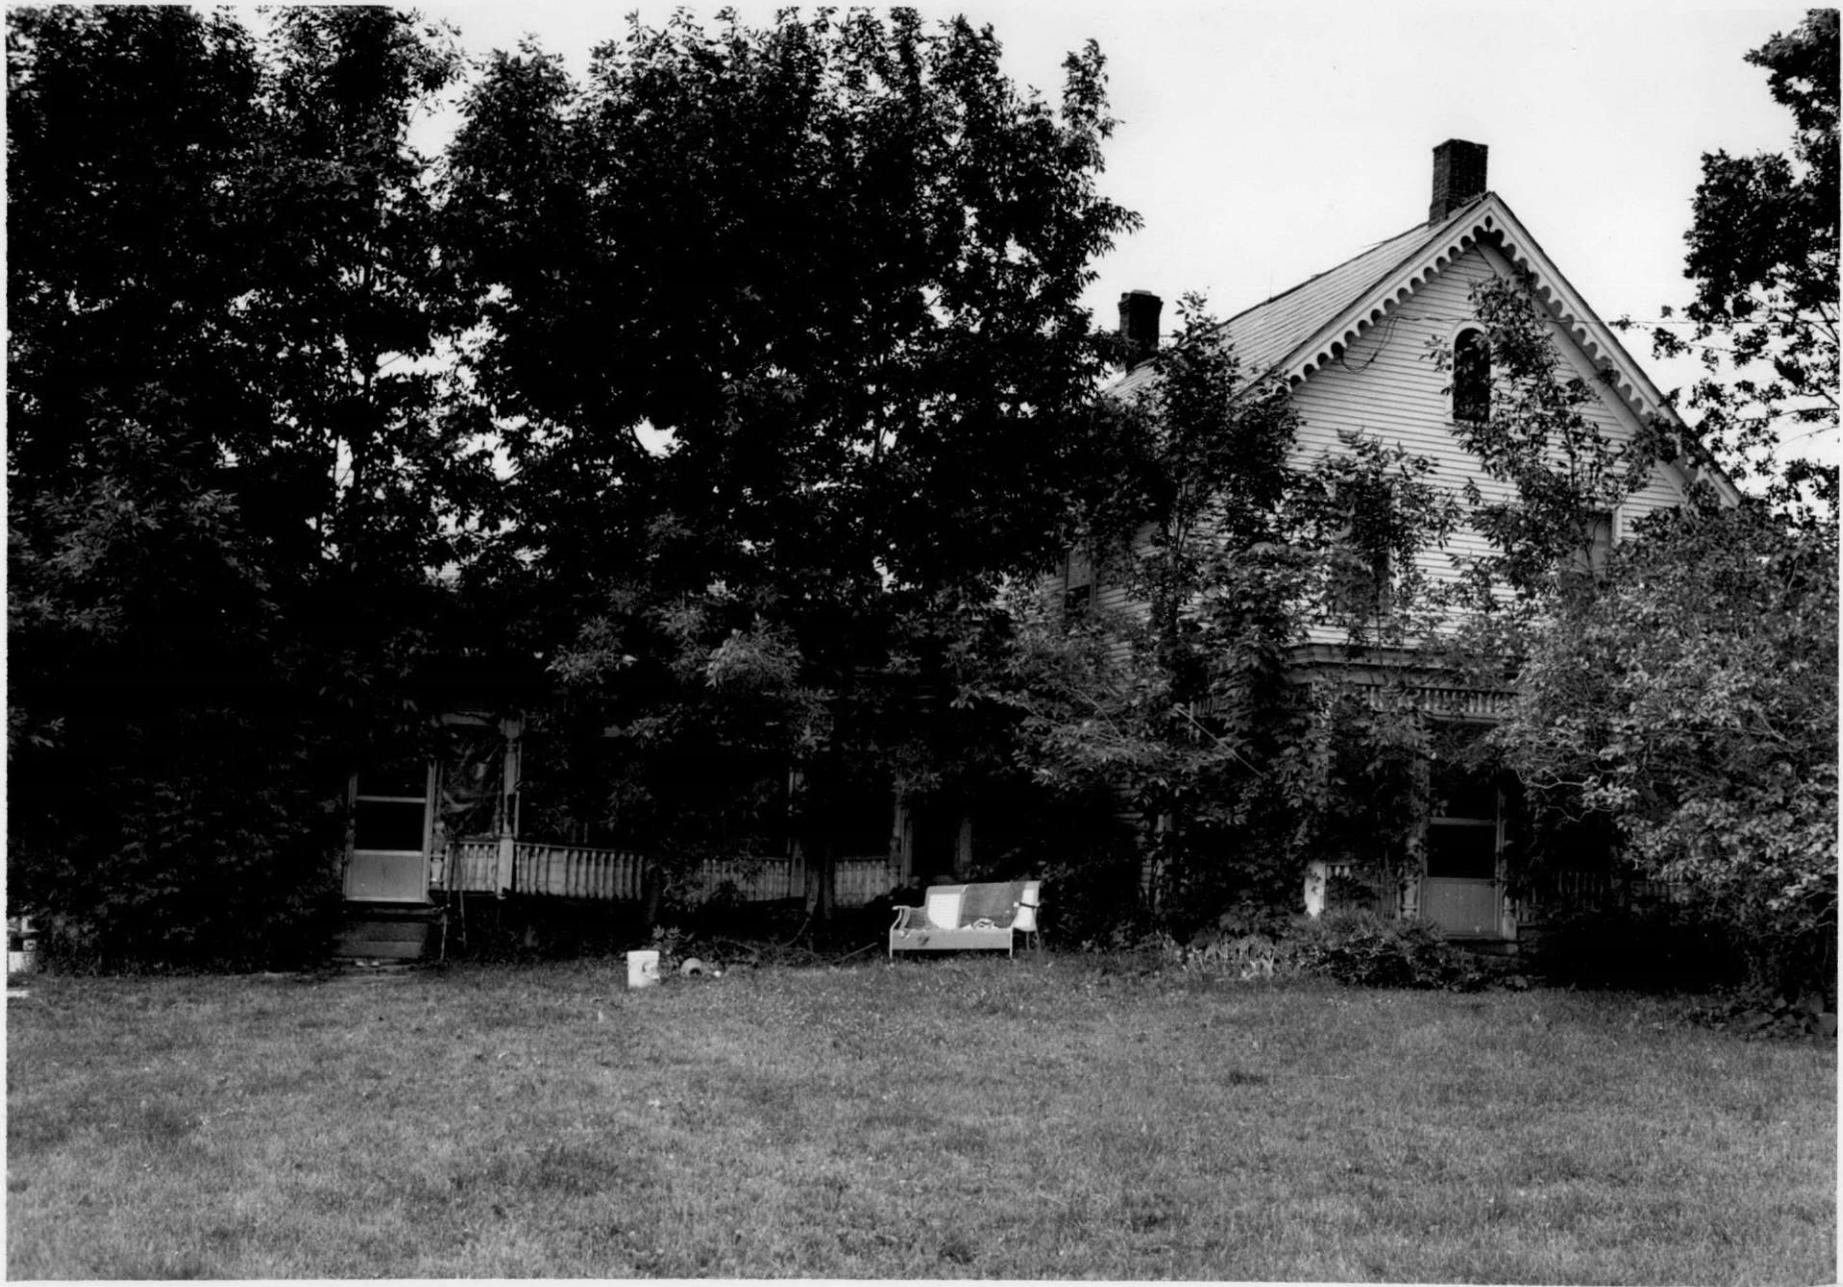
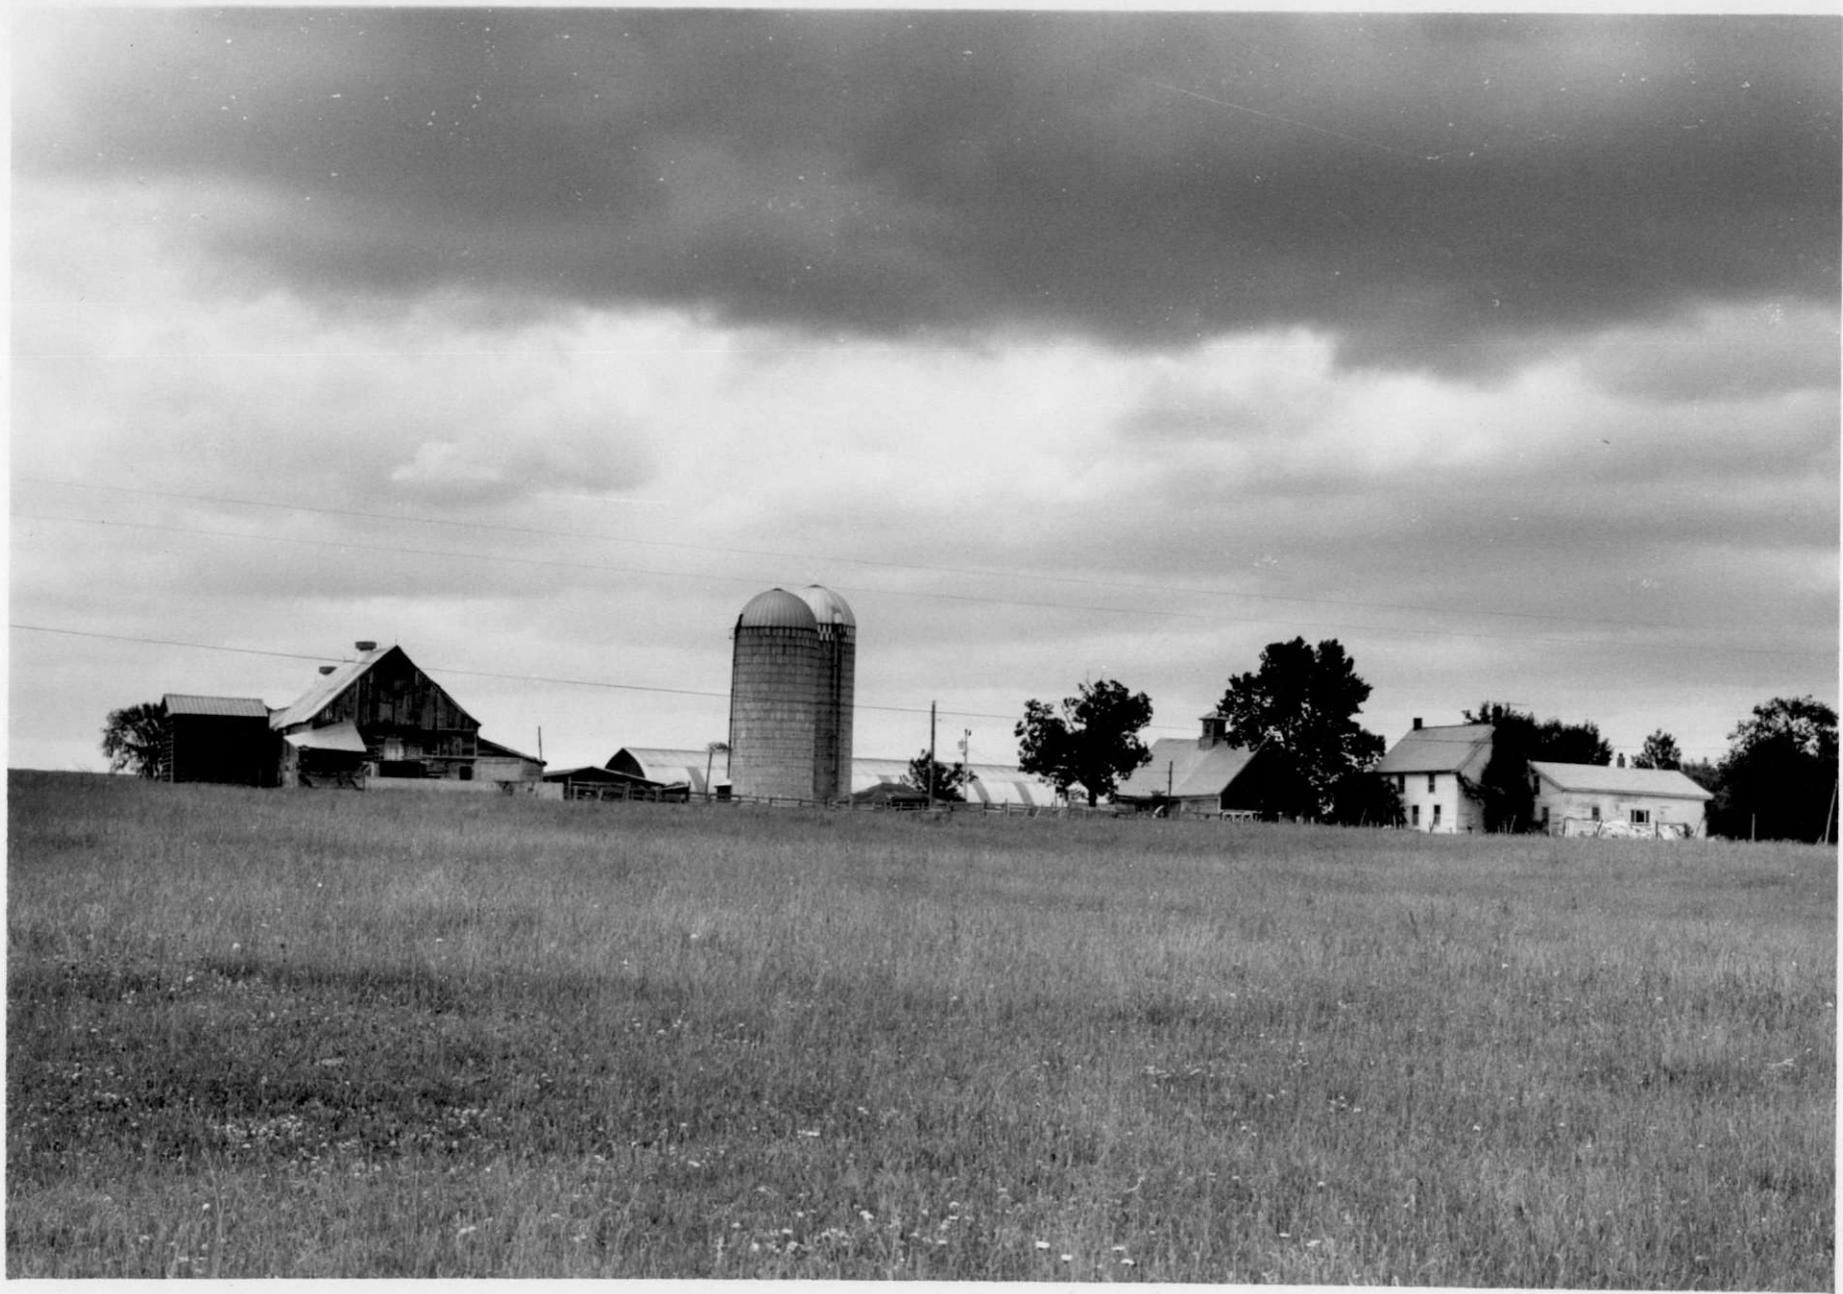
0102-14

CO. Addison TOWN Bridport DATE 6/77
SUBJECT Stephen Hawlett Complex (house) VIEW NW
FILE # 77-A-144 CREDIT Ph. by Wesley

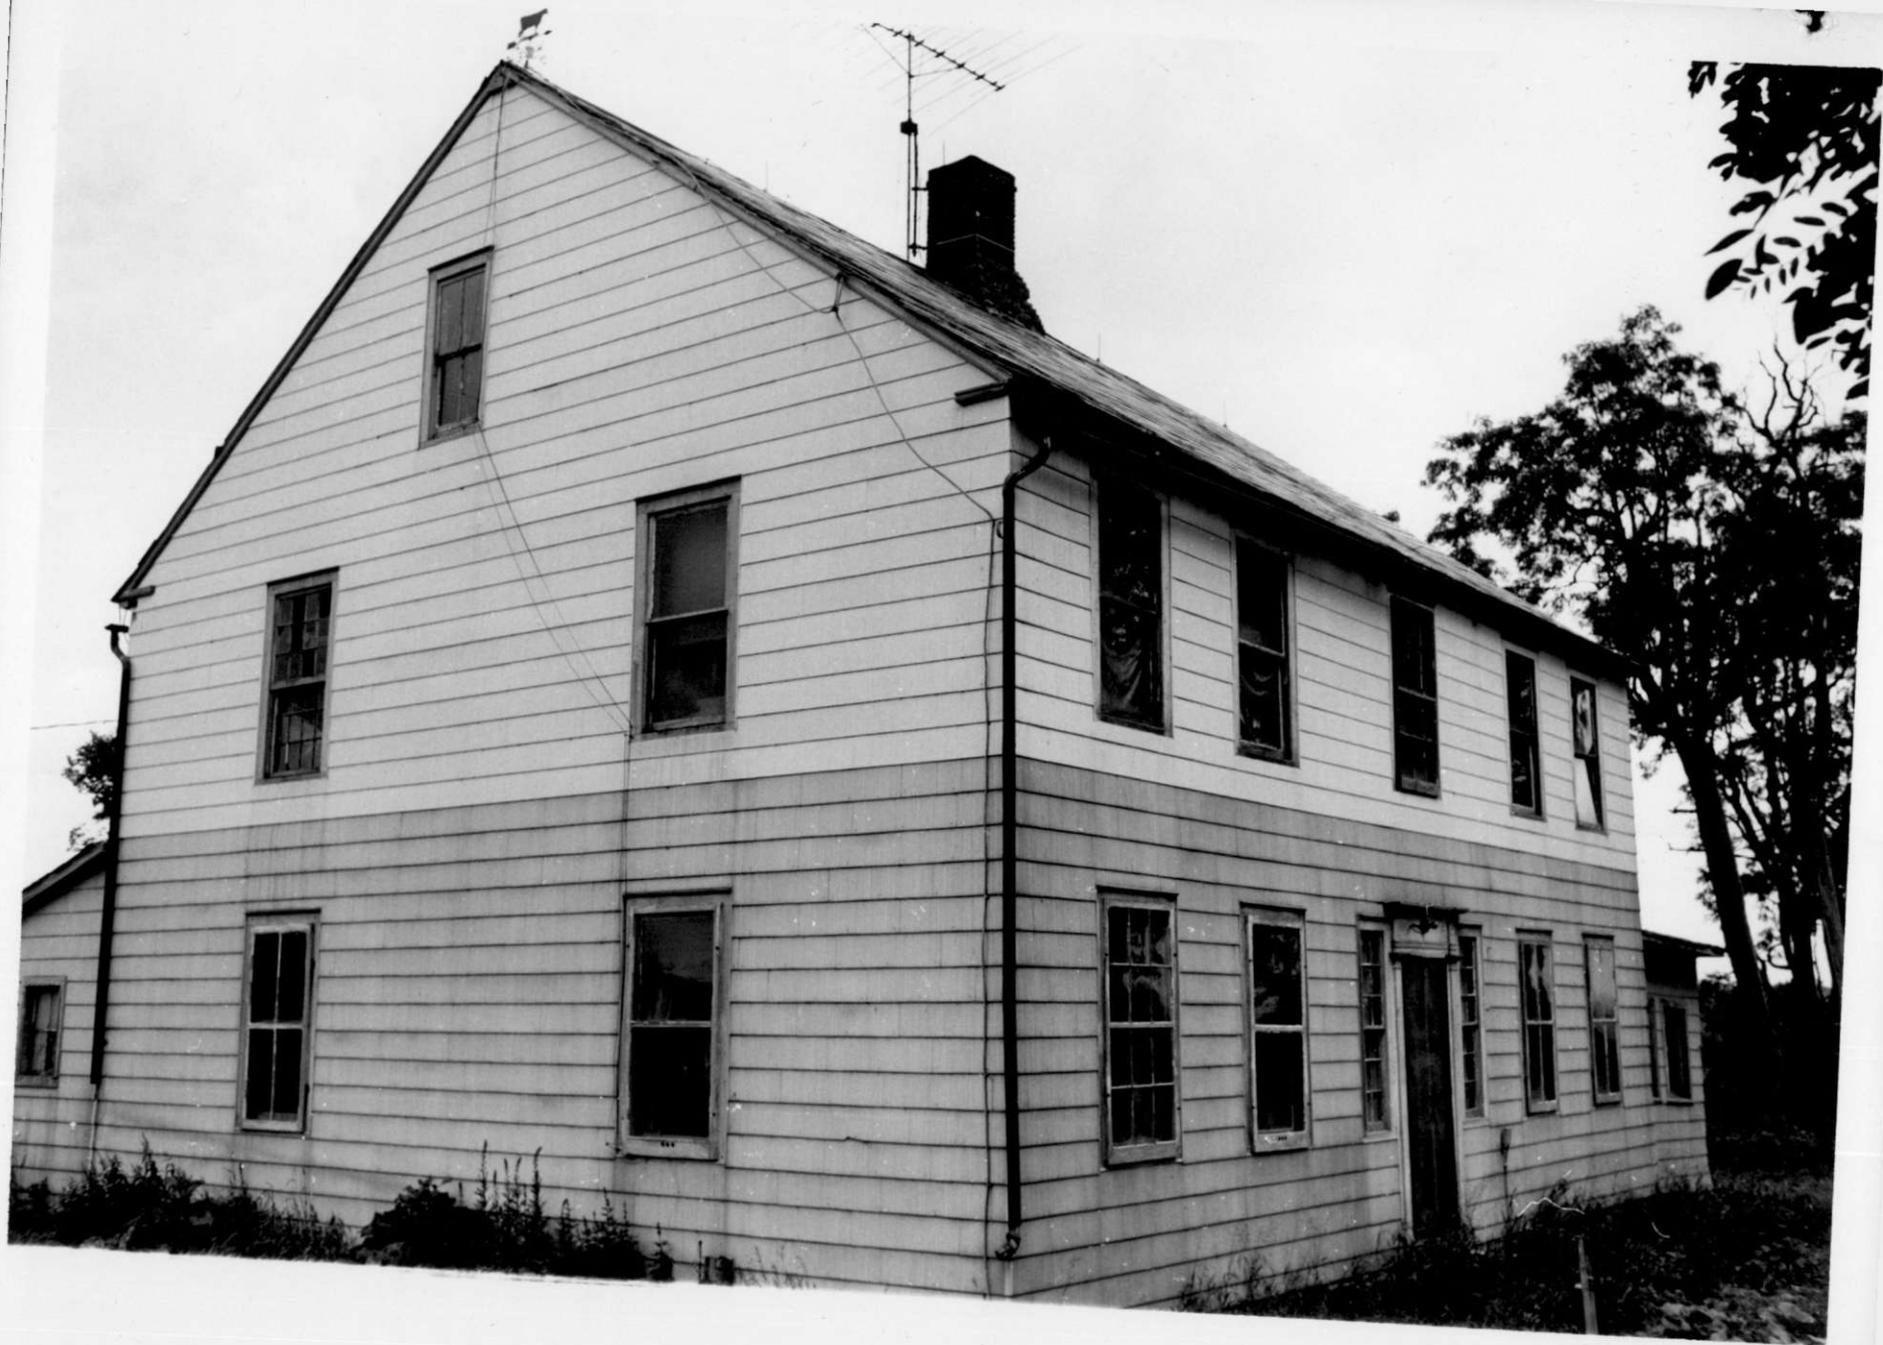
0102-17

Originally a fish shanty, moved here to raise chickens.

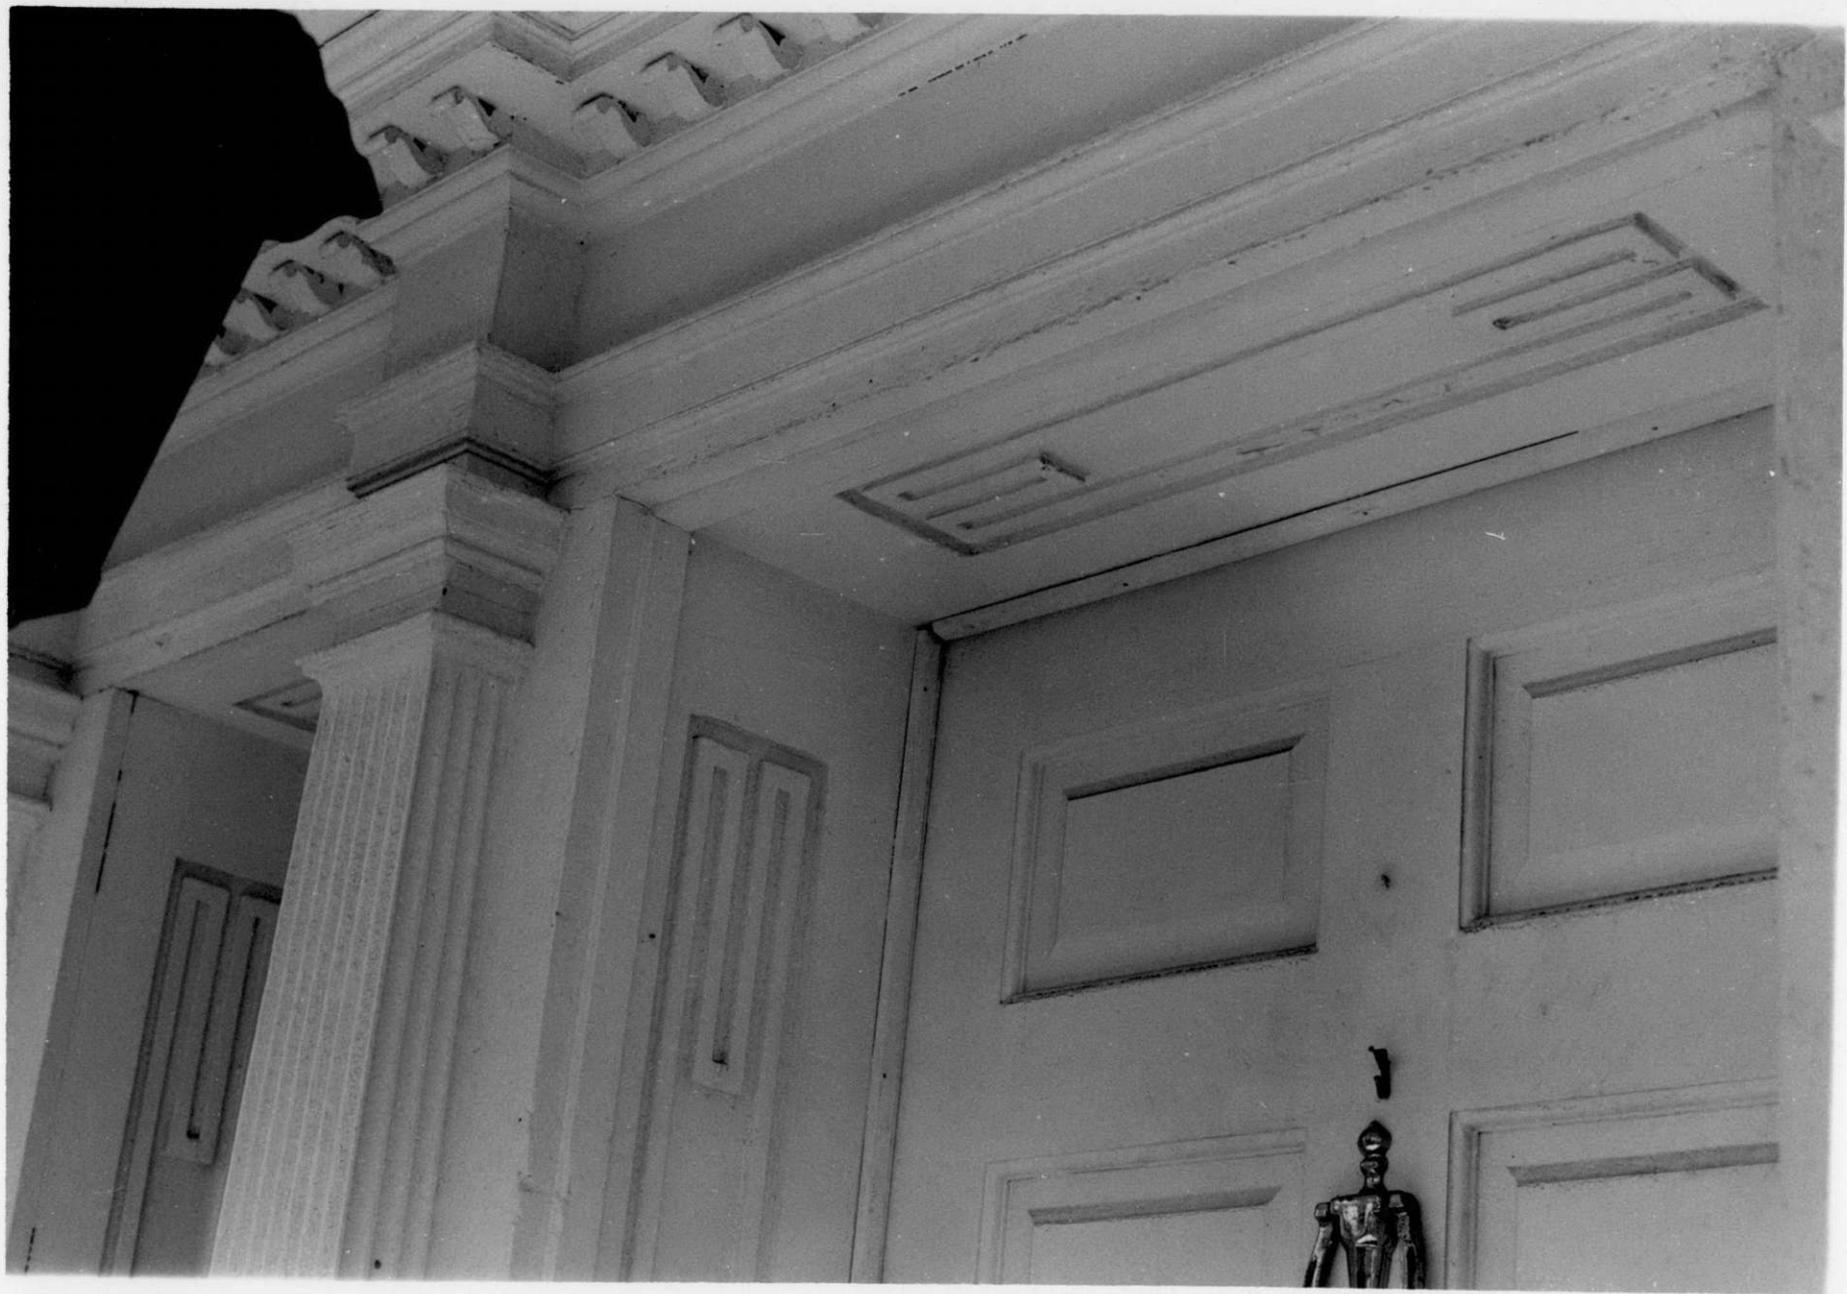
0102-23

CO. Addison TOWN Bridport DATE 6/77
SUBJECT Buck-Conner House VIEW NW
FILE # 77-A-146 CREDIT H. N. Hosley
