DIFFERENCES IN SITE NUMBERS USED IN PUBLISHED TOWN HISTORY AND VERMONT HISTORIC SITES & STRUCTURES SURVEY

BRIDPORT

**THE HISTORIC ARCHITECTURE
OF ADDISON COUNTY**
*Including a listing of
the Vermont State Register of Historic Places*

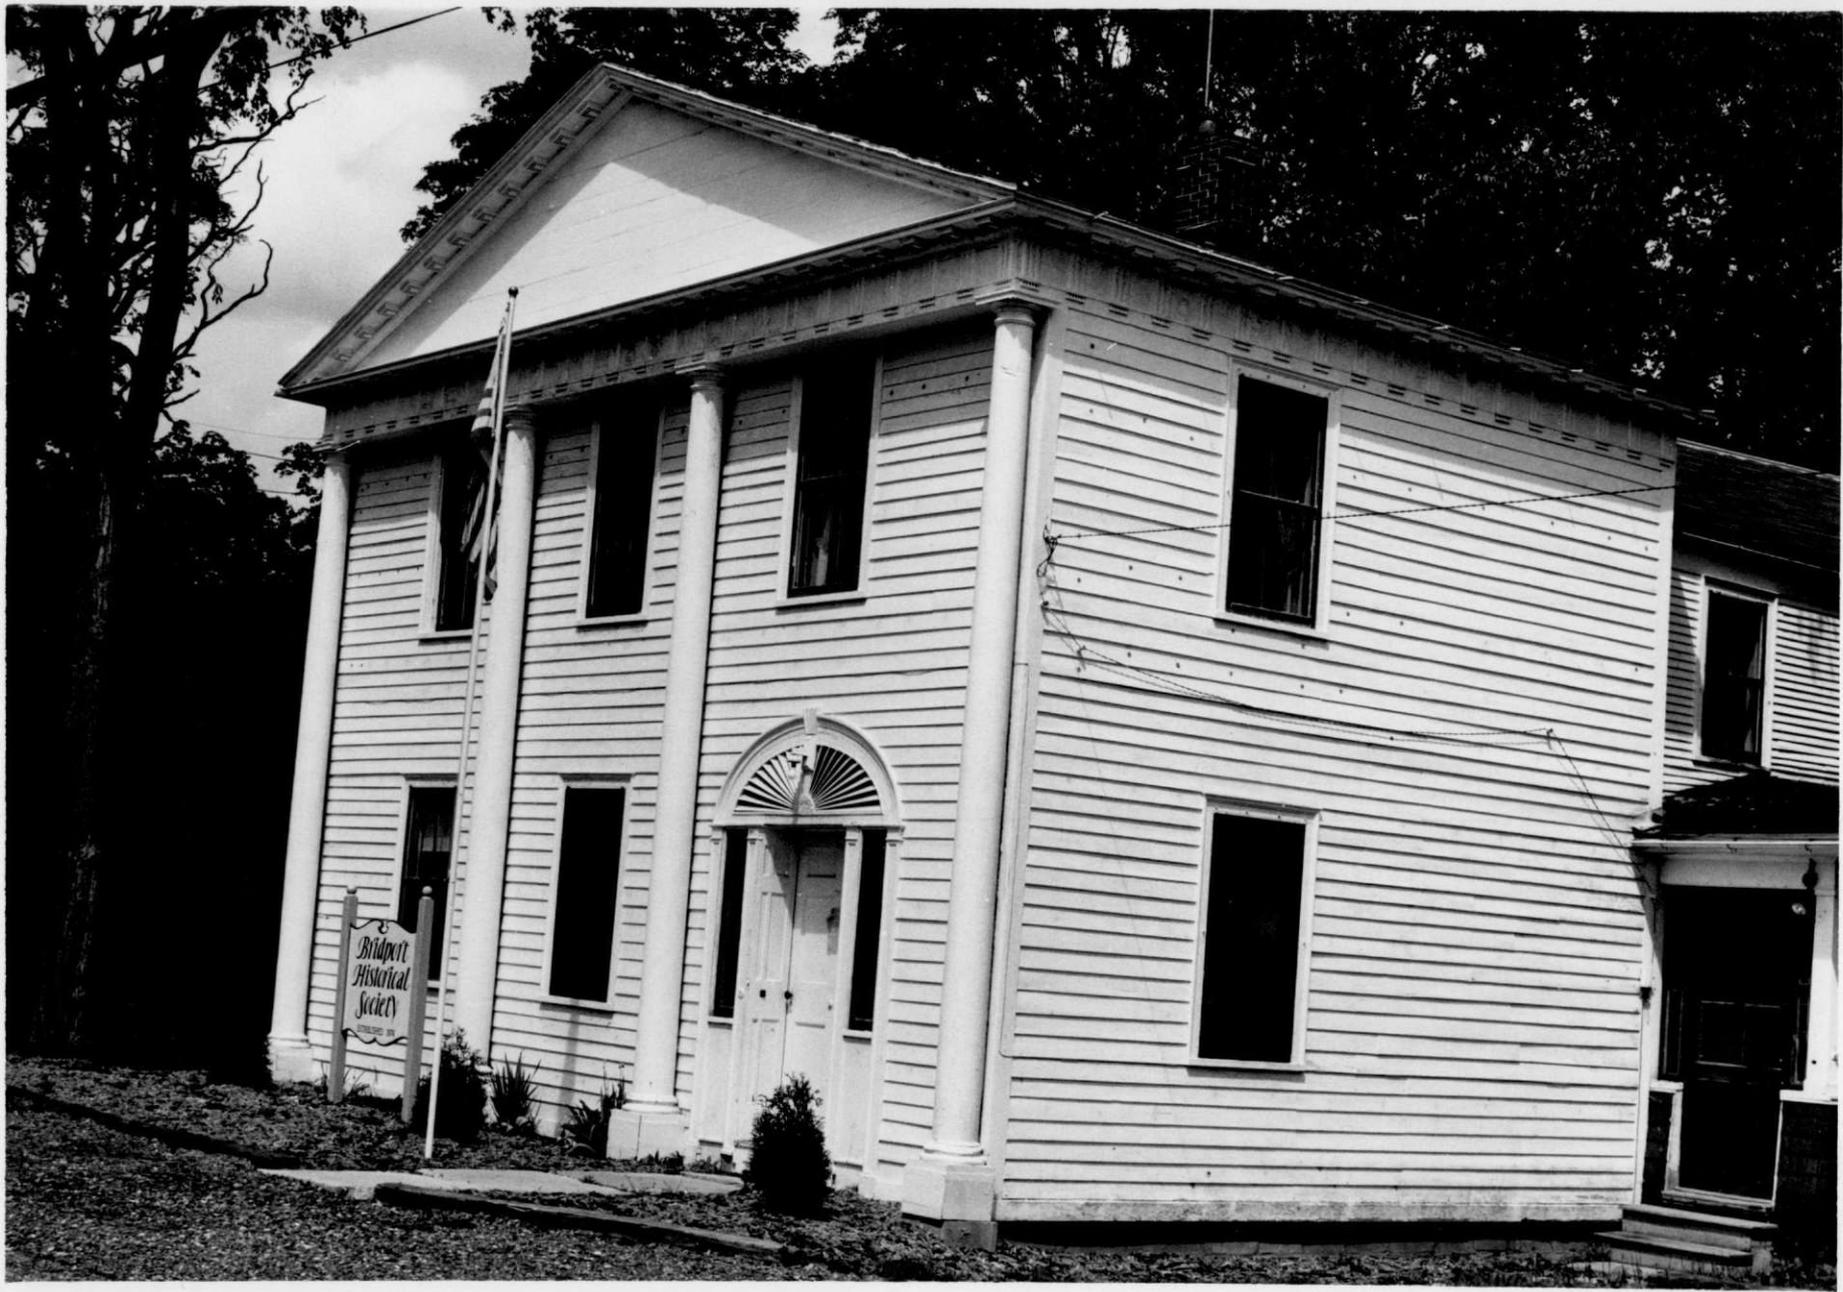
0102-24
#23

CO. Addison TOWN Bridport DATE 6/77
SUBJECT Bridport District #1 VIEW W
FILE # 77-A-145 CREDIT H. N. Haskin

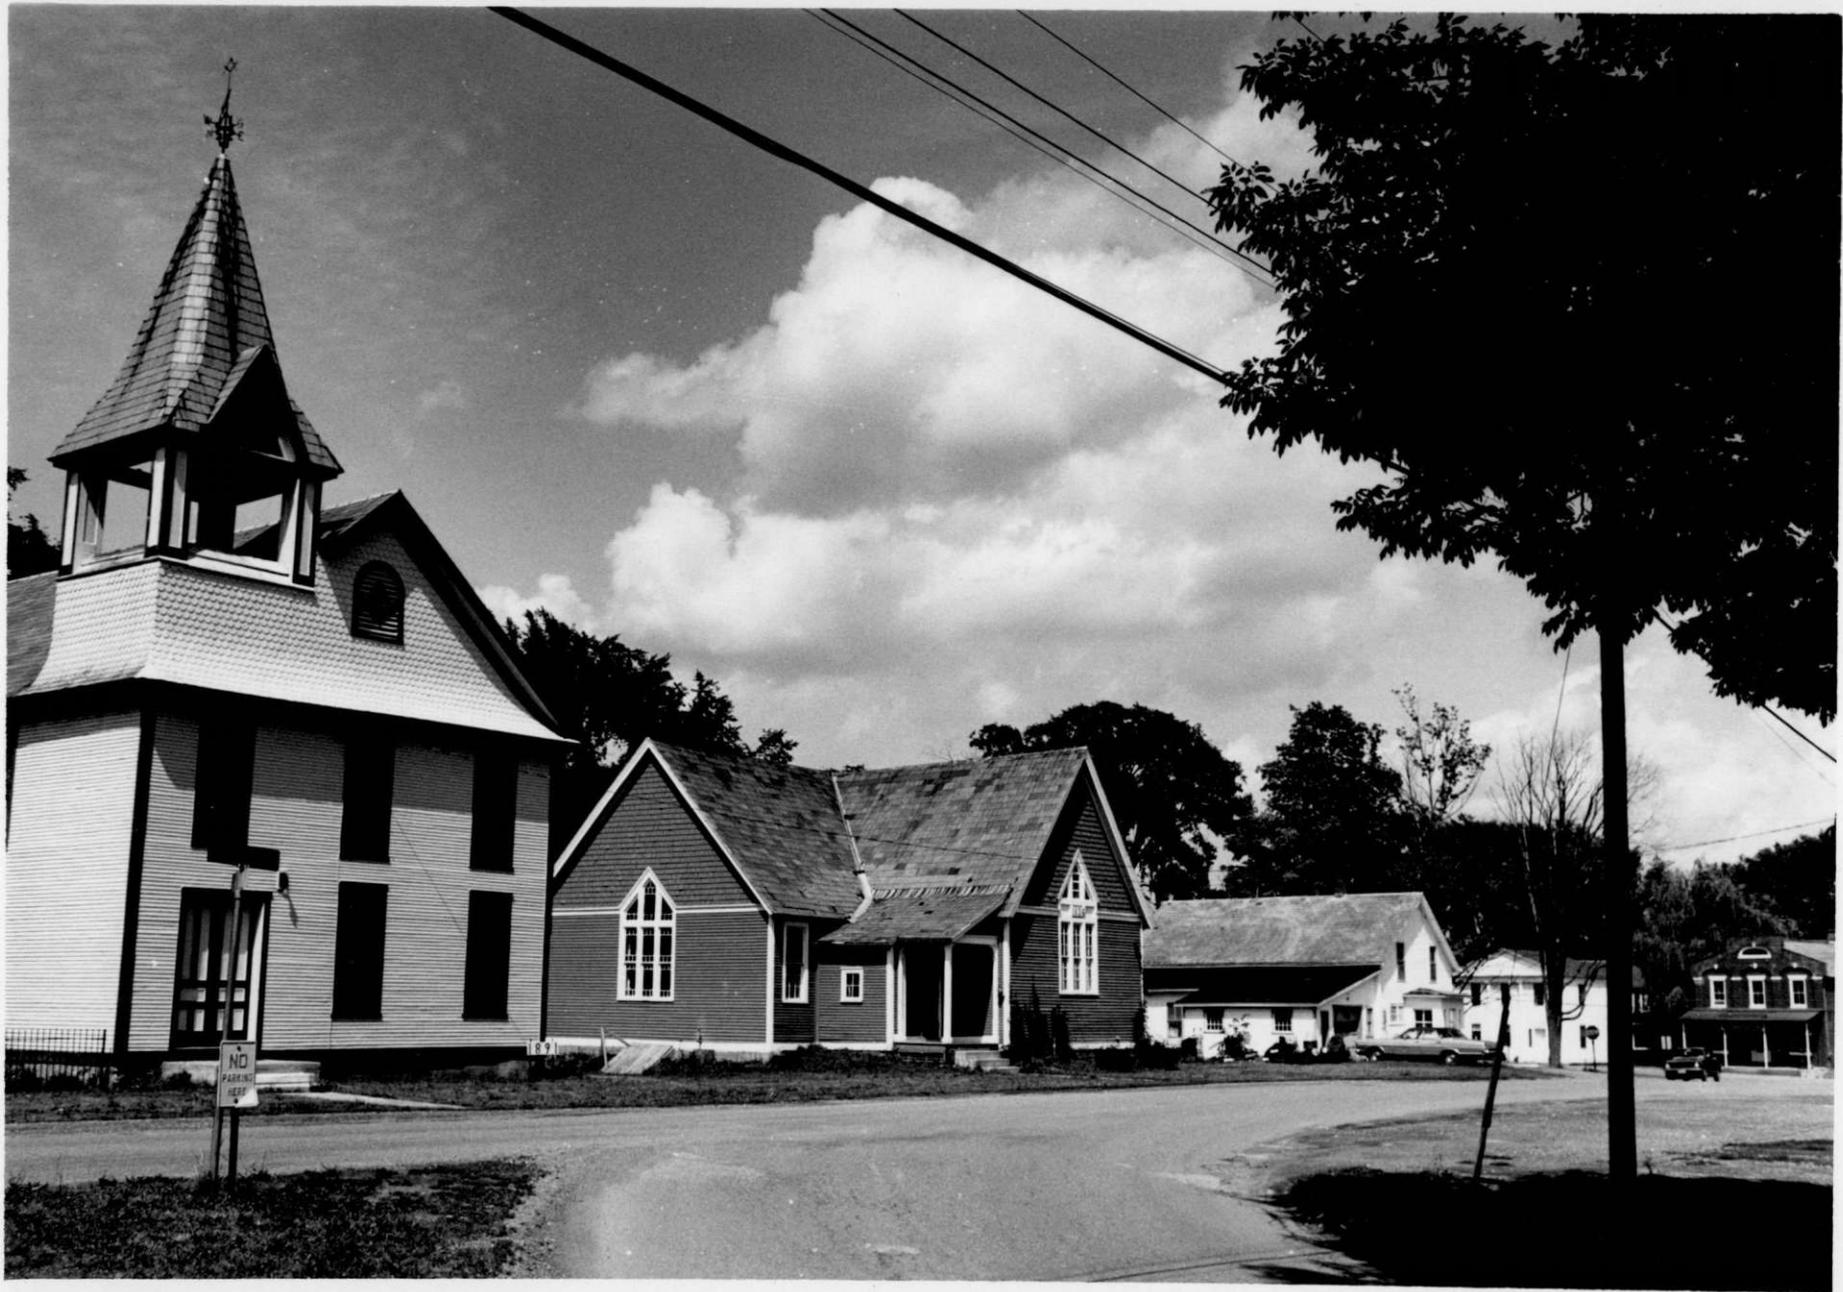
0102-24
#29,28,27,23

CO. Addison TOWN Bridport DATE 7/77
SUBJECT Bridport Lds. Nos. 29, 28, 27, 23, 24 VIEW WNW
FILE # 22-A-149 CREDIT H. N. Haskley

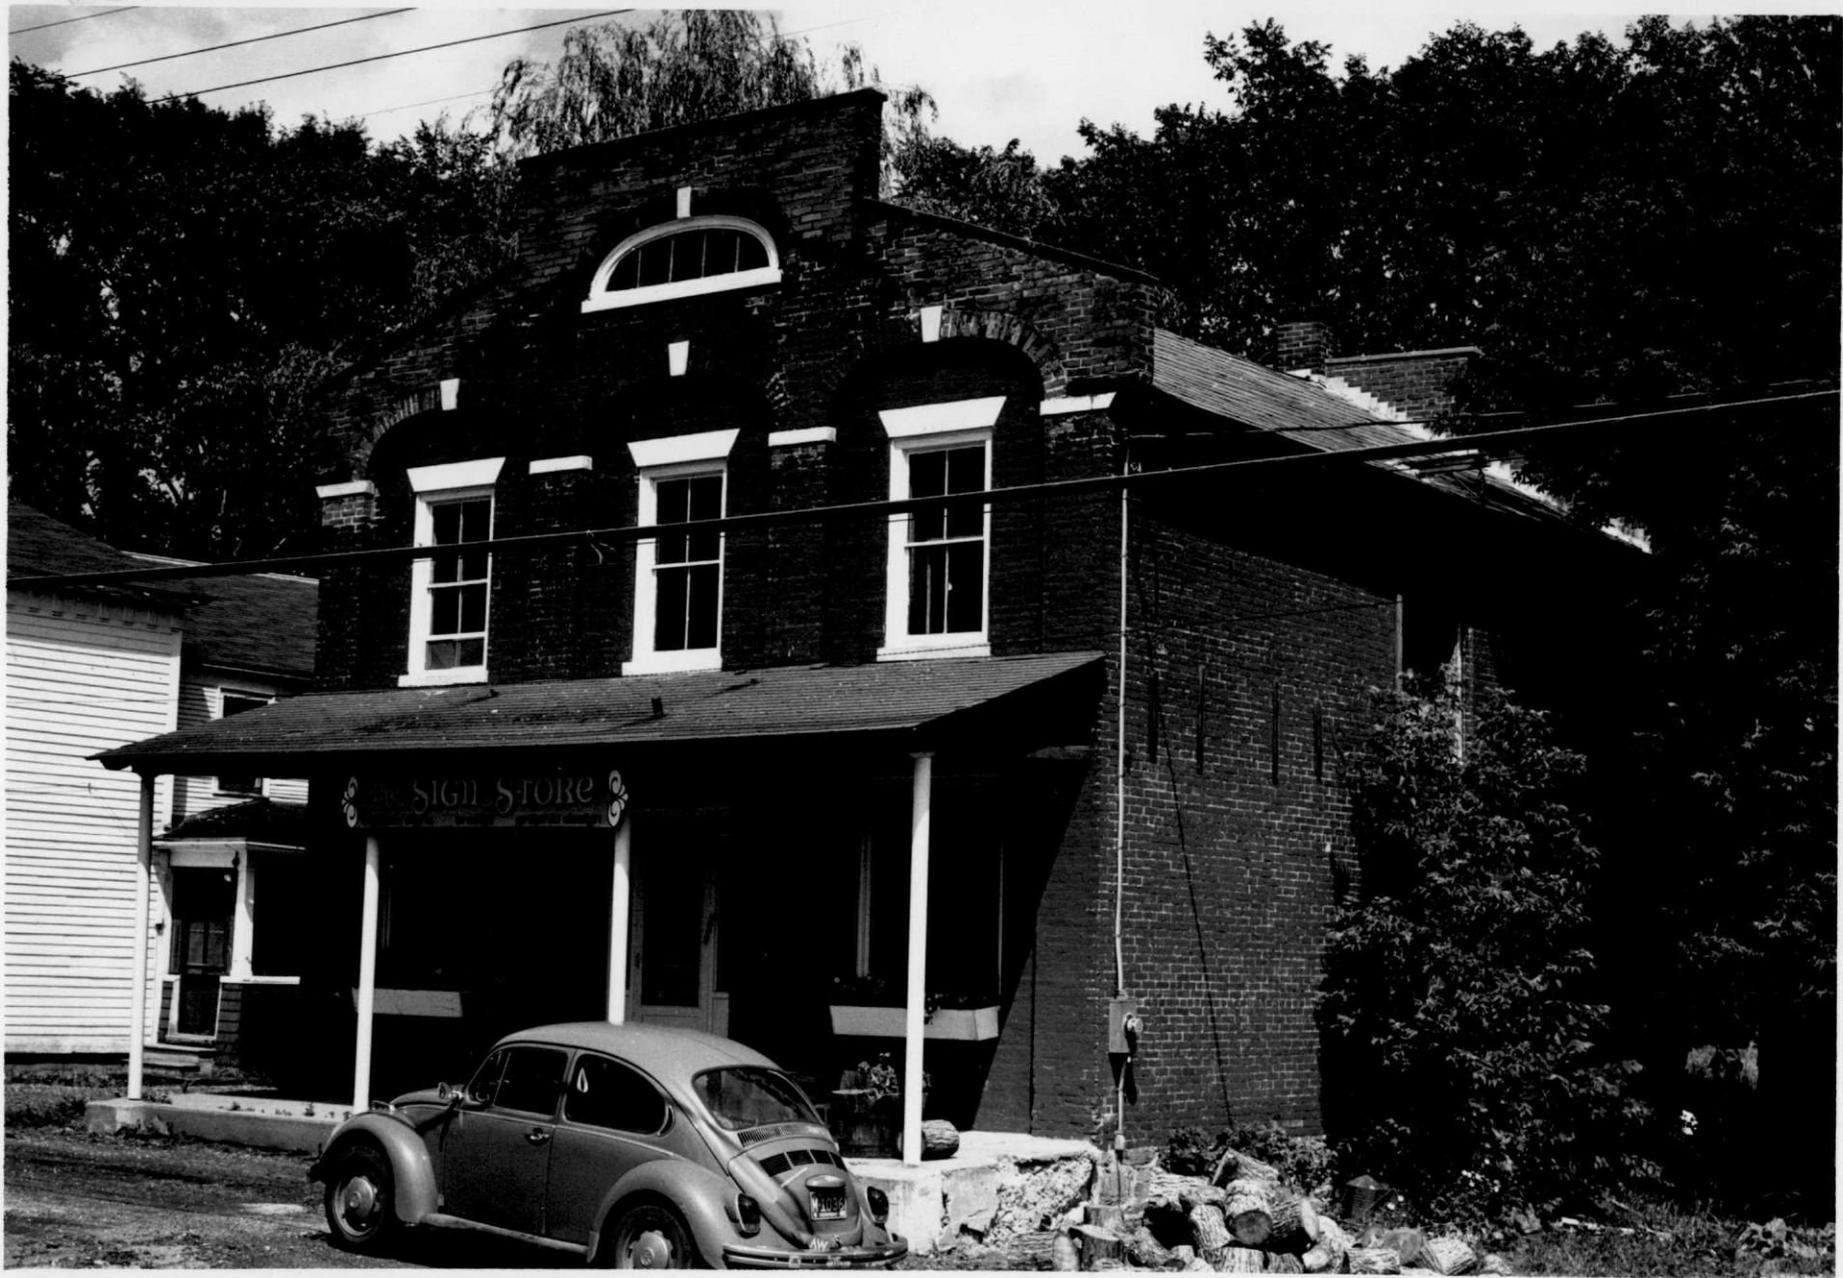
0102-24
#24

CO. Addison TOWN Bridport DATE 7/77
SUBJECT Bridport His. Mts. #24 VIEW NE
FILE # 77A-149 CREDIT H. N. Hasley

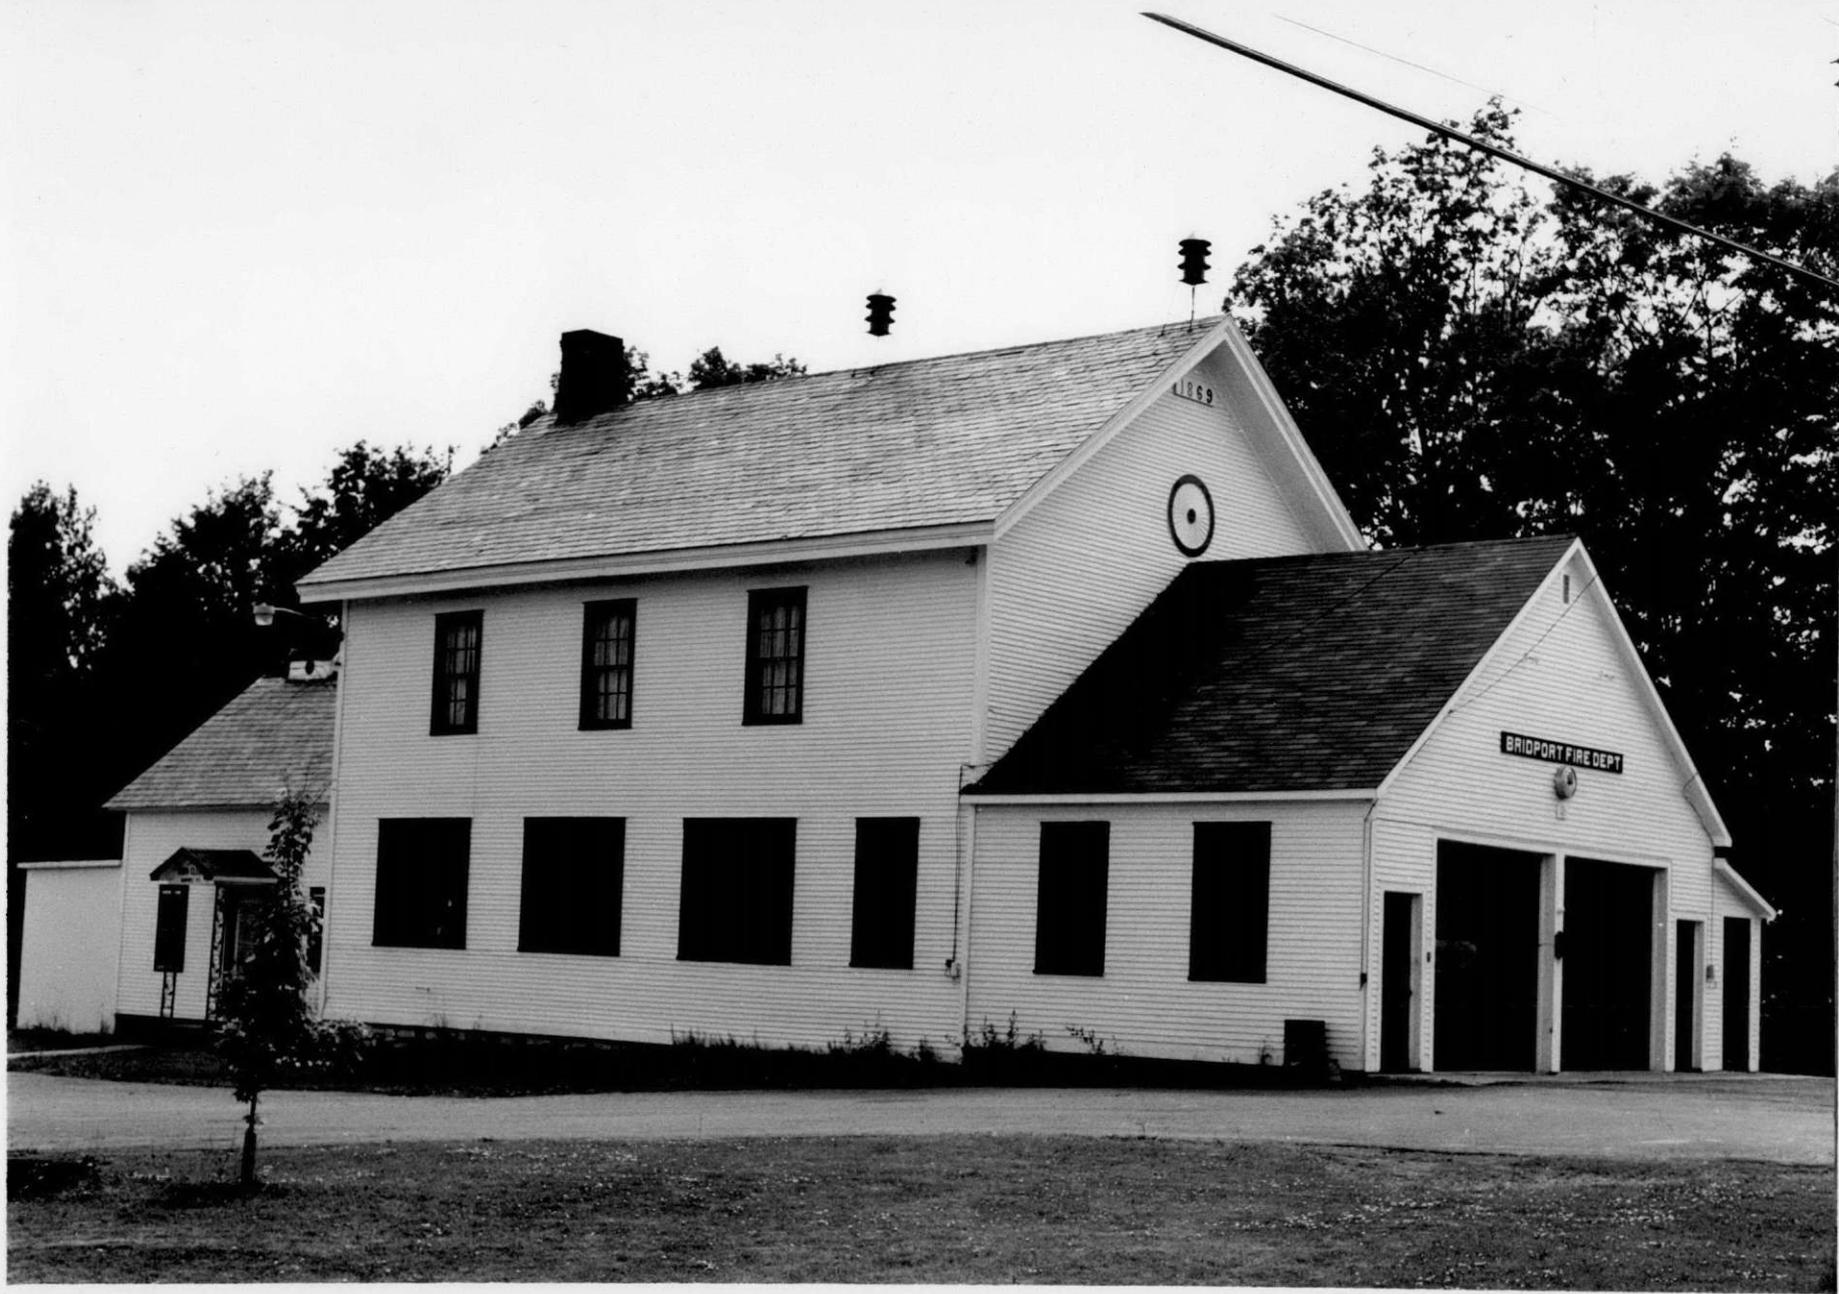
0102-24
#30

CO. Addison TOWN Bridport DATE 7/77
SUBJECT Bridport His. Soc. # 30 VIEW S
FILE # 77-A-149 CREDIT H. N. Wesley

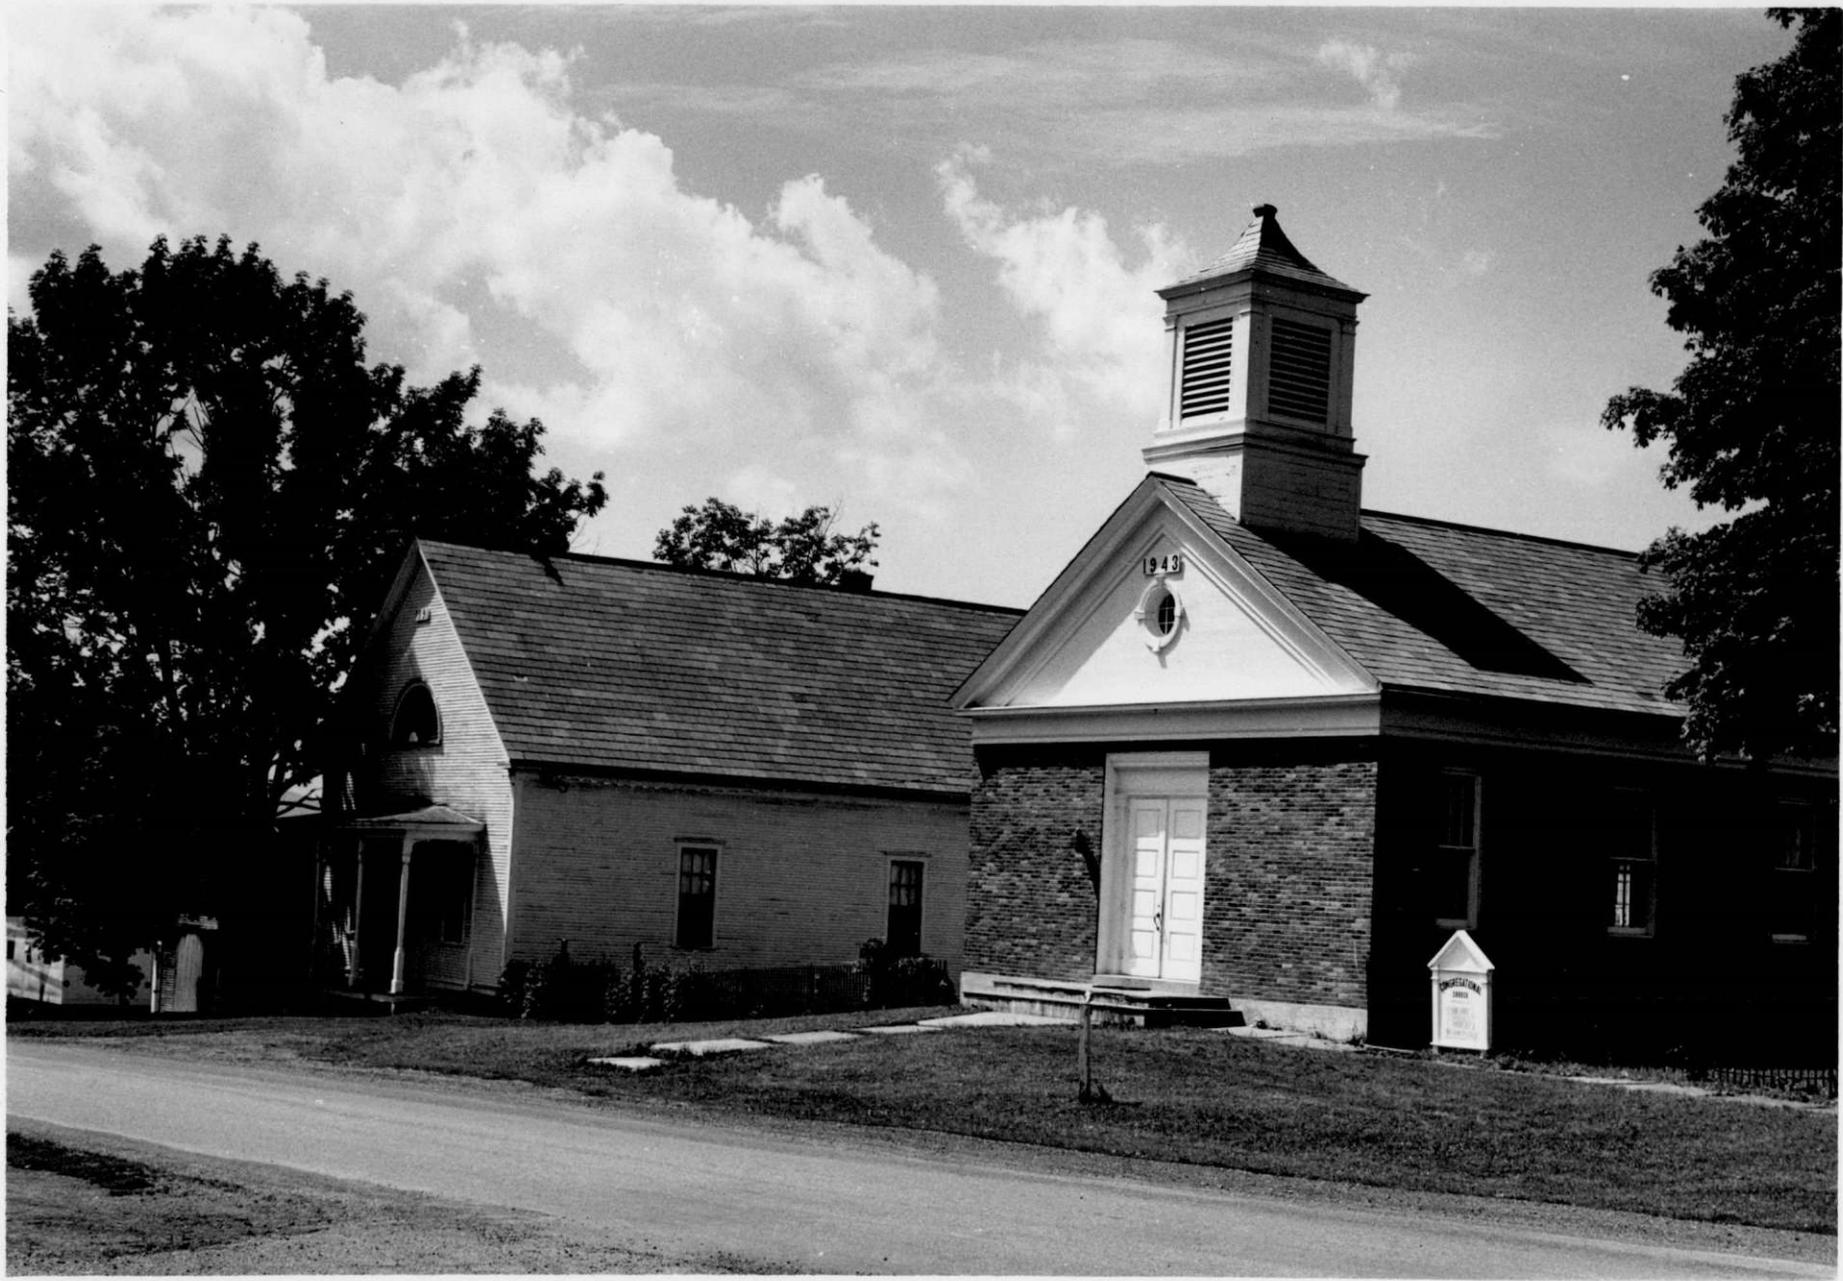
0102-24
#36.32.31

CO. Addison TOWN Bridport DATE 7/77
SUBJECT Bridport His. Dis. 36, 30, 31 VIEW NW
FILE # 77-A-140 CREDIT H. N. Wesley

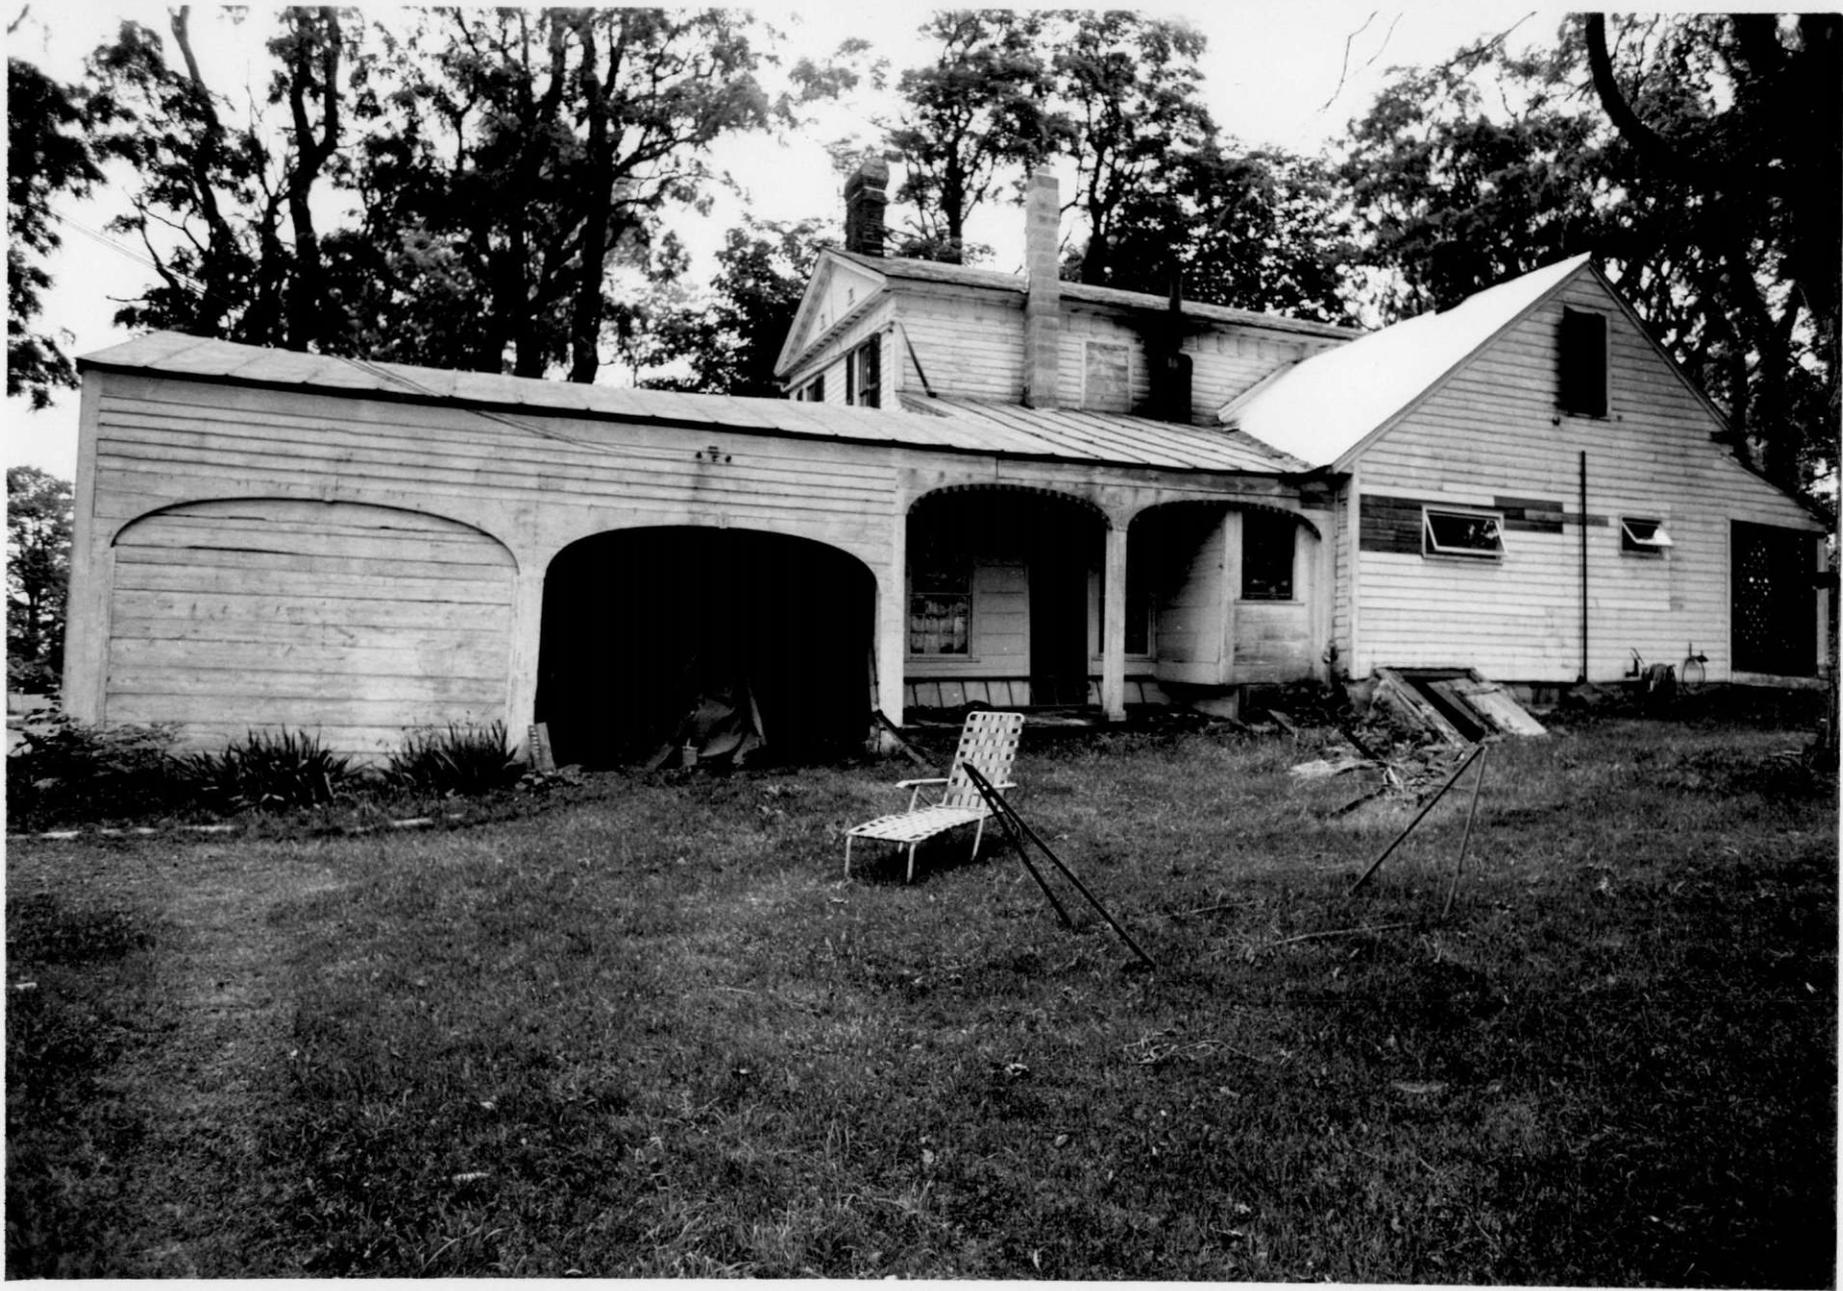
0102-24
#44

CO. Addison TOWN Bridport DATE _____
SUBJECT Bridport Hist. Hse (near) VIEW 5
FILE # 77-A-147 CREDIT H. N. Hasley

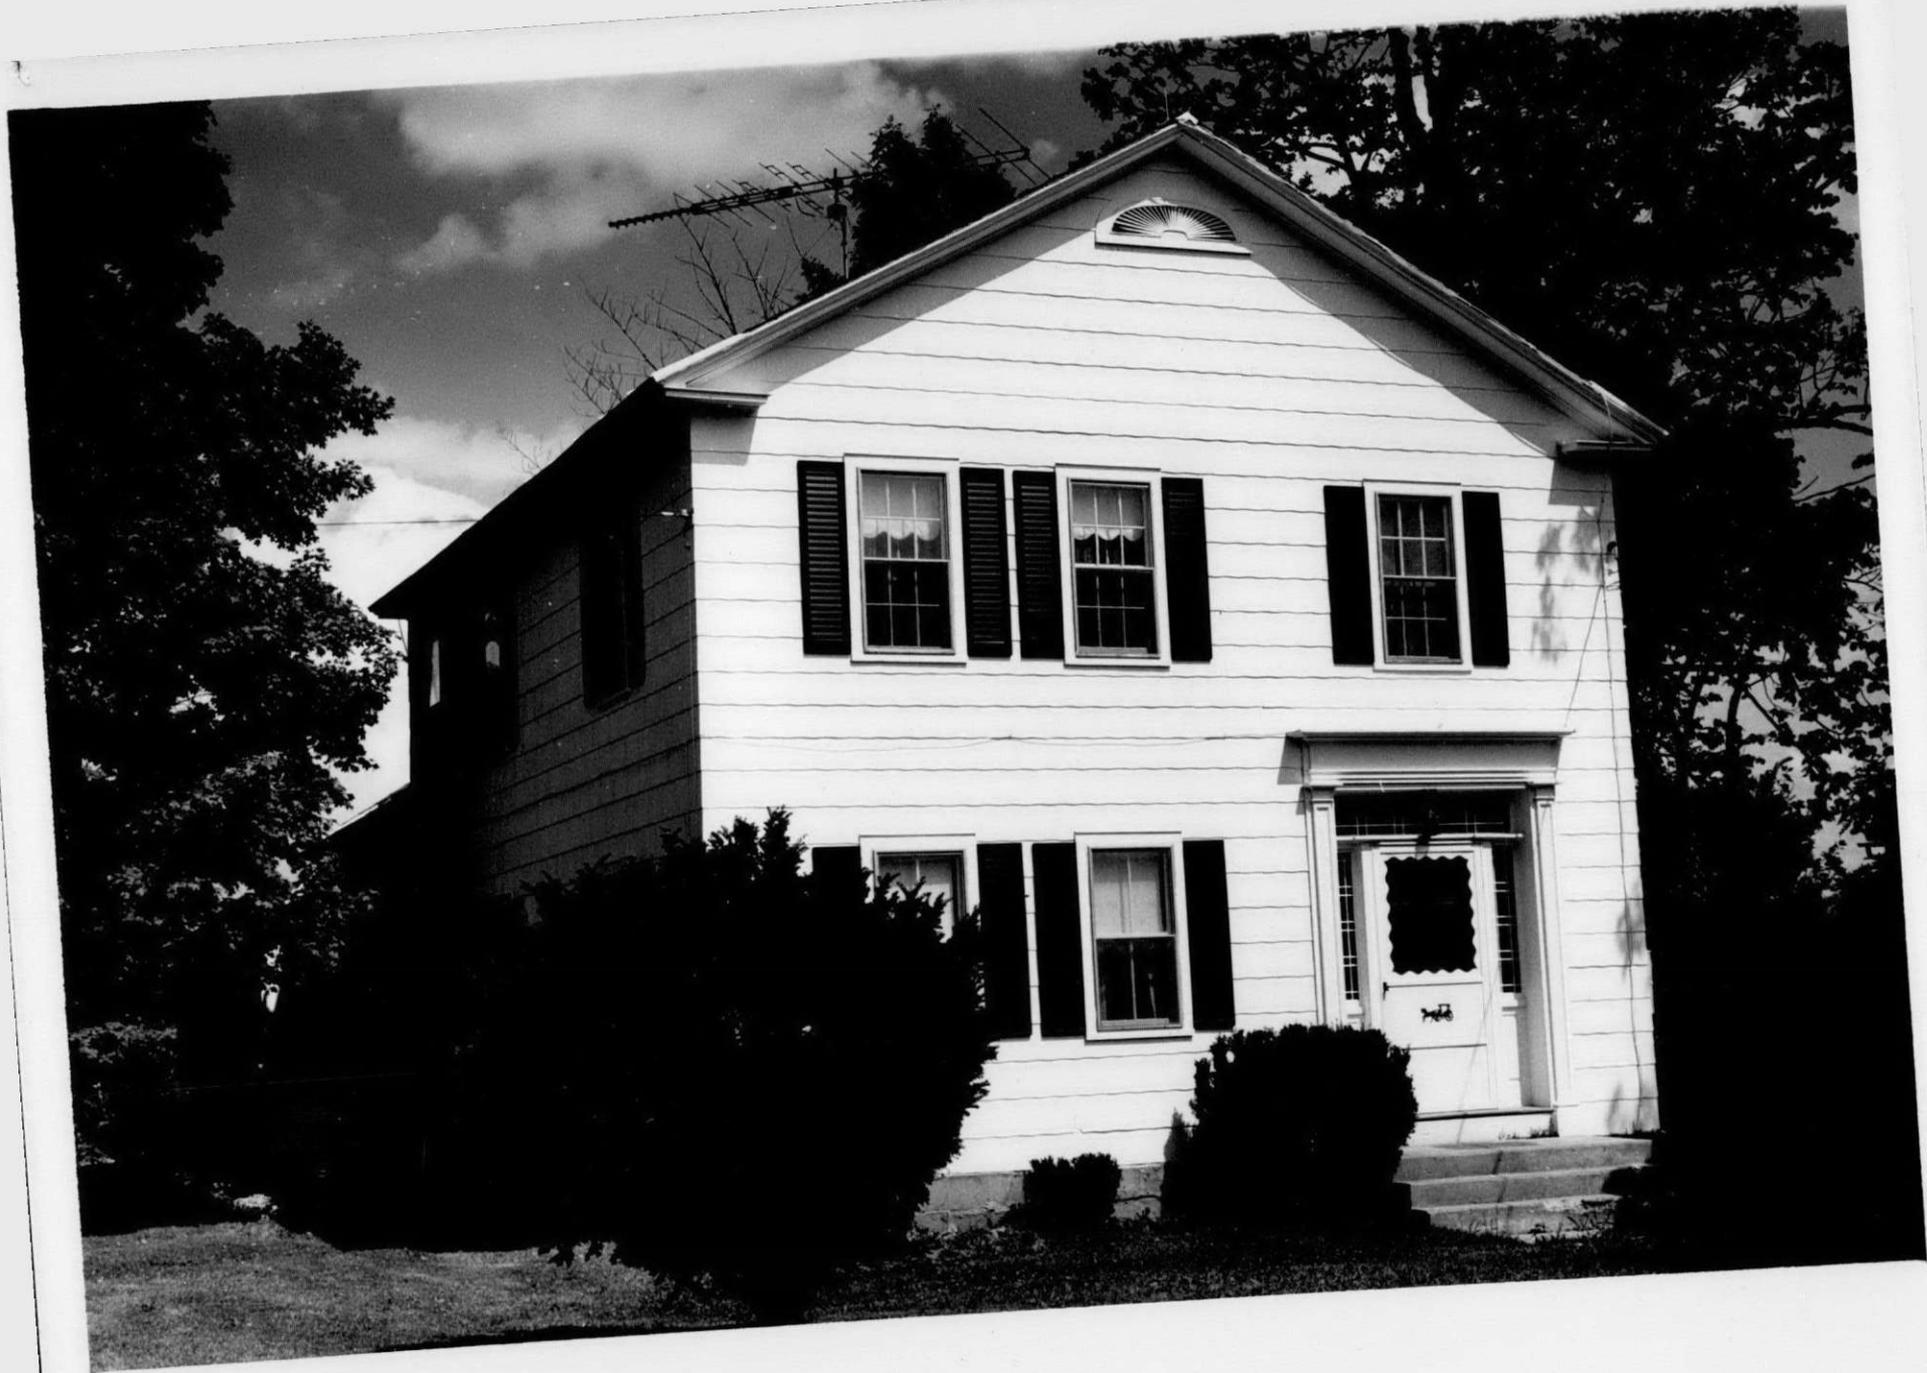
0102-24
#49

SUBJECT Bridport His. No. 47 VIEW S

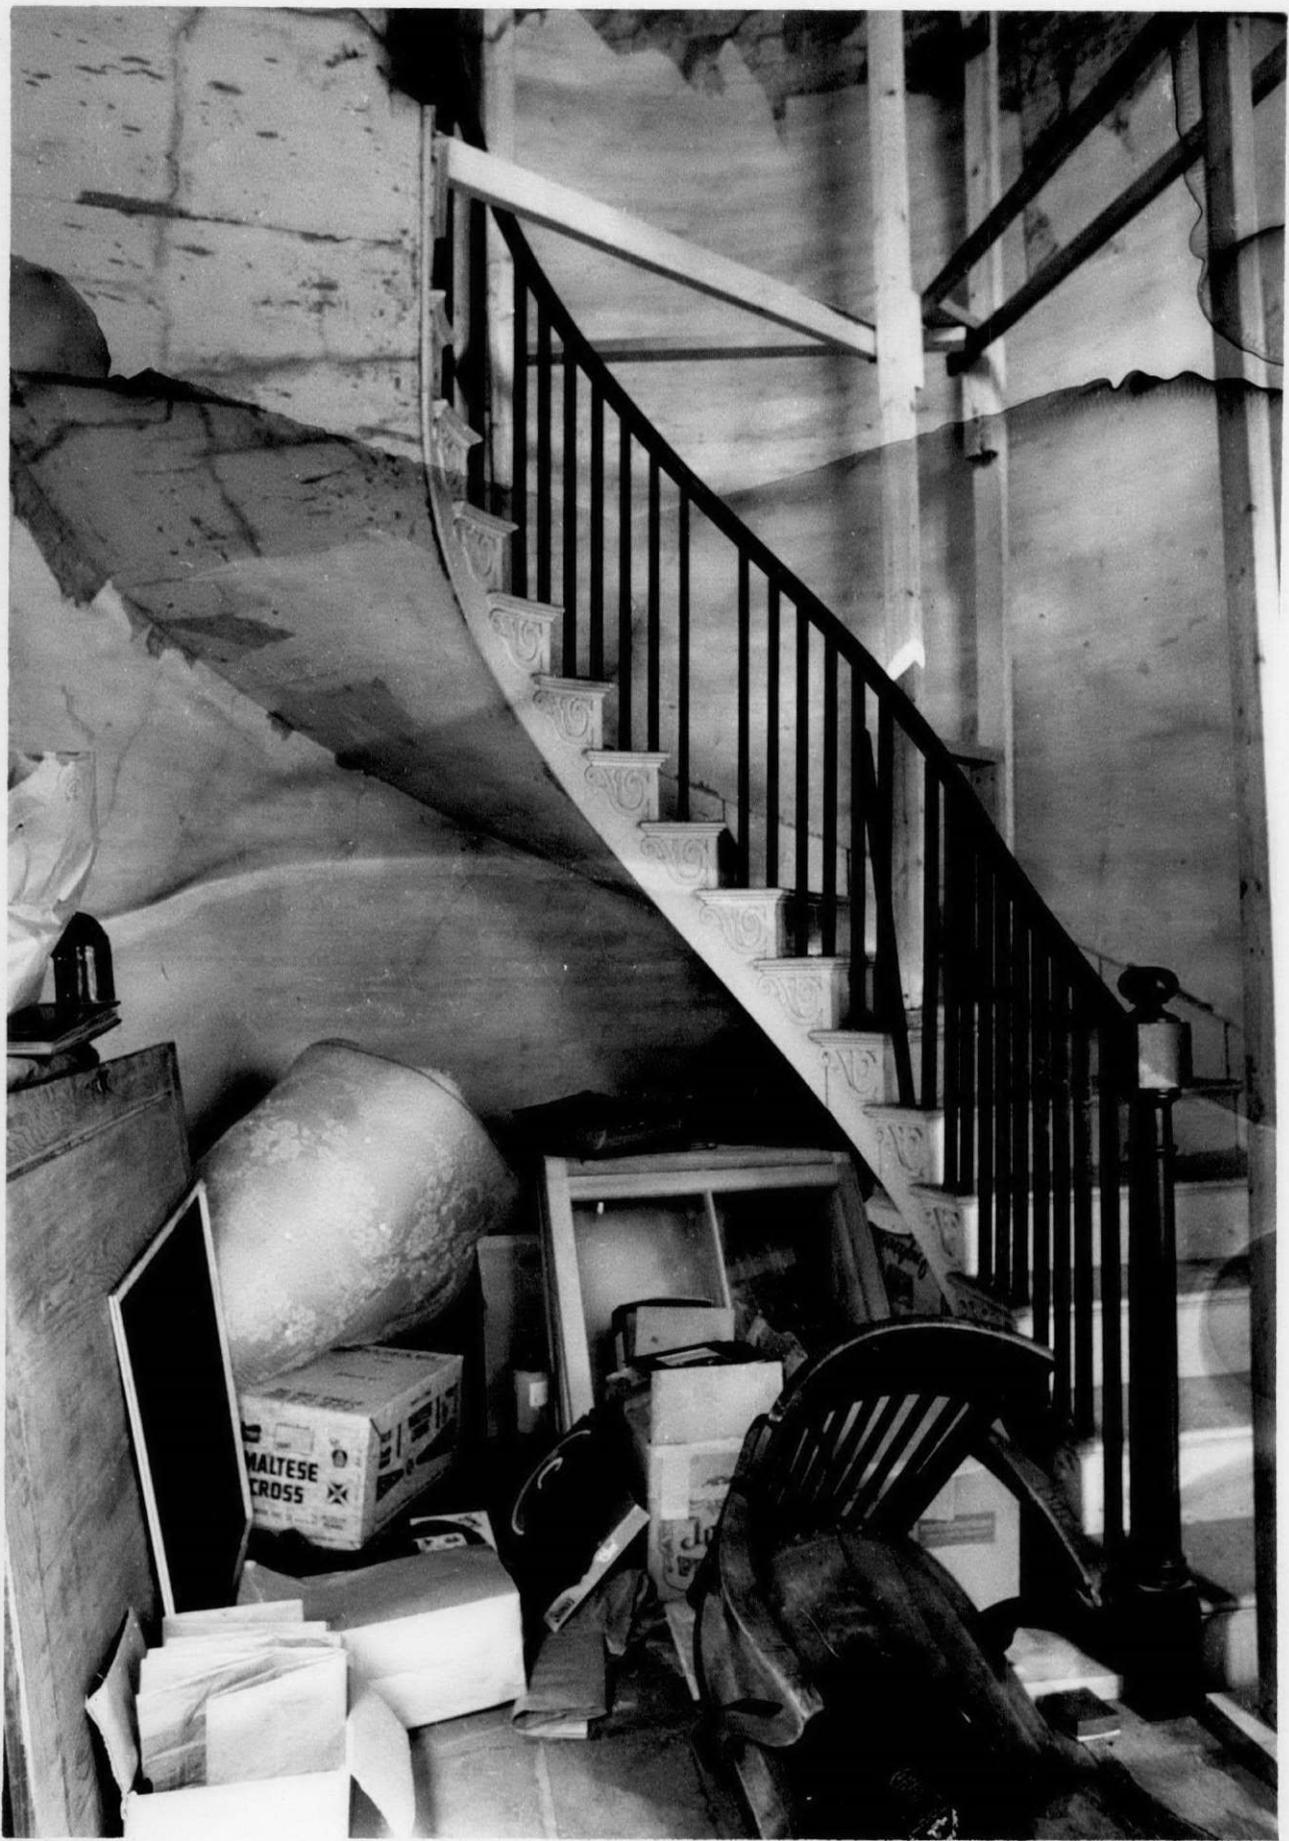
0102-25

CO. Addison TOWN Budport DATE 6/77
SUBJECT Peter Sandrian House VIEW SW
FILE # 77-A-145 CREDIT H. N. Rosley

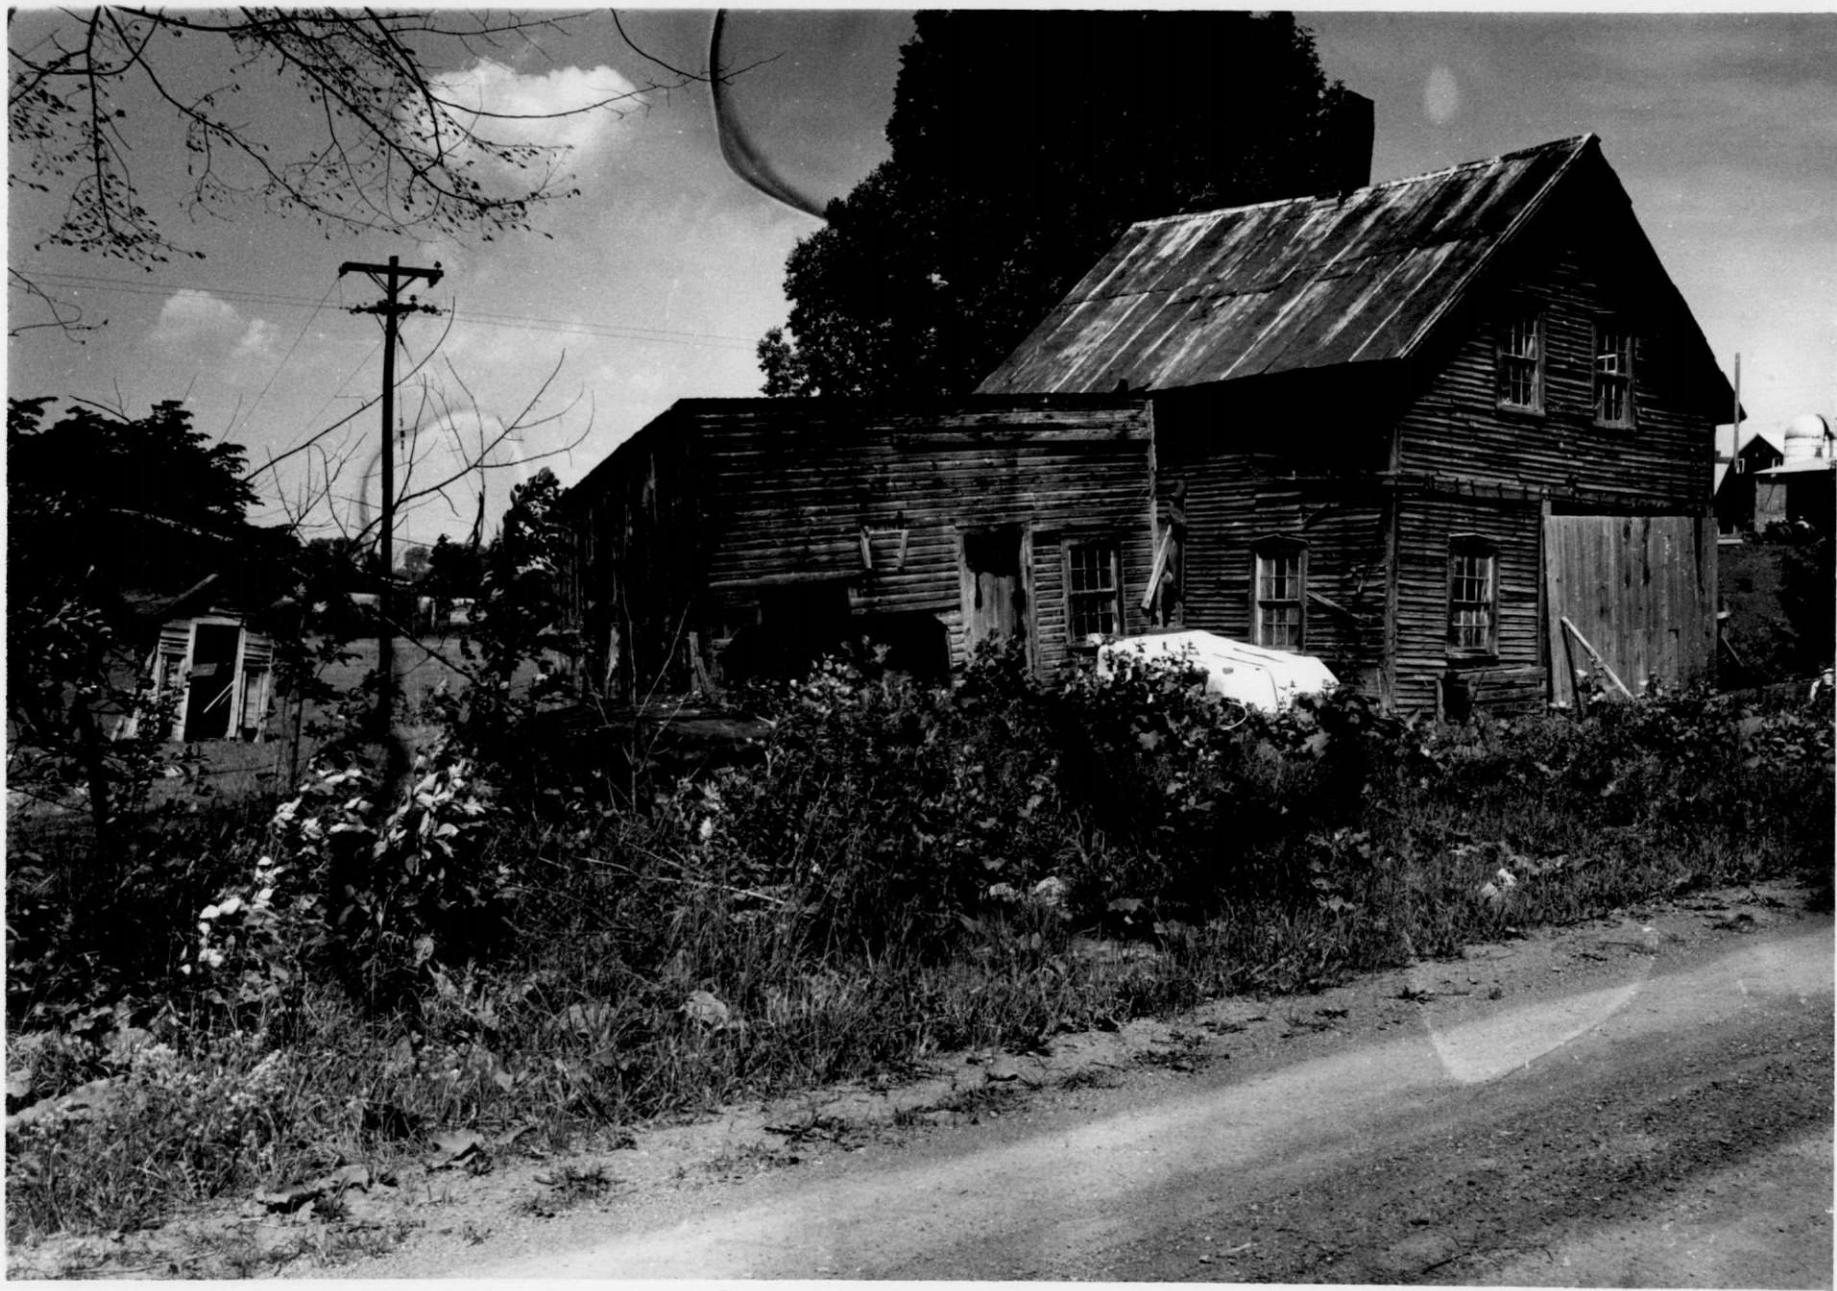
0102-28
#1, 2

CO. Addison TOWN Bridport DATE 6/77
SUBJECT Rice Ethier Complex (House) VIEW NW
FILE # 77-A-145 CREDIT H. J. Hasley
