DIFFERENCES IN SITE NUMBERS USED IN PUBLISHED TOWN HISTORY AND VERMONT HISTORIC SITES & STRUCTURES SURVEY

BRIDPORT

**THE HISTORIC ARCHITECTURE
OF ADDISON COUNTY**
*Including a listing of
the Vermont State Register of Historic Places*

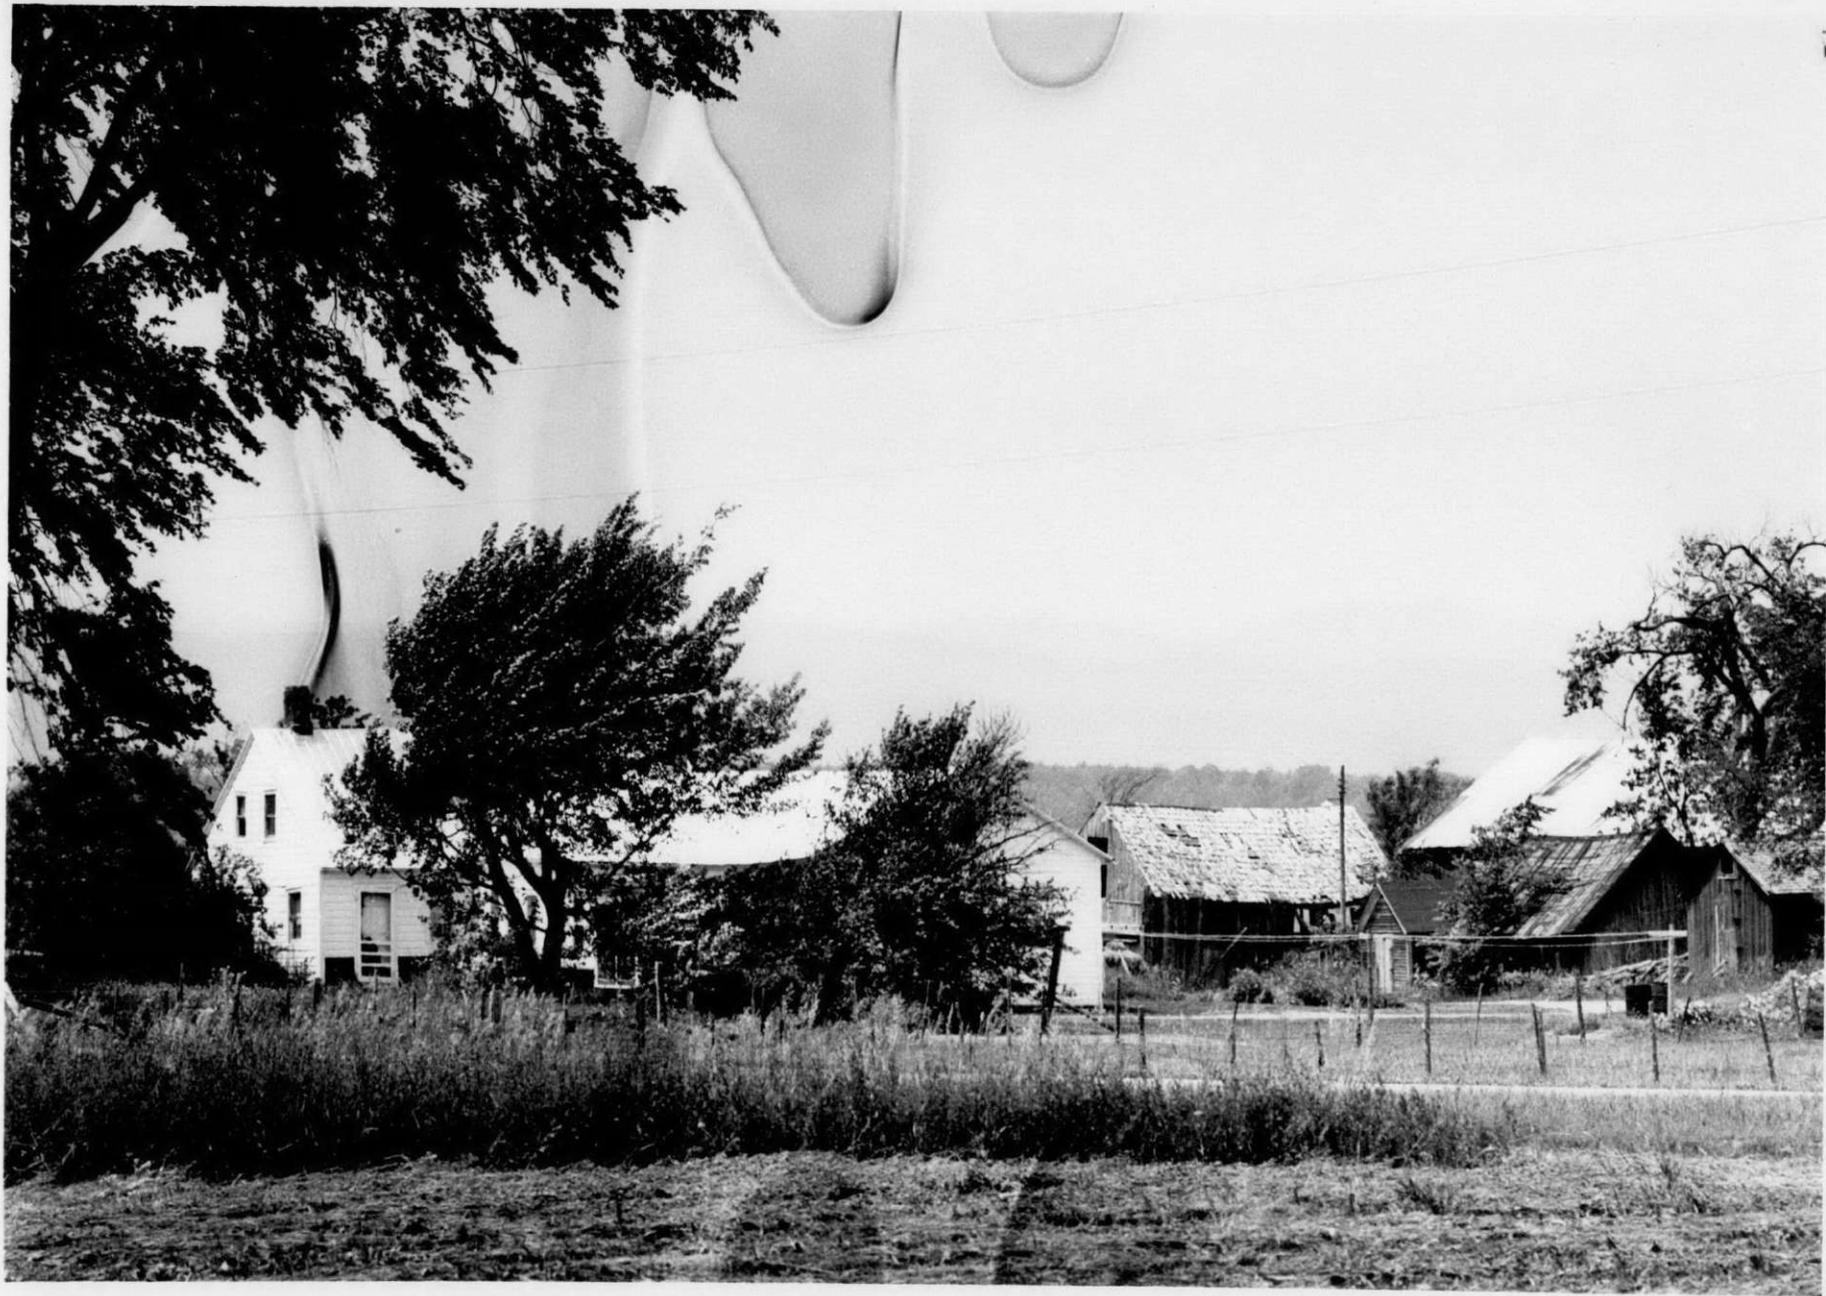
0102-31

COMMON NAME:	OWNER: Violet Nadeau		
DESCRIPTION			
Open and almost wholly deteriorated.

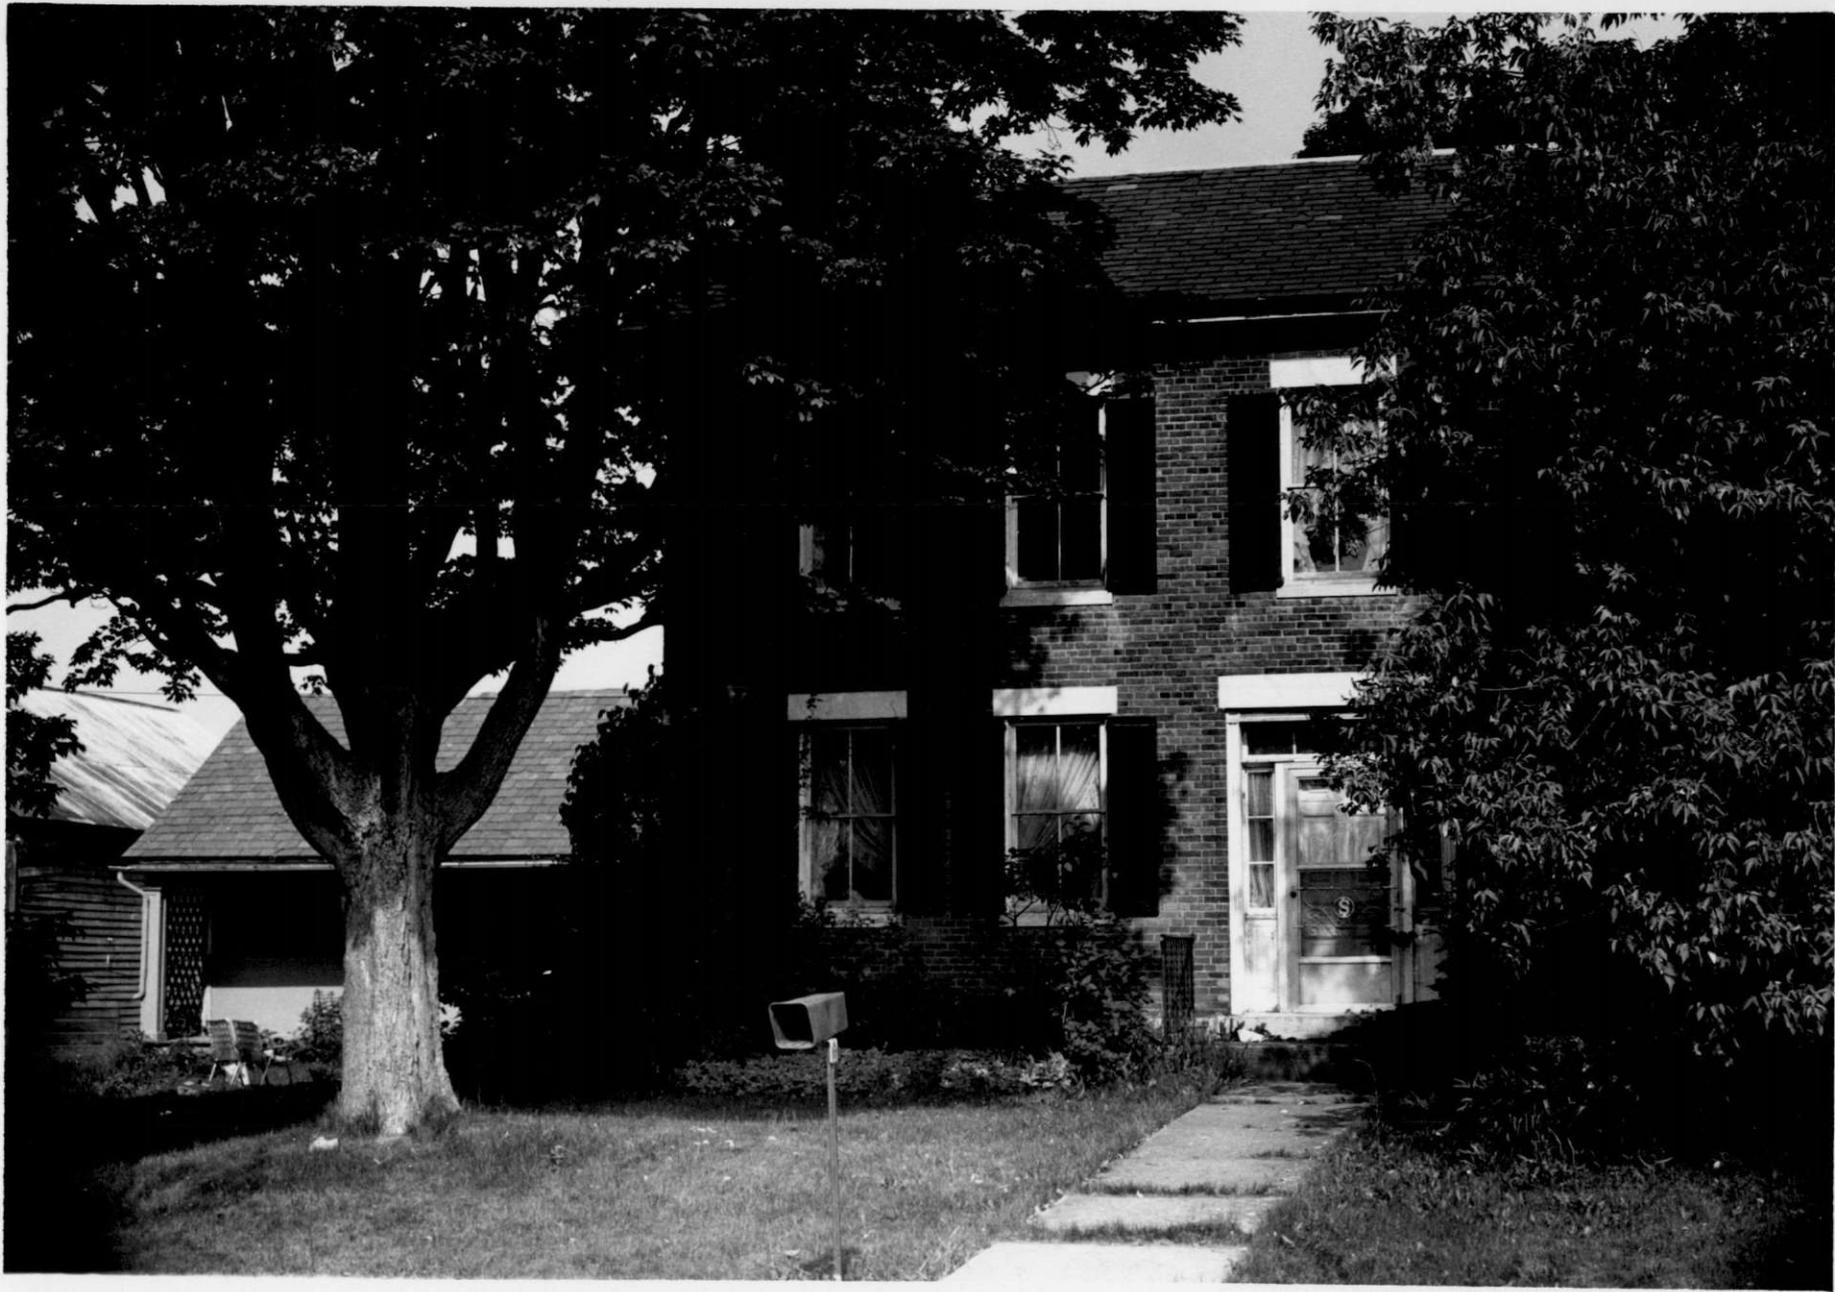
0102-34
#1

CO. Addison TOWN Bridport DATE 6/77
SUBJECT Seal-Banner Complex (local) VIEW _____
FILE # 77-A-146 CREDIT H. N. Wesley

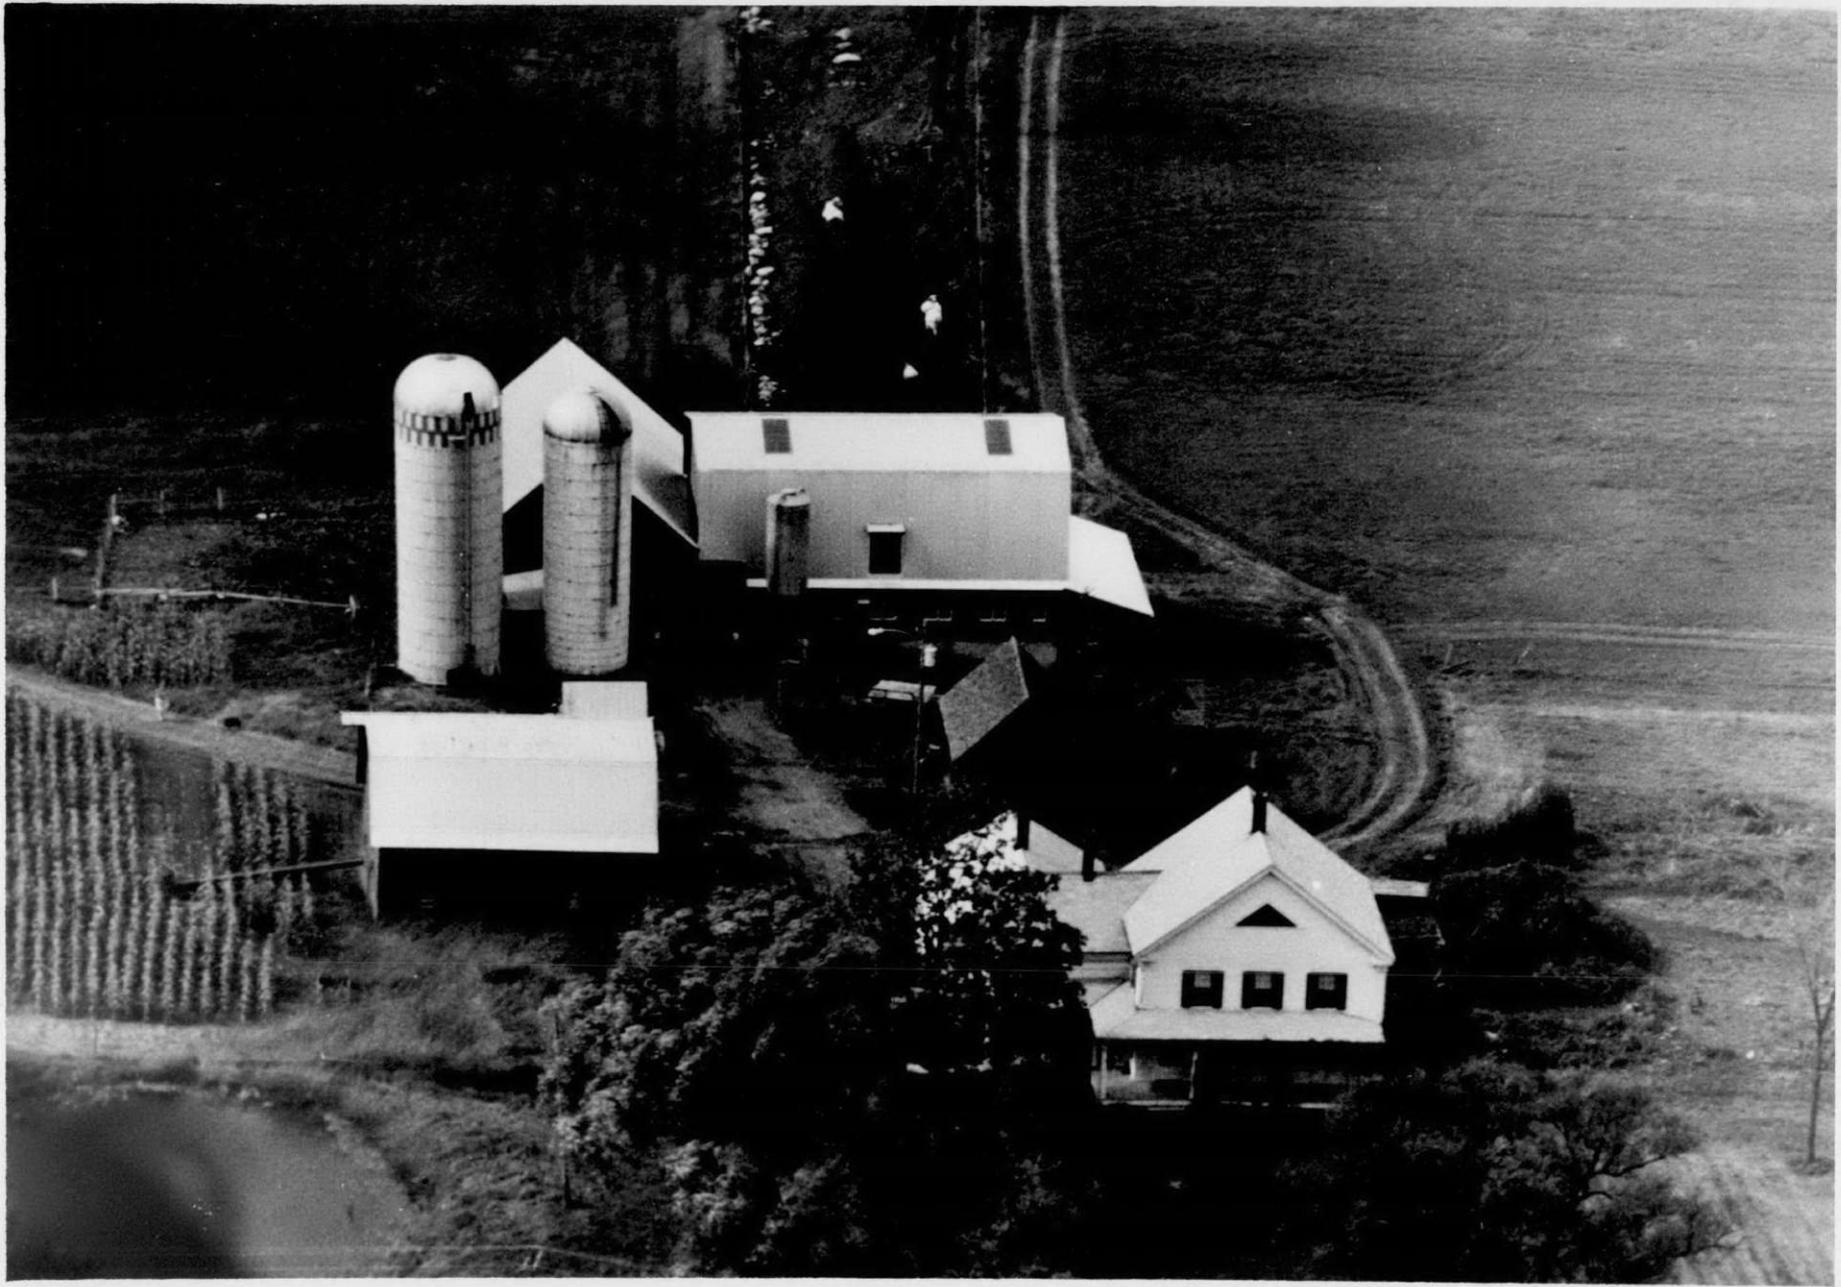
CO. Addison TOWN Bridport DATE 6/77
SUBJECT George Barnes Complex VIEW W
FILE # 77-A-146 CREDIT H. N. Hosley

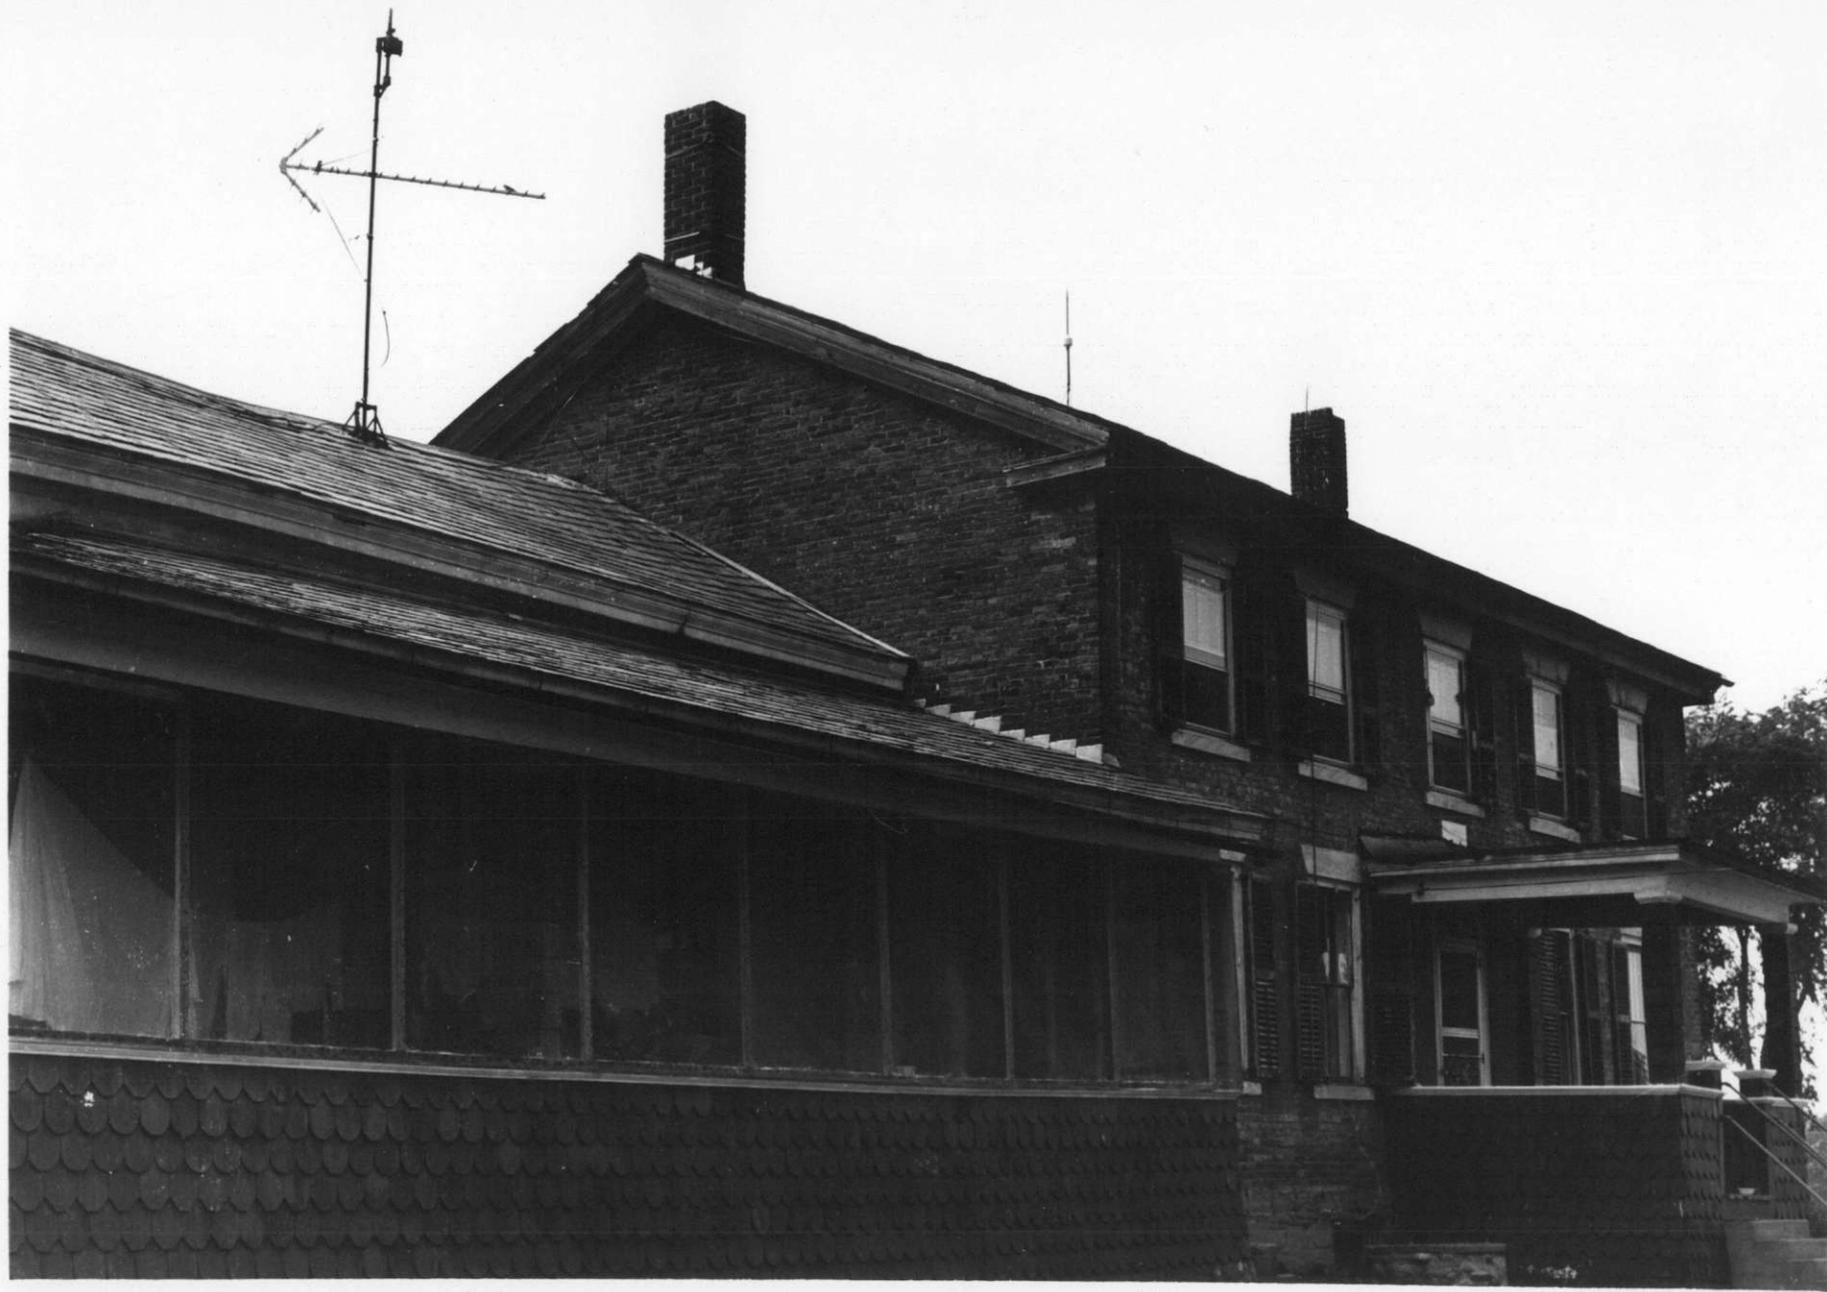
0102-45
#1

CO. Addison TOWN Bridport DATE 6/77
SUBJECT Campbell-Norton Complex (aerial) VIEW
FILE # 77-A-146 CREDIT H. N. Hasley

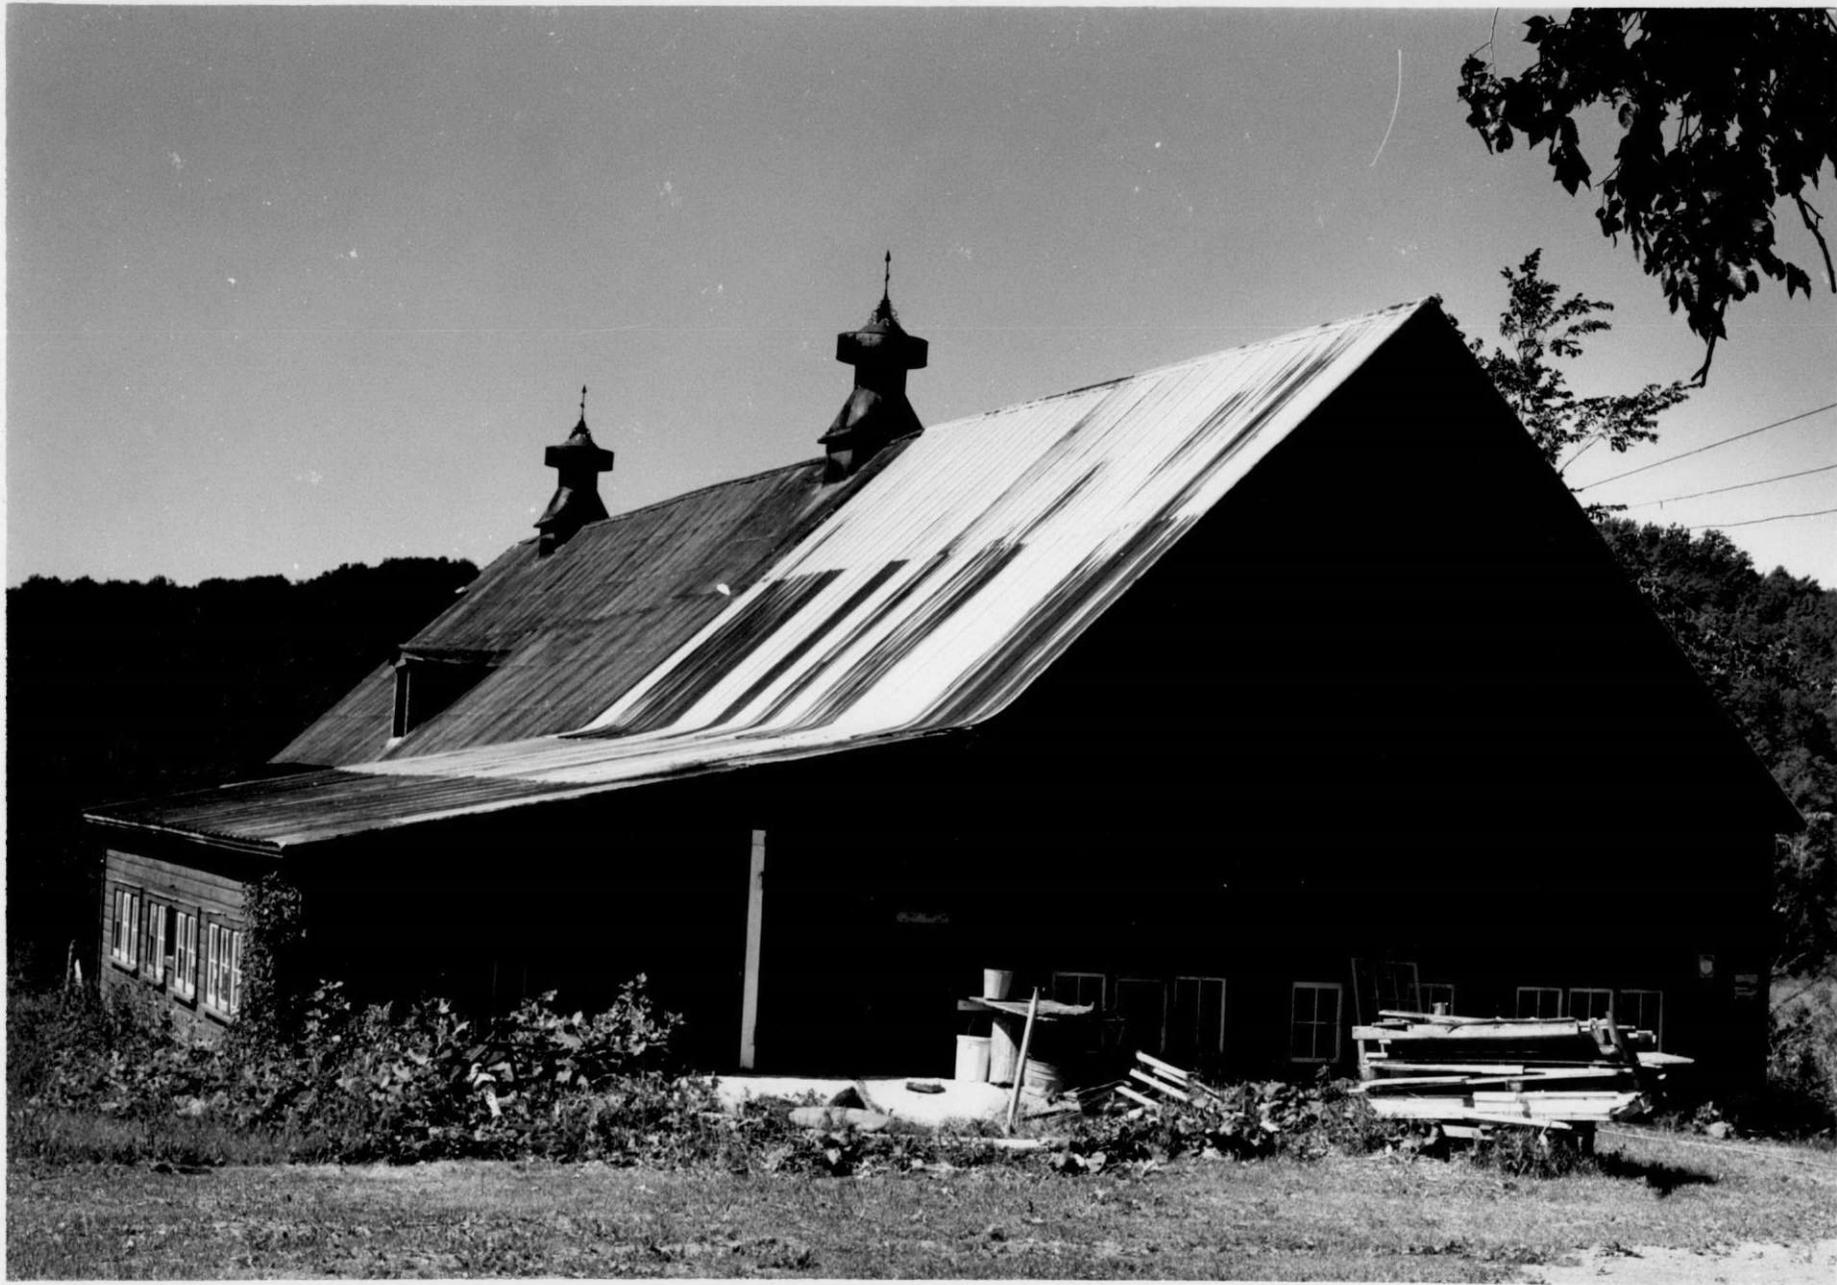
0102-48
#2

Small with gable roof; clapboard sides; and louvered ventilator on roof

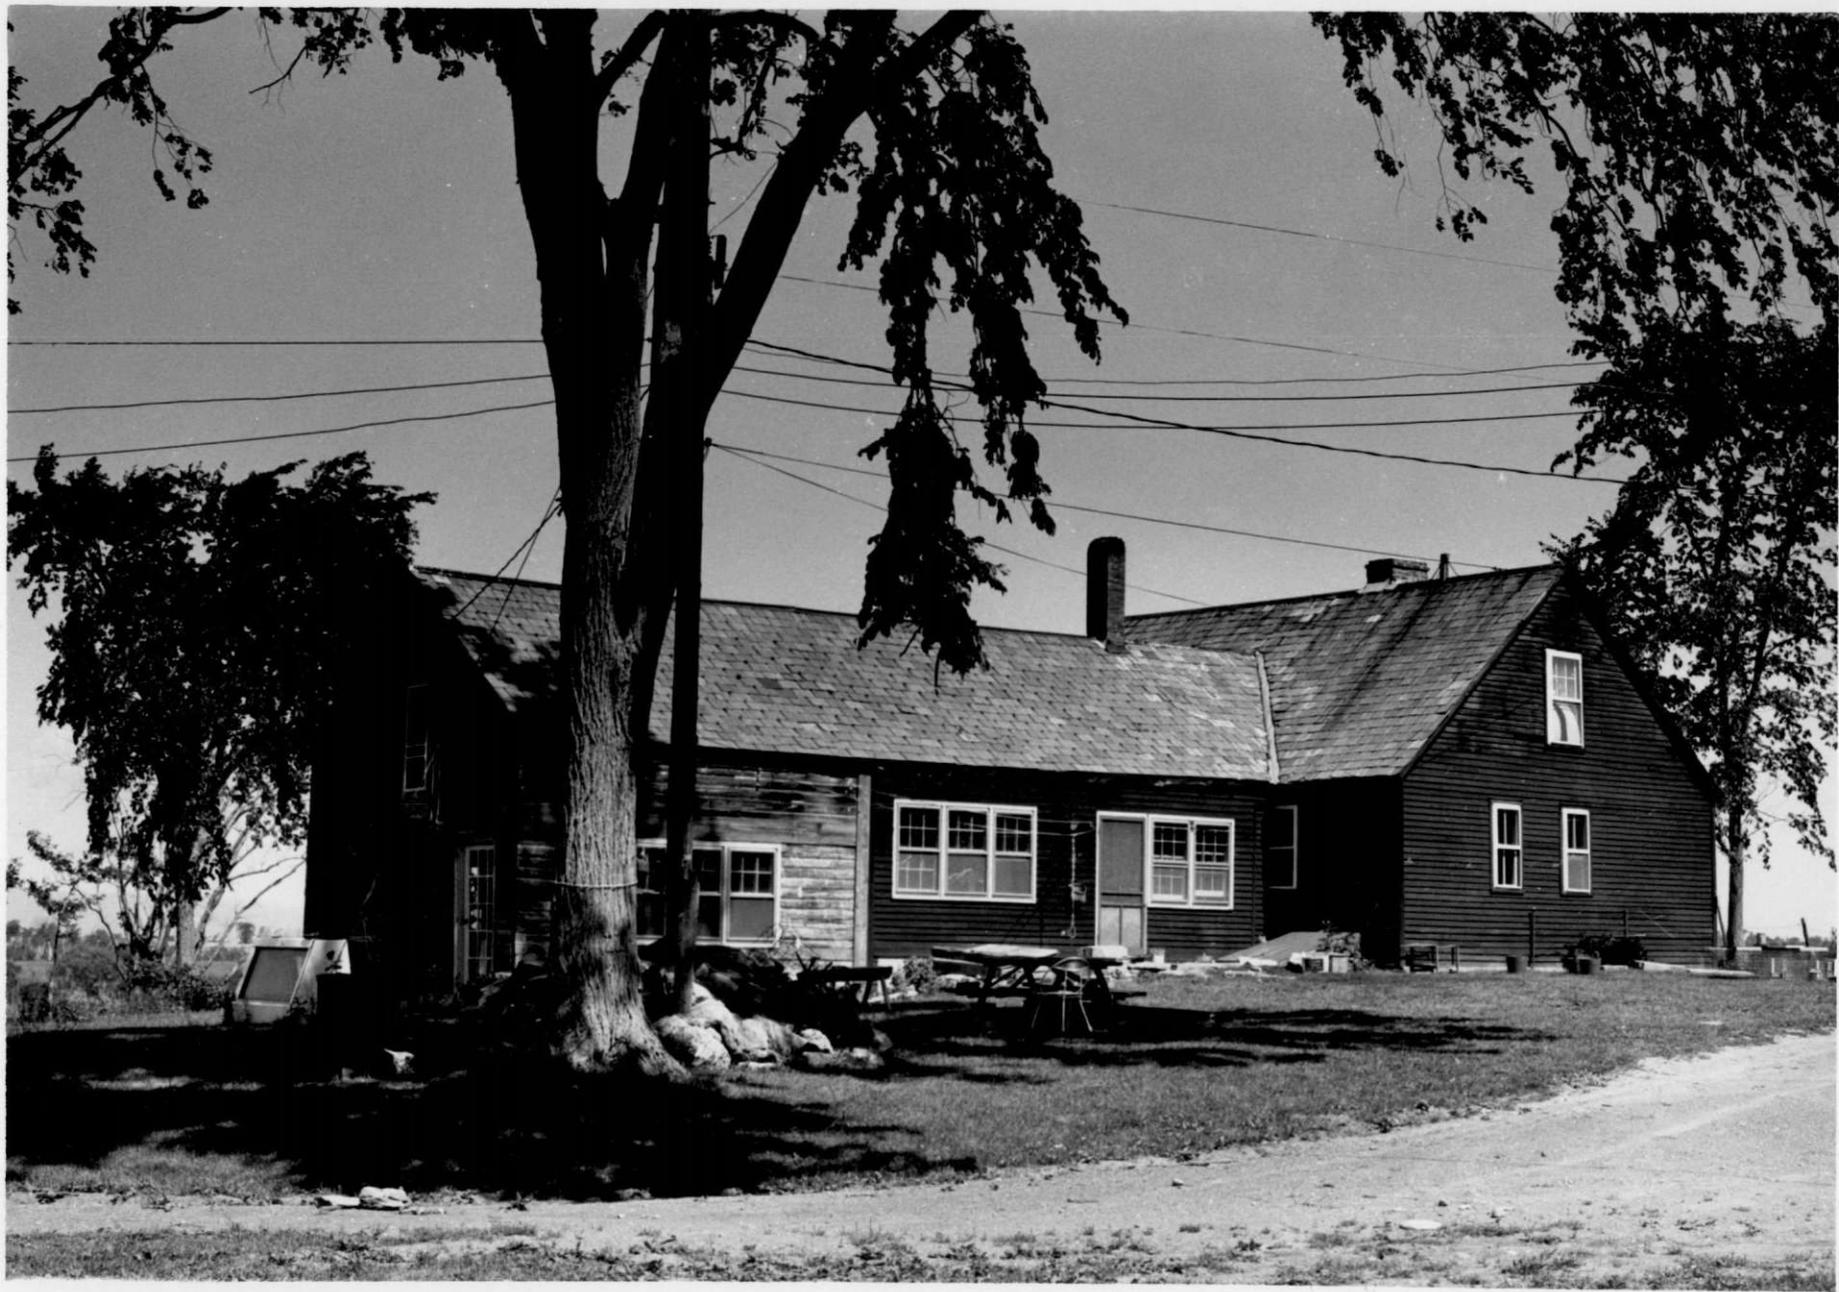
0102-48
#1

CO. Addison TOWN Bridport DATE 6/77
SUBJECT Hamilton-Kerton Complex (ham) VIEW WSW
FILE # 77-A-146 CREDIT A. D. Hasley

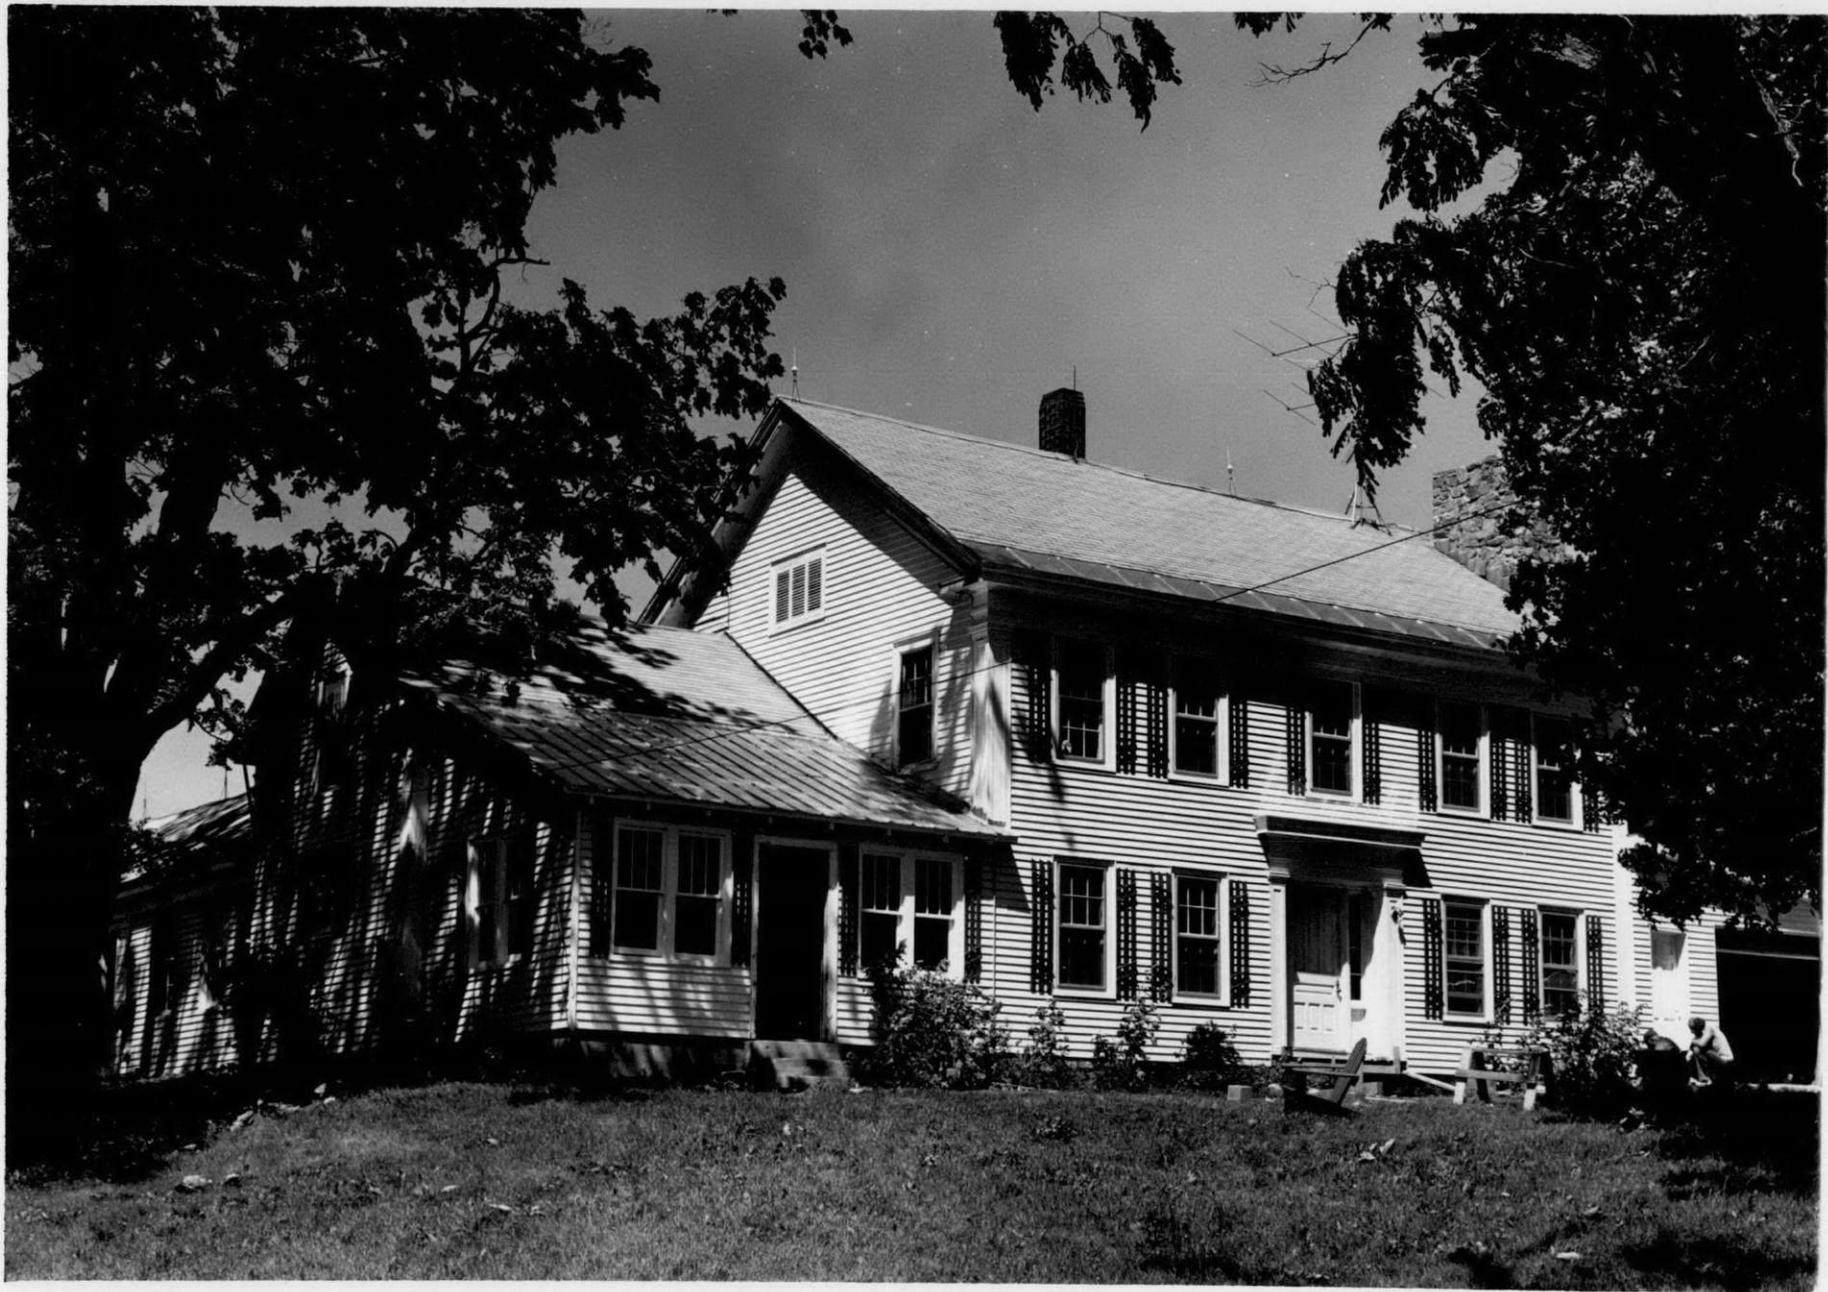
SURVEY NUMBER:	0102-49
NEGATIVE FILE NUMBER:	77-A-147
UTM REFERENCES	Zone/Easting/Northing
	18. 637980 4876000
U S G S QUAD MAP	Port Henry N.Y. - Vt.
PRESENT FORMAL NAME	
ORIGINAL FORMAL NAME	
PRESENT USE.	farmhouse
ORIGINAL USE.	farmhouse
ARCHITECT/ENGINEER	
BUILDER/CONTRACTOR	
PHYSICAL CONDITION OF STRUCTURE	Excellent <input type="checkbox"/> Good <input checked="" type="checkbox"/> Fair <input type="checkbox"/> Poor <input type="checkbox"/>
THEME.	
STYLE.	Greek Revival
DATE BUILT	c. 1840

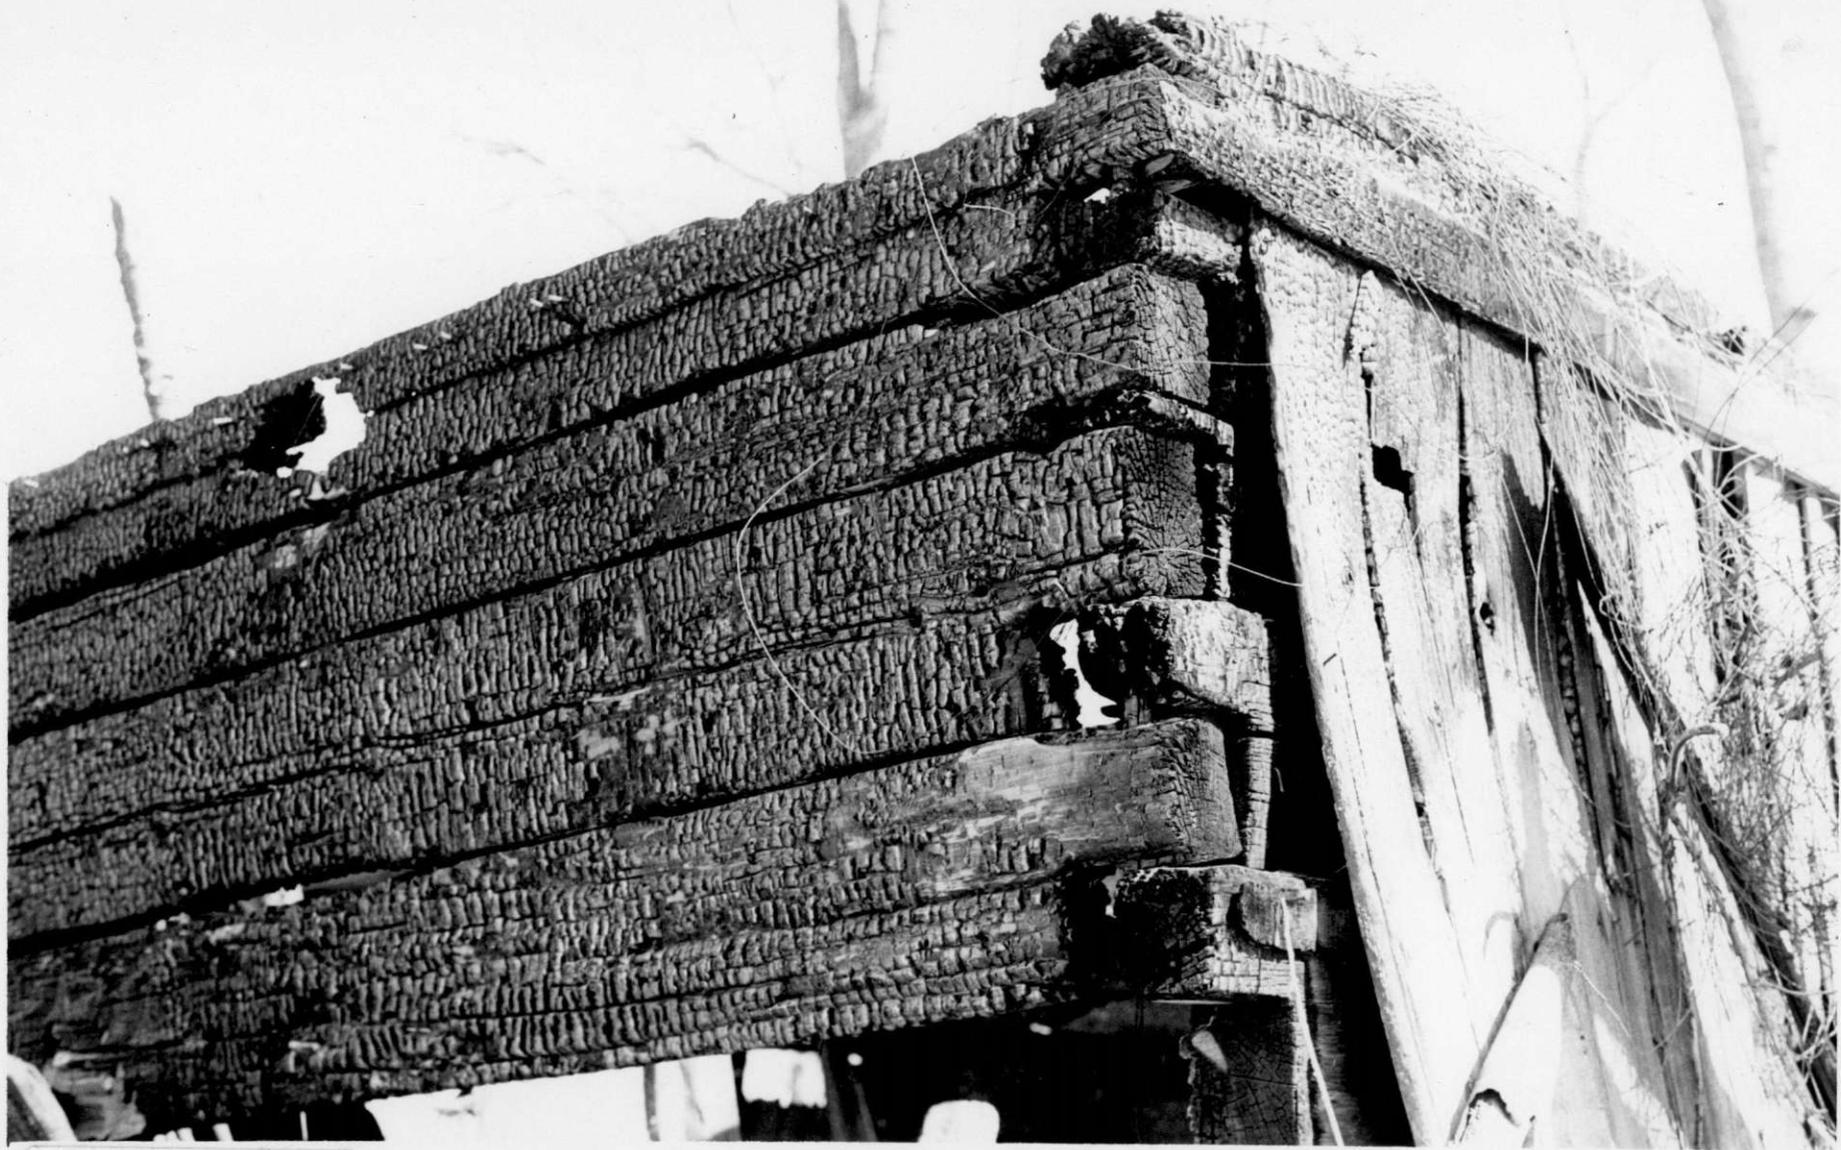
0102-1

This structure appears to have originally been a hewn log lap-jointed dwelling. It was more recently converted to a barn with a shed attached to the west. Recently it was burned out. Although the timbers are substantially solid, two walls are leaning and threatening to collapse. Bricks, perhaps the remains of chimney on north side. Logs removed from opening into attached shed may have been used to fill in former chimney location. Appears to have had no cellar. Walls 10 logs high. Logs are hewn to 6 1/2" thickness and 8-15" broad. Doors and older windows were chopped out; * (Continued Below)

This appears to have been an early hewn log structure. Its chopped out (not sawn) windows and doors with pegged frames mark it as primitive and possibly from the early settlement era. The large size of the hewn timbers also supports this hypothesis. Although used as a barn until it was burned out recently, Leo Huestis, a farmer who rents the surrounding land, has been told by older Bridport residents that it was formerly a dwelling. Date is unknown.

*later openings were sawn Door and window frames pegged in place
