**National Register of Historic Places
Inventory—Nomination Form**

historic Bristol Downtown Historic District

BRISTOL DOWNTOWN
HISTORIC DISTRICT
Bristol, Vermont

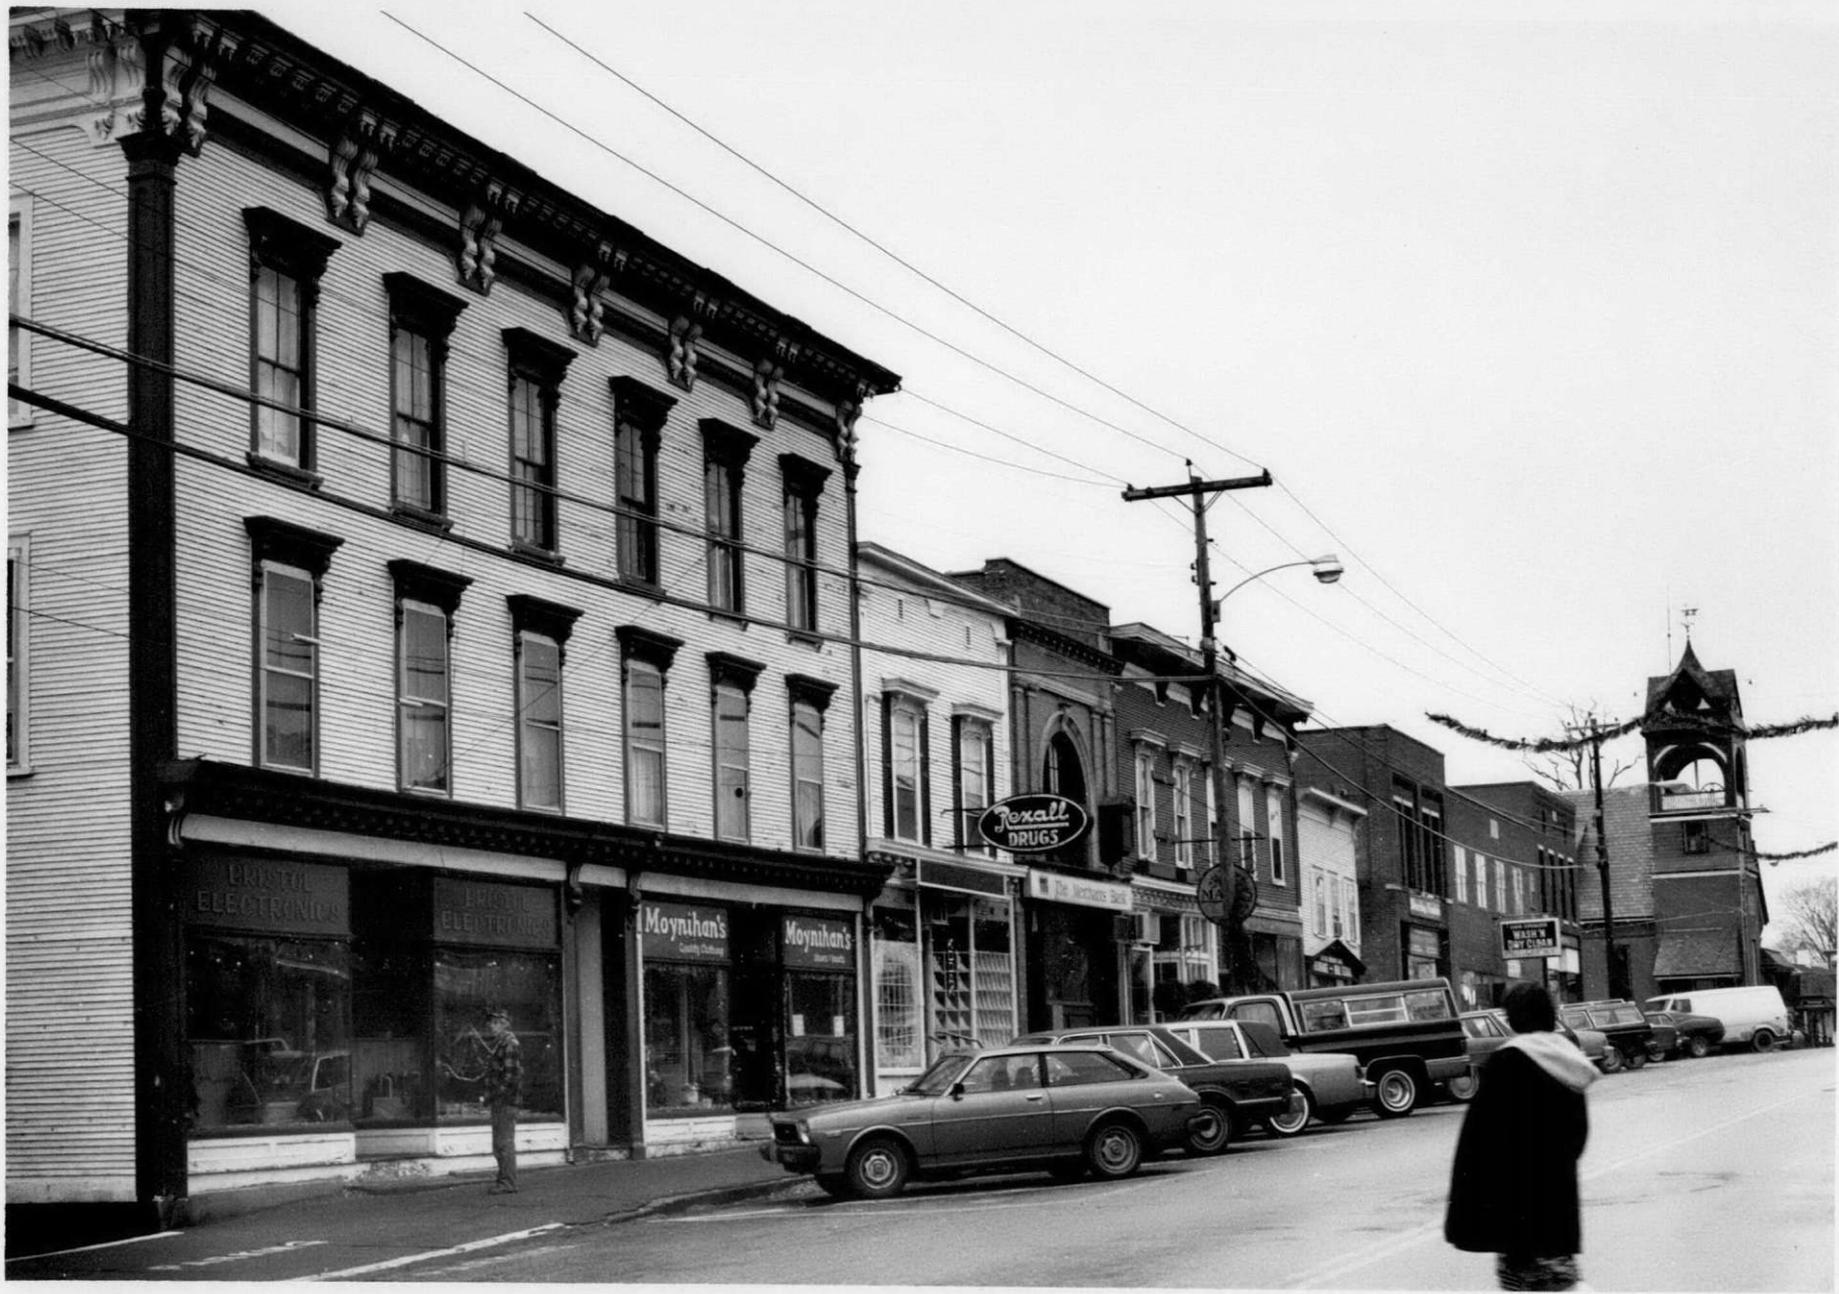
Bristol Downtown Historic District
Bristol, Vermont
Credit: Gina Campoli
Date: December, 1982
Negative Filed at Vermont Division for
Historic Preservation
Description: South side of Main Street (L to
R: #'s 6, 7, 8, 9, 10, 11, 12, 13, 14);
View Southwest
Photograph 1

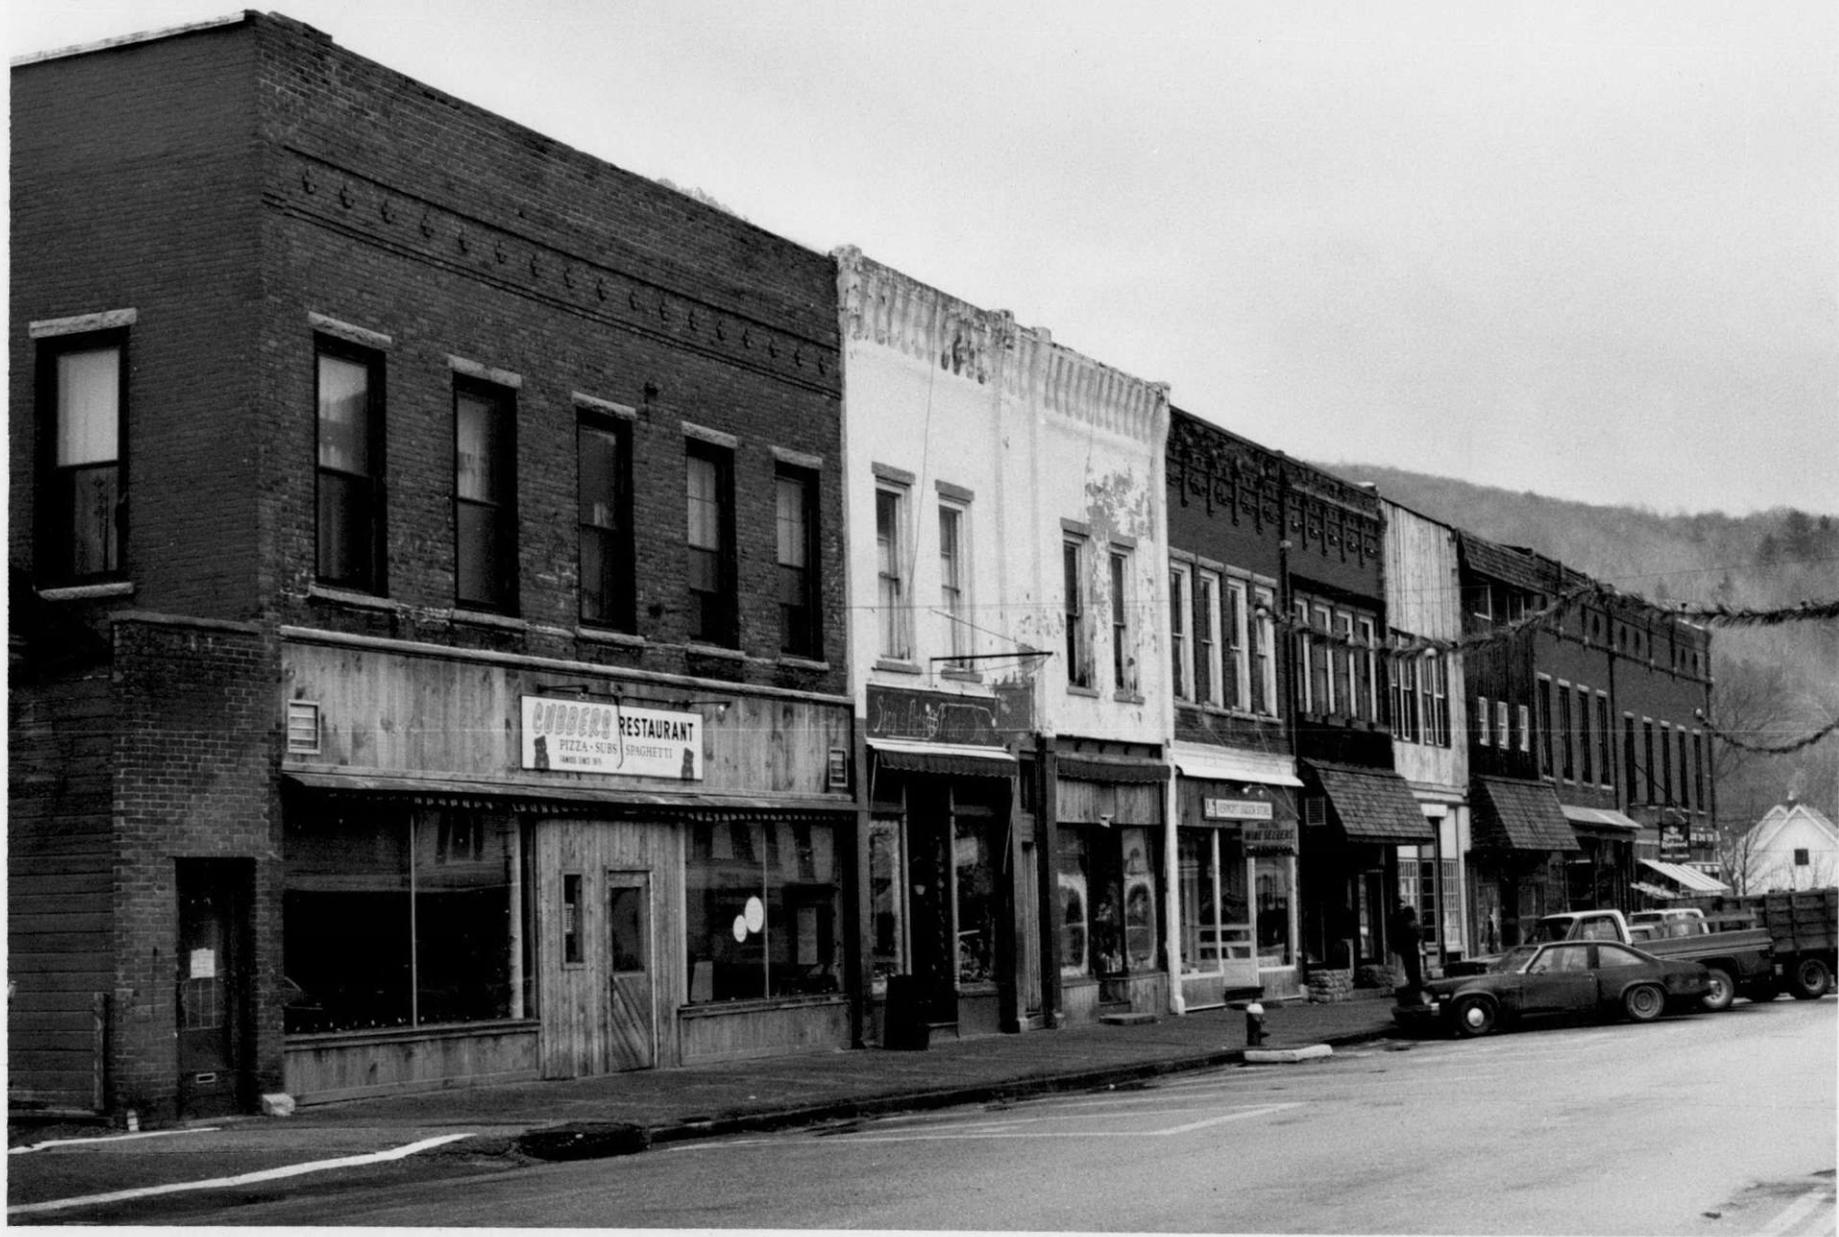
Photograph 3

Description: Union Block, North side of Main
Street (L to R: #'s 15A, 15B, 15C, 15D, 15E,
15F, 15G); View Northeast

The original Union Block was a clapboard structure which stood on the same site and had almost exactly the same plan and proportions as the present building. Built in the 1870's, it was Bristol's most important commercial block until it burned in 1898. Its name derived from the fact that, although built on a single frame and foundation, the separate retail spaces were separately owned, and the building was thus a "union" of merchants and property owners under a single roof. When the building burned on October 26, 1898, the various owners immediately set out to rebuild under the same scheme but with 12" brick firewalls separating the sections. The last of the new stores opened on March 25, 1899, less than five months after the fire. The result was a 2-story, flat-roofed block with seven separate brick veneered facades which varied in appearance to a degree, but generally employed similar organizational schemes and period stylistic motifs, and thus combined to create a continuous, cohesive commercial streetscape. The individual facades are described as follows:

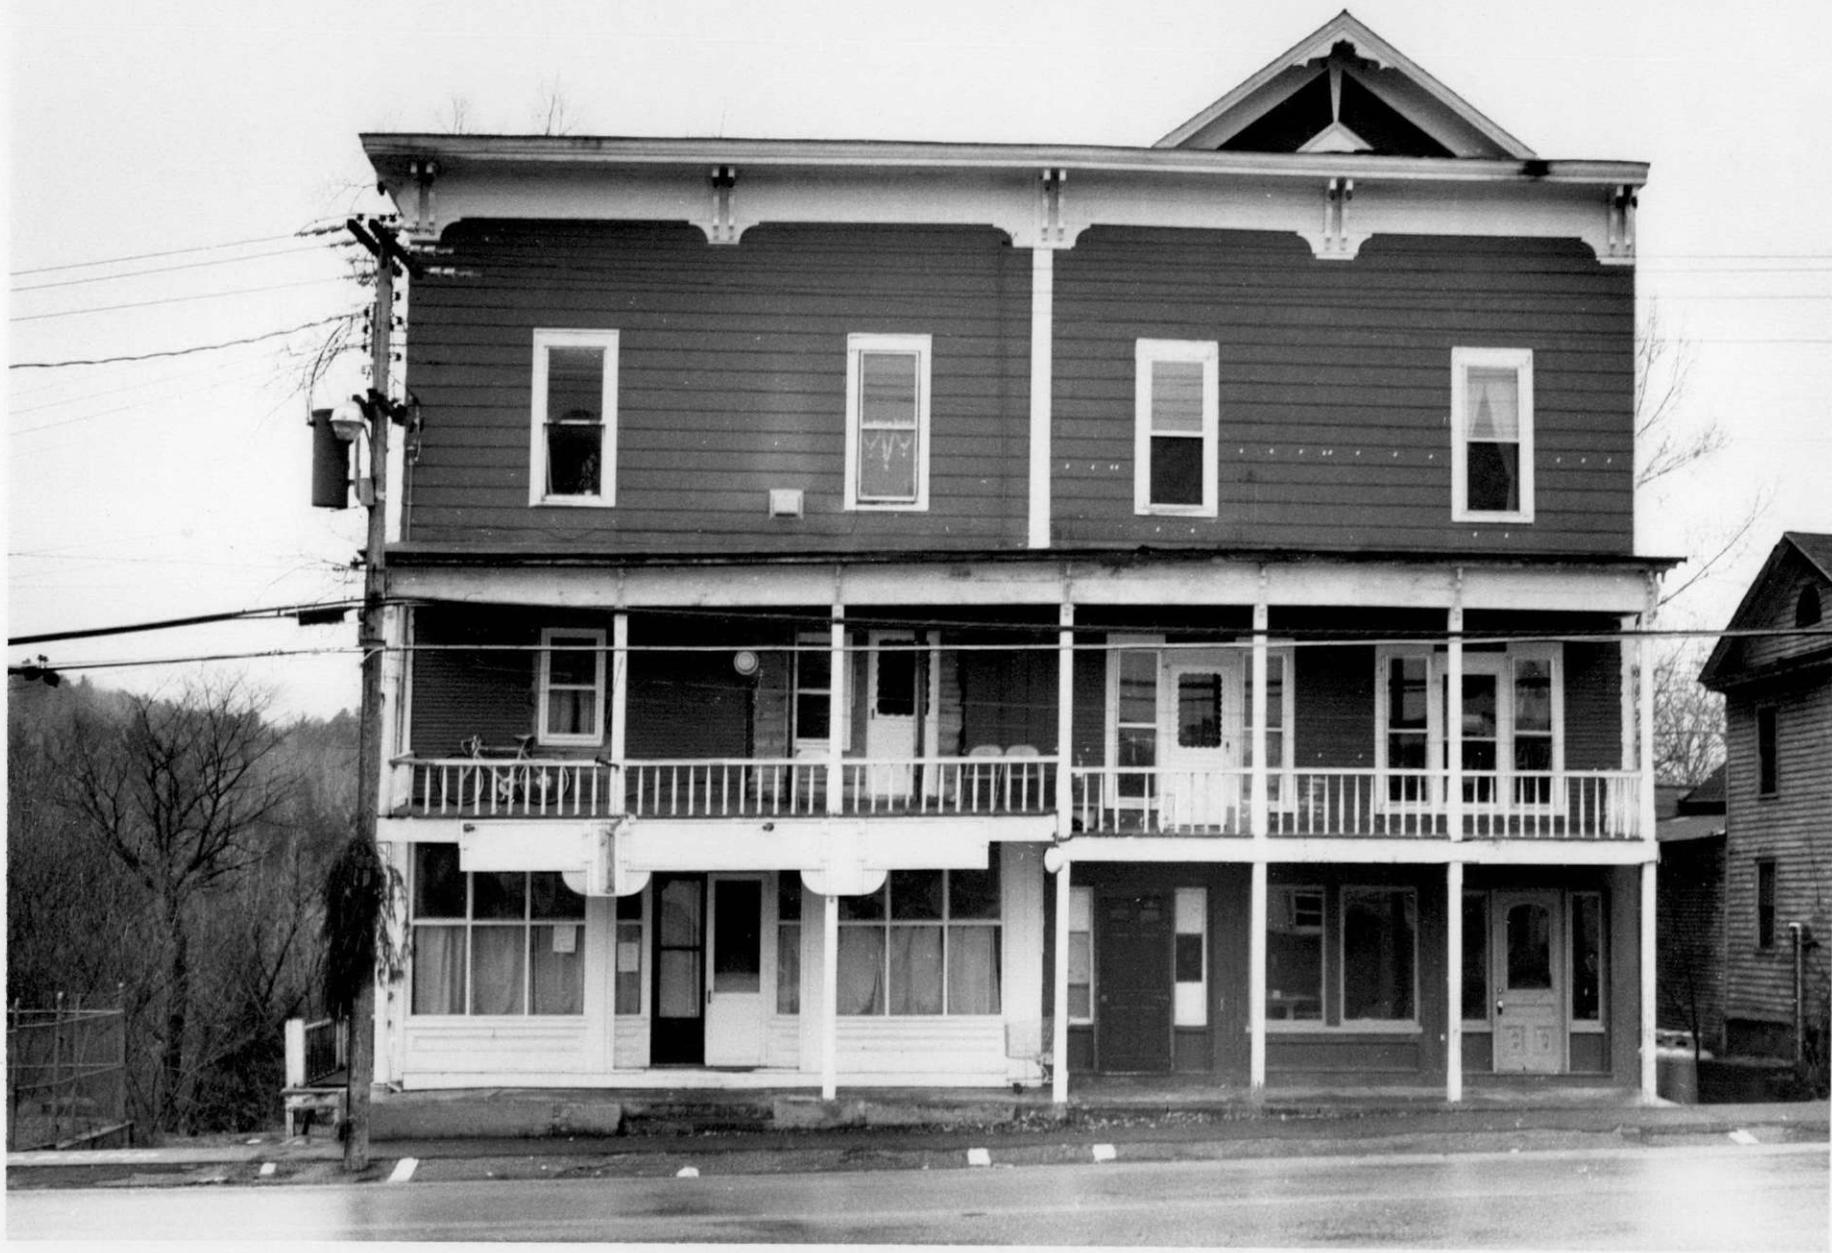
Description: Hatch Block (#1); View South
Photograph 4

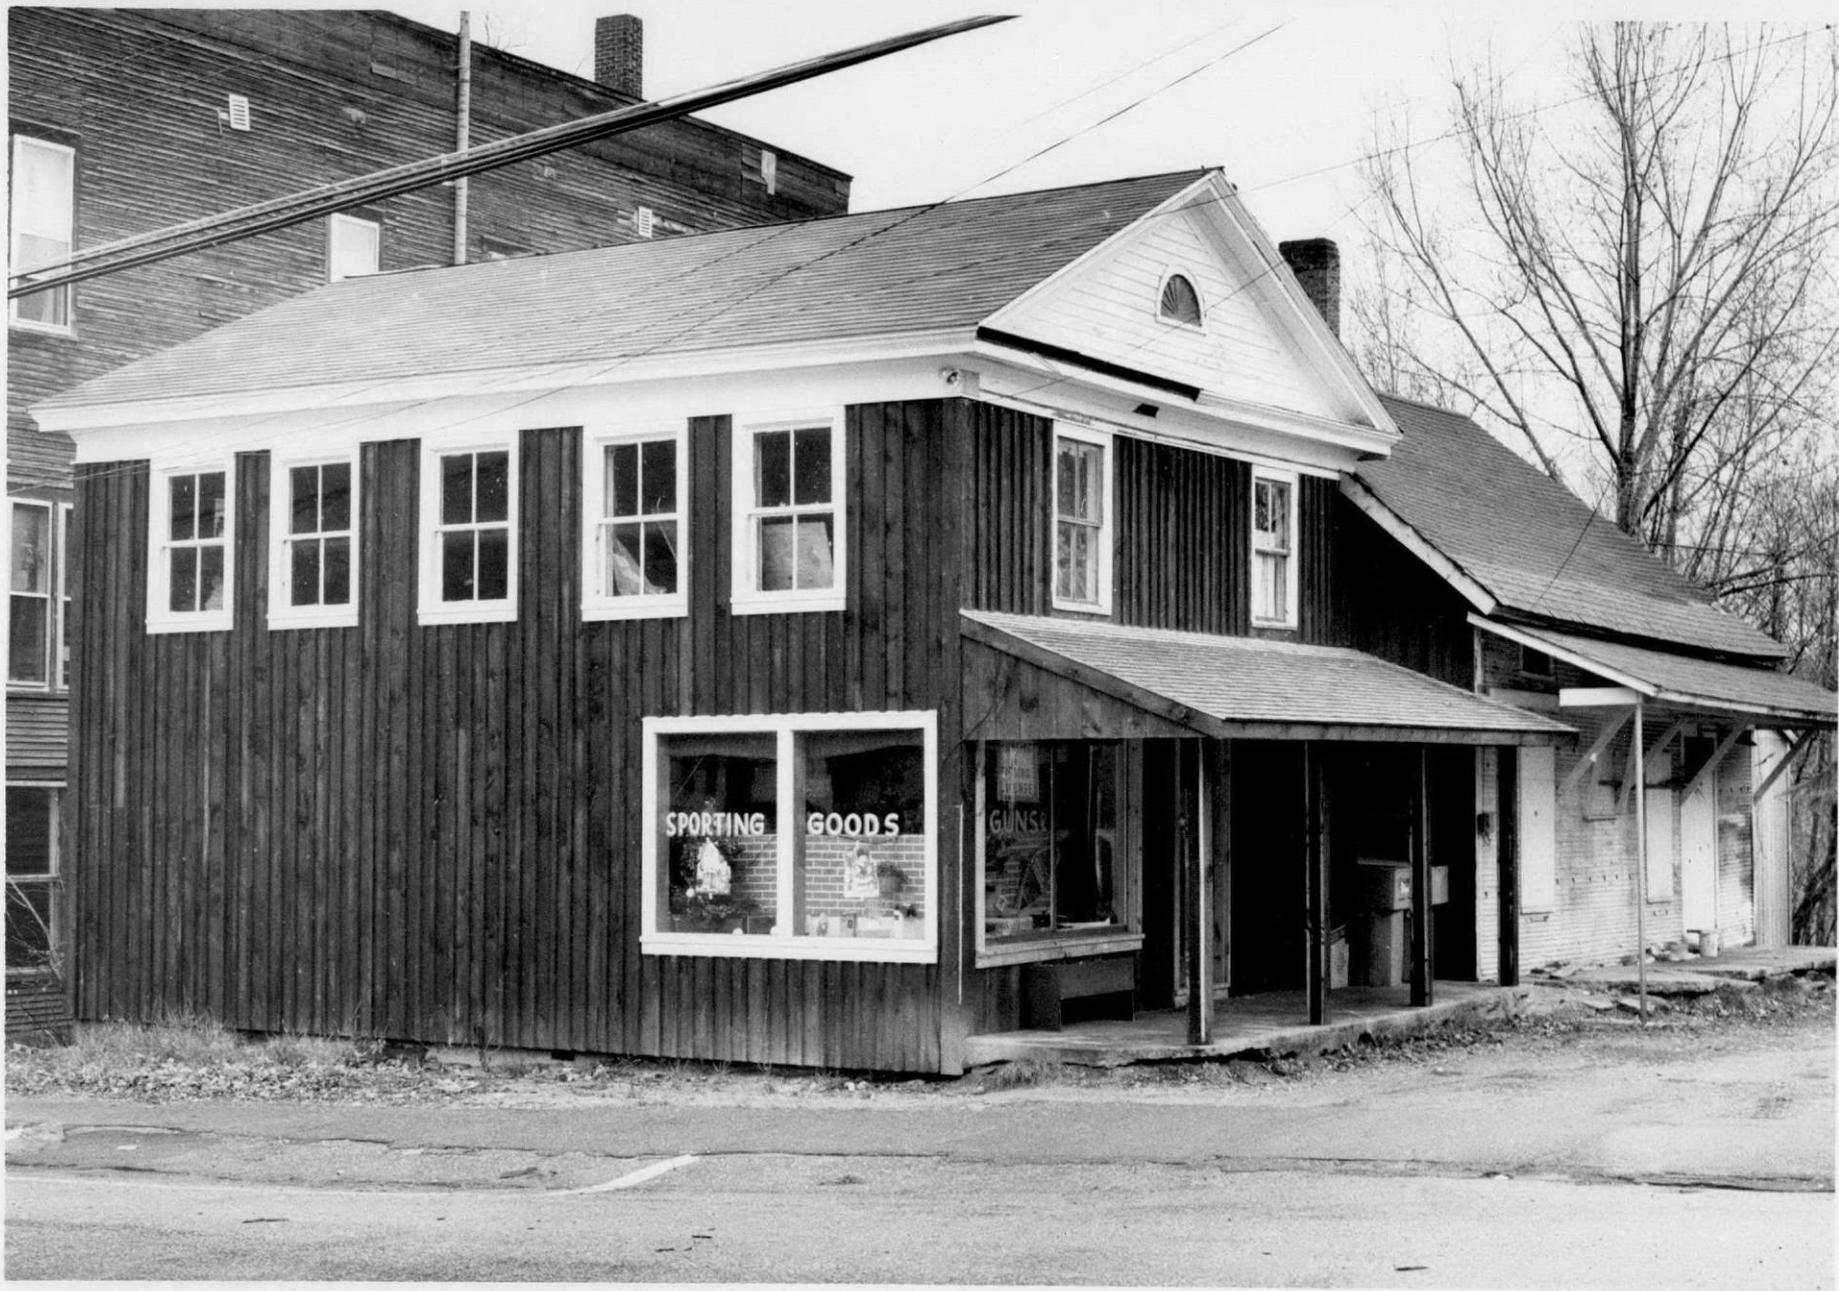
Bristol Downtown Historic District
Bristol, Vermont
Credit: Gina Campoli
Date: December, 1982
Negative Filed at Vermont Division for
Historic Preservation
Description: Thomas Block (#2); View
Southeast
Photograph 5

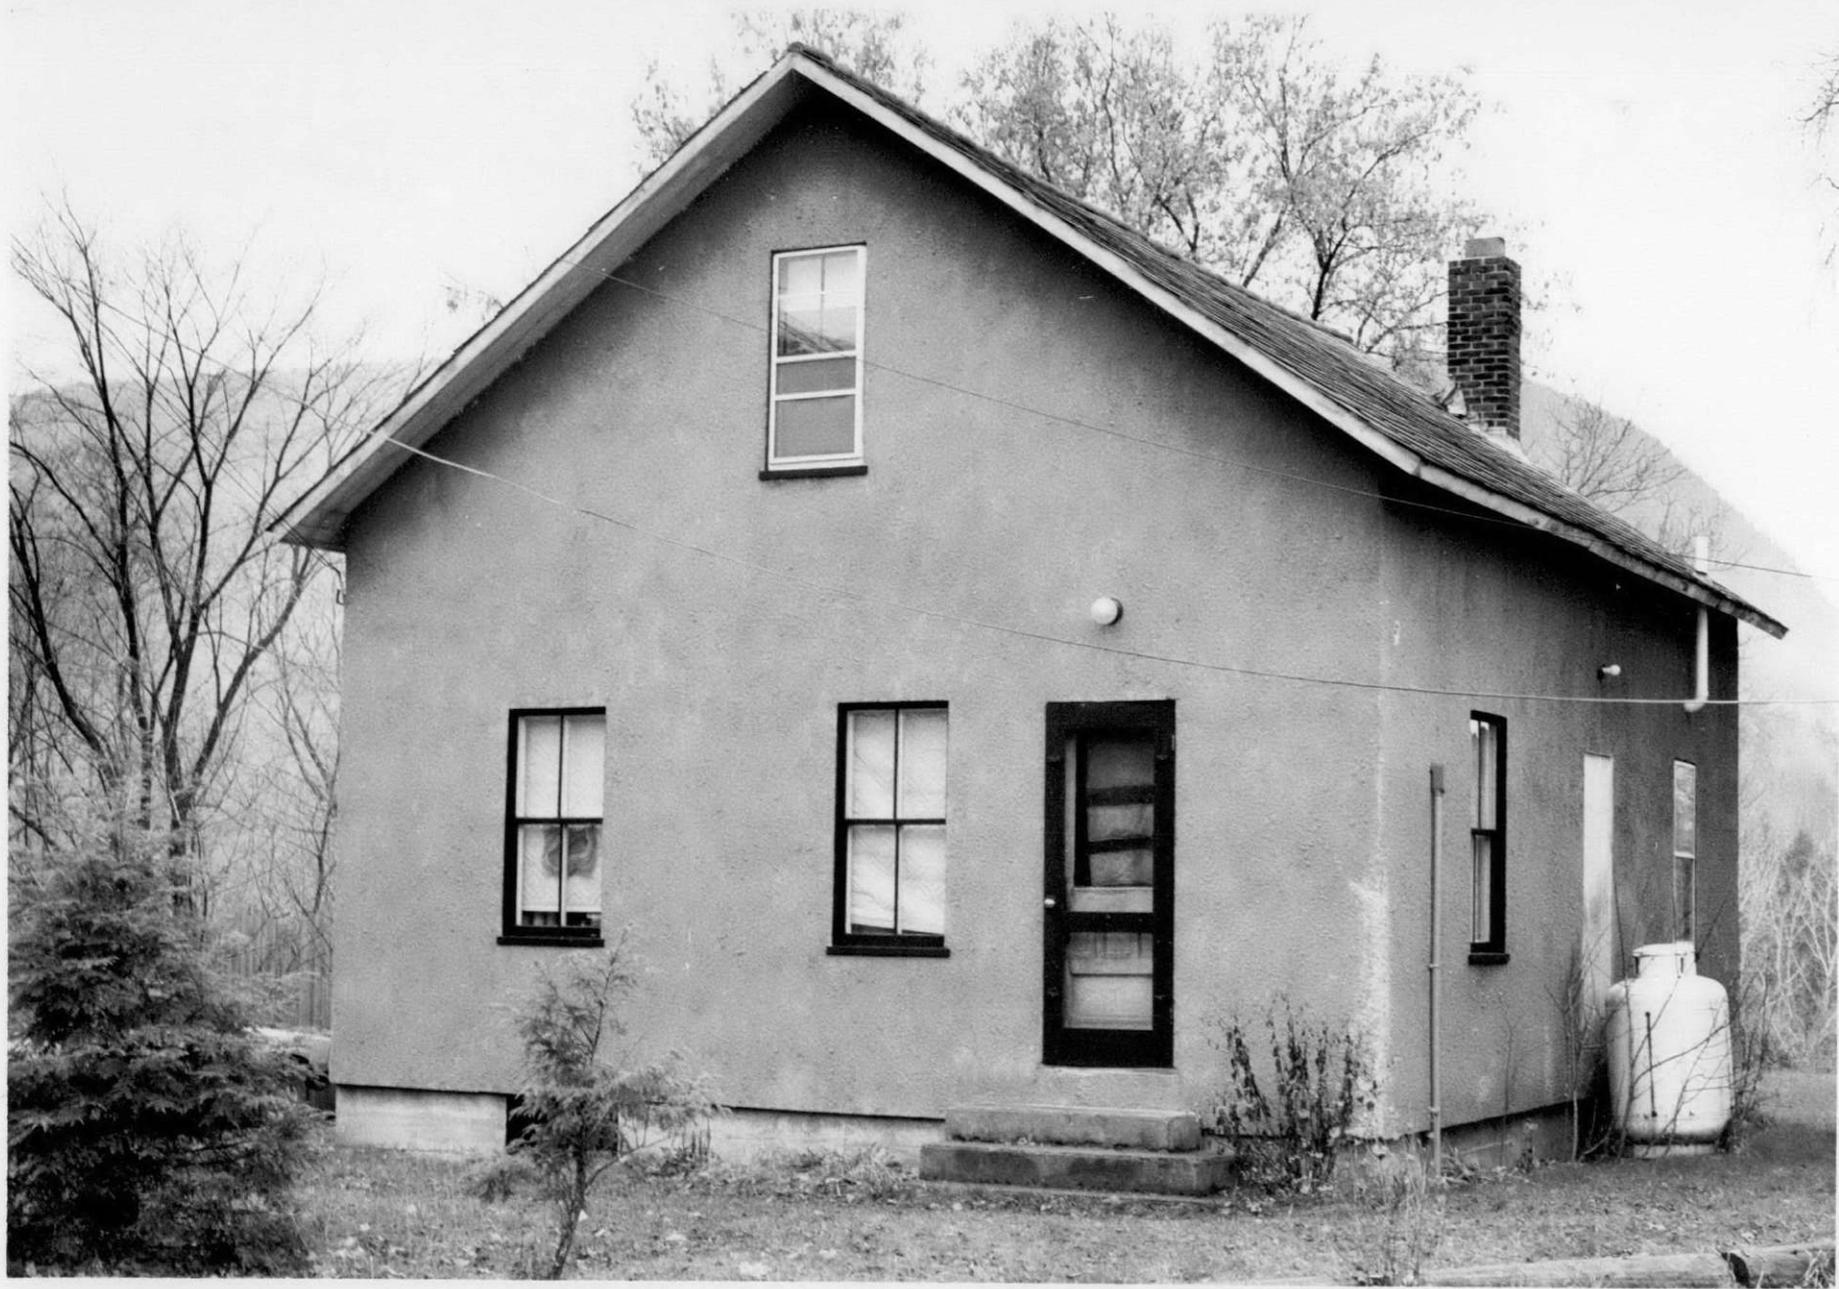
Photograph 7

Description: Kilbourn Grist Mill Office (#4);
View Southeast

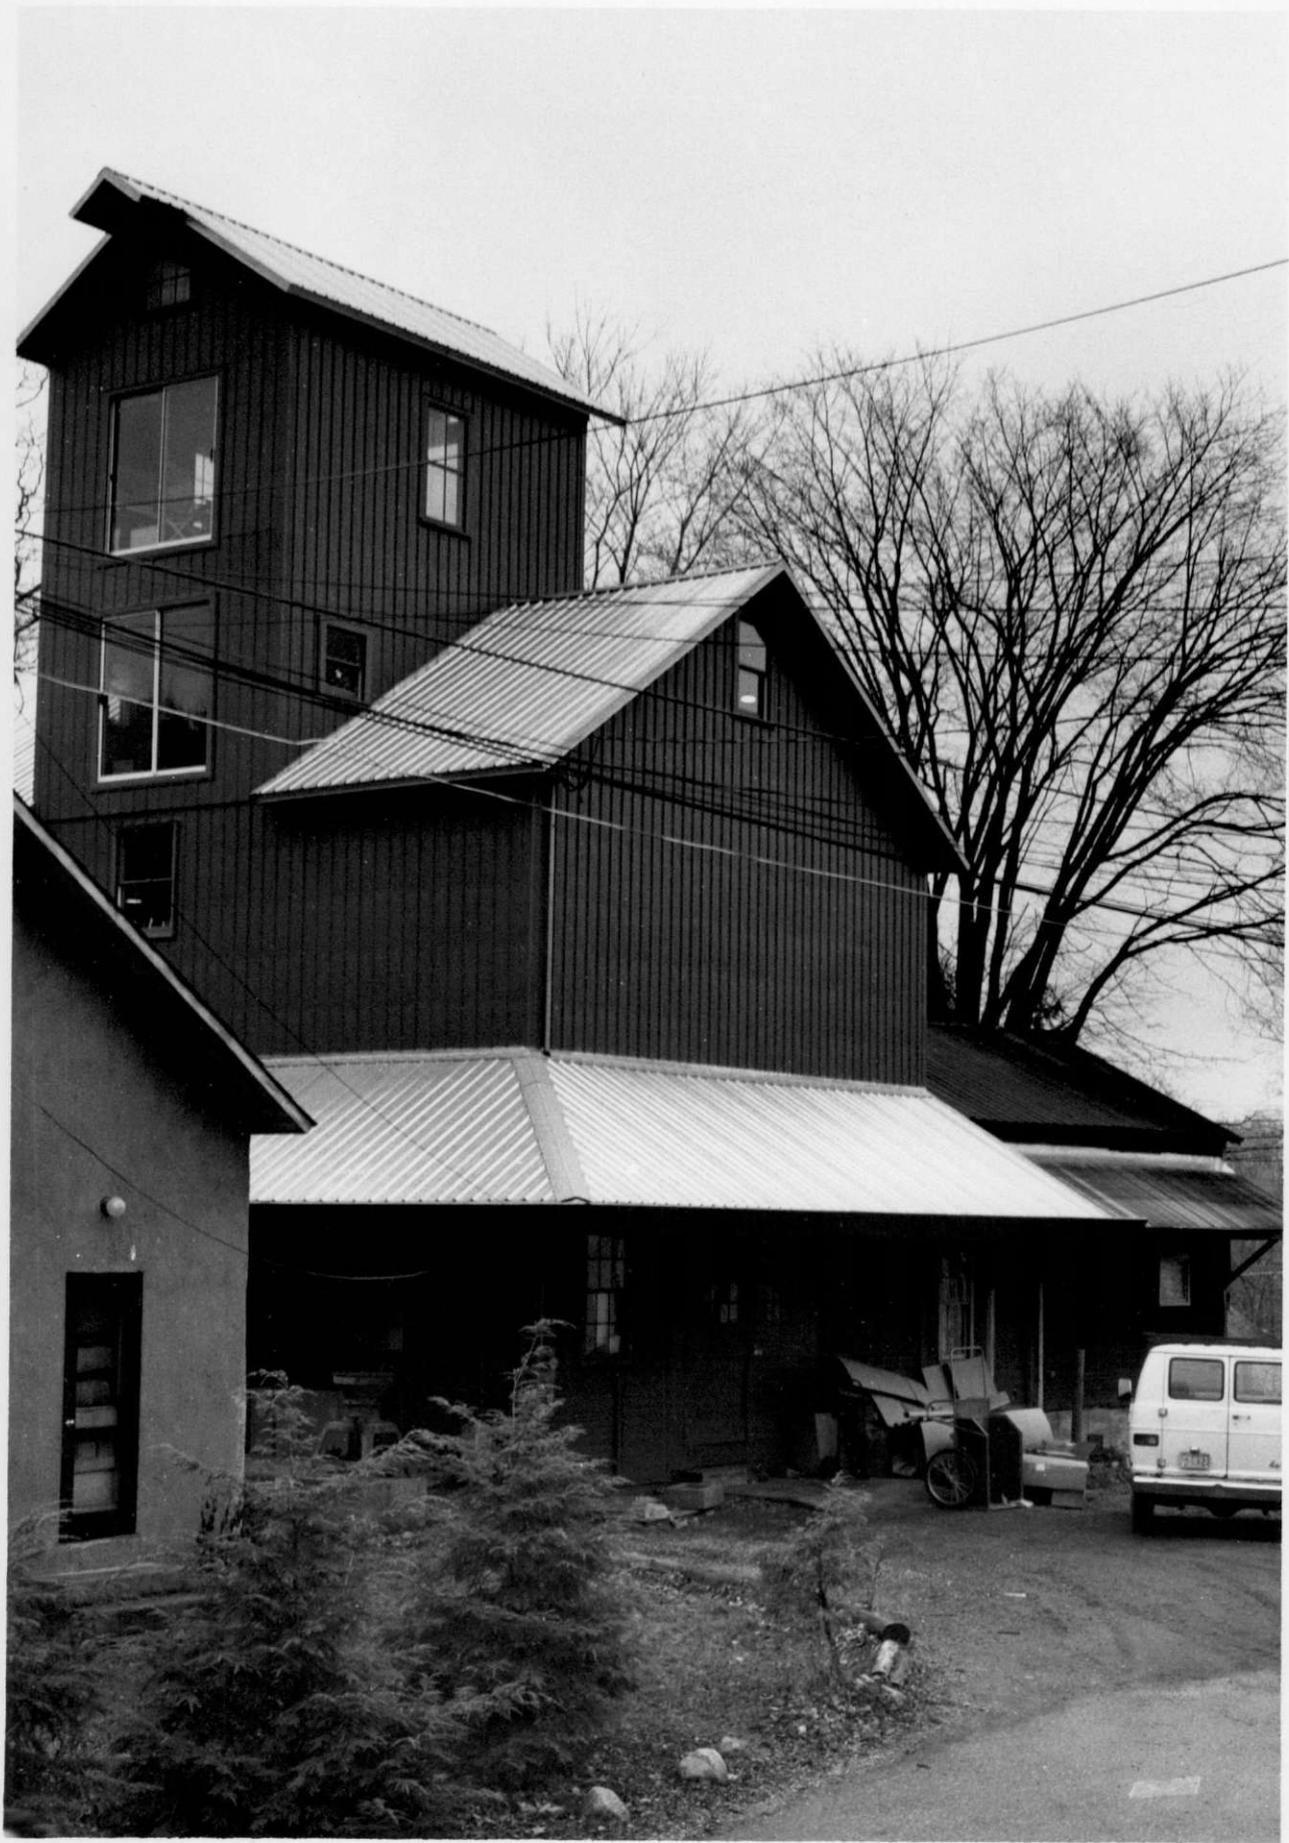
Bristol Downtown Historic District
Bristol, Vermont
Credit: Gina Campoli
Date: December, 1982
Negative Filed at Vermont Division for
Historic Preservation
Description: Kilbourn Grist Mill (#5); View
Southwest
Photograph 8

The Kilbourn Grist Mill may have been the last structure of its type erected in Vermont. It replaced an earlier mill - the "Cyclone" - which burned in 1924. The present building, built in the same year, owes its design more to the 19th century than to the 20th century. Now converted to a toy factory, it has been altered only by the addition of red, vertically striated sheet metal siding and new windows above the second floor. The building's most distinctive feature is its four-story grain elevator which rises two stories above the main gable roof. The frame is of very heavy post-and-beam construction.

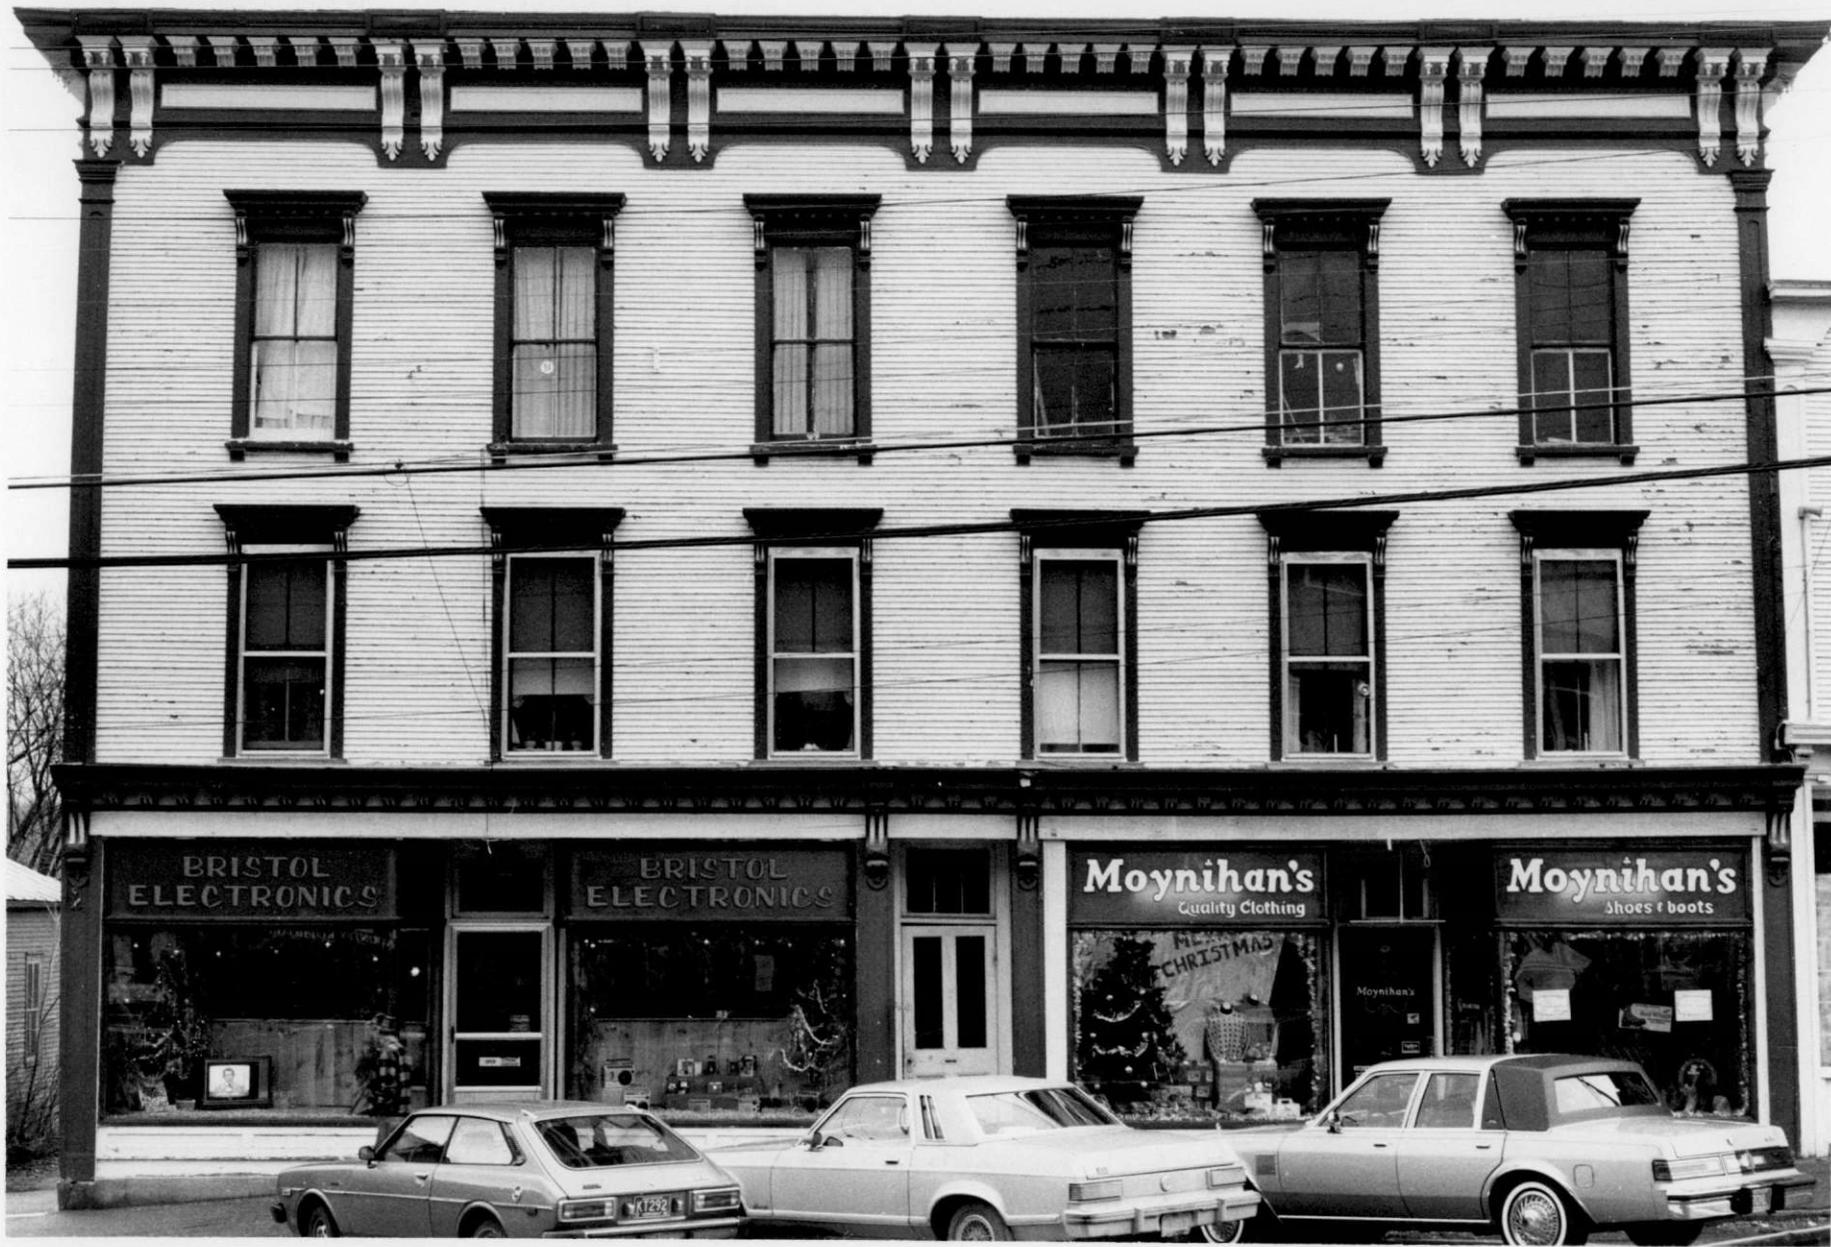
Description: Dunshee Block (#6); View South
Photograph 9

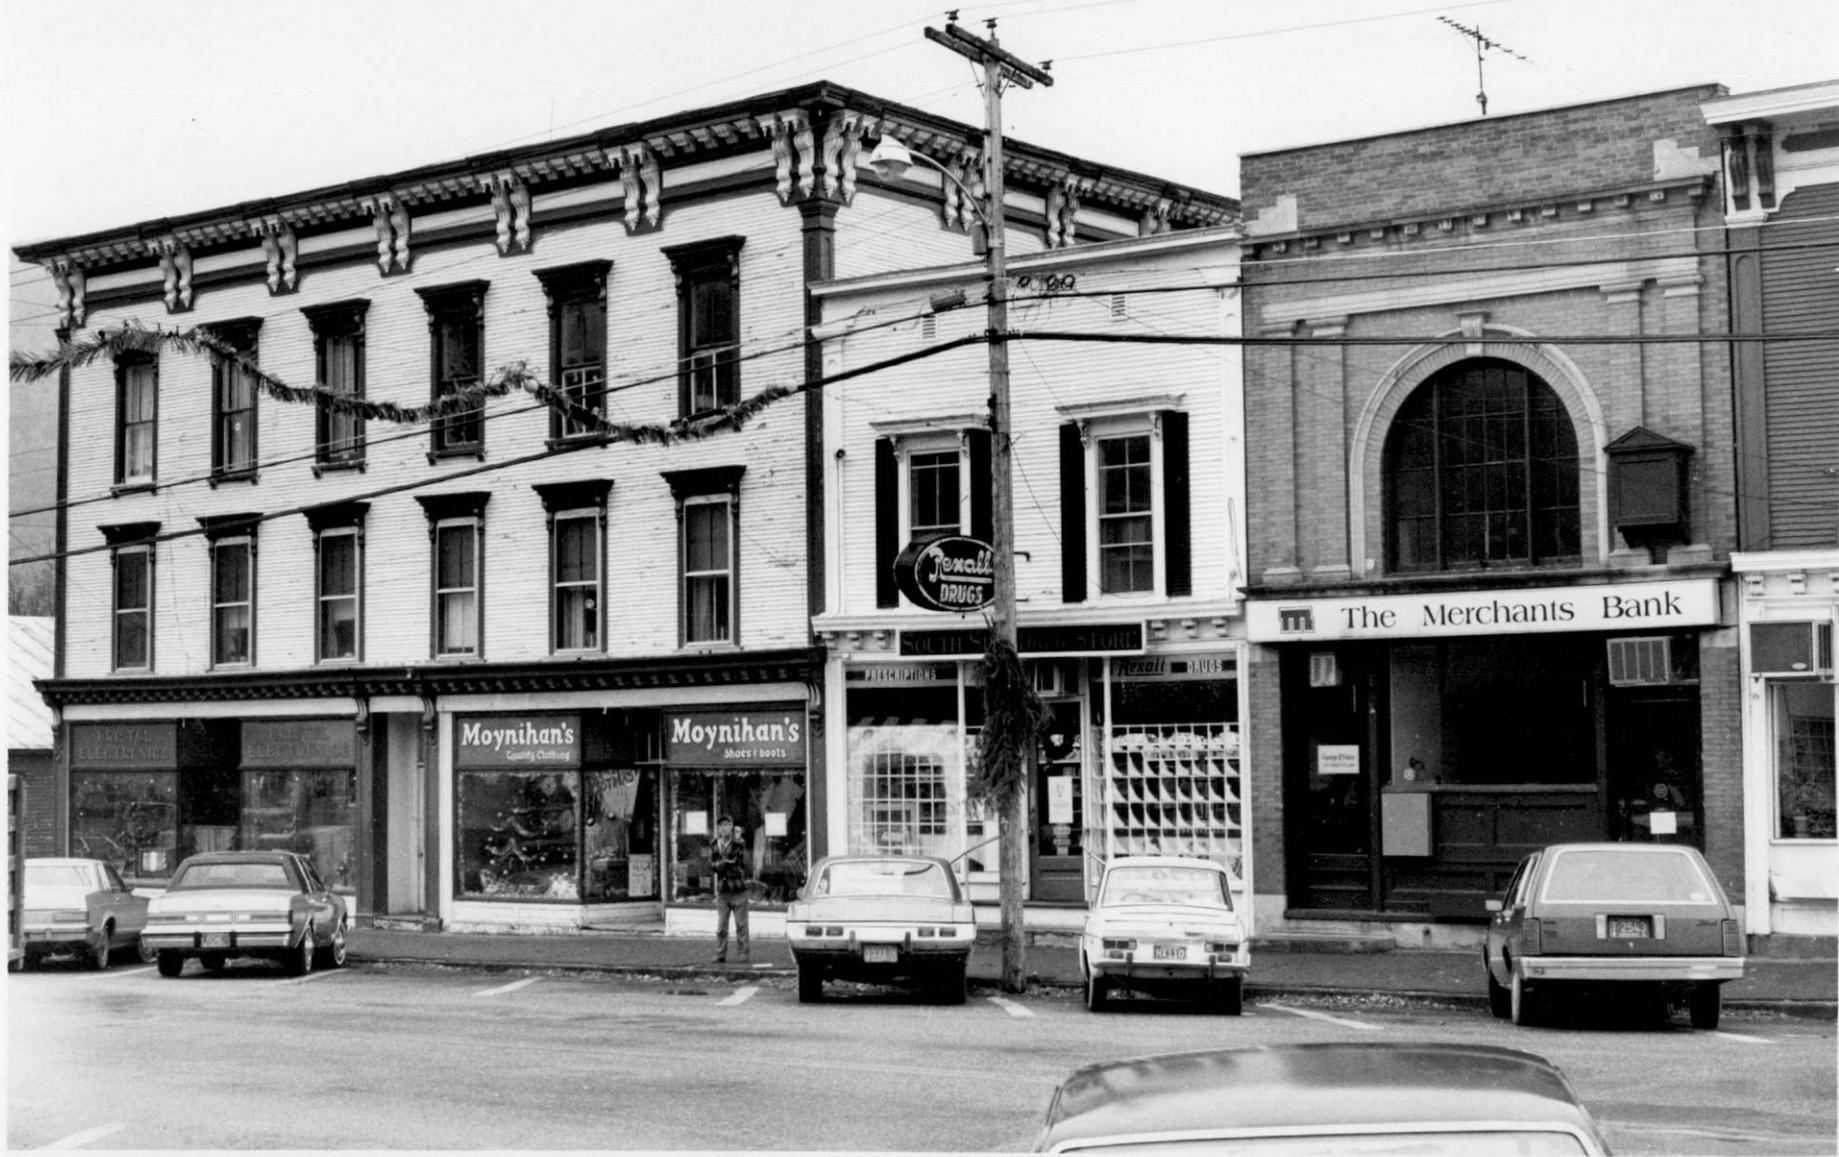
Photograph 10

Description: (L) Dunshee Block (#6); (C) South
Side Drug Store (#7); (R) Merchants Bank
(#8); View Southeast

A 2-bay, 2-story, clapboard commercial block which, before a fire in 1924, was the easternmost shop in the Patterson Block (#9). Except for the missing cornice and a reglazed storefront, it retains most of its original Italianate Revival detail, and makes a significant contribution to the surrounding streetscape by maintaining its scale, style and texture.

When a fire struck the Patterson Block (see #7 and #9) in 1924, this section, housing the First National Bank of Bristol was so heavily damaged that the bank totally rebuilt it with 12" fire walls separating it from the older wood sections on either side. The new facade combines beige-tinted bricks and granite trim in a neo-classical motif which was popular throughout Vermont in the 1920's. Although it differs in style and construction from the adjacent Italianate clapboard facades, the design of the Merchants Bank is compatible and adds a degree of variety to the commercial district's architectural resources.

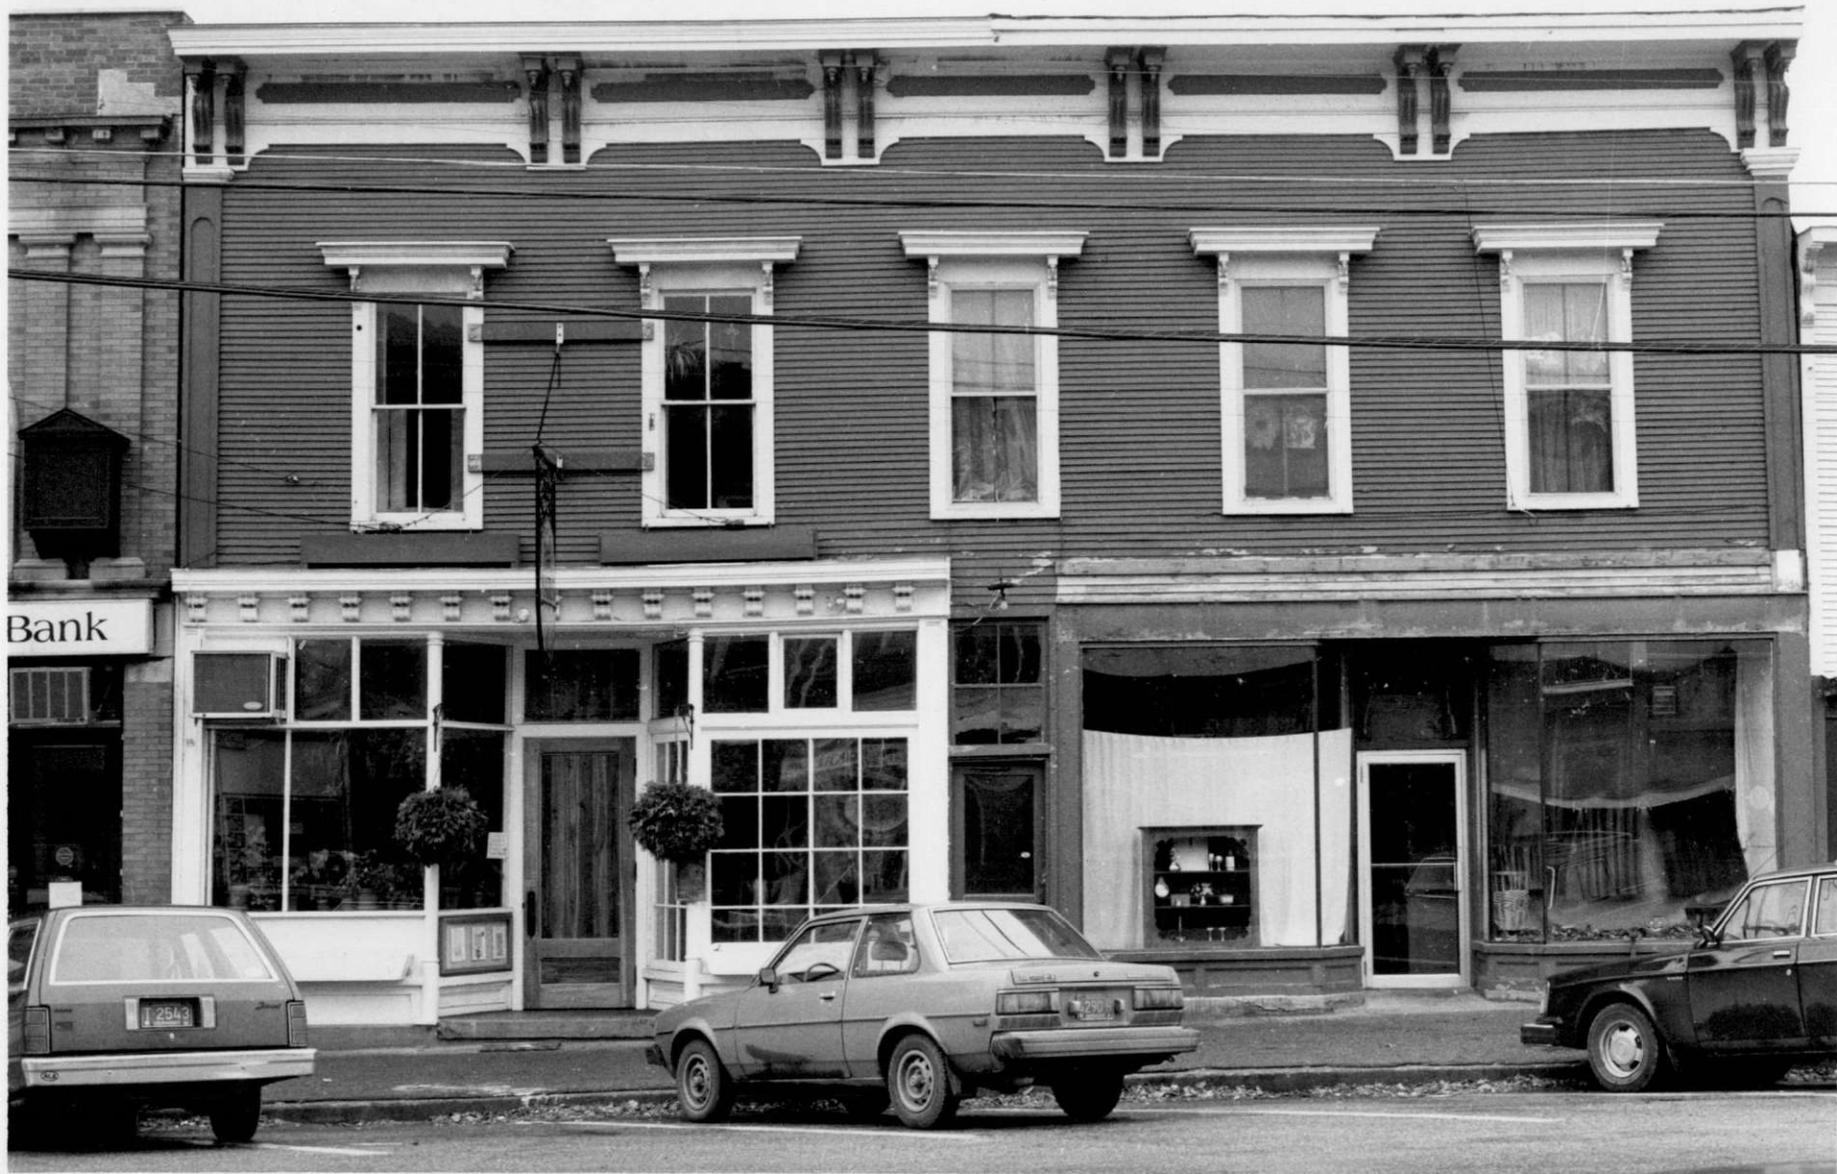
Description: Patterson Block (#9); View South
Photograph 11

A 5-bay, 2-story, Italianate Revival commercial block in well-preserved condition. The facade originally extended another 4 bays and two shops to the east; a fire in 1924 destroyed the section now occupied by the Merchants Bank (#8) and left the present South Side Drug Store block (#7) separated and slightly altered. Although not quite as elaborate, the Patterson Block resembles the Dunshee Block (#6) in both style and form, and may well have been the work of the same builder. It is an integral component in the cohesive commercial streetscape along the south side of Main Street.
