**National Register of Historic Places
Inventory—Nomination Form**

historic Bristol Downtown Historic District

BRISTOL DOWNTOWN
HISTORIC DISTRICT
Bristol, Vermont

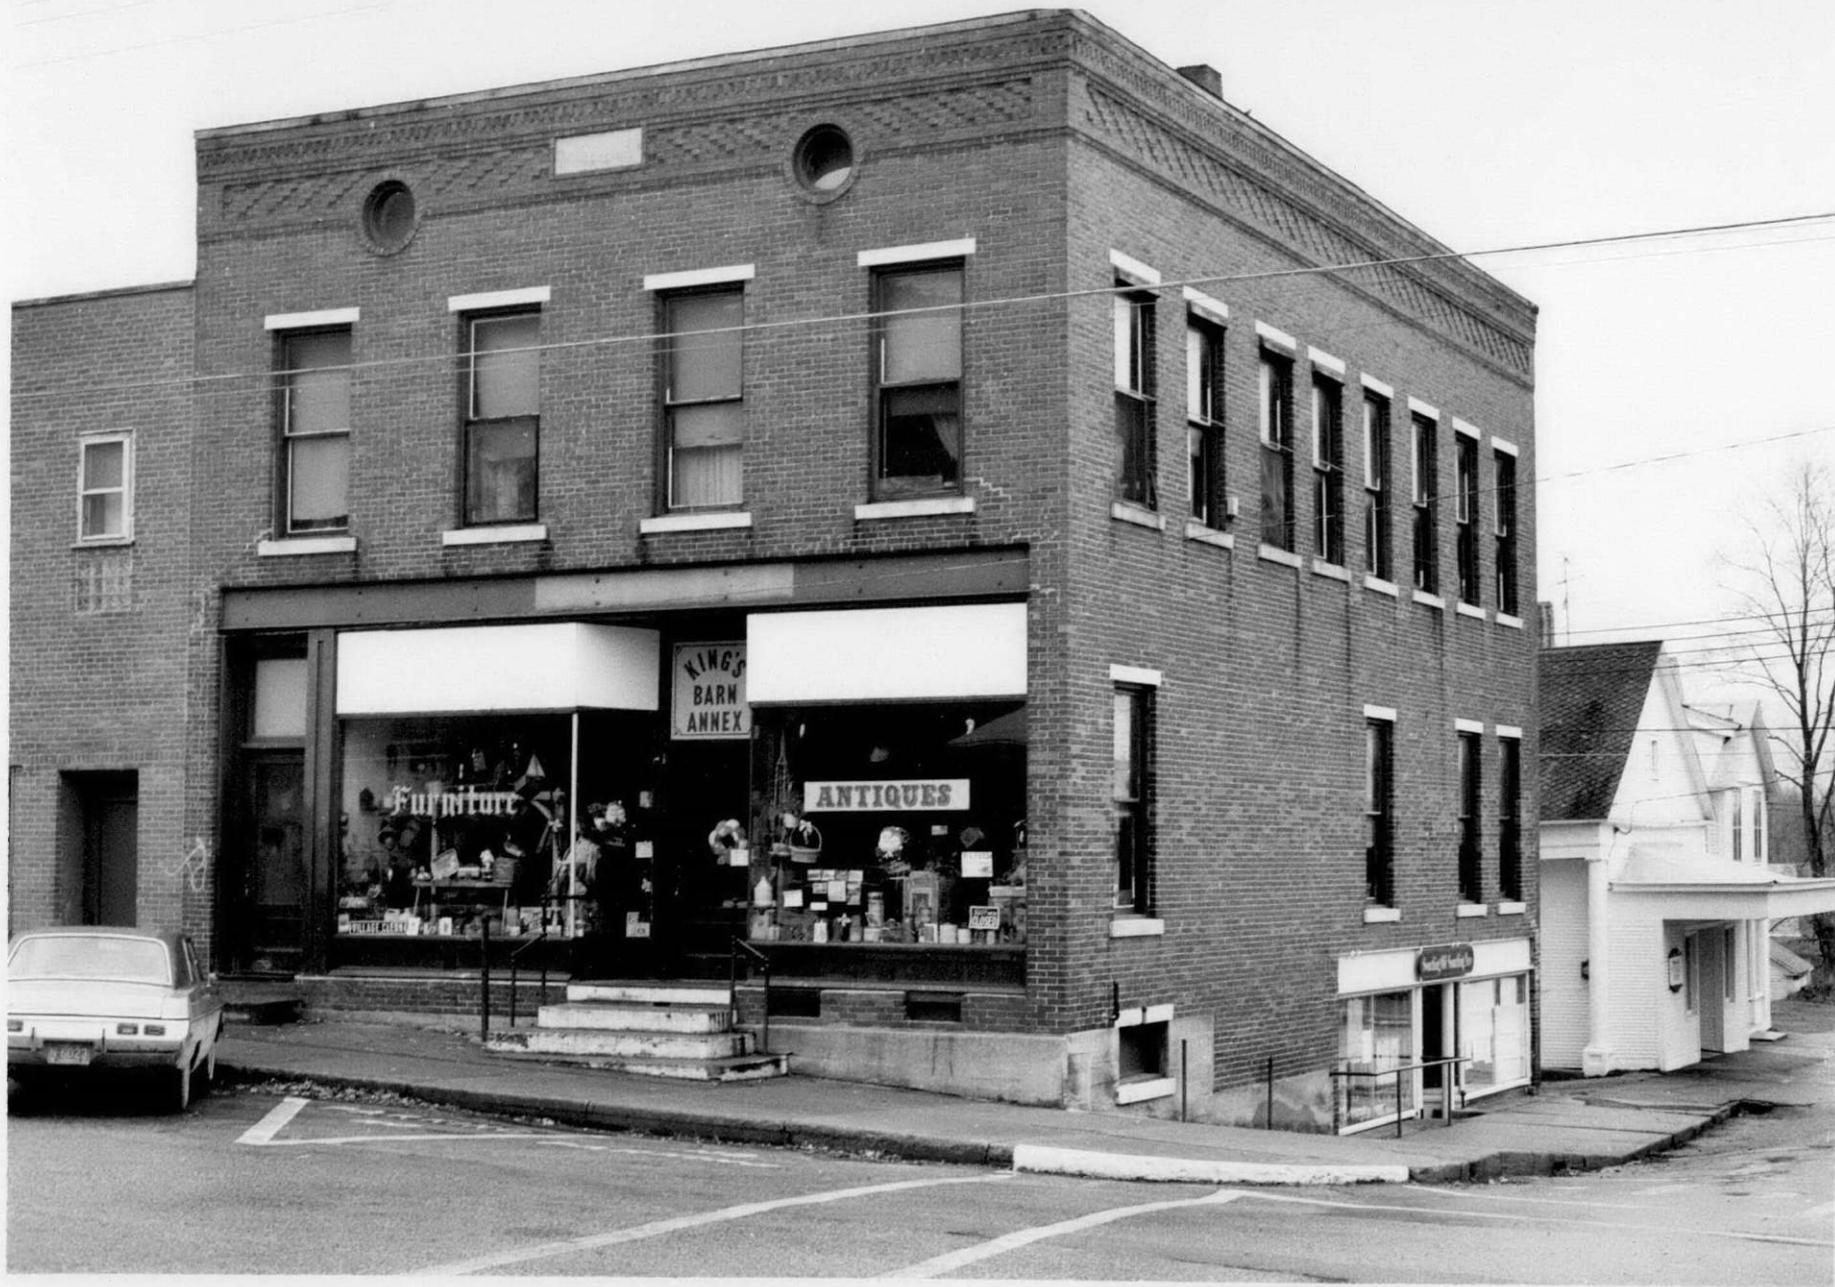
Photograph 12

Description: Lathrop Block (#13); View
Southeast

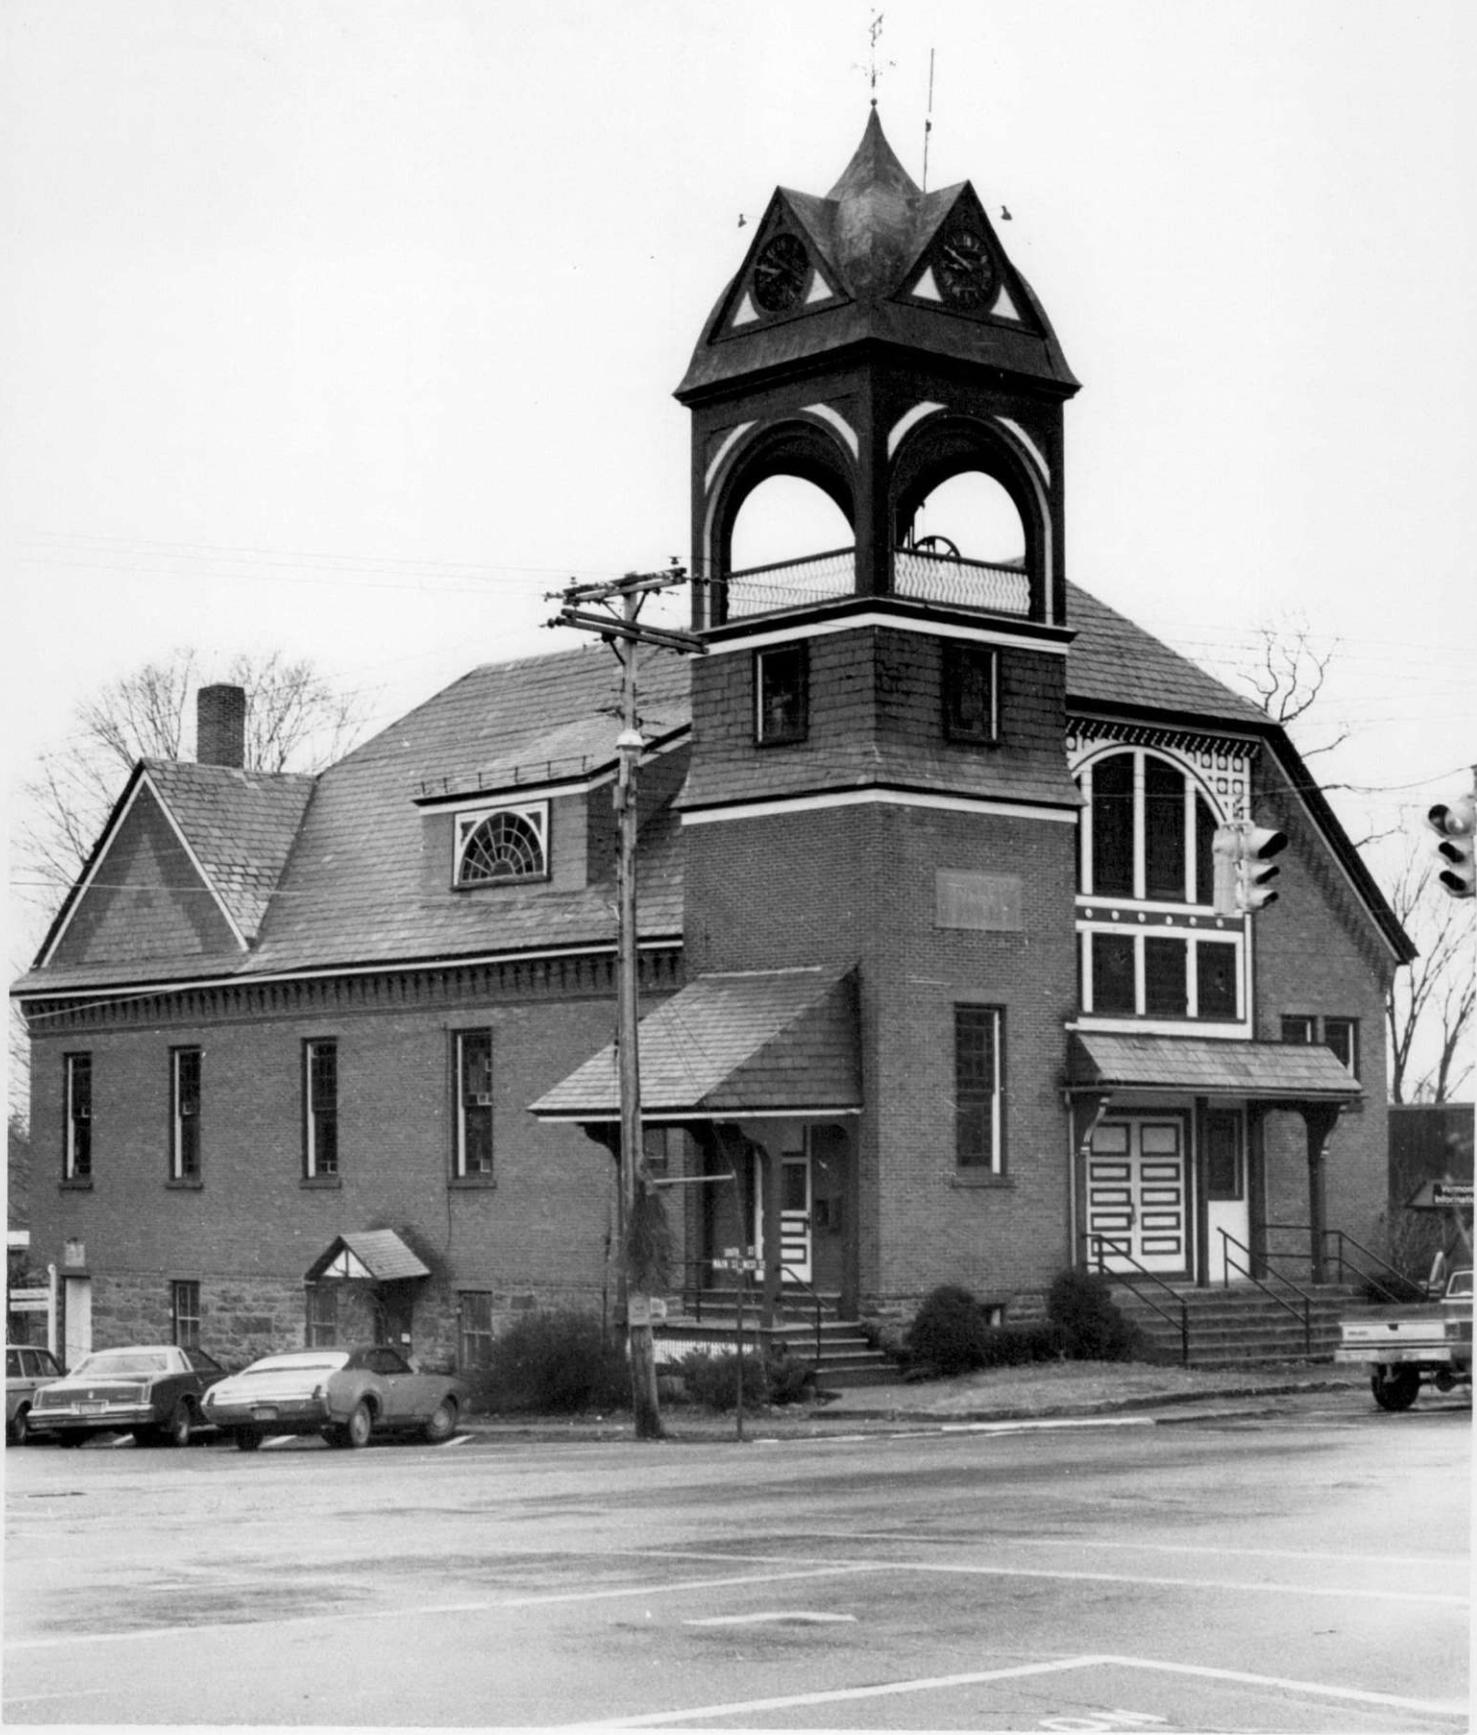
Photograph 13

Description: Holley Hall (#14); View
Southwest

The building's style is essentially Queen Anne, with irregular massing and a variety of surface enrichment, but it also shows much Romanesque influence. Its most prominent feature is a 3-stage tower on the northeast corner which emphasizes the building's corner site. Construction is of brick veneer on a post-and-beam frame, with polished slate trim, slate-clad roof and dormers, and some wood shingle wall coverings. The main (north) facade shows a pronounced jerkinhead roof over a very large round-arched mullion window, a Romanesque feature, with stained glass lights and decorative wood "bullseye" motif spandrel panels. Round arches, the chief characteristic of the Romanesque Revival style, also appear on all four sides of the open belfry and on the east side shed dormer. The arcade-motif corbelled cornice is also a distinctive Romanesque feature.

The main (north) entrance has panelled double doors flanked by stained glass vestibule windows. The entry porch has a shingled shed roof supported by chamfered posts and large consoles. A secondary entry on the east side of the tower base has a panelled and glazed door set under a long shed roof supported by chamfered posts. On the north side of the tower base is a slate tablet inscribed "Holley Hall". The tower's second stage has shingle siding, flared at the bottom, and rectangular 8-light windows. The arched belfry openings are enclosed by decorative zig-zag motif pierced balustrades. The bellcast roof has a weathervane and clocks set in gables which emerge from the roof on all four sides. Side elevation windows have slate lintels and sills enclosing Queen Anne sash with borders of small stained glass lights. A tall gabled dormer on the east roof slope is faced with polychromatic slates in a concentric triangle pattern. The shed dormer beside it is trimmed with an iron roof crest and scroll spandrel ornament around a semi-circular light with radiating muntins.

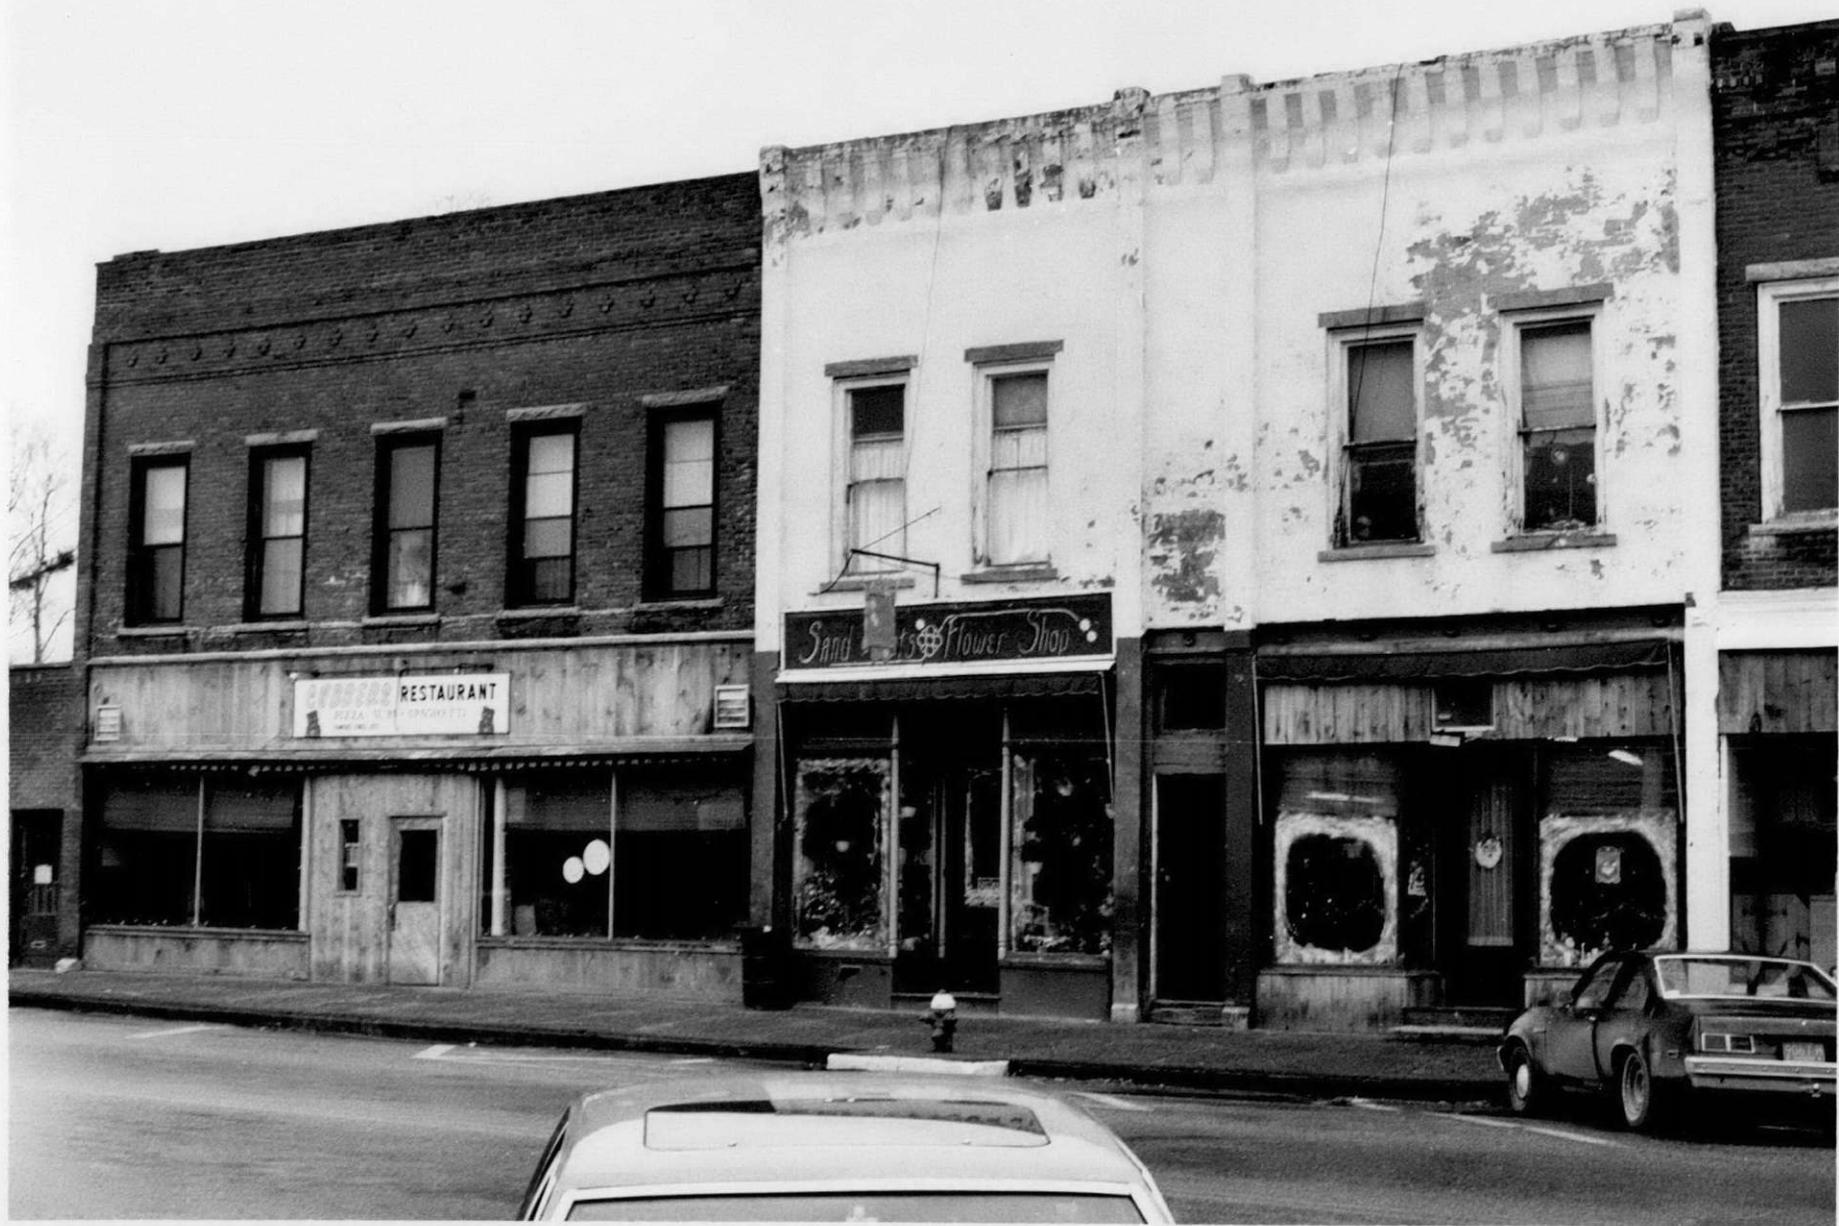
Bristol Downtown Historic District
Bristol, Vermont
Credit: Gina Campoli
Date: December, 1982
Negative Filed at Vermont Division for
Historic Preservation
Description: Union Block (L to R: #'s 15A,
15B); View Northwest
Photograph 14

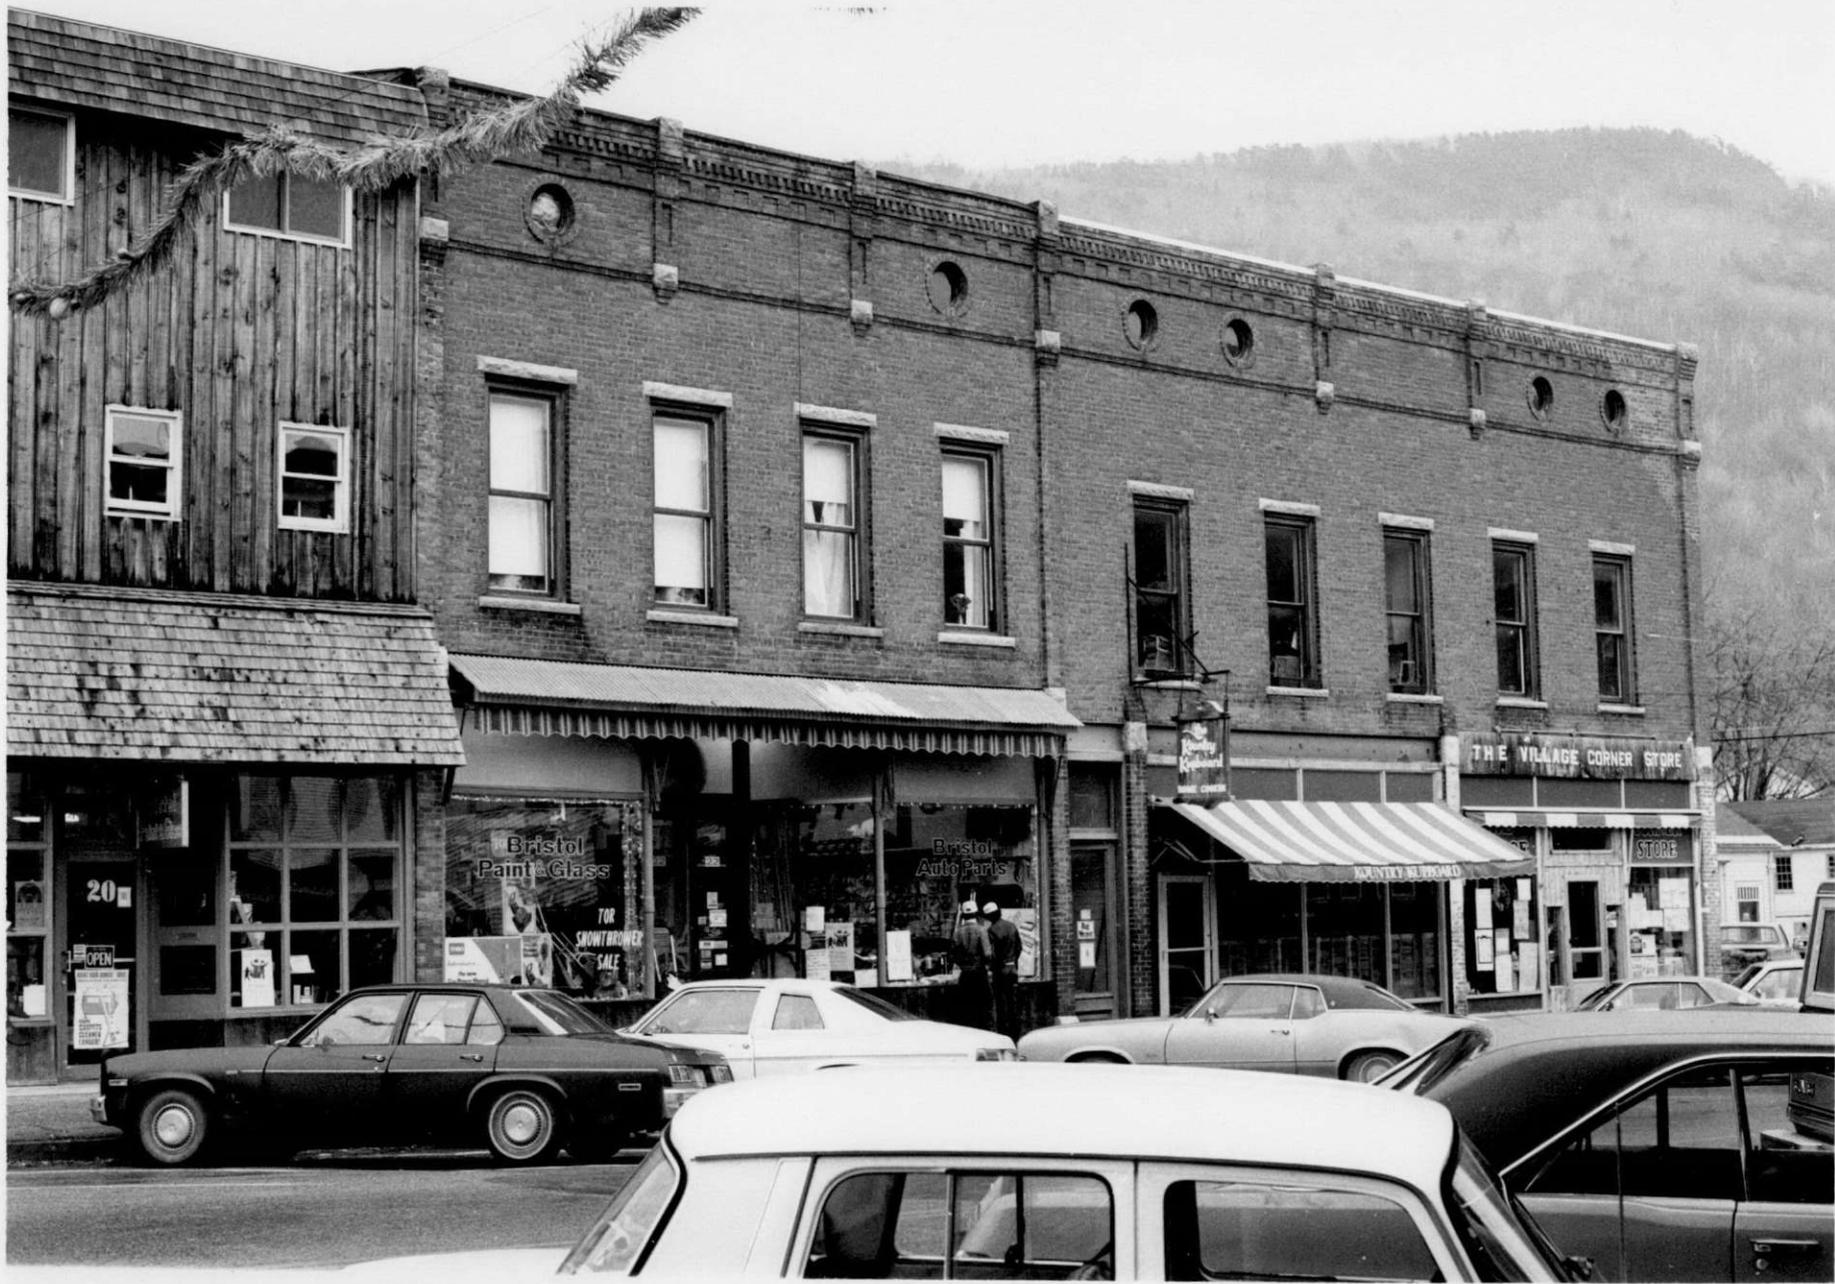
Bristol Downtown Historic District
Bristol, Vermont
Credit: Gina Campoli
Date: December, 1982
Negative Filed at Vermont Division for
Historic Preservation
Description: Union Block (L to R: #'s 15E,
15F, 15G); View Northeast
Photograph 15
