DIFFERENCES IN SITE NUMBERS USED IN PUBLISHED TOWN HISTORY AND VERMONT HISTORIC SITES & STRUCTURES SURVEY

THE HISTORIC ARCHITECTURE OF ADDISON COUNTY

FERRISBURGH

**THE HISTORIC ARCHITECTURE
OF ADDISON COUNTY**
*Including a listing of
the Vermont State Register of Historic Places*

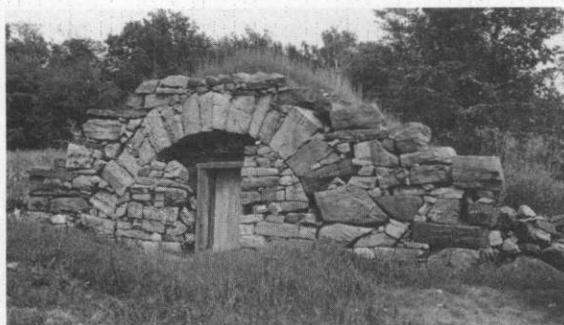
An unusual structure used for a common practice of the early nineteenth century, this arched, masonry ground cellar (68) in Ferrisburgh likely stored root crops for humans and livestock, especially sheep. Smaller root cellars are known to have been a feature in many houses and barns of the period.

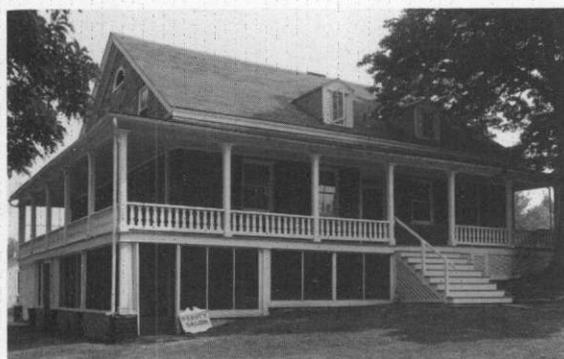
Platt Rogers established a shipyard and ferry at Basin Harbor, constructing this stone residence (120) about 1792. James Winans, who built the first steamboat on Lake Champlain in 1809, converted the house into an inn for those traveling on the lake. In 1887 Adelia Beach remodeled the inn to receive summer guests, and since that time under the direction of her heirs the inn has become the centerpiece of the over eighty buildings of the Basin Harbor Club summer resort.

in the old Rogers house (120, c.1792), remodeled in 1887 to accommodate guests. Known as "The Lodge," this inn, after 1910 under the direction of Allen Beach, became the center of the Basin Harbor Club, a resort that by the 1920s included a working farm (123, c.1890), which provided meat, produce, and dairy products for the guests, and a number of modest cabins (117, 119; c.1925). During the 1930s, the club added more substantial cabins to the property, including the Colonial Revival style "Sunny Pines" (118, 1933) with its date stone and Palladian window set in a fieldstone facade. In 1937 three cabins (110, 111, 112) were added along the lakeshore, their stone faces reflecting local building-material traditions.

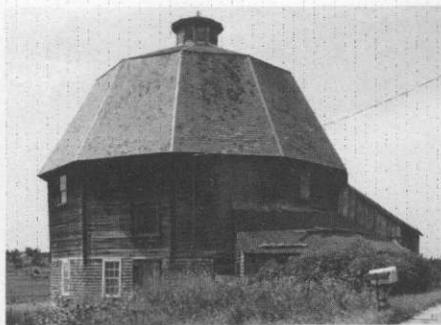
Round dairy barns were meant to save labor by allowing farmers to feed all stabled cows from a central location, but they never became widely popular. One of two round-type barns built in Ferrisburgh, this barn (51) was constructed about 1900.

During the last half of the nineteenth century, livestock breeding and dairy farming came to dominate local agricultural activity, and these pursuits are reflected in a large number of Italianate style farmhouses and their associated outbuildings. The Italianate style house (48, c.1870) built for Thomas Field, a farmer and cattle dealer, displays paneled corner pilasters, cornice brackets, and distinctive window lintels. A. O. Ball, a dairyman and stock breeder, had another Italianate style house (36, c.1875) built with a particularly elaborate cornice with dentils and supporting brackets. Among the many barns built to accommodate dairy farming and livestock breeding is one (76) with "Kimball 1885" inscribed in polychrome slate on its roof and further enhanced by a cupola and weathervane. Two Ferrisburgh farmers also built unusual round barns (21, 51), which are actually eighteen-sided, around 1900.

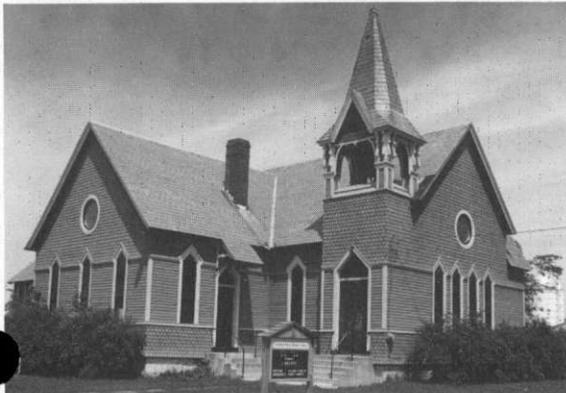
Widely spaced residences and public buildings form the linear village of Ferrisburgh along the main road from Vergennes to Burlington. The Ferrisburgh Grange (63, c.1870), originally the Congregational church, and the Methodist church (62, c.1890) are two landmarks of this village, the first probably designed by Joseph Falarido and the second by his one-time employee Charles LeBoeuf, both of Vergennes.

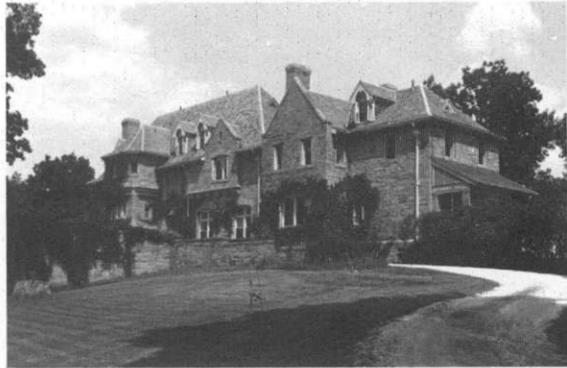
Walter Scranton, a bank president in neighboring Vergennes, commissioned Percy Griffin of New York City to design the Chateausque style "Woodbridge Hall" (4) as his residence in 1896. After Scranton hurriedly left when substantial funds were found missing from his bank, the property was sold to Charles and Jessica Swift of Middlebury, who used it as a summer residence and resort for their family and friends.

While most summer residents lived relatively simply in modest camps, others enjoyed larger homes with servants' quarters and secluded on expansive grounds. One of these sprawling summer residences, Woodbridge Hall (4, 1896), designed by architect Percy Griffin for Walter Scranton, sits prominently between Porter and Kingsland bays. An unusual design, the home was modeled after an English manor house with its stone construction, irregular massing, and steeply pitched hipped roof. A number of related buildings also mark the property, including a camp (4c, c.1925) and playhouse (4d, c.1925) built with log walls in the Adirondack Rustic style. In the 1890s, Dr. and Mrs. Oppenheim of New York City constructed a camp (100, c.1890) on Mile Point, but as the point became crowded with summer residents, they commissioned a Cornish, New Hampshire, architect, Charles Platt, to design a new summer house on a farm they had purchased at the eastern end of Kingsland Bay. According to Mrs. Oppenheim, they all decided that the house should be built "out of the rocks that

4 Woodbridge Hall
a. House, 1896
Architect/builder: Percy Griffin
Chateausque style, stone, hip
roof, 2½ stories.
Features: fieldstone, lintels,
distinctive dormer, segmental
pediment, porch.
b. Carriage Barn, c.1900
Wood shingle, hip roof,
1½ stories.
Features: peaked lintelboards,
porch.
c. Camp, c.1925
Adirondack Rustic style, log
vener, gable roof, 1½ stories.
Features: decorative rafter tails.
d. Playhouse, c.1920
Adirondack Rustic style, log
vener, gable roof, 1 story.
Features: porch, distinctive
chimney.
e. Garage, 1896
Stone, hip roof, 1 story.

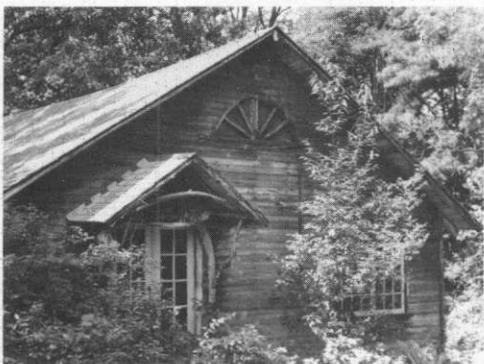
Between 1910 and 1930 many summer recreational camps for children were established throughout Vermont. One such camp in Ferrisburgh was Camp Marbury for girls. Its buildings, such as this cabin (108, c.1925) with rustic door hood and gable fan, were built in the Adirondack Rustic style to complement the back-to-nature experience of camp life.

With ample opportunity for lakeside recreation, the shores of Ferrisburgh also proved an ideal location for summer camps for children when such camps became popular in the 1920s. Camp Marbury for girls was established by the Sleeper family of New York City. Three of its surviving camp structures, a jewelry shop (106 c.1925), recreational hall (107, c.1925) and cottage (108, c.1925) are outstanding Adirondack Rustic style buildings with rubblestone chimneys and many details worked in tree branches. The École Champlain (8), a camp for girls that specialized in French language instruction, was established at Kingsland Bay around 1925 and incorporated Hawley's Ferry House (7, c.1790). A vernacular Colonial Revival style cottage (8, c.1925) and dining hall (8c, c.1925) near the lake, as well as a number of other buildings scattered around the property, housed camp functions.

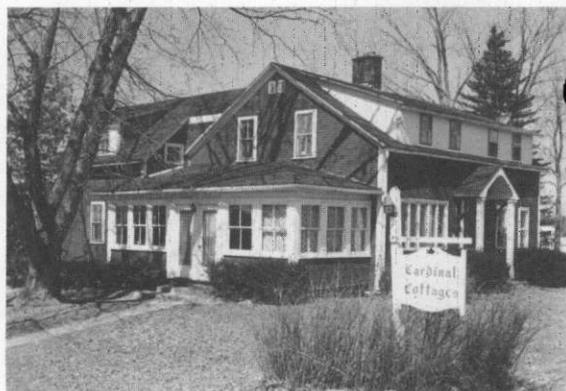
During the 1920s, as an increasing number of automobiles followed the new paved road to Burlington that became U.S. Route 7, enterprising Ferrisburgh residents constructed motor courts, such as this one (27, c.1930), to accommodate travelers. Typically such courts include a central office and a number of radiating tourist cabins.

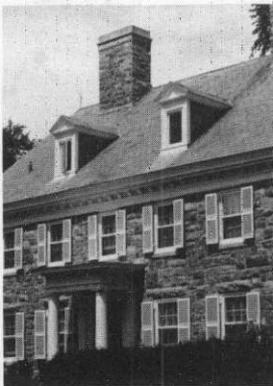
6 House, c.1910

Architect/builder: Charles
Platt
Colonial Revival style, stone,
Georgian plan.
Features: Colonial Revival
porch, enriched cornice,
lintels, transom, entry
pilasters, distinctive chimney.
Related barn, house.

formed the backbone and the lake shore of our farm." Random rough-faced ashlar stone was then used to construct a massive Georgian plan, Colonial Revival style house (6, c.1910).

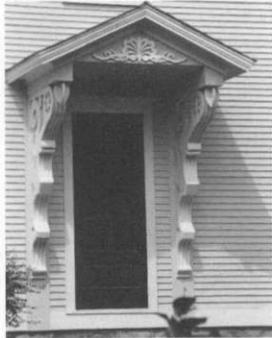
40 House, c.1880

Italianate style, Georgian plan.
Features: door hood, cornice caps, Italianate porch.
Related garage.

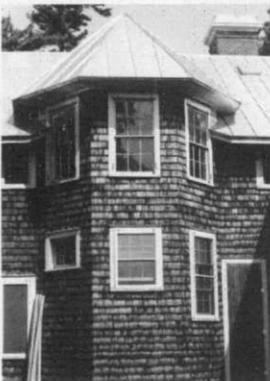
90 Camp, c.1905

Shingle Style, wood shingle, gable roof, 1½ stories.
Features: Colonial Revival porch, towers, distinctive chimney. Related servants quarters.
Features: shinglework, decorative woodwork.

The peninsula north of Mile Point began attracting seasonal residents about the same time and was named, appropriately, "Summer Point". Among the more fanciful camps constructed is one (92, c.1895) with a circular Queen Anne style porch capped by a conical roof. A duplex camp (97, c.1900) nearby displays many of the elements commonly found on camps along Lake Champlain, including a Queen Anne style porch, decorative rafter tails, and a stone chimney. A later Shingle Style camp, "Thendora" (90, c.1905), also has a broad porch linking its inside with the outdoors.

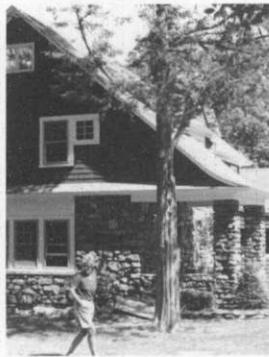
101 Camp, 1906

Vernacular-Craftsman style, gable roof, 1¾ stories.
Features: bellcast, cobblestone, porch, distinctive chimney.

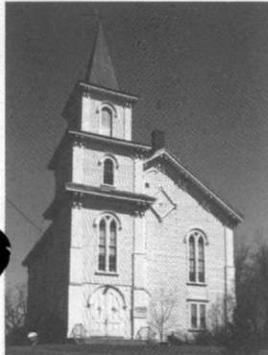
A3 Church, 1873

Italianate style, gable roof,
2 1/2 stories.
Features: cornice brackets,
distinctive door, side tower,
round arch window, stained
glass, applied woodwork.

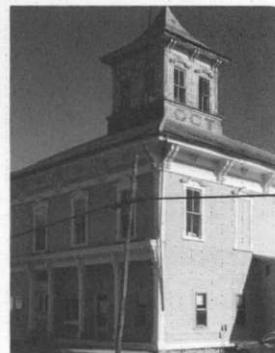
A28 Store, 1885

Italianate style, hip roof,
2 stories.
Features: belvedere, cornice
brackets, polychrome slate,
original storefront, distinctive
lintelboards, name inscrip-
tion, date inscription, cornice
brackets, full entablature.

village encouraged J. A. Allen to commission Charles LeBoeuf of Vergennes to replace Allen's store with a grand Italianate style commercial block (A28). About the same time a smaller, brick, Italianate style store (A25, c.1885) was erected to the east. Houses large and small were also built along the Hollow Road, filling in the stretch from the mills to the Methodist church. A villa-plan, Italianate style house (A15, c.1880) stands next to two modest homes (A13, A14; c.1890) distinguished by peaked lintelboards and enriched cornices.

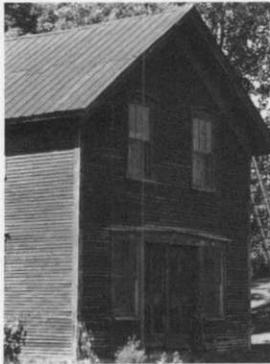
A34 Carriage Barn, c.1890

Features: peaked
 lintelboards, distinctive door.

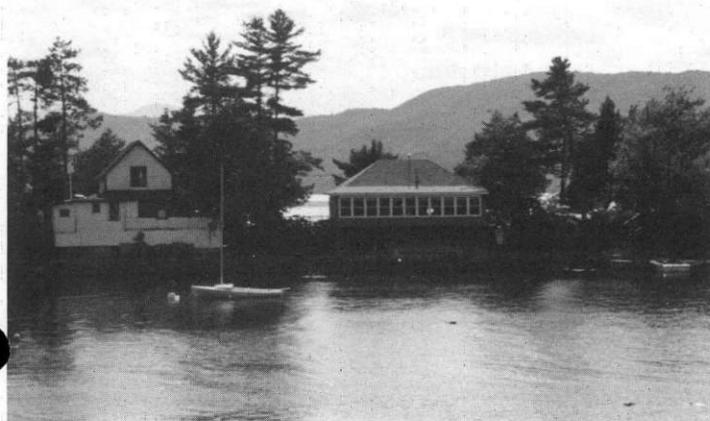
43 East Road

Camp, c.1900
Wood shingle, gable roof,
1 1/2 stories.
Features: shinglework,
Queen Anne porch.

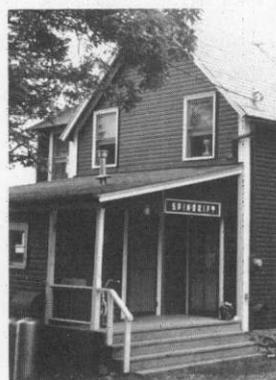
Camp, c.1915
Gable roof, 1 1/2 stories.
Features: porch.

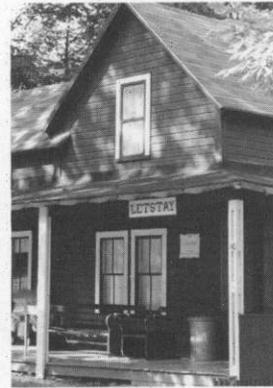
Camp, c.1910
Gable roof, 1 1/2 stories.
Features: porch.

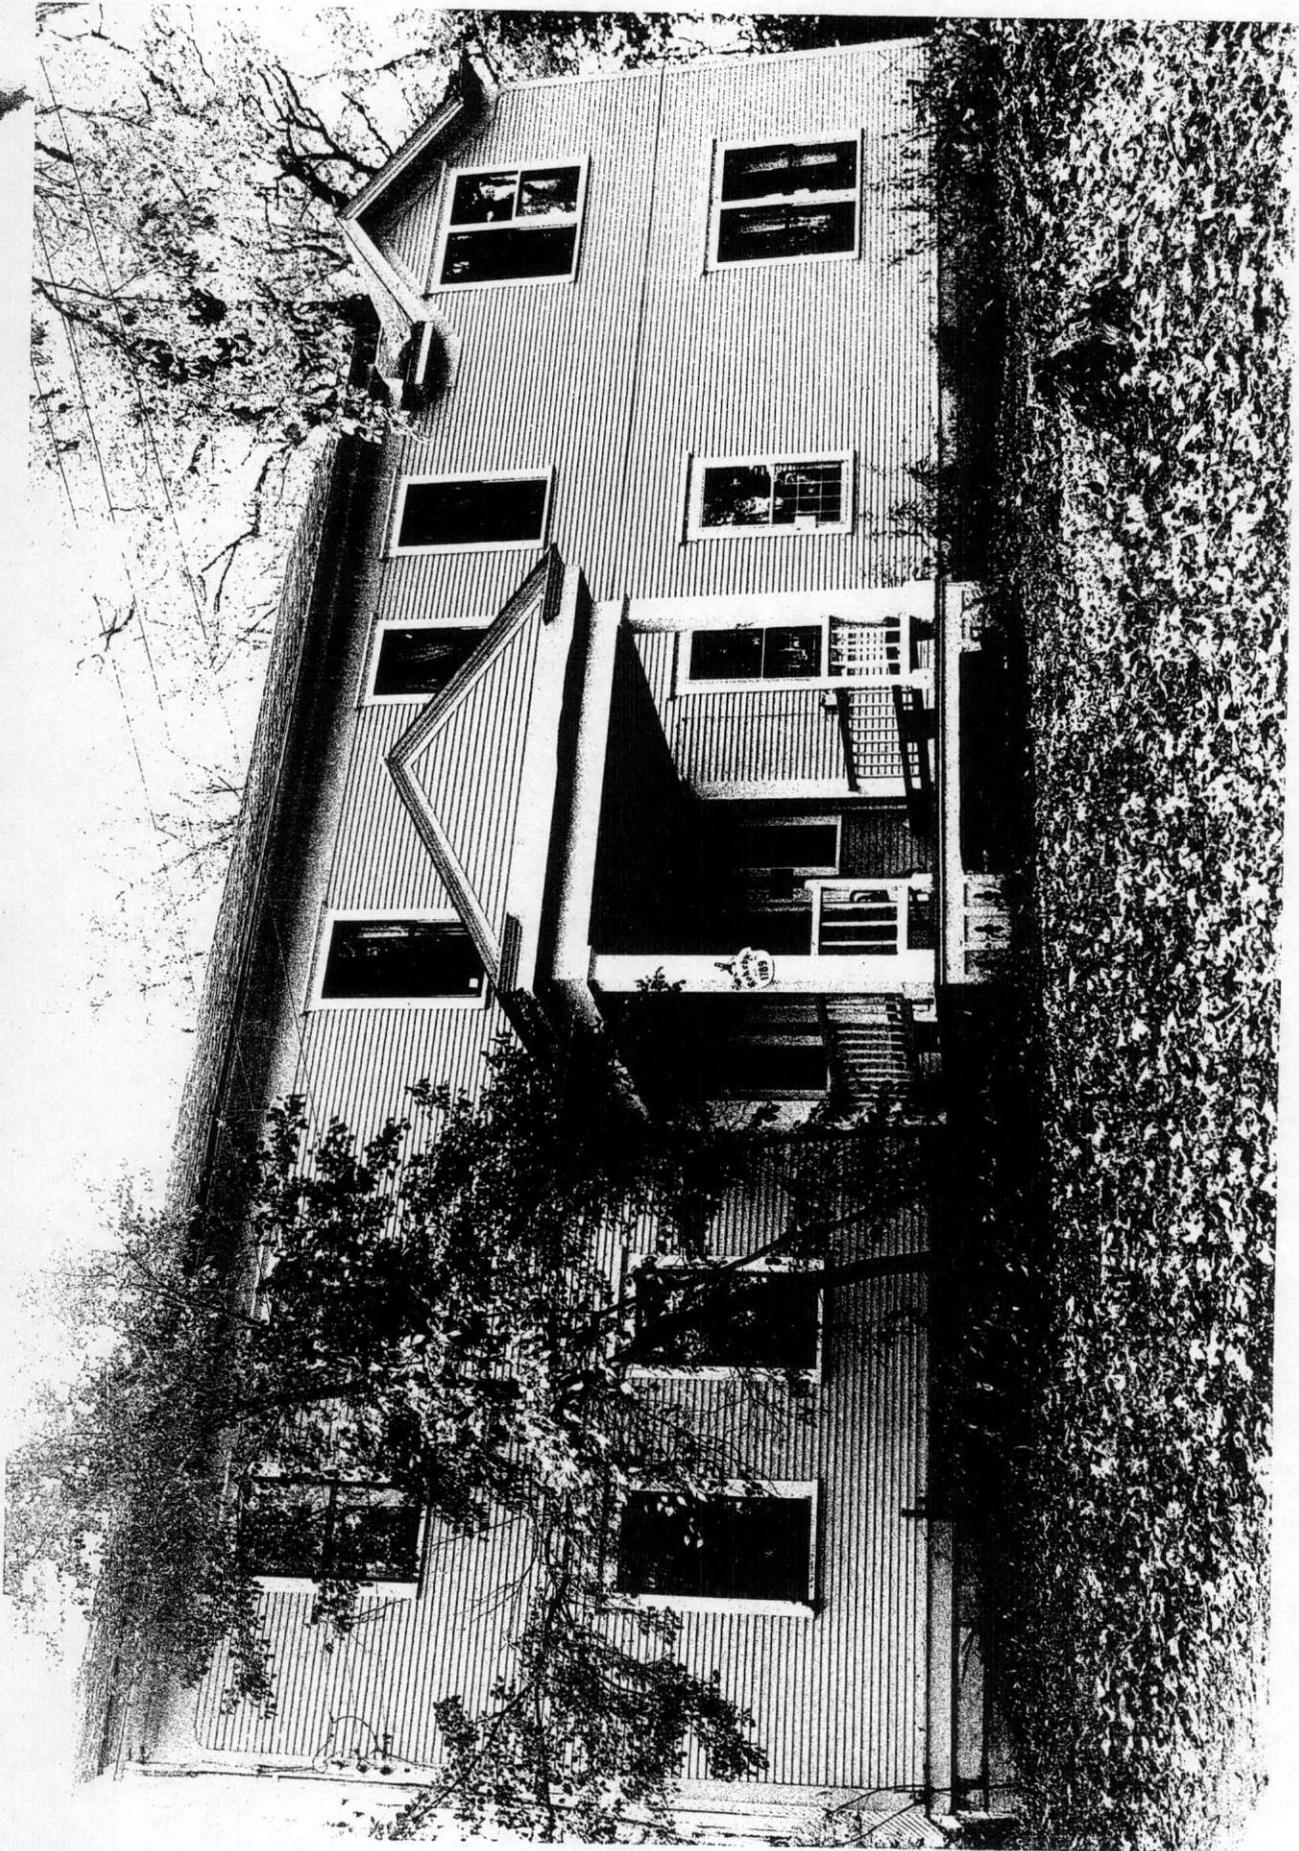
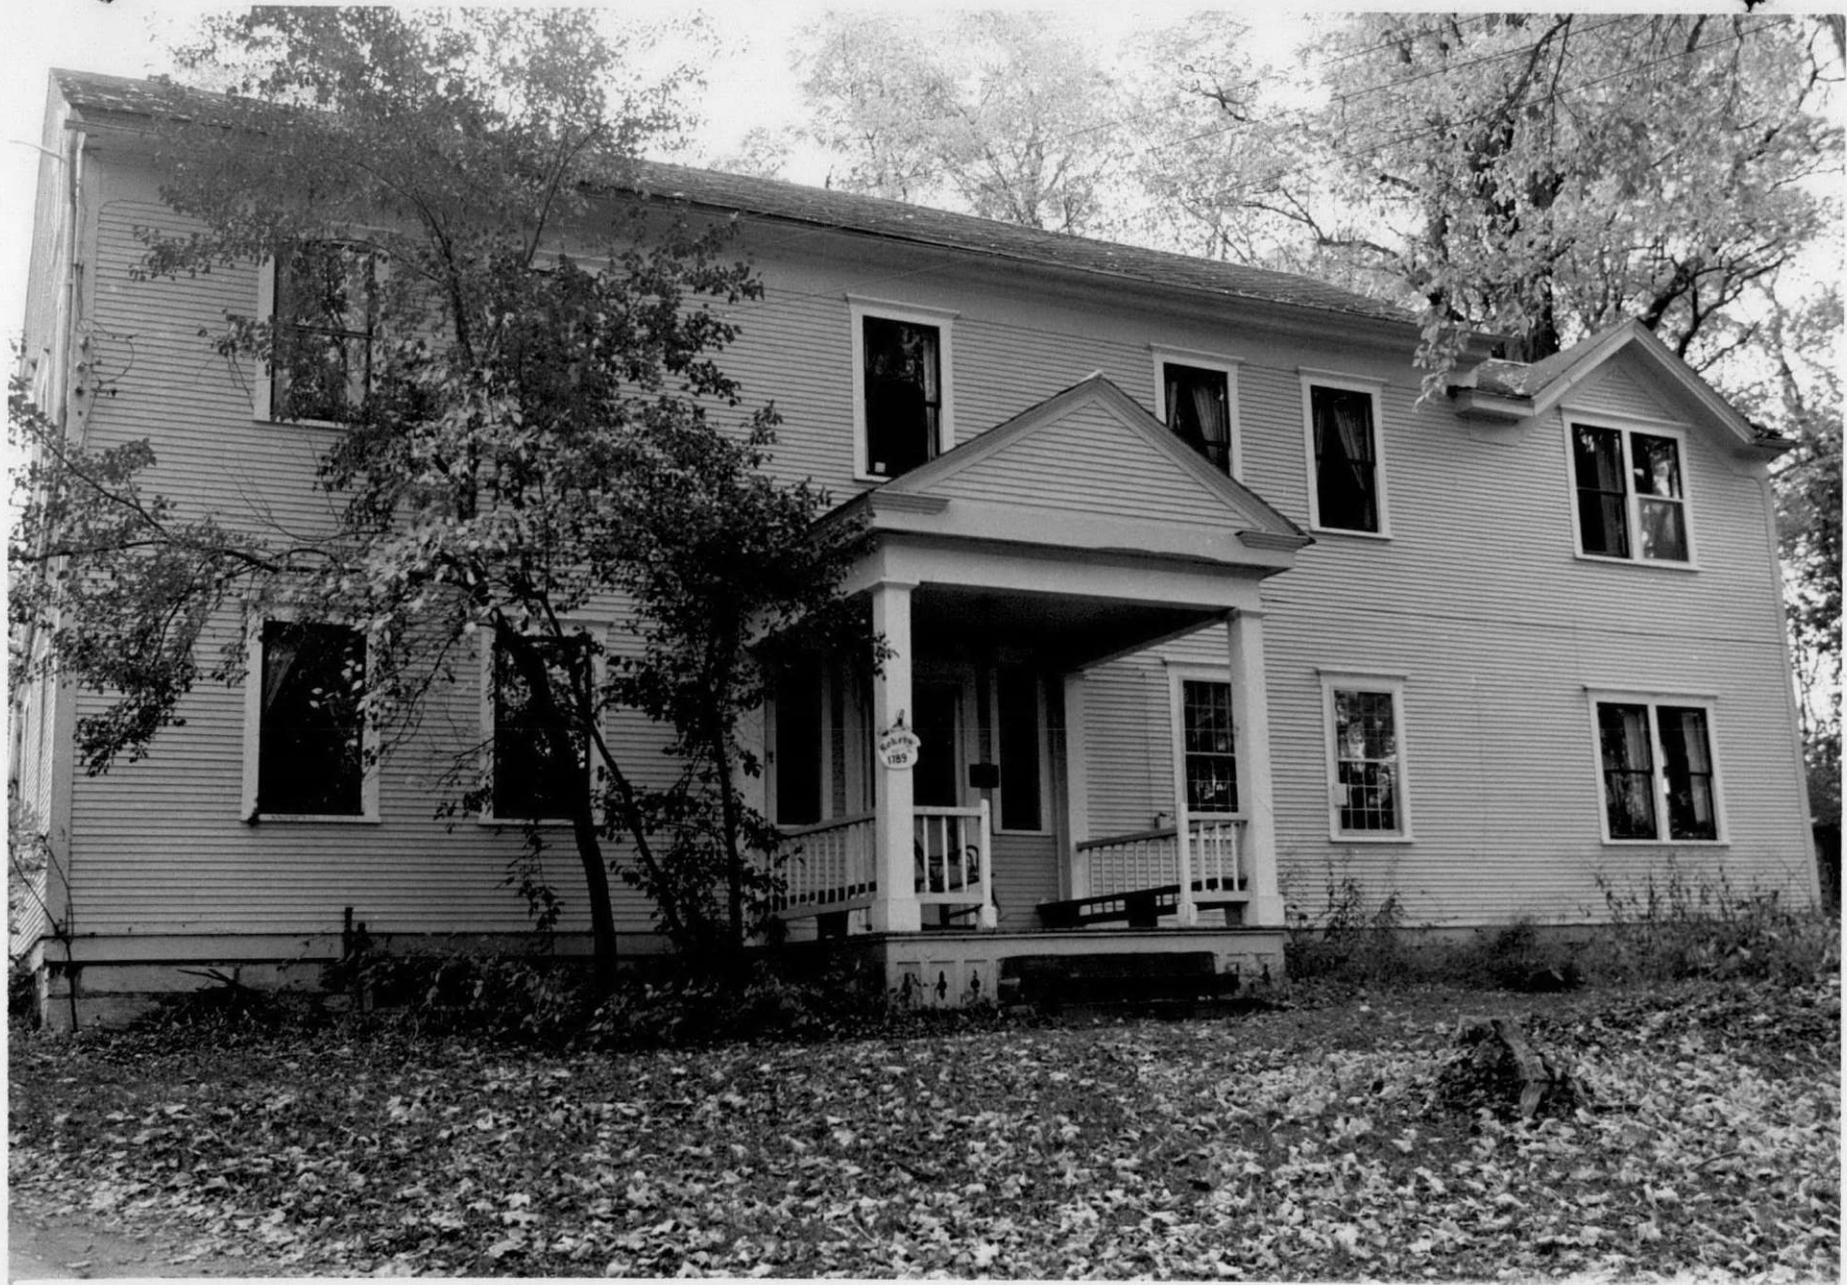
Rokeby is significant for its association with Roland Robinson, noted Vermont folklore writer Serving as Robinson's birthplace and boy-hood home, the house still contains a large number of personal and family artifacts The property is open as a house museum daily from 9 to 5 during the summer

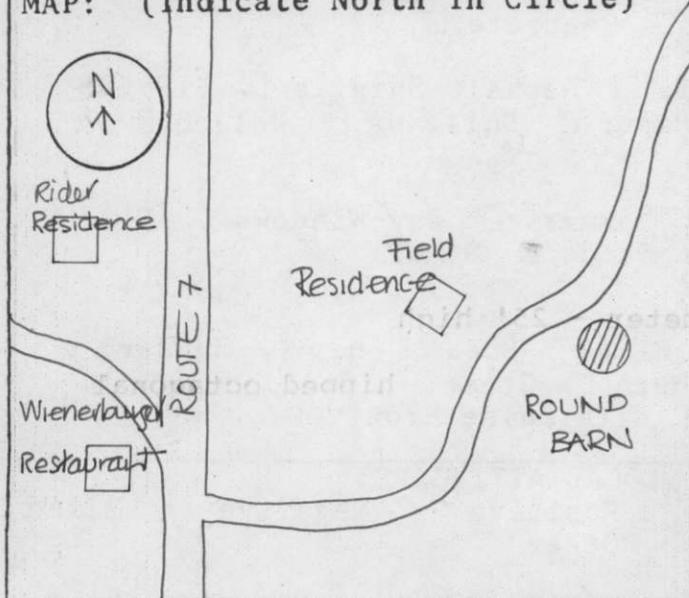
Although it appears round, the barn is actually eighteen-sided and was built by Bert Parker, the father of its present owner. It is ingeniously designed so that the cupola is a central silo from which the livestock can feed, their stalls arranged around the core in radiating sections like spokes of a wheel. Hay is stored in a hay loft above and dropped down through trap doors.

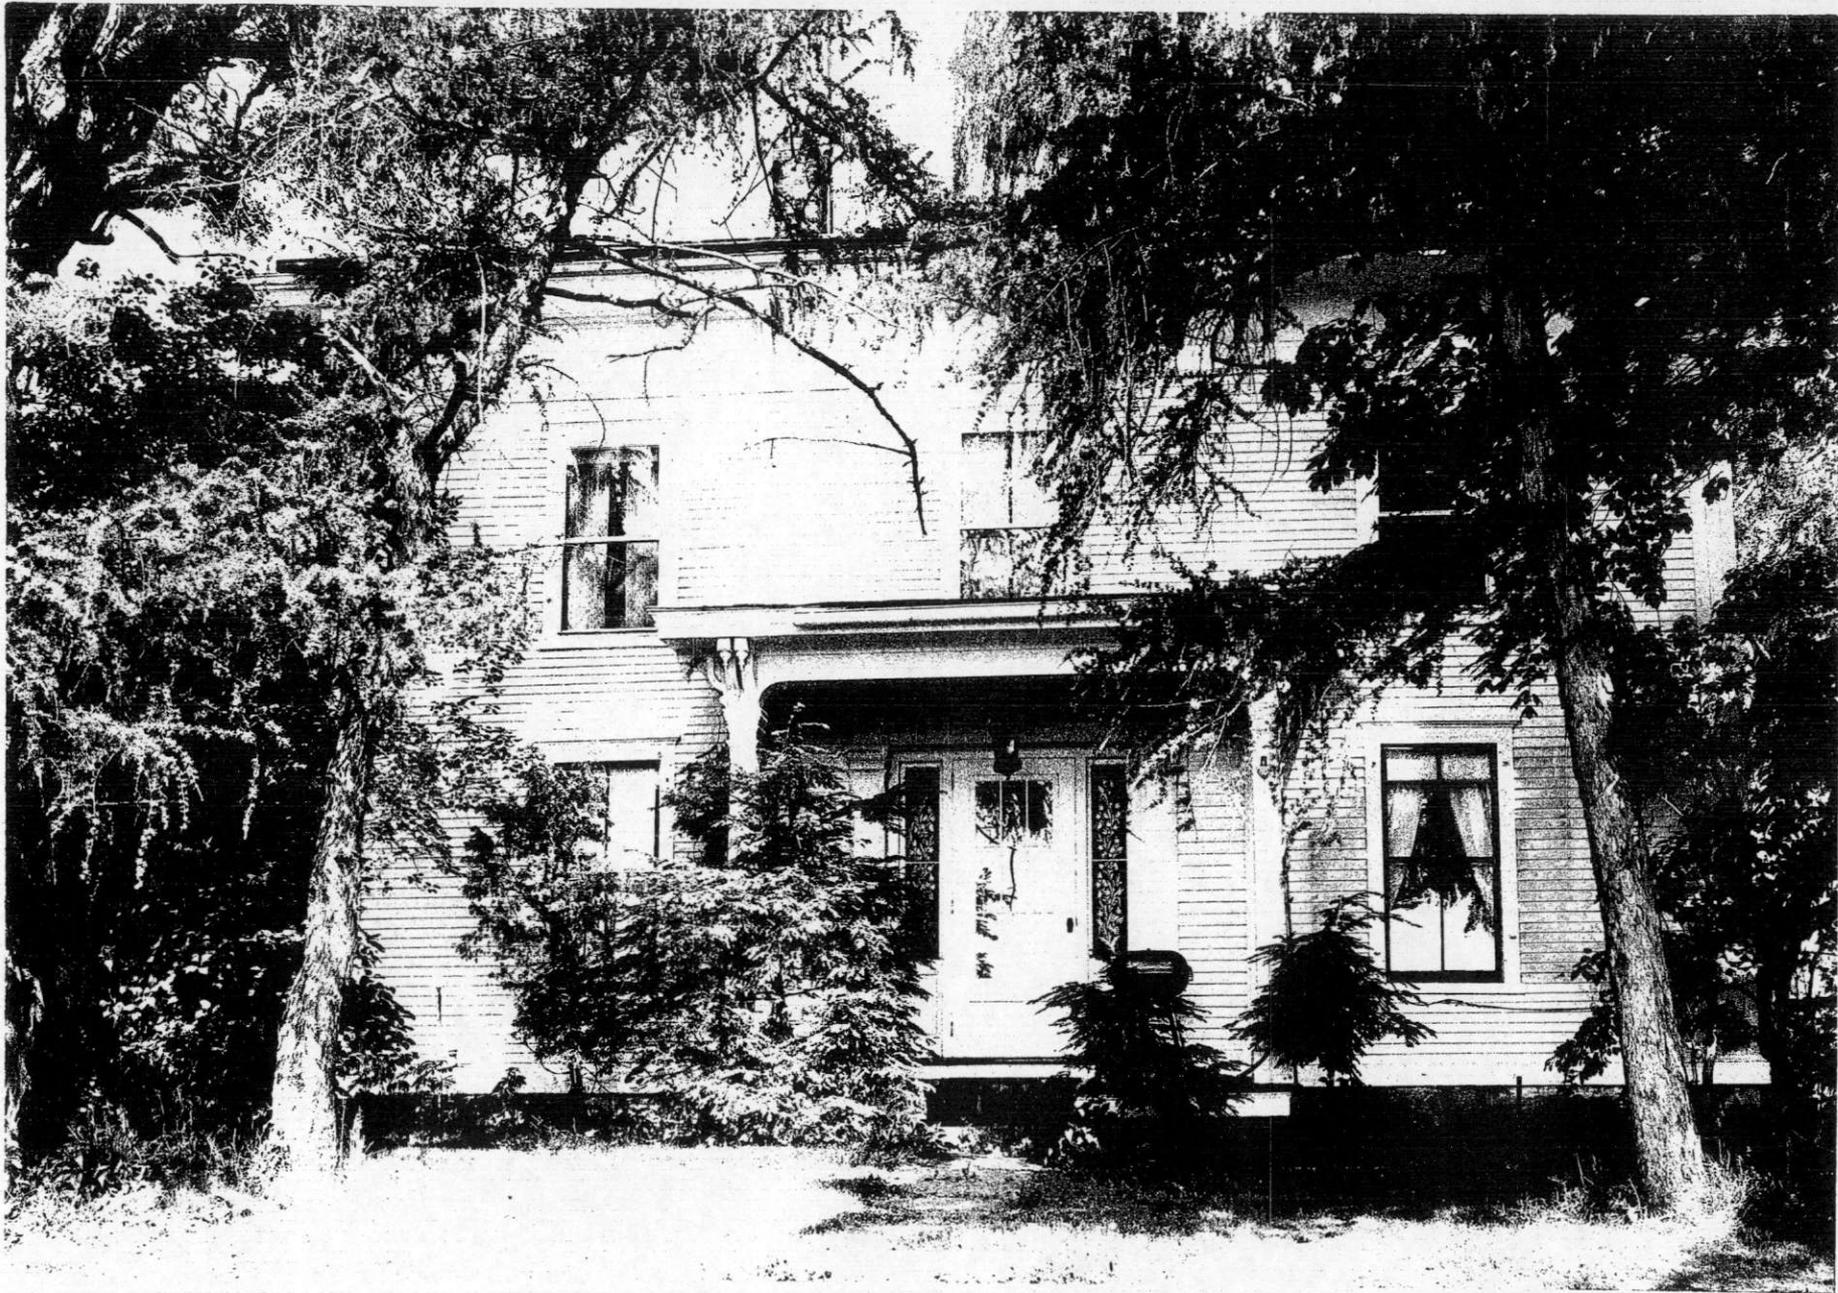
0105-4

Three-bay house has corner pilasters, wide entablature with paired pendant consoles on cornice. Smaller brackets of similar design found on one-story entrance porch. Entrance flanked by 3/4 sidelights and topped by simple entablature supported on pilasters. Sash 2/2.

This house is typical of the symmetrical three or five-bay, gable-across house form that appears in the Federal period and persists throughout the nineteenth century and is particularly amenable to the embellishment of the Italianate style by the addition of simple projecting ornaments such as brackets, small porches, bay windows, etc. In a good state of repair, the Tucker residence is endangered, like many neighboring structures, by its placement close to Route 7.

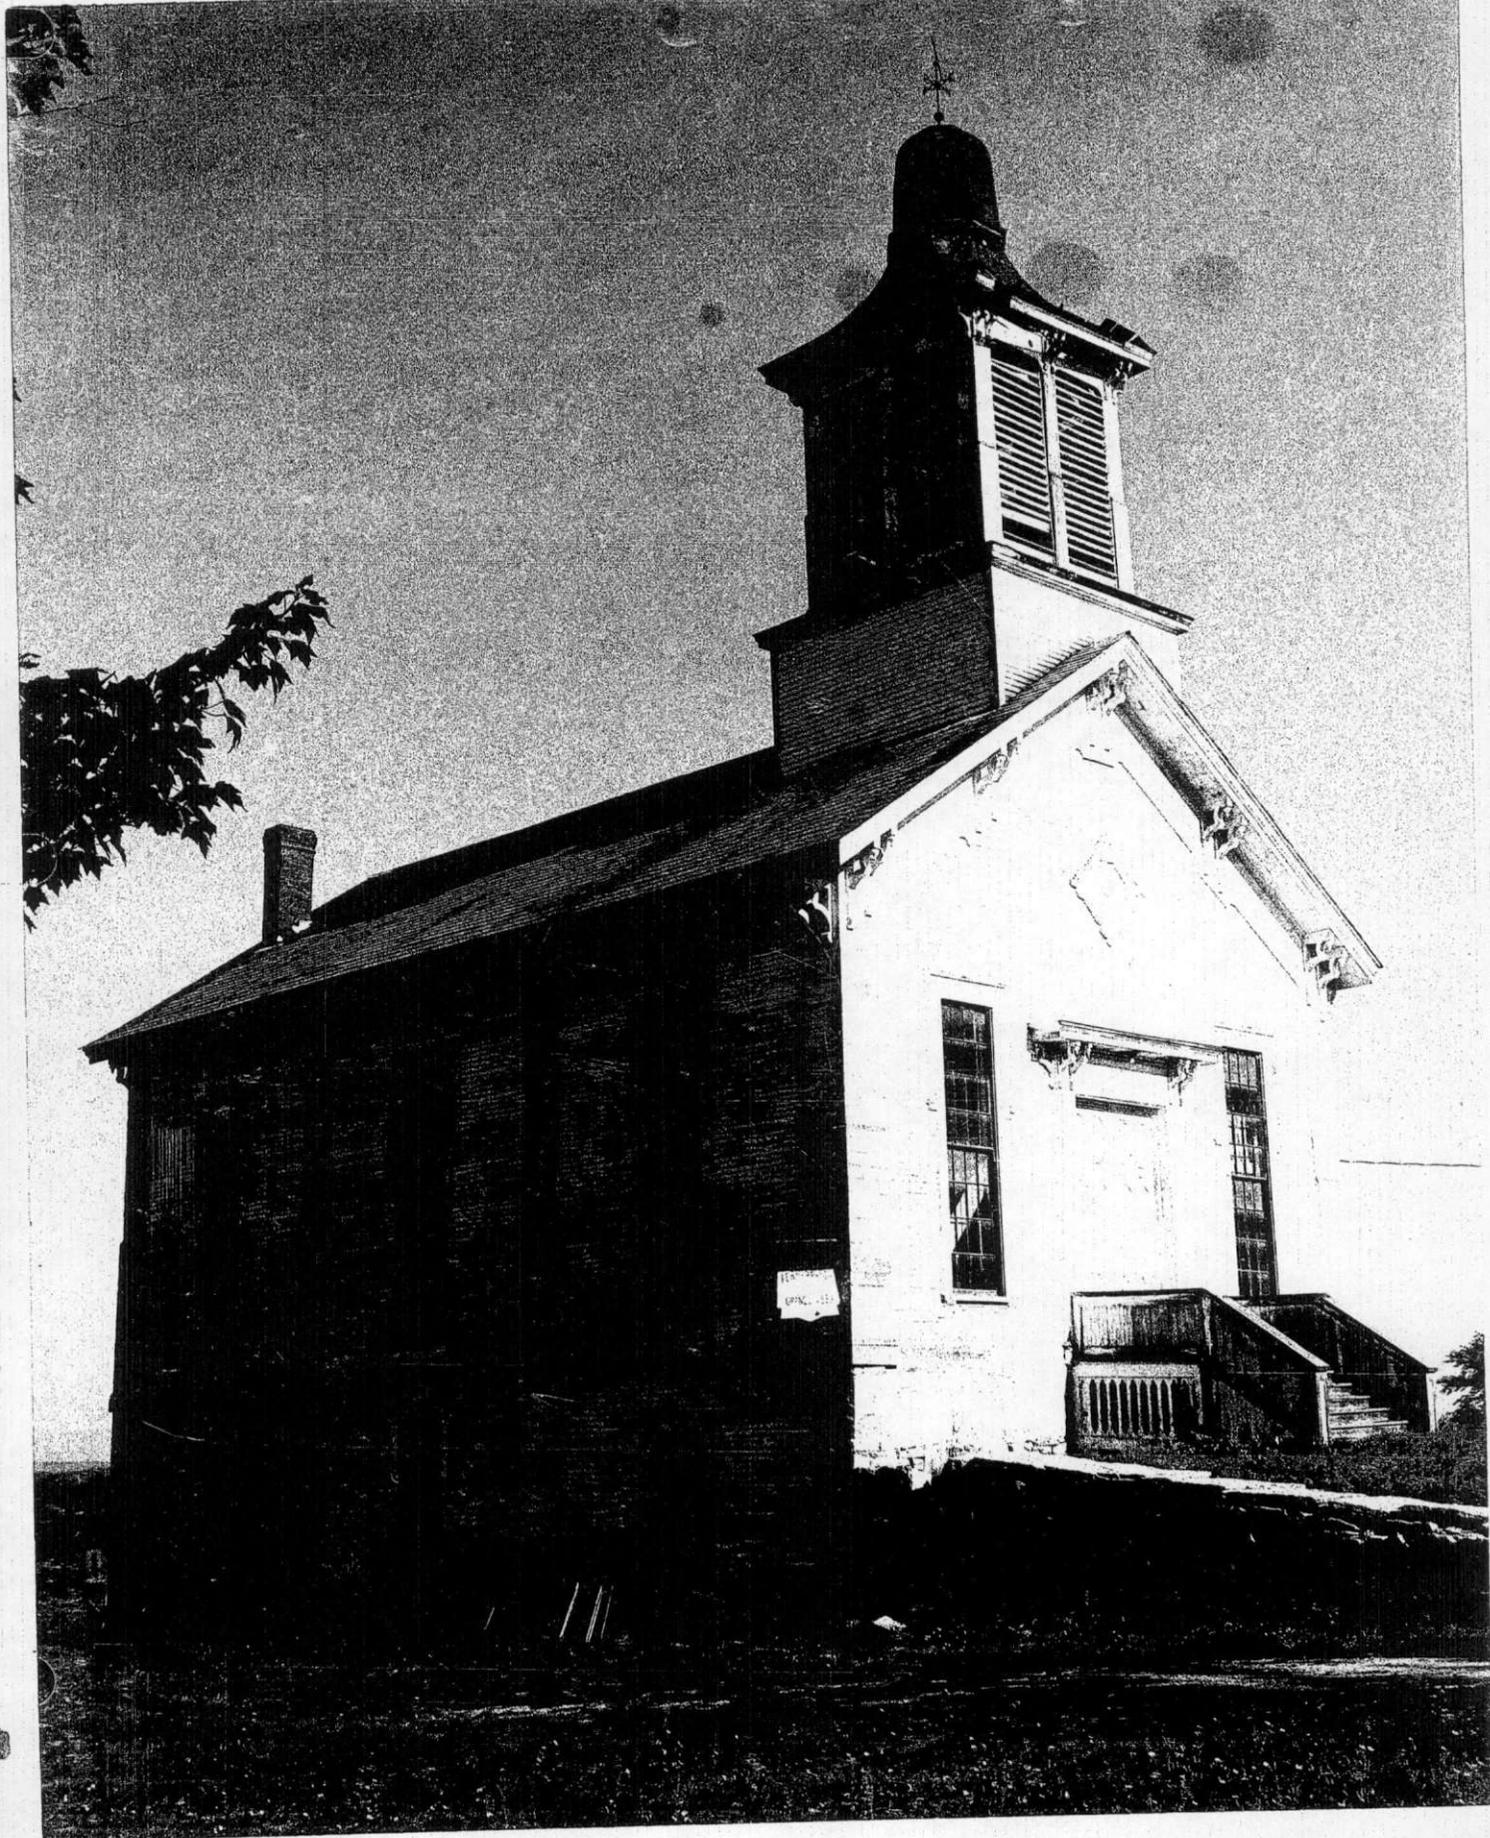
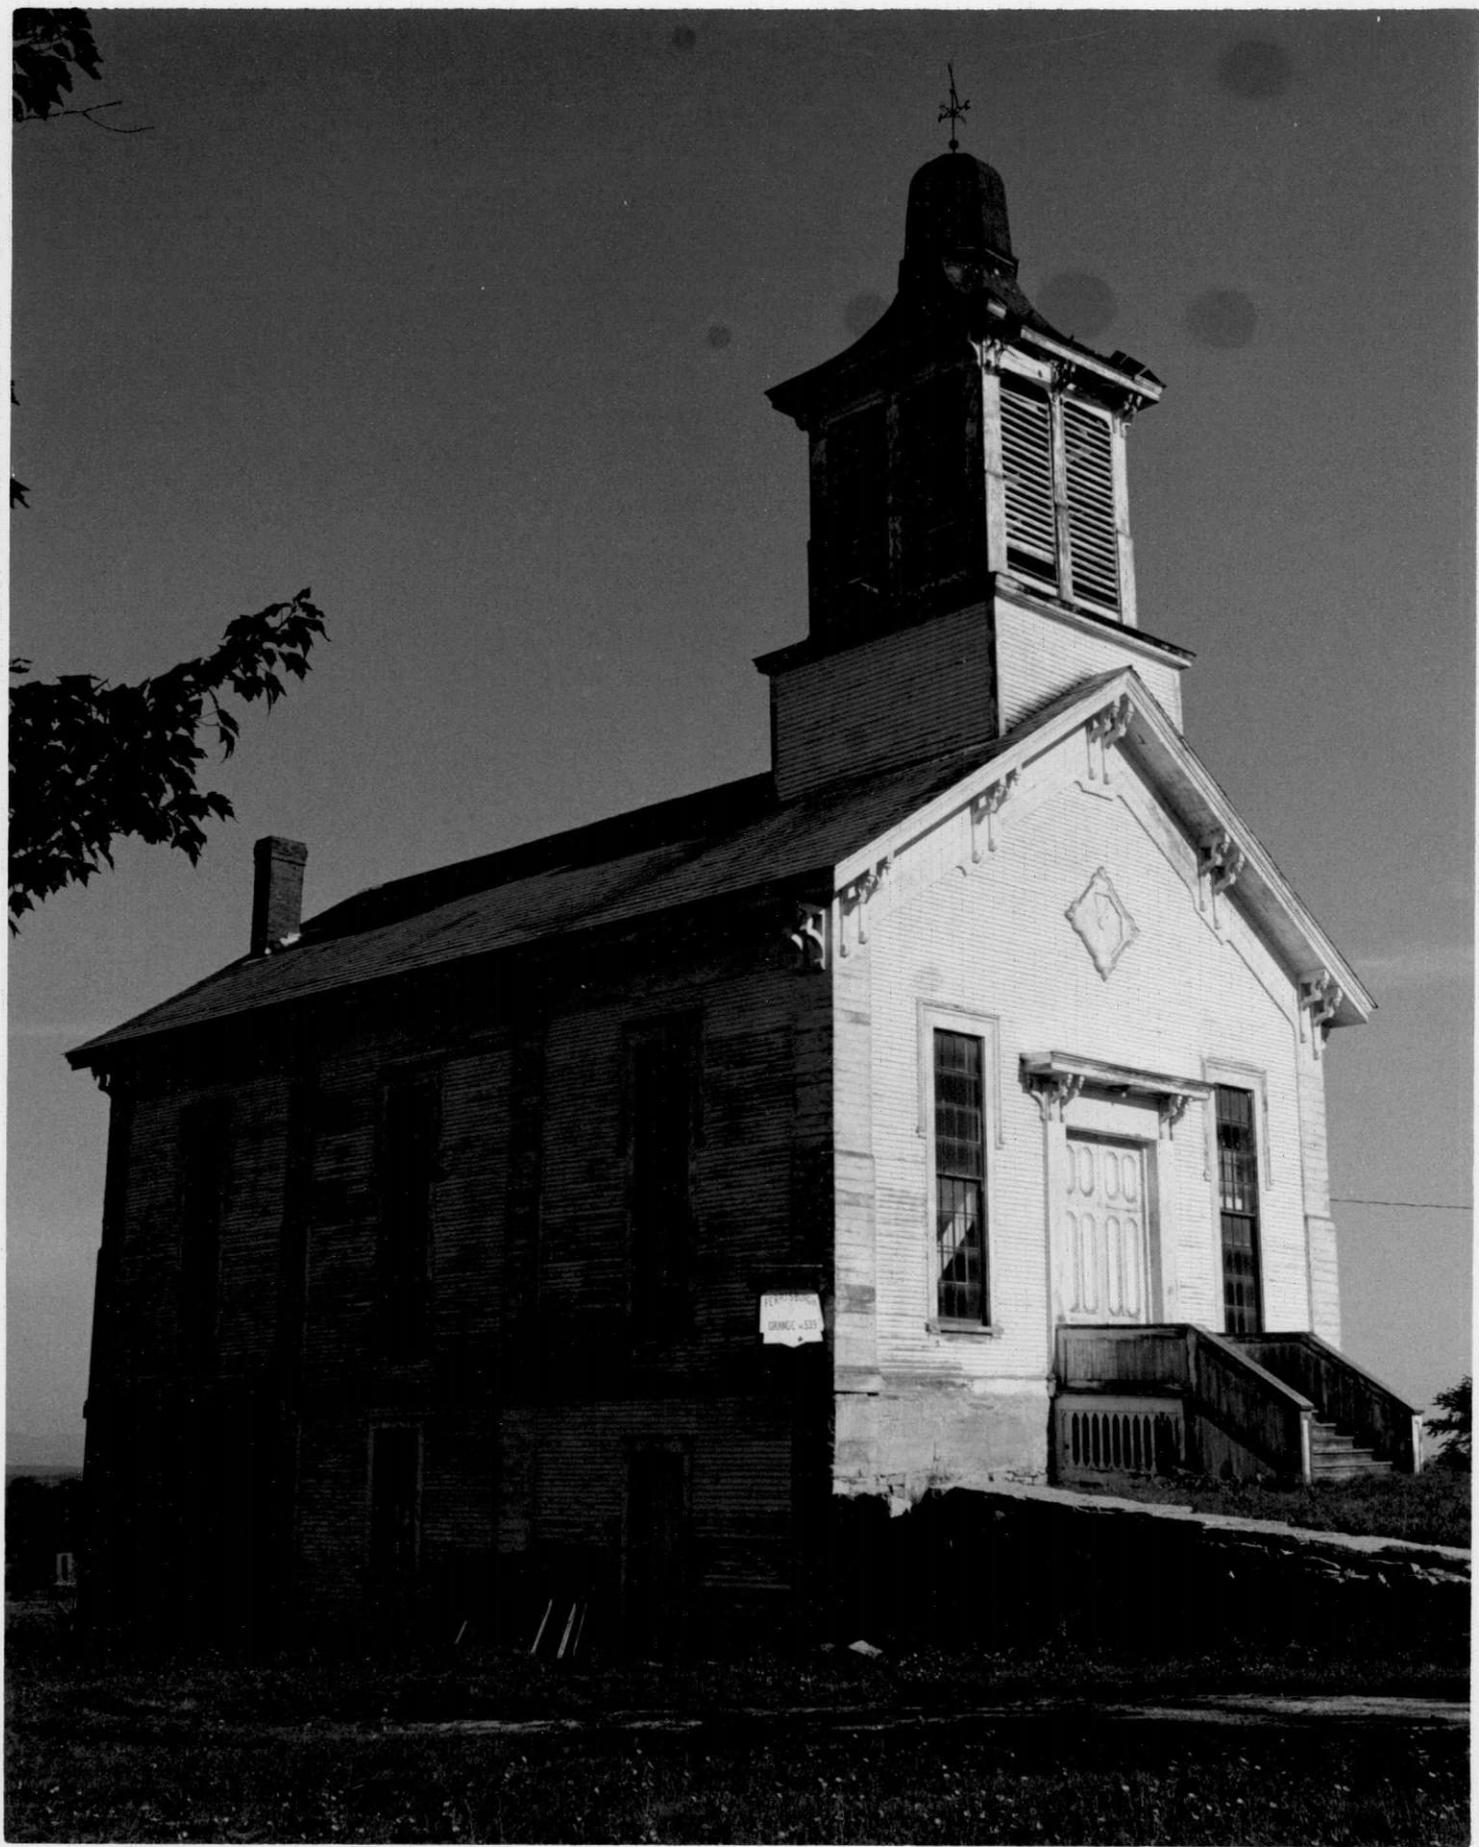
The Grange is a fine example of Victorian wood architecture, featuring a number of interesting ornamental treatments. It demonstrates how the basic Greek Revival gable-front form is embellished and transformed into the Italianate style through the addition of a variety of applied details. Here, these include a cupola, pendant consoles, and a continuous pilaster and cornice motif formed by intersecting wide clapboards.

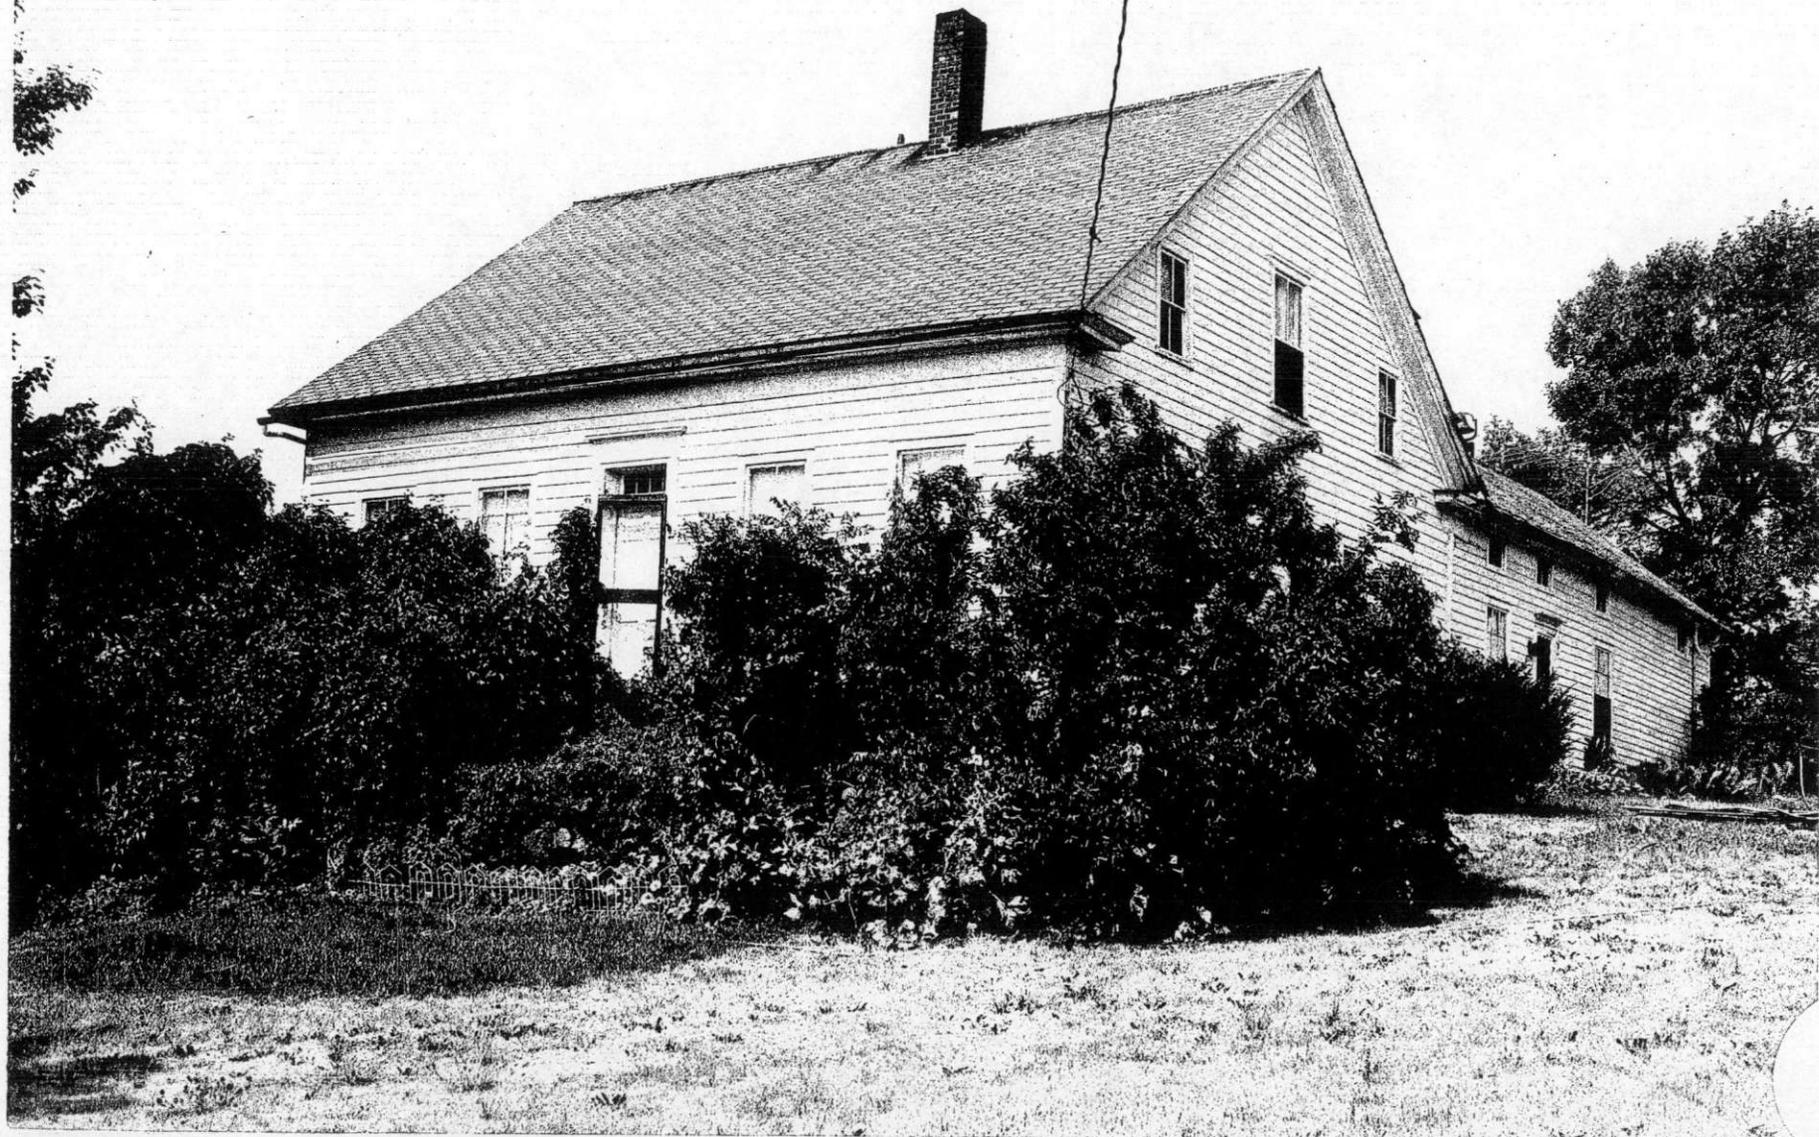
0105-9

This house is another good example of an early vernacular Georgian frame dwelling, of which there are many examples in rural Vermont.
