DIFFERENCES IN SITE NUMBERS USED IN PUBLISHED TOWN HISTORY AND VERMONT HISTORIC SITES & STRUCTURES SURVEY

THE HISTORIC ARCHITECTURE OF ADDISON COUNTY

FERRISBURGH

**THE HISTORIC ARCHITECTURE
OF ADDISON COUNTY**
*Including a listing of
the Vermont State Register of Historic Places*

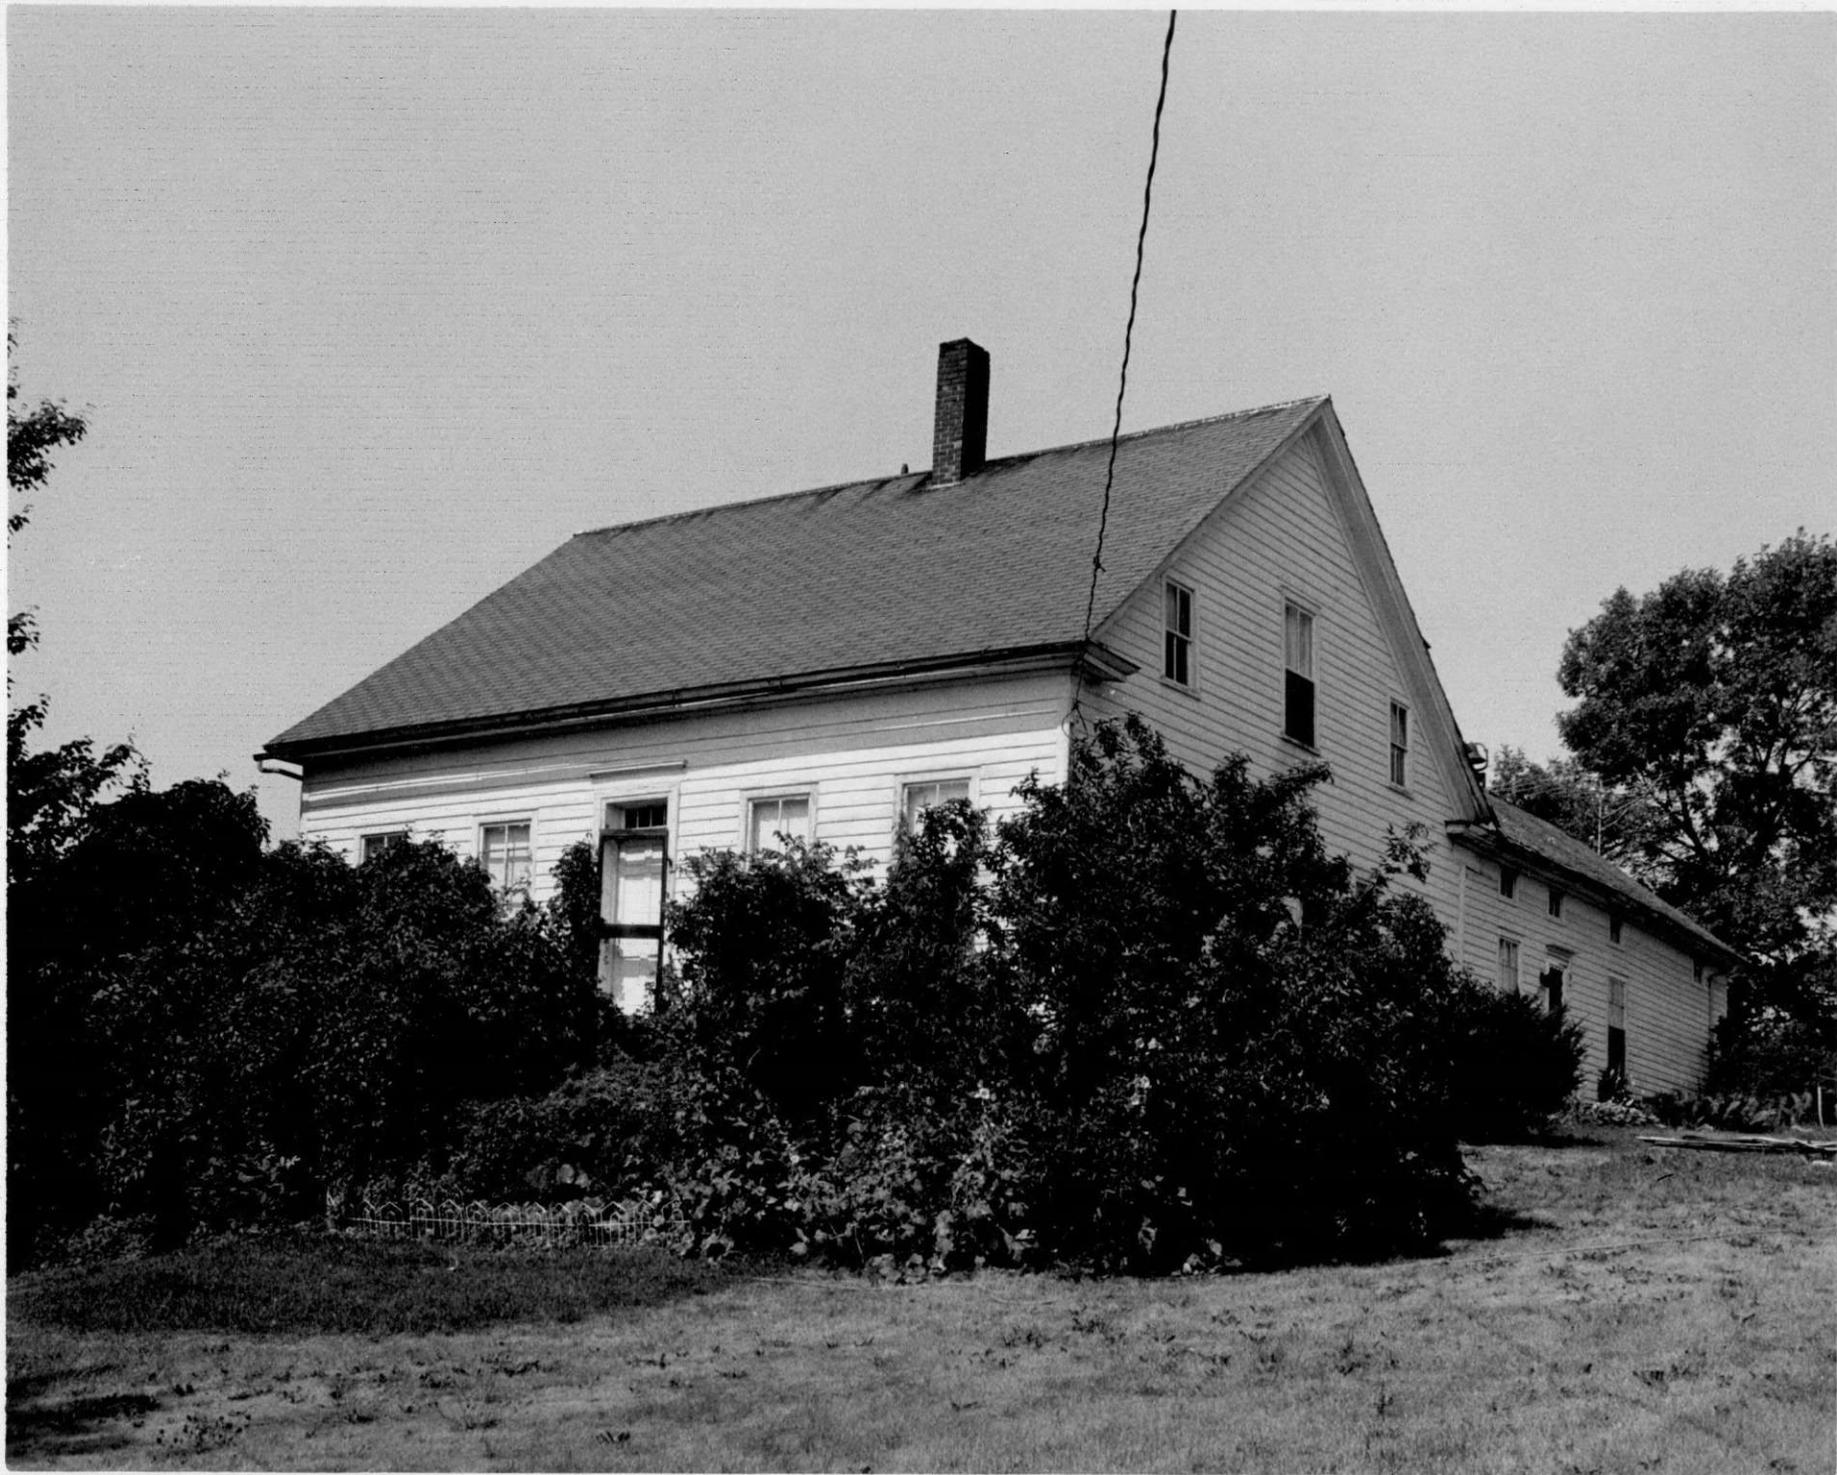
0105-9

This house is another good example of an early vernacular Georgian frame dwelling, of which there are many examples in rural Vermont.

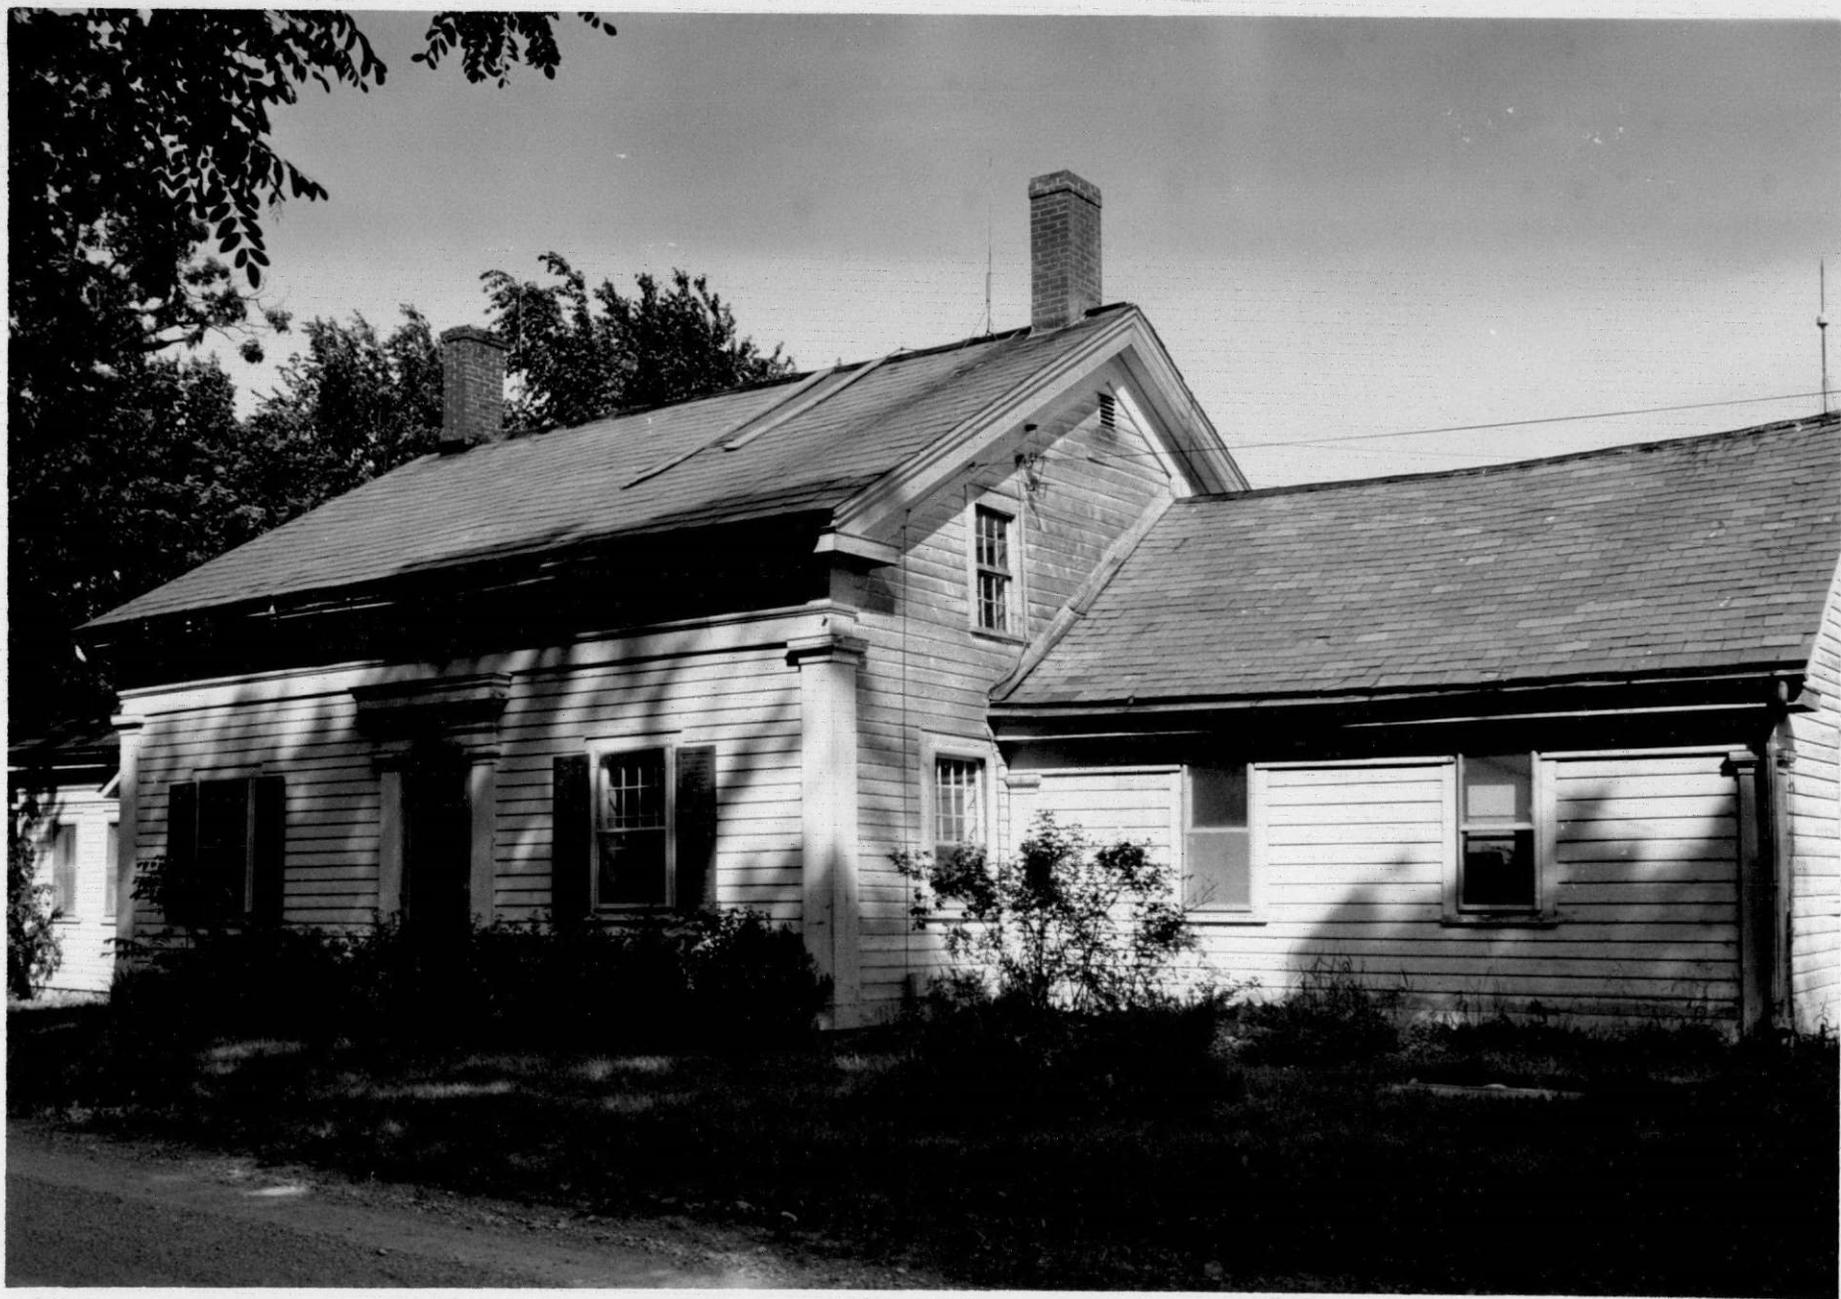
0105-1c

Another early farmhouse in Ferrisburg, this structure typifies the basic three-bay, one-and-a-half-story central-hall Greek Revival house with symmetrical end chimneys and simple vernacular details (pilasters, eaves returns and entablature, etc.) which was added to an earlier vernacular Georgian construction, as the owners of the property grew more prosperous. The house has been in the current owner's family for many years. It belonged to John Birkett, a live-stock dairy and merino sheep farmer, in the late 19th century.

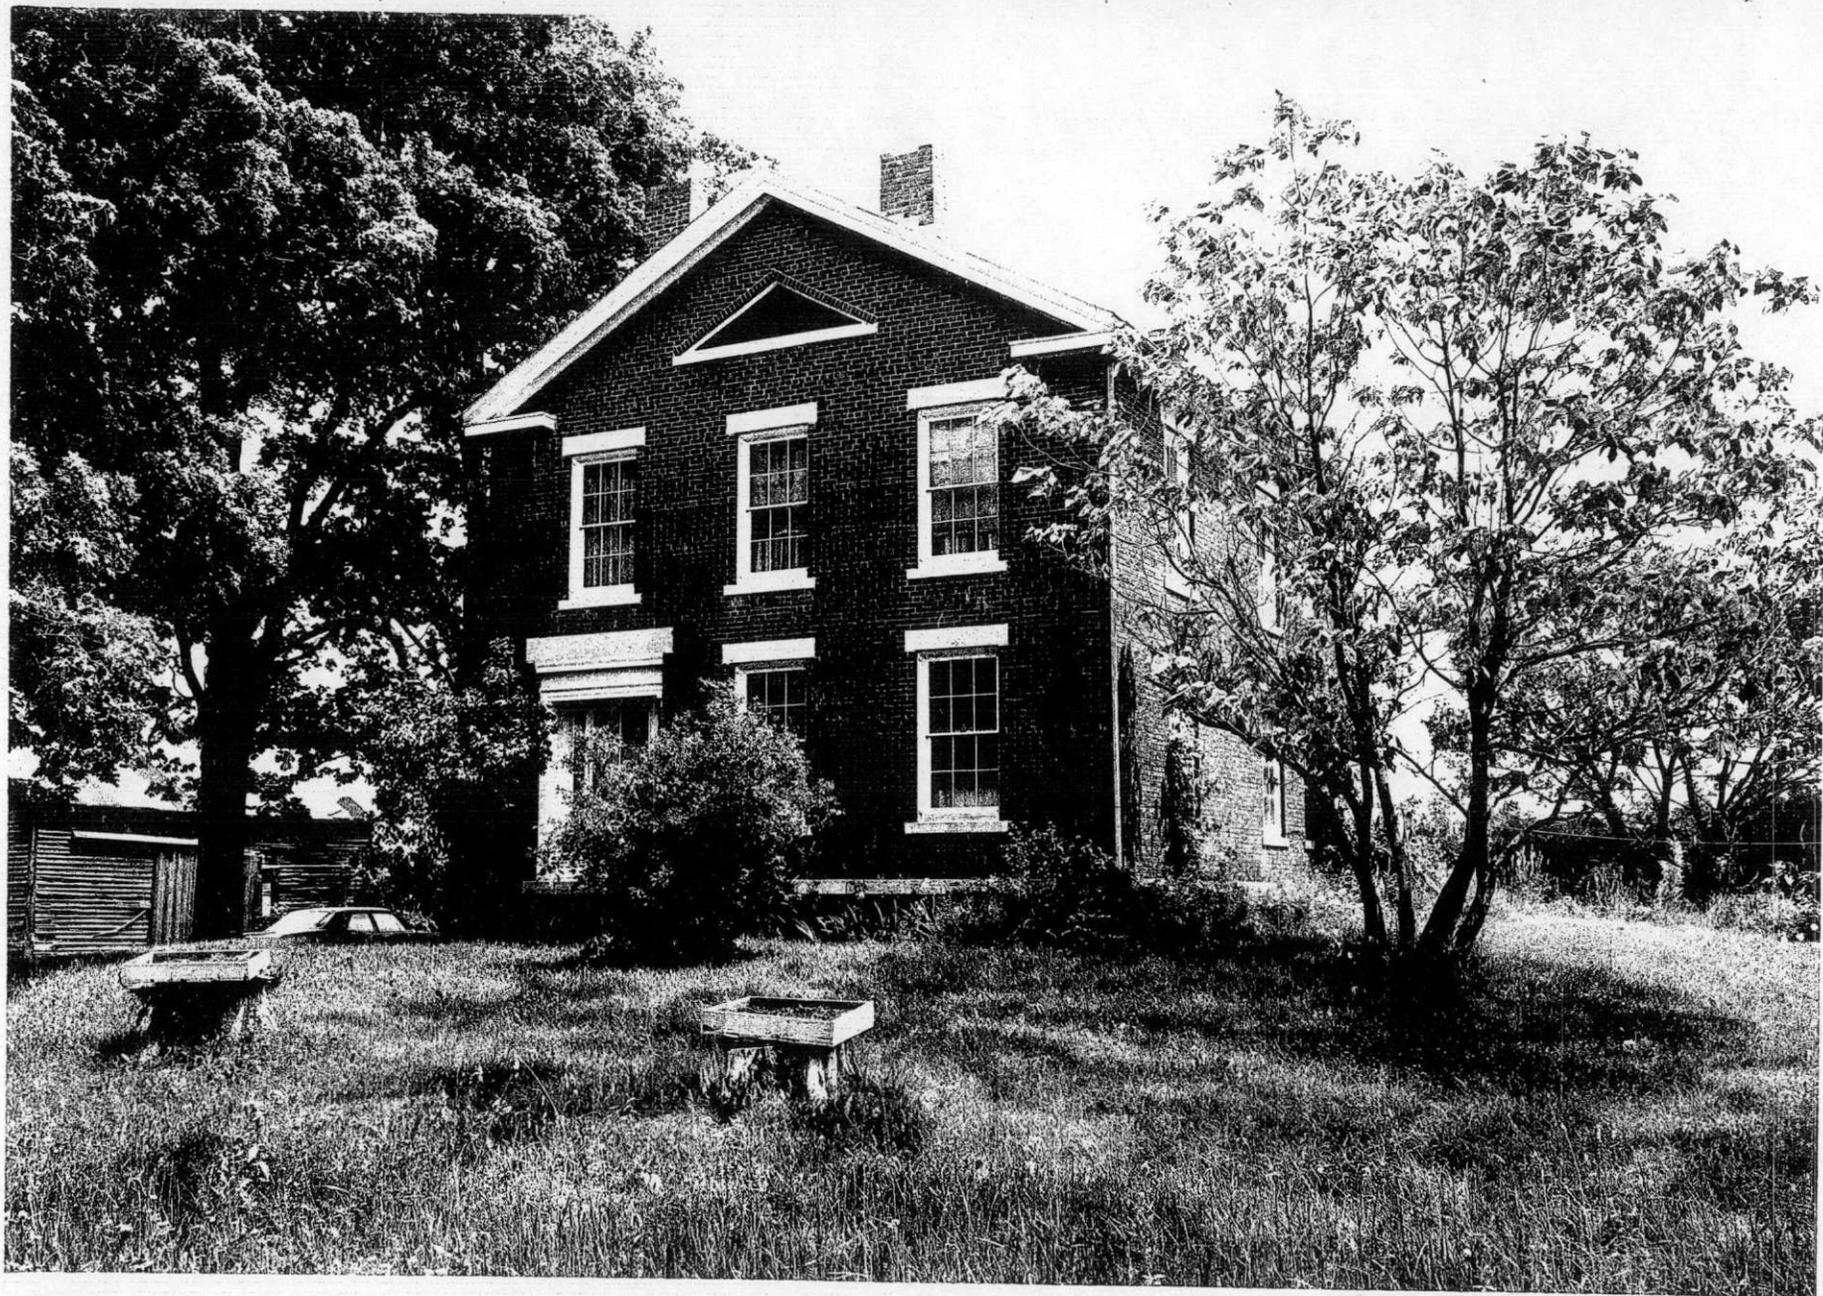
0105-15

This striking Greek Revival house strongly resembles several other brick constructions of the same type in Ferrisburg (see forms #0105-46, 0105-24, 0105-11). It is of a basic vernacular Greek Revival type—the three-bay, gable-front, sidehall plan house.

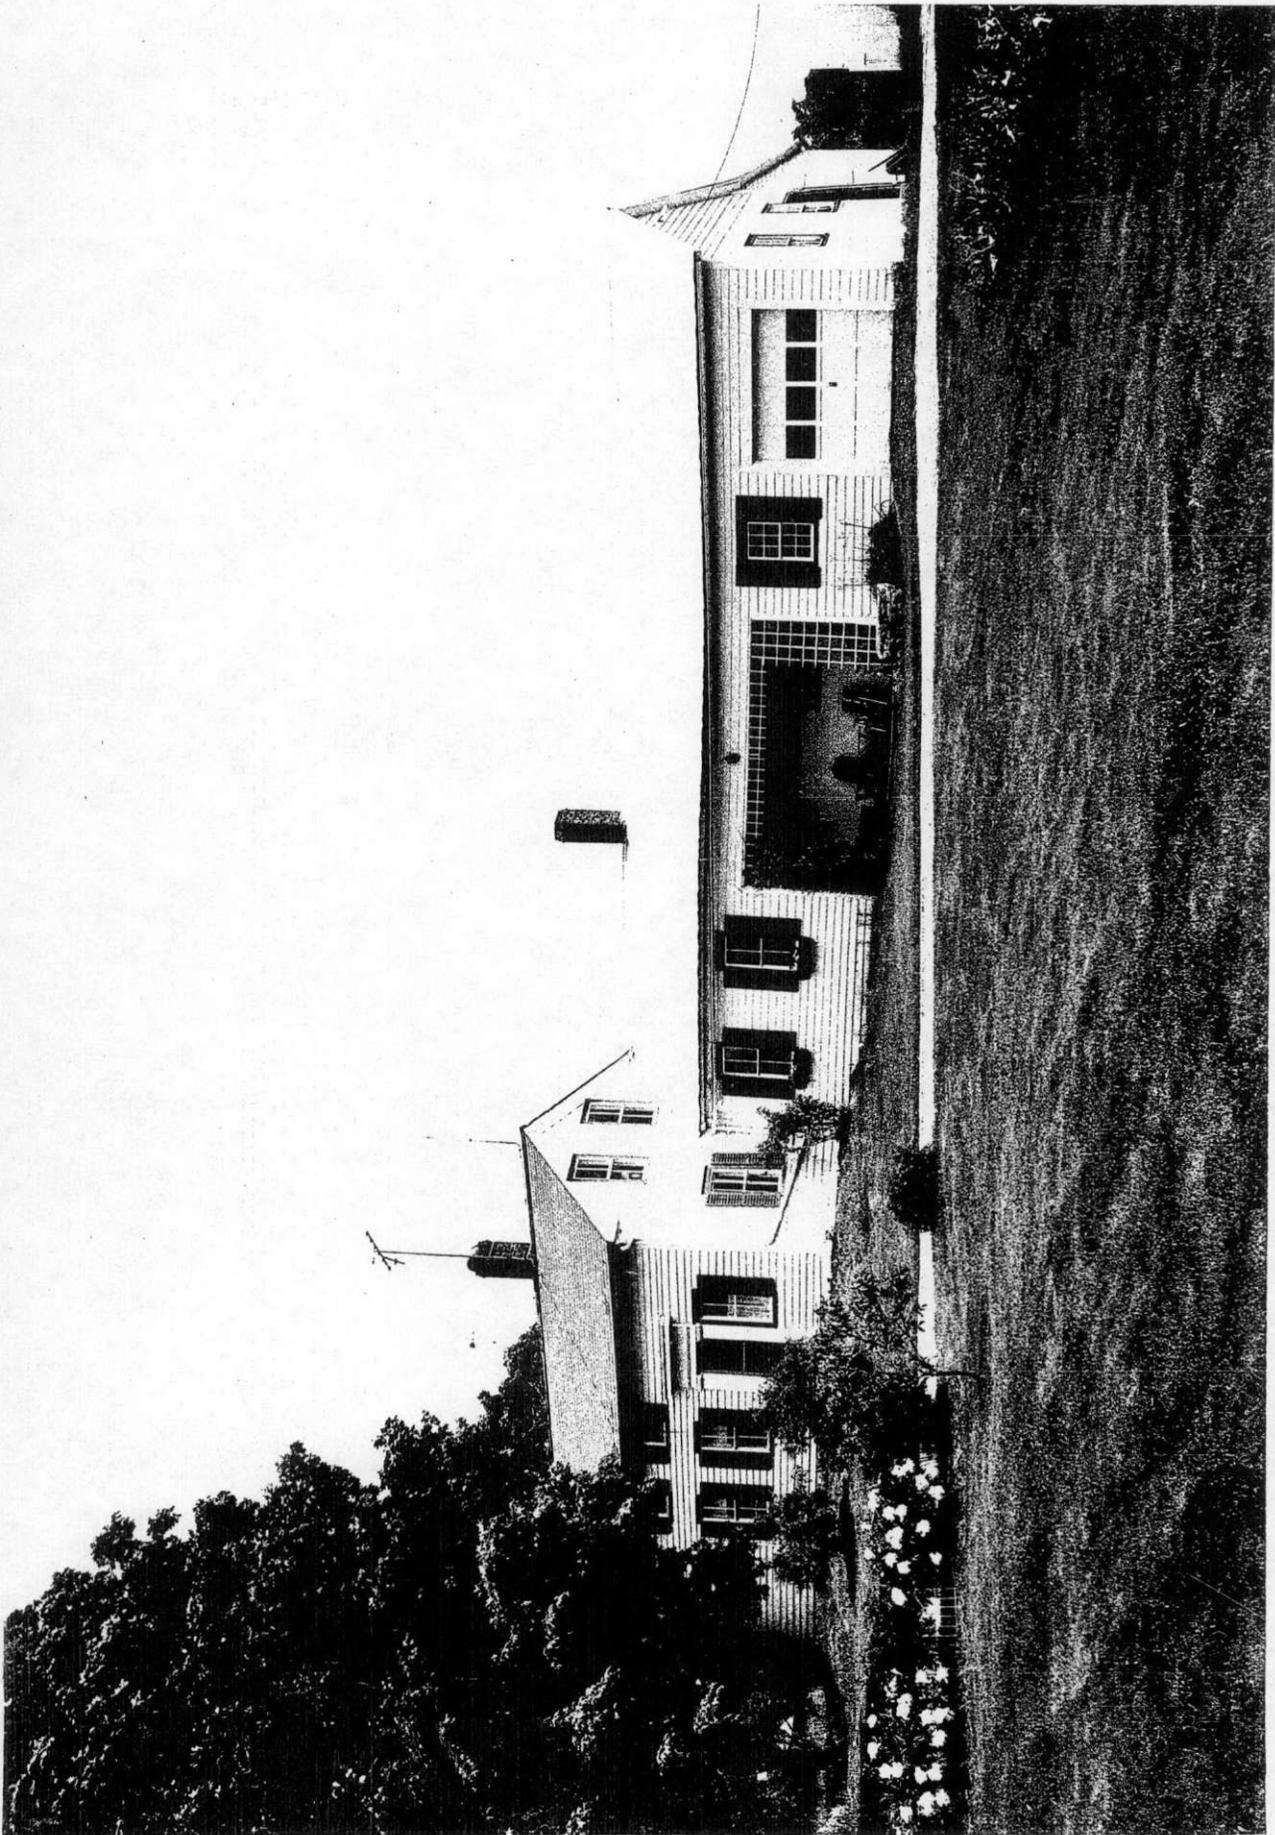
0105-18

This house typifies the early vernacular one-and-a-half-story Greek Revival house plan that is a continuation of vernacular Georgian architecture and its characteristic details (e.g. assymetrical bays, central hearth, eyebrow windows).

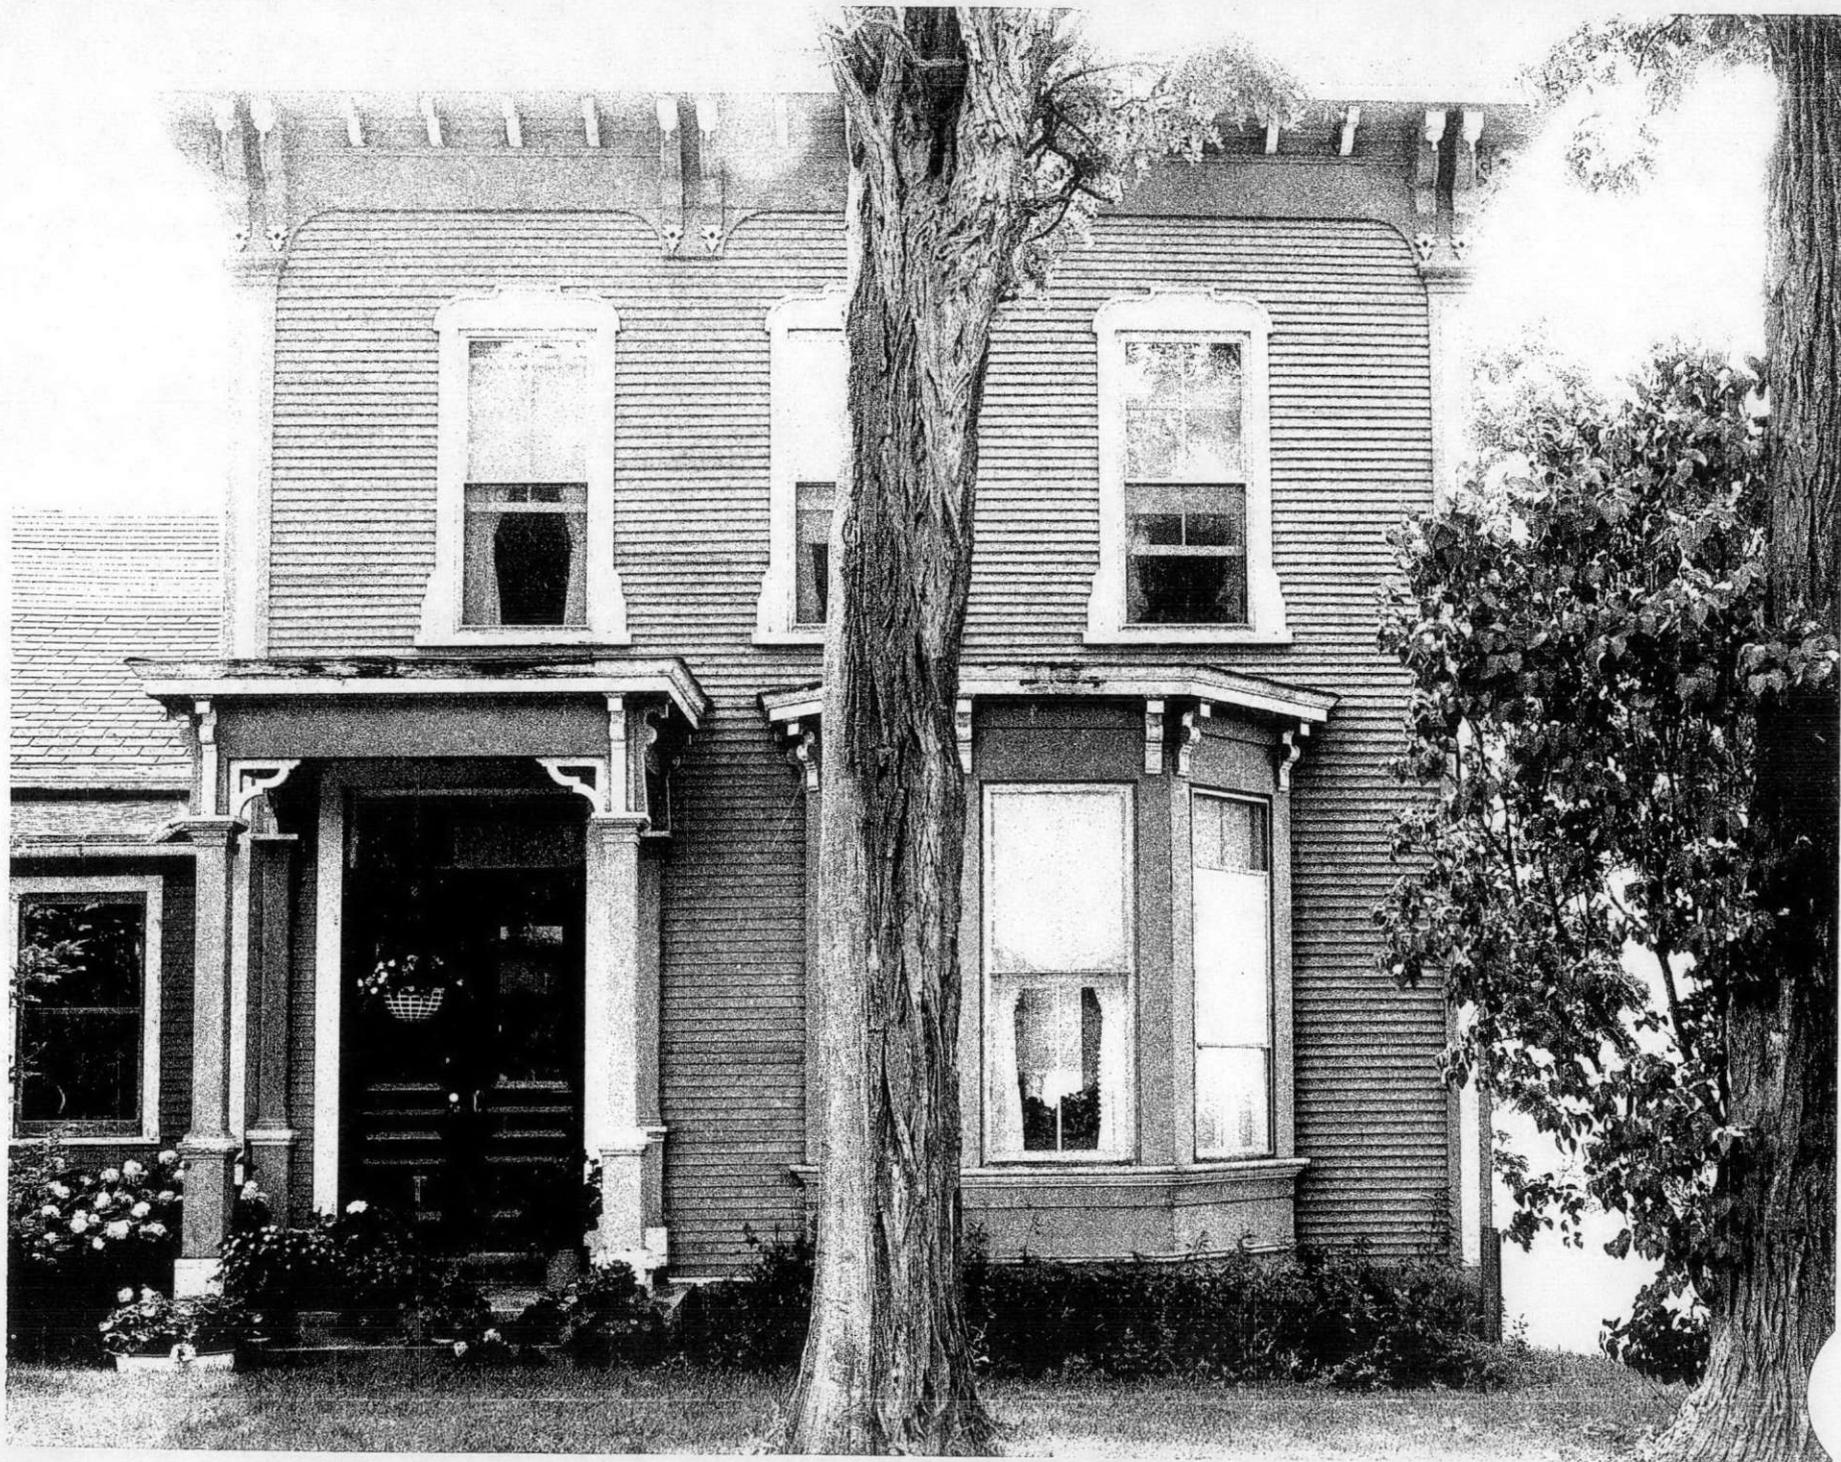
0105-19

Three-bay, square main block has panelled corner pilasters, box cornice with paired pendant consoles and small brackets between them. Molded window lintels (variant of shouldered architrave). Bay window on ground story. Doorway has plain surround with frosted glass transom light. Small, bracketed entrance porch. Central brick chimney. One-story south wing with enclosed porch.

The Burnett residence is another good example of the prototypical hip-roofed, box-like Italianate house form with bracketed cornice. (see forms #0105-4, 0105-6, and 0105-7 for other area variants of this stylistic type).

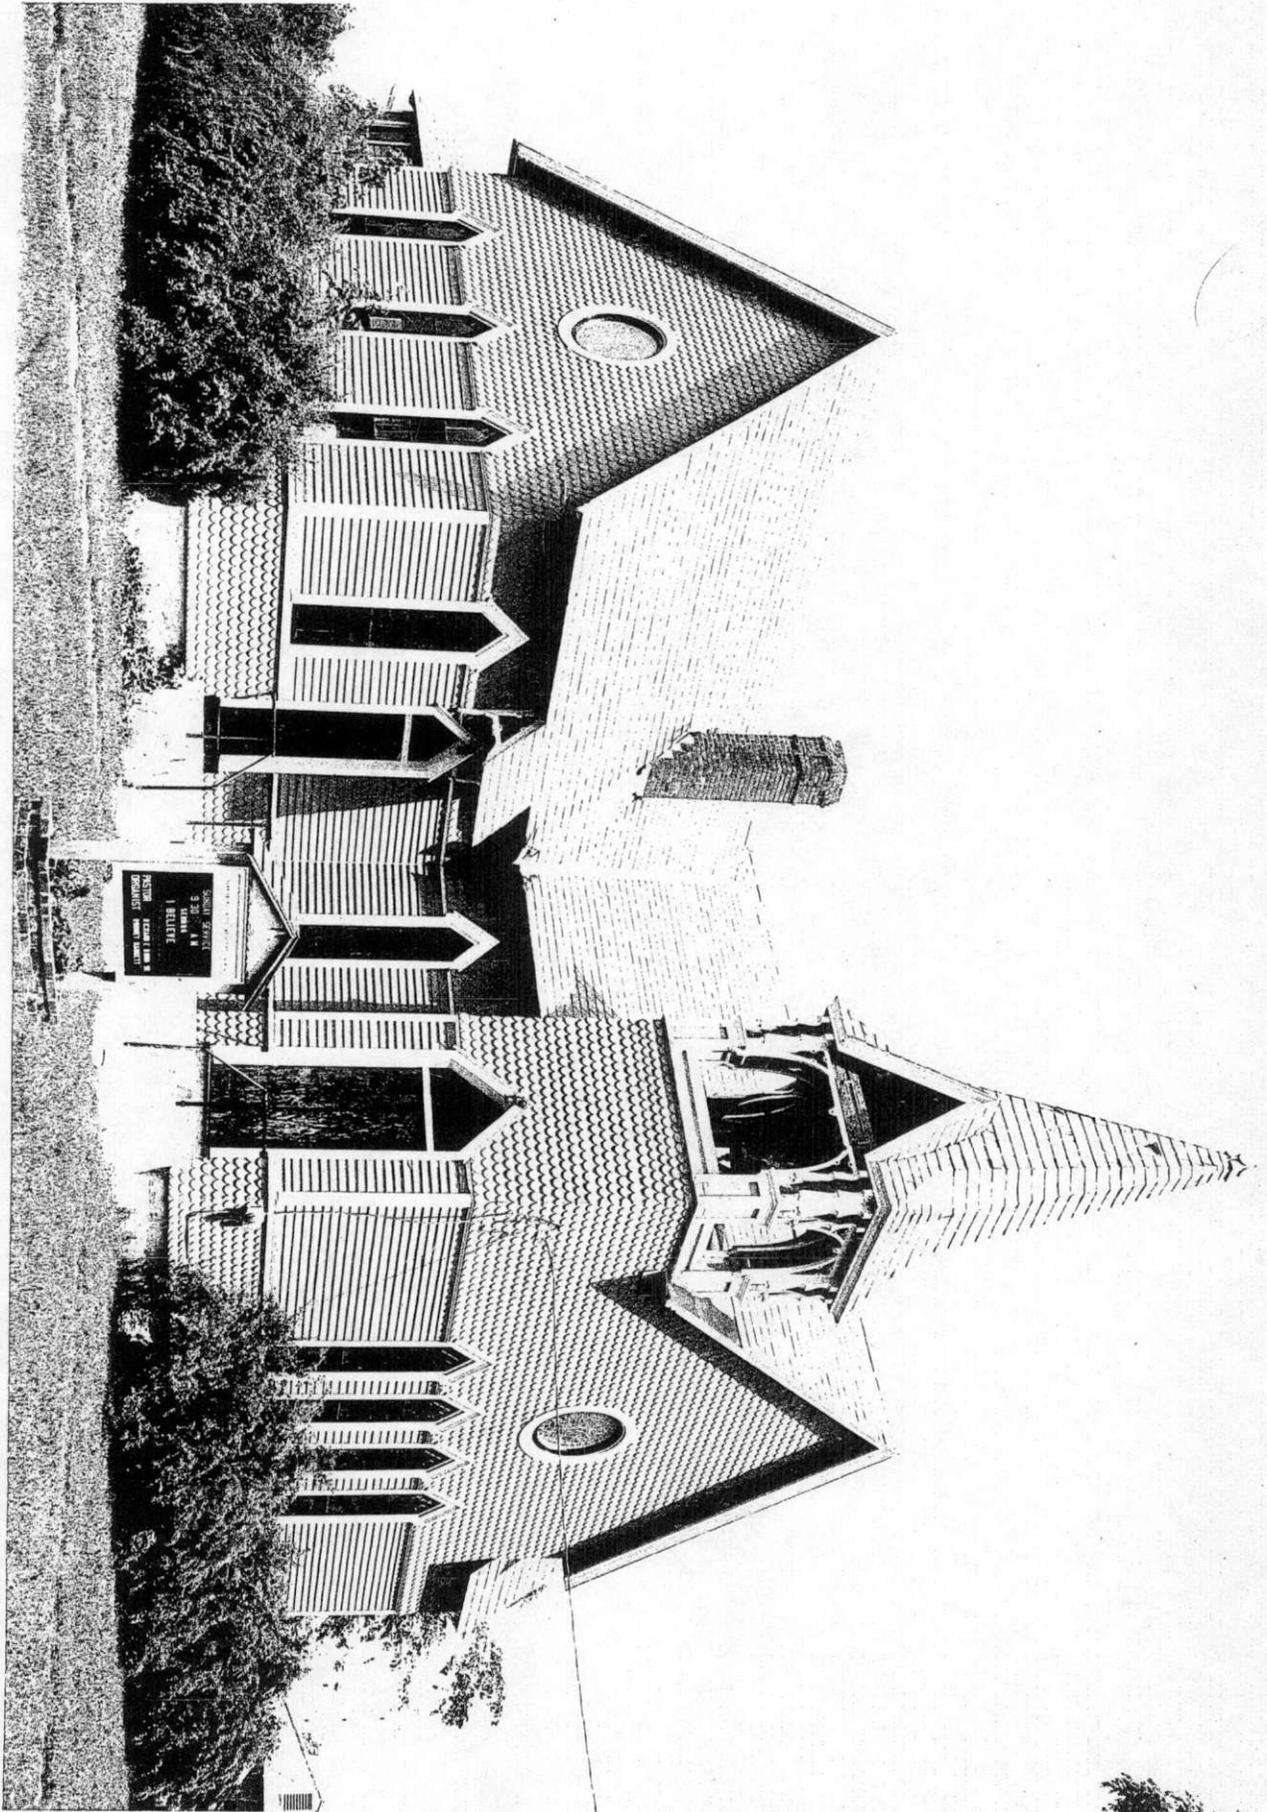
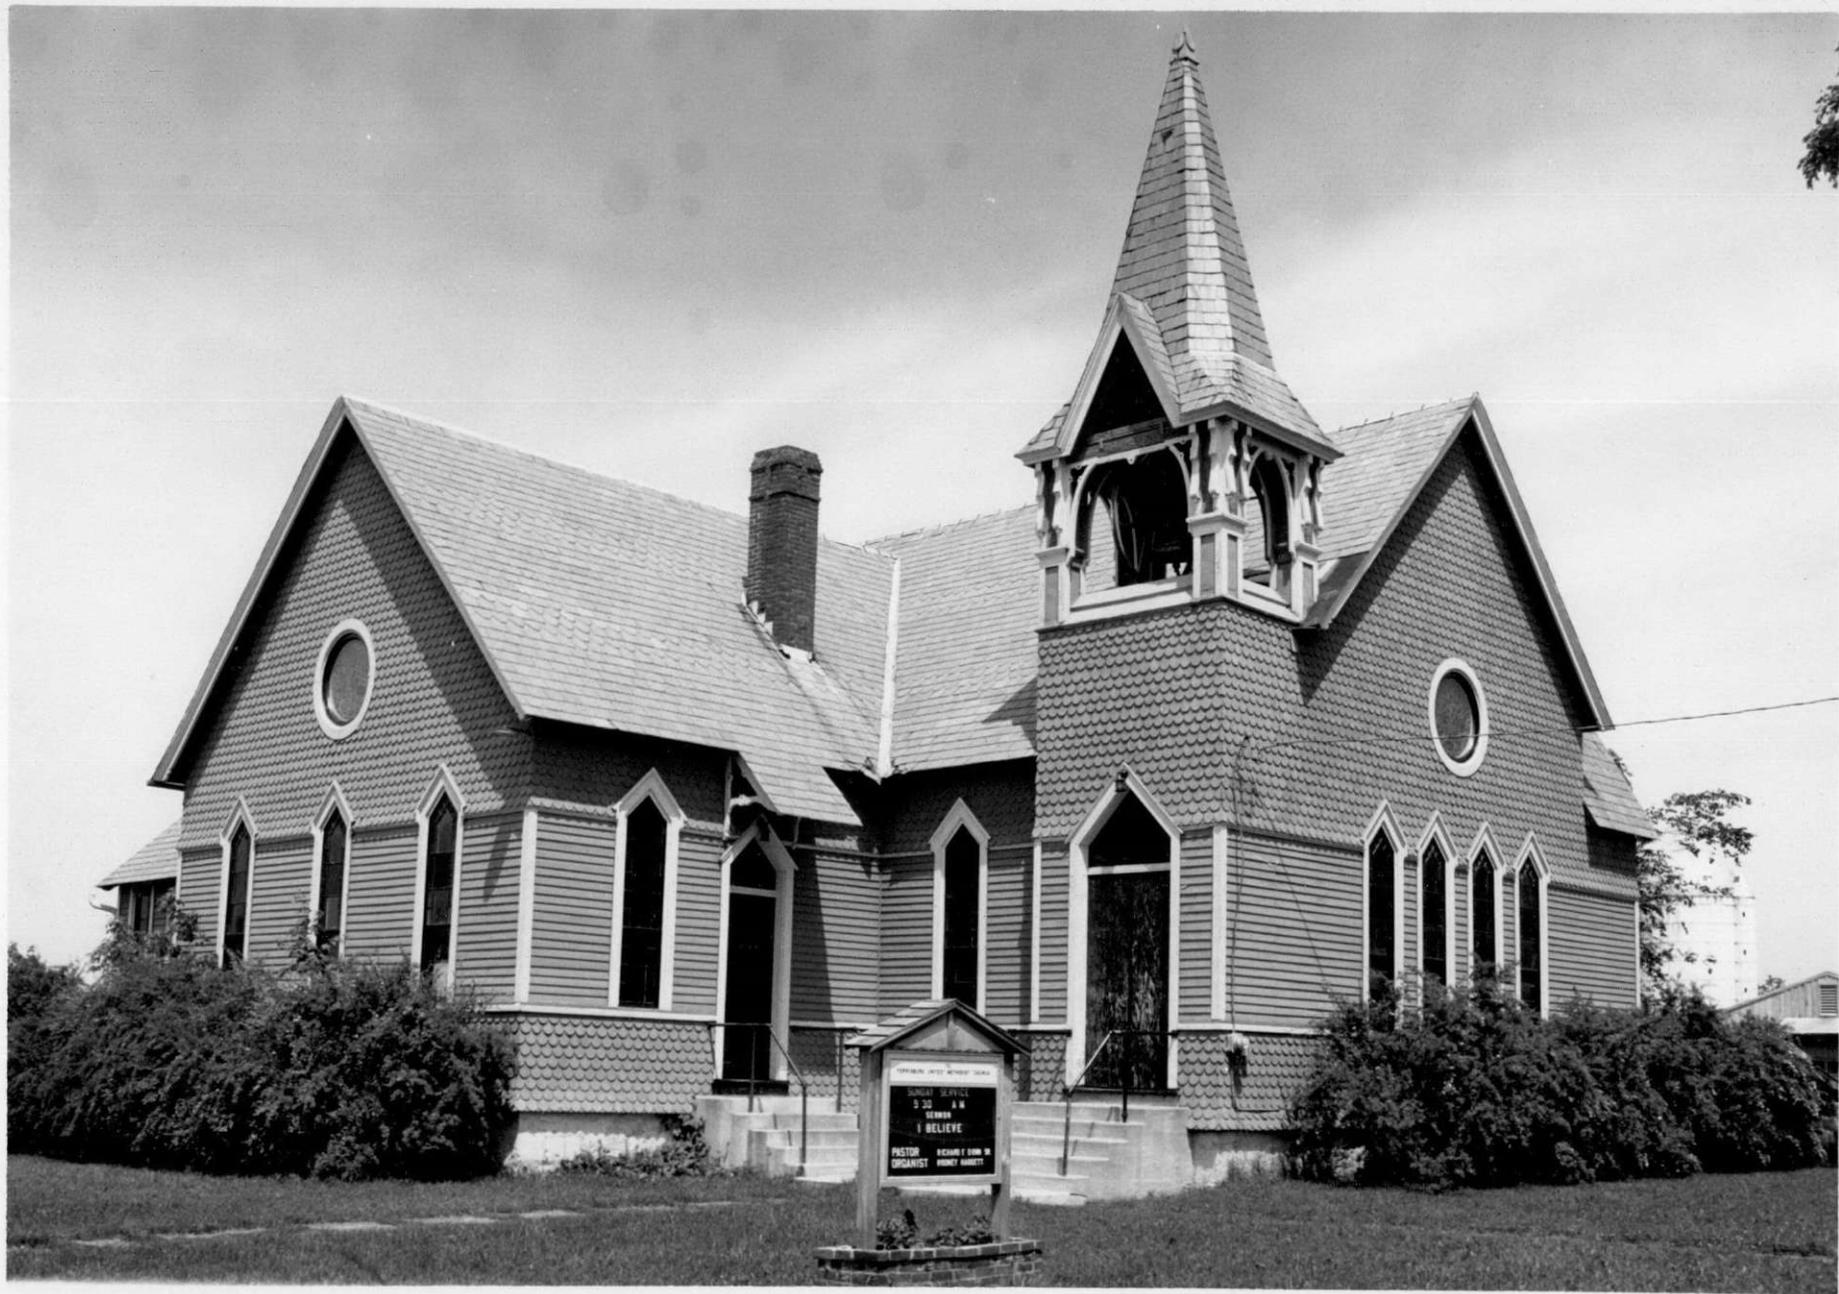
Assymmetrically-massed church has intersecting gable roof, imbricated wood shingle and horizontal clapboard wall treatment with timber string courses and corner boards. Pointed triangular windows with stained glass. Entrance set into tower which terminates in high ornate belfry and slate-sheathed spire.

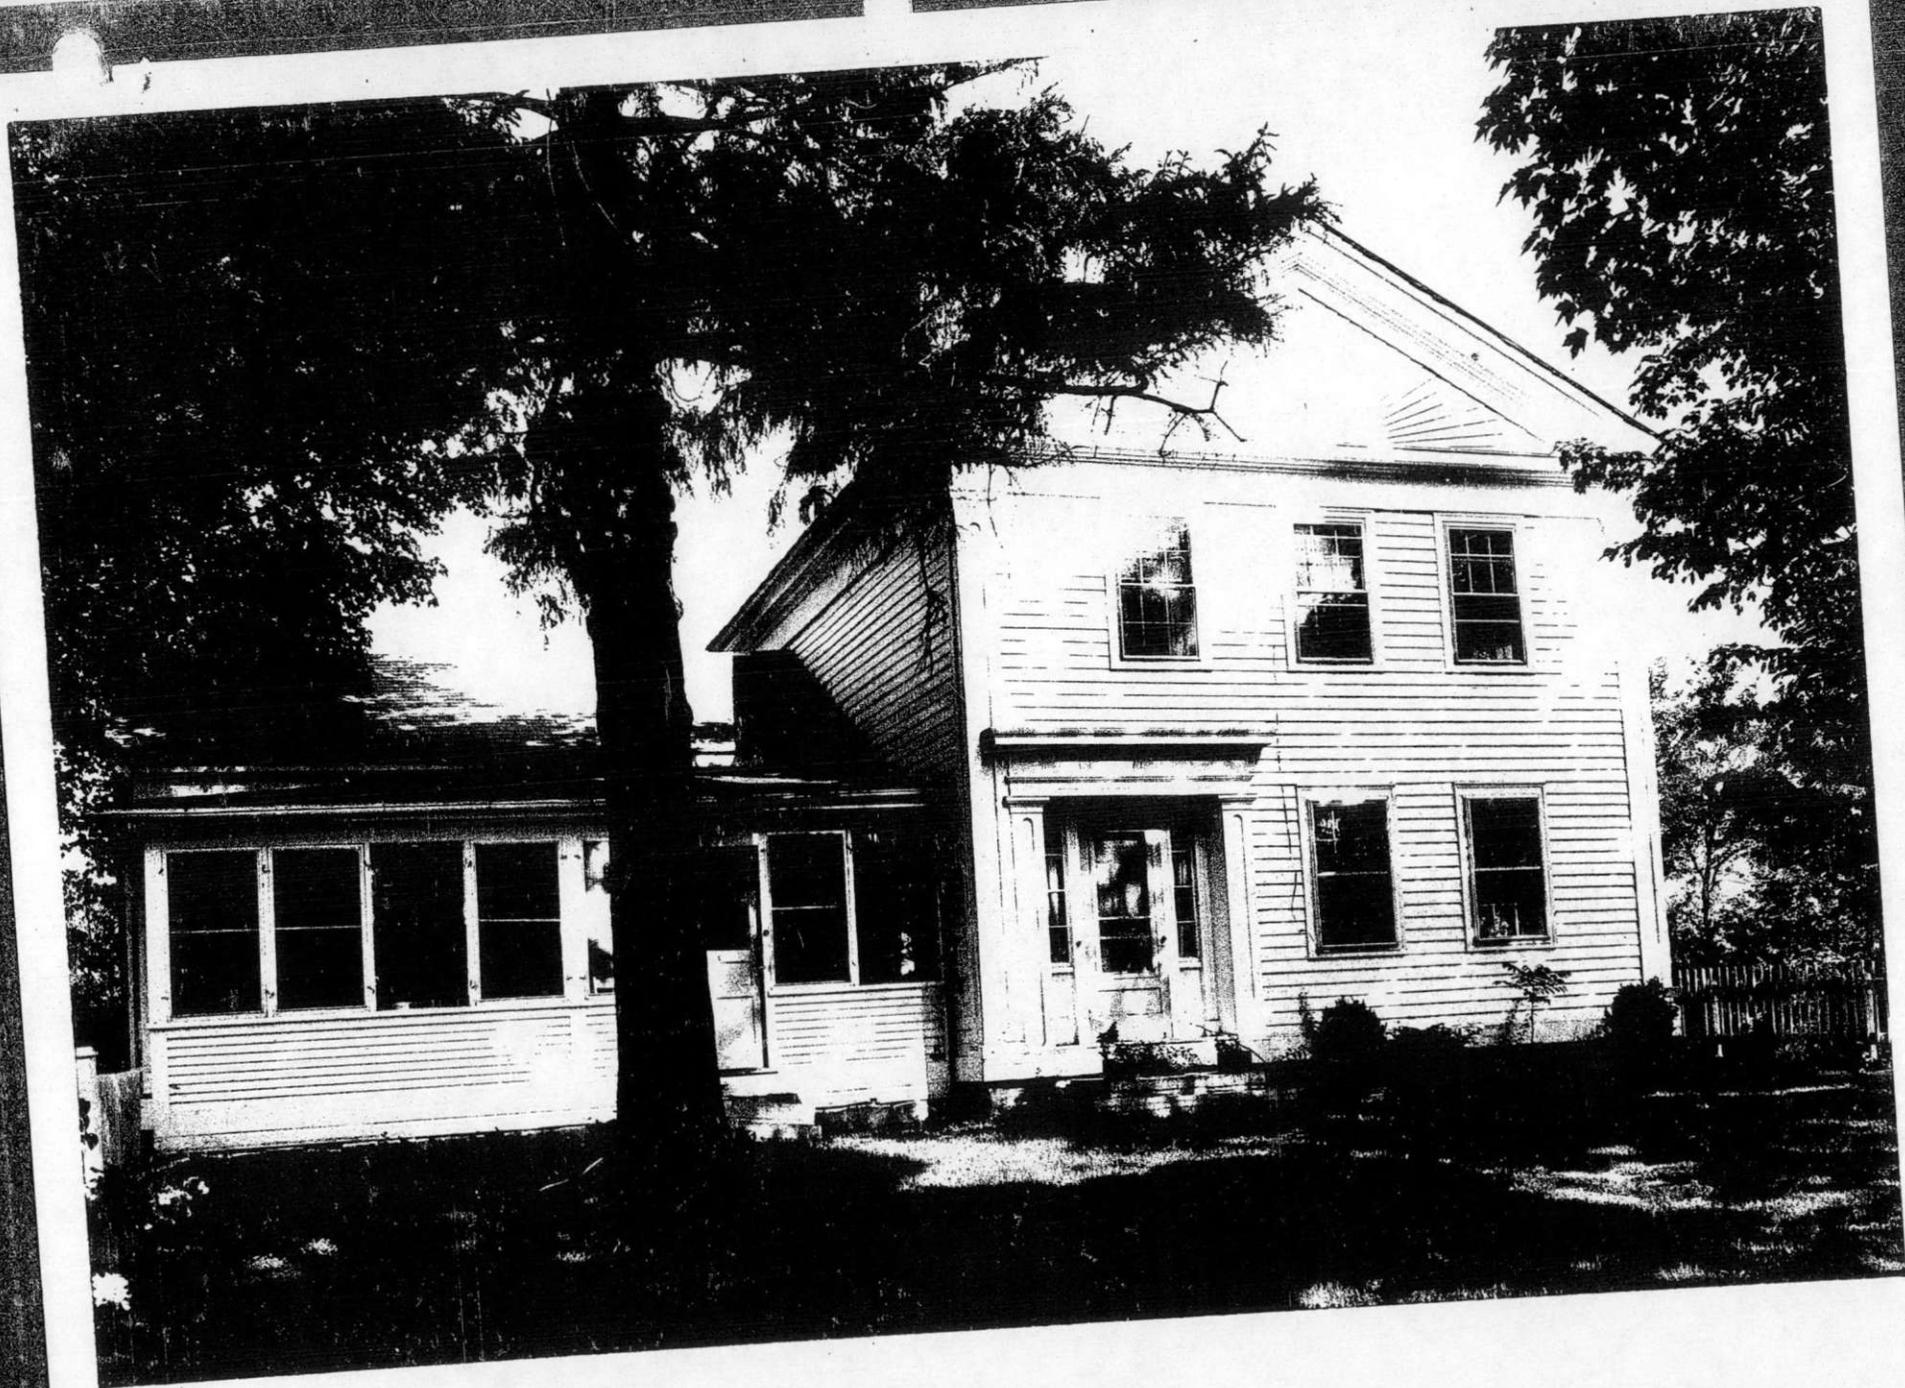
0105-21

Like several other neighboring structures, the house is endangered by its proximity to Route 7.
