DIFFERENCES IN SITE NUMBERS USED IN PUBLISHED TOWN HISTORY AND VERMONT HISTORIC SITES & STRUCTURES SURVEY

THE HISTORIC ARCHITECTURE OF ADDISON COUNTY

FERRISBURGH

**THE HISTORIC ARCHITECTURE
OF ADDISON COUNTY**
*Including a listing of
the Vermont State Register of Historic Places*

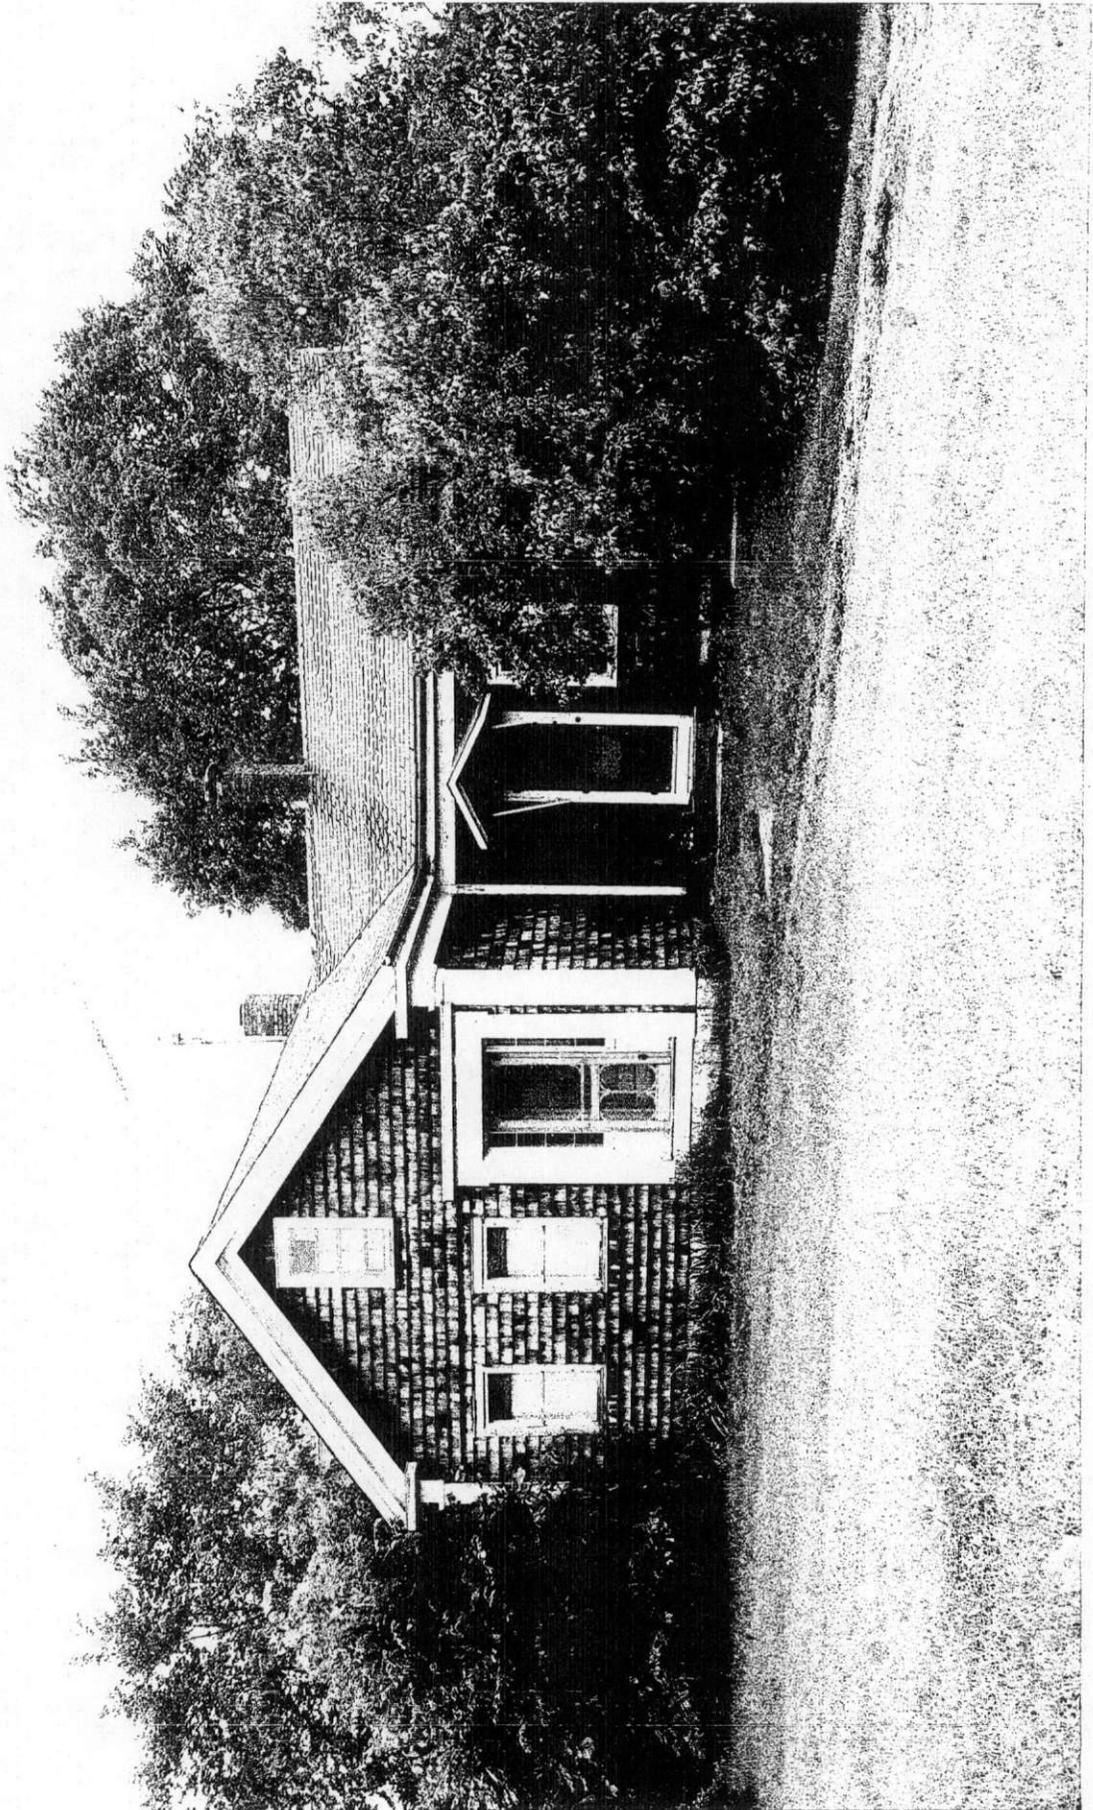
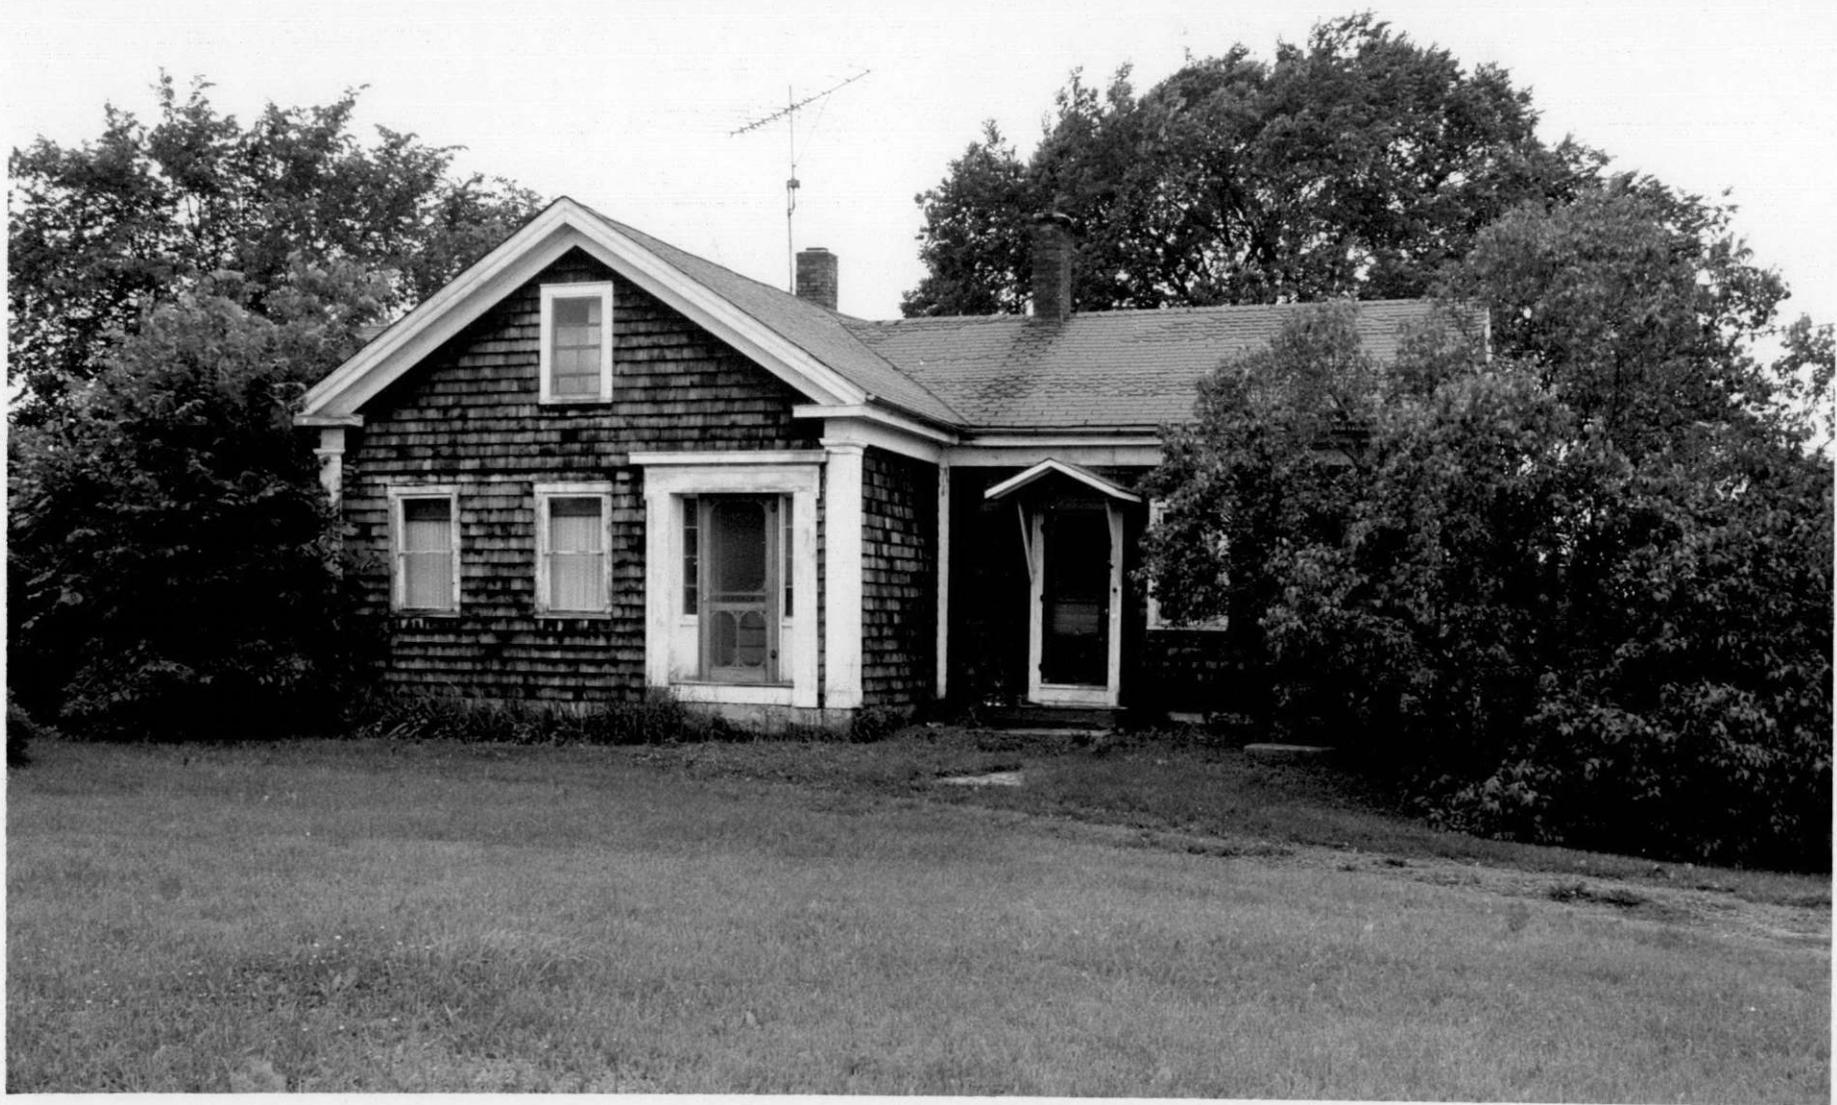
The Harris residence exhibits a Greek Revival house form of which there are few remaining examples, either vernacular or high style, in the county: the T-plan house. In its vernacular form, symmetrical wings are frequently the same height as the central, gable-front section of the structure, which they flank. More high style expressions of the T-plan house often feature a portico or temple facade on the main block of two or two-and-a-half-story, and shorter flanking wings of one or one-and-a-half-story. (A good example of the latter type is the Old Brookside Dairy Farm on Route 22A in Orwell, VT).

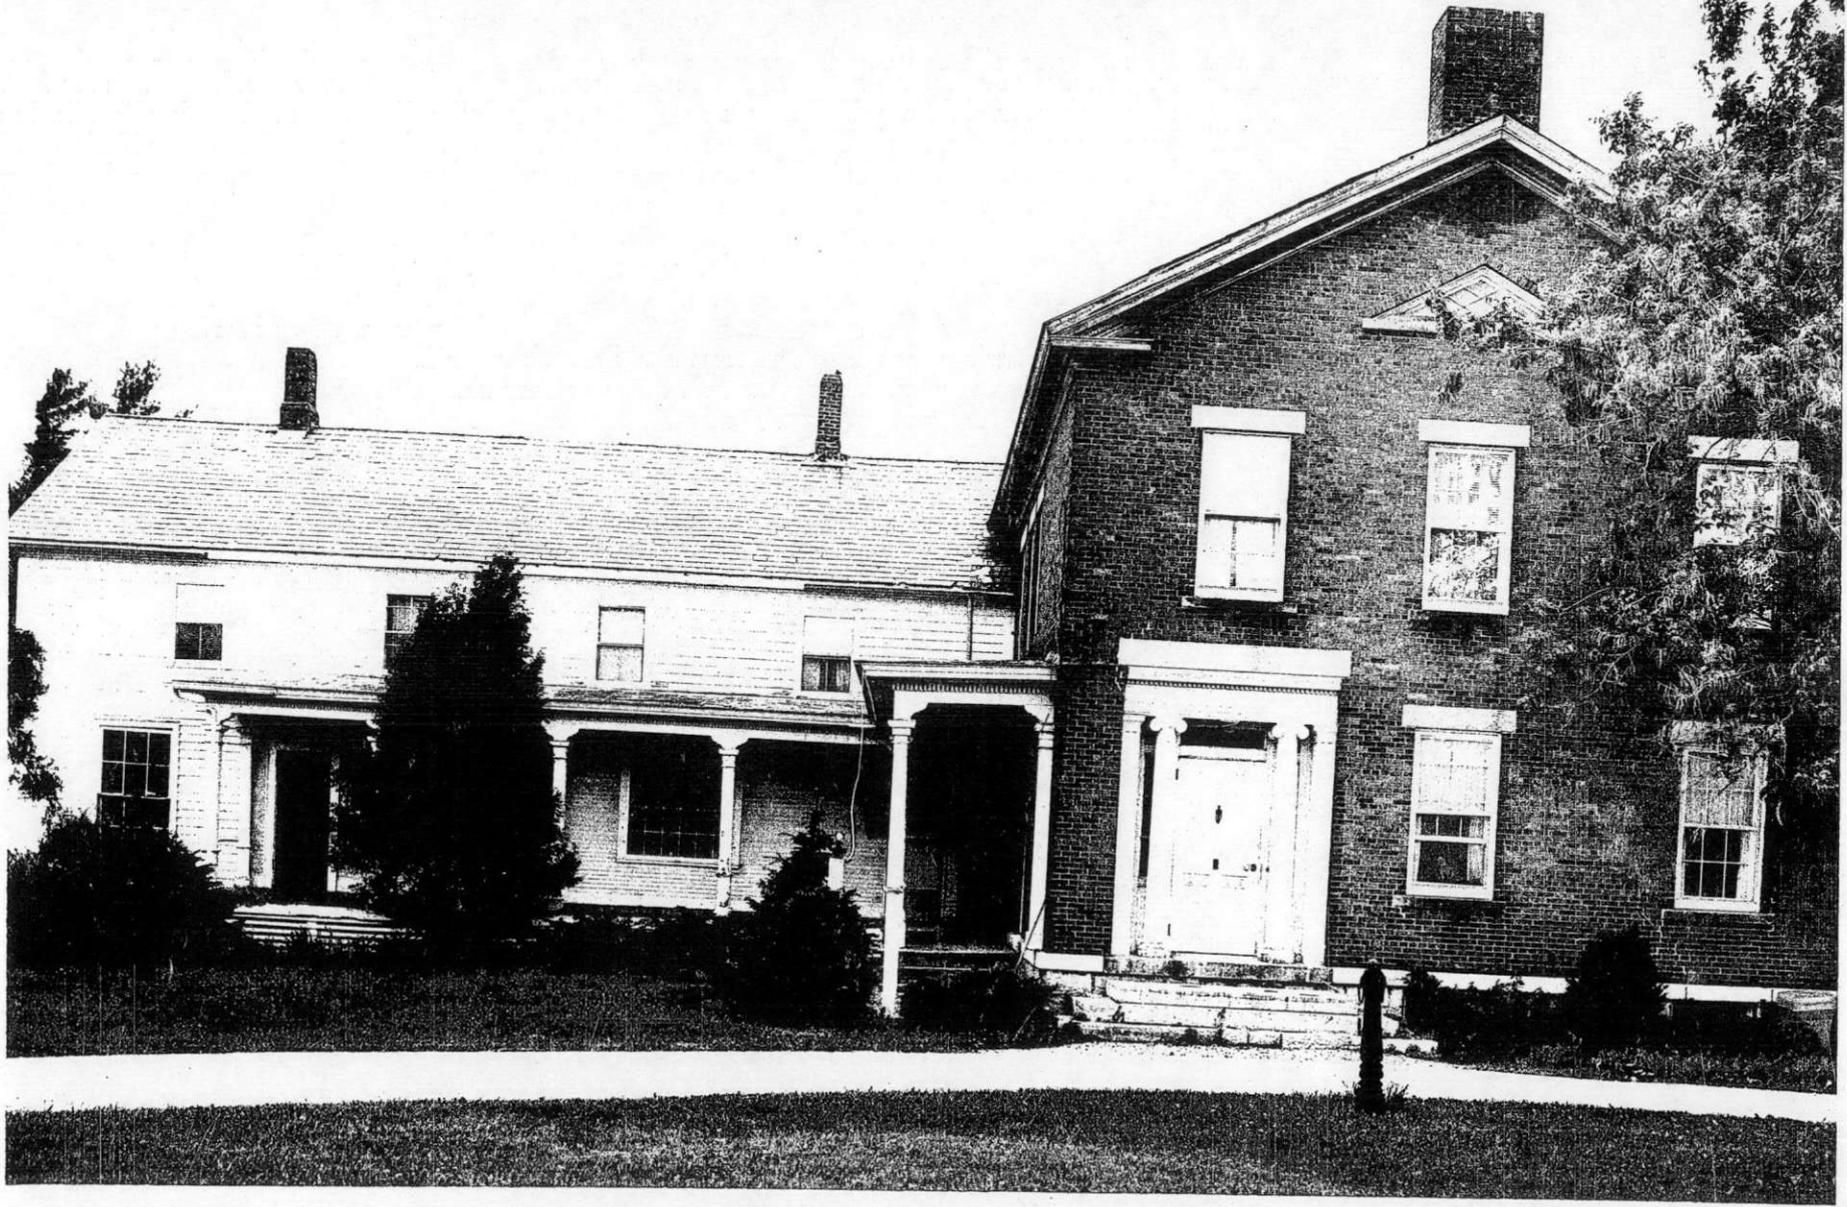
0105-24

Like other structures located very close to Route 7, the Spade Farmhouse must be placed in an "endangered" category.
