National Register of Historic Places Registration Form

historic name Montpelier Historic District Amendment (Boundary Increase)

street & number 70 to 101 East State Street and 1 West Street

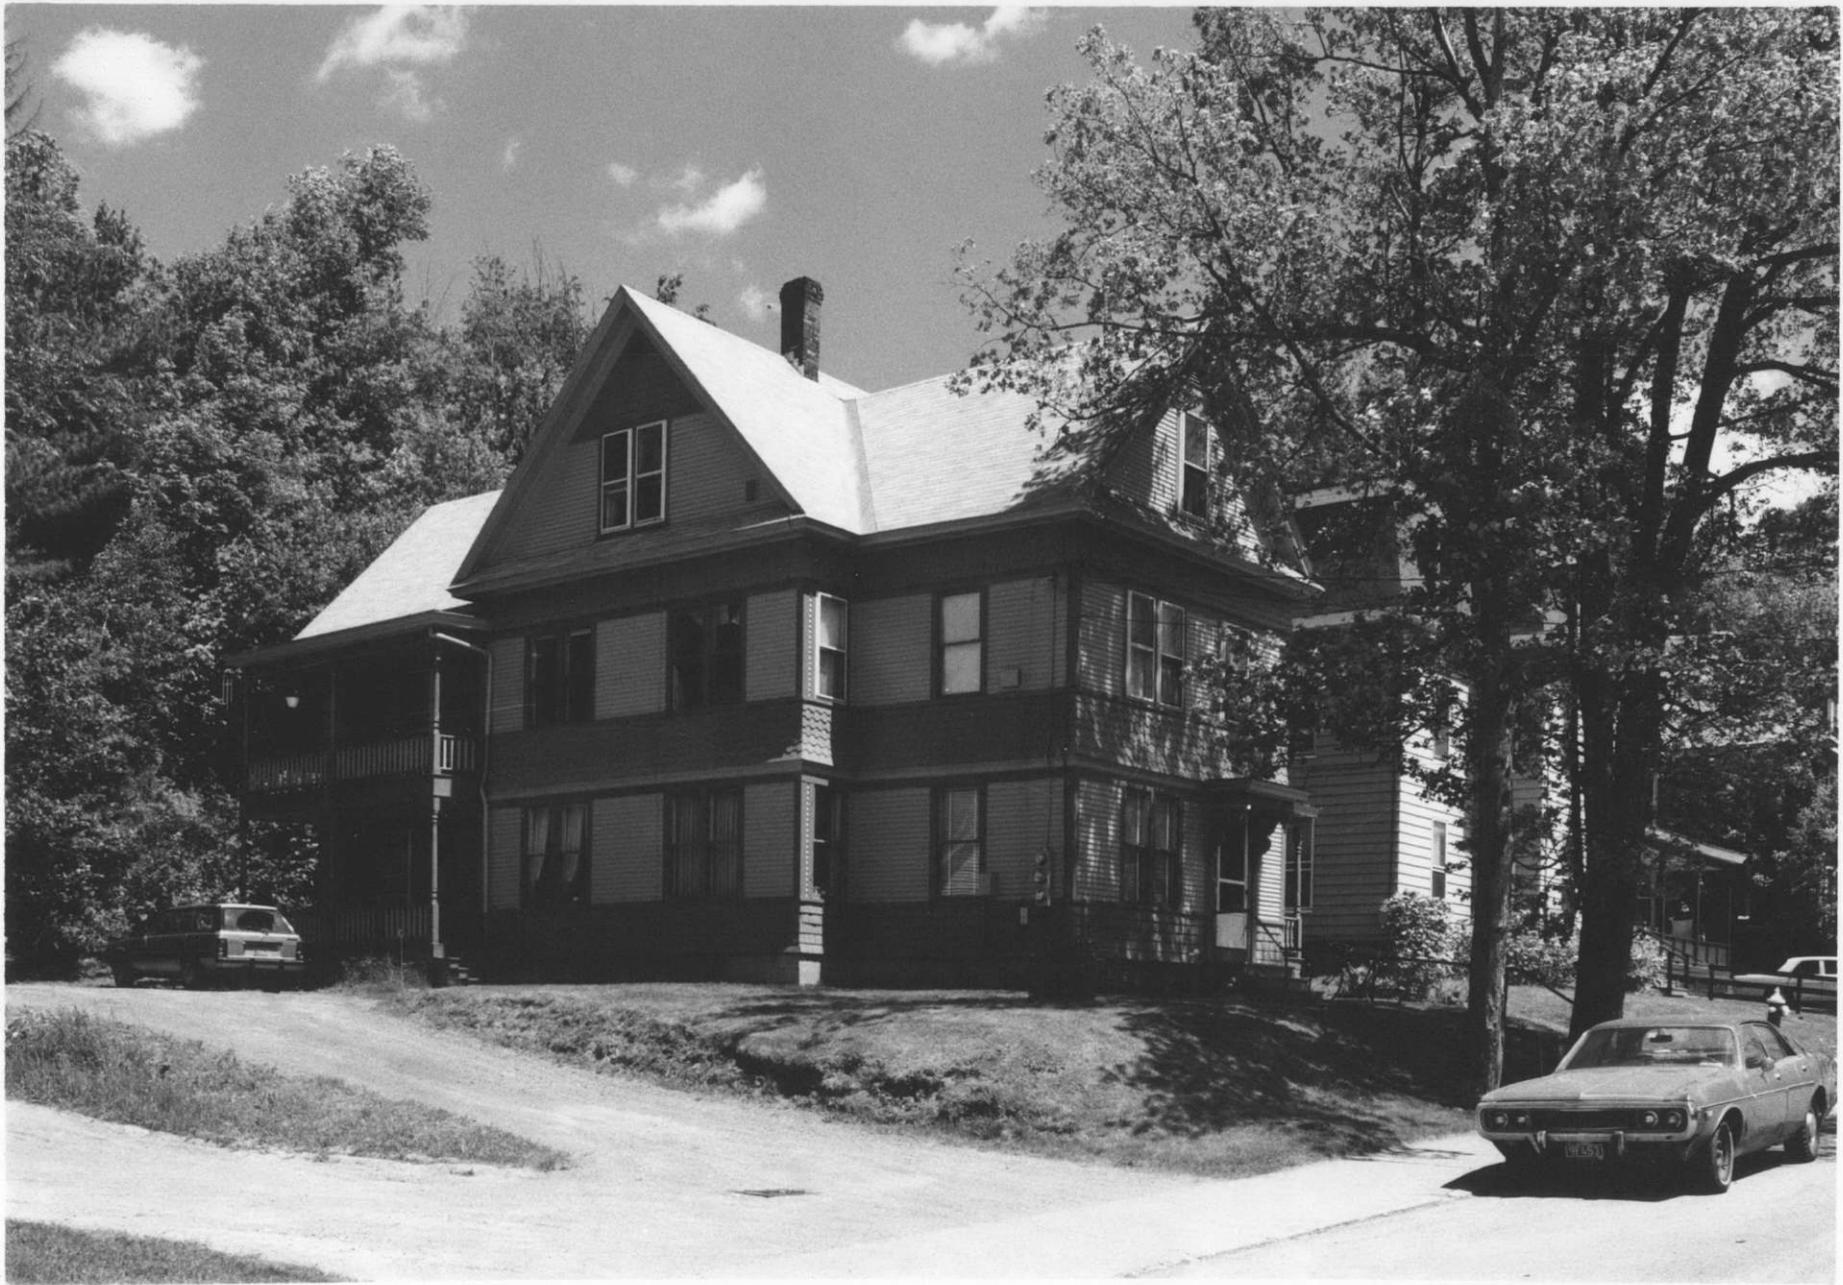
1

Montpelier Historic District Amendment (Boundary Increase)
East State Street, Montpelier, Vermont
Negative on file Vermont Division for Historic Preservation
Credit: Reid Larson
Date: June 1988
Description: #1. (70 East State St.), looking northeast
Photograph 4

1. Toby-Goodwin Duplex (70 East State Street), c. 1897.

This 2 1/2 story, Queen Anne style duplex rises from a granite foundation up to an asphalt-shingled, gable roof, which is divided by a slightly higher cross-gable which parallels the street to the south. A corbelled brick chimney is located on the cross-gable's ridge, just west of the roofs' intersection, and a smaller chimney is located on the east slope of the roof behind the cross gable. The gables are separated from the walls below by pent eaves and are sheathed with imbricated shingles in the peak and clapboards below, with the exception of the north gable which is sheathed entirely with clapboards. Below the roof's overhanging eaves, the walls are sheathed with variously patterned wooden shingles above and below the windows -- imbricated shingles in the upper section, alternating imbricated and square-cut shingles between floors, and square-cut shingles in the lower section -- and with clapboards between the windows.

The duplex's walls are fenestrated with single and paired 1-over-1 windows with plain surrounds in the gables and the two floors below, and with 3-pane windows in the basement. The main entrance contains a three-panel door with a large window and is protected by a flat-roofed hood supported by scrolled brackets with pendants. Ancillary entrances with panelled doors are located on the west and north facades.

A 1-by-1 bay, flat-roofed porch on the duplex's southeast corner occupies the space extending from the slightly projecting bay under the cross-gable to the front facade. The single-story porch is decorated with a turned corner post and a turned balustrade, which sit above a wooden skirt elaborated with geometric cut-outs in the shape of circles, eight-pointed stars, diamonds, and abstract fleur-de-lis patterns. A 2-story, 2-by-1 bay porch with turned posts and square balusters is located on the northwest corner of the house. A wooden stairway, which rises from the back edge of the building up to the gable, has been added to its east side.

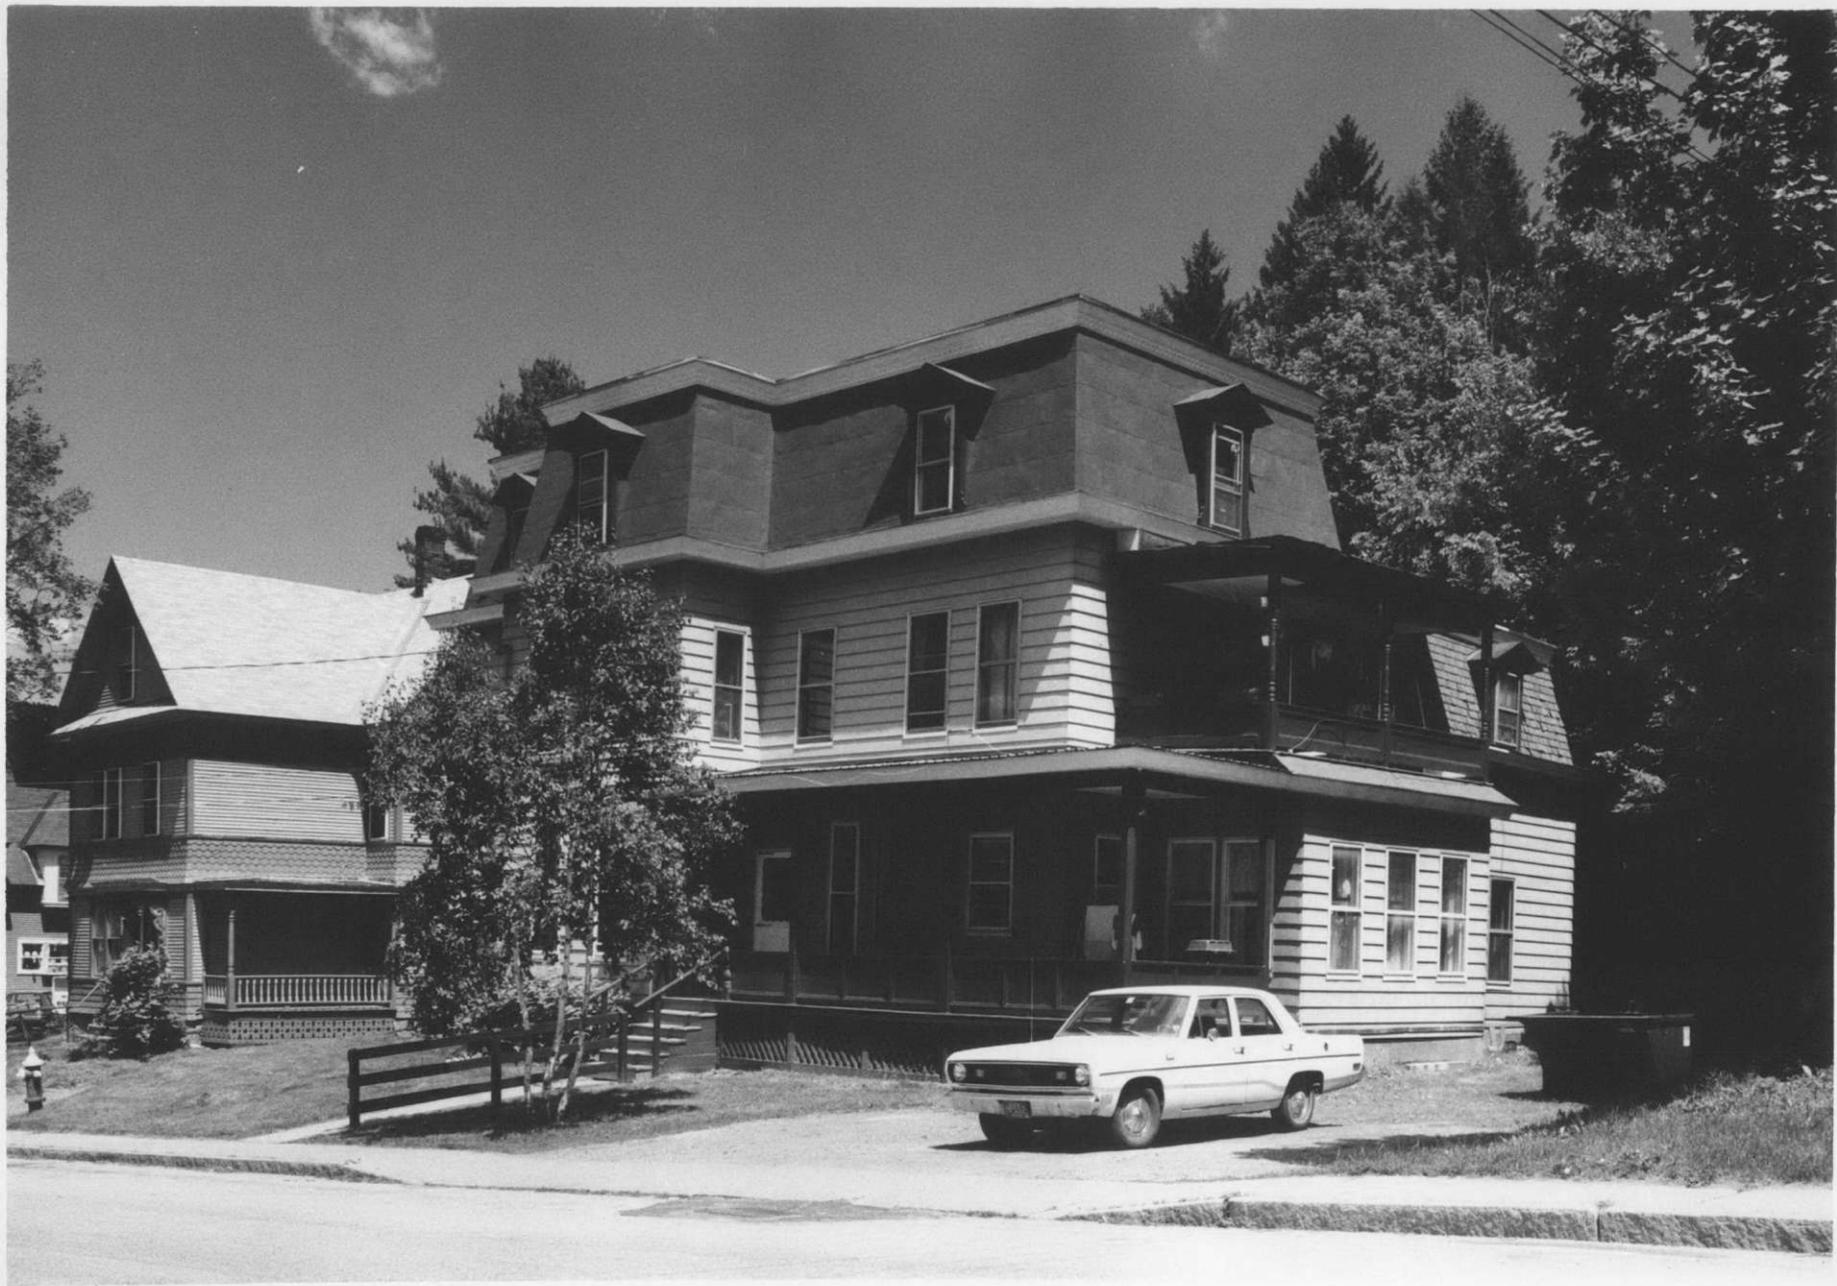
2

Montpelier Historic District Amendment (Boundary Increase)
East State Street, Montpelier, Vermont
Negative on file Vermont Division for Historic Preservation
Credit: Reid Larson
Date: June 1988
Description: #2. (72 East State St.), looking northwest
Photograph 5

2. Charles DeForest Bancroft House (72 East State Street), c. 1897.

This 3-story, Second Empire style house is rectangular in plan with an off-center, rectangular bay in front (south) and a 2-story, Mansard-roofed ell extending back from the northeast corner. The main block rises from a granite slab foundation up to a metal-clad, Mansard roof which comprises the third floor and contains pedimented dormers with scrolled window surrounds. Below the denticulated cornice of the roof, the walls of the house are covered with aluminum siding and fenestrated with 1-over-1 windows. The 2-story ell at the rear of the main block is finished in a similar manner, with the exception of the roof, which is sheathed with wooden shingles and contains two, 2-over-2 windows on its rear (north) face.

The house's main entrance is located on the south facade and is screened by a single-story, 3-by-1 bay, flat-roofed porch with chamfered posts (one which still retains flat, triangular brackets) and cross-hatched lattice skirting. Extending between the front porch and the rear ell is a 3-bay, shed-roofed, enclosed porch, above which is an open, 2-bay, second-story porch with turned columns. Another porch on the rear of the house is three stories high with wooden stairs leading up to an enclosed, shed-roofed space on the third floor. Only the 3-by-1 bay, front porch is original to the house. The other porches appear to have been constructed sometime after 1960, with the exception of the second story of the east (side) porch, which was probably constructed at ground level between 1909 and 1915 and moved to its present location when the enclosed porch was built.

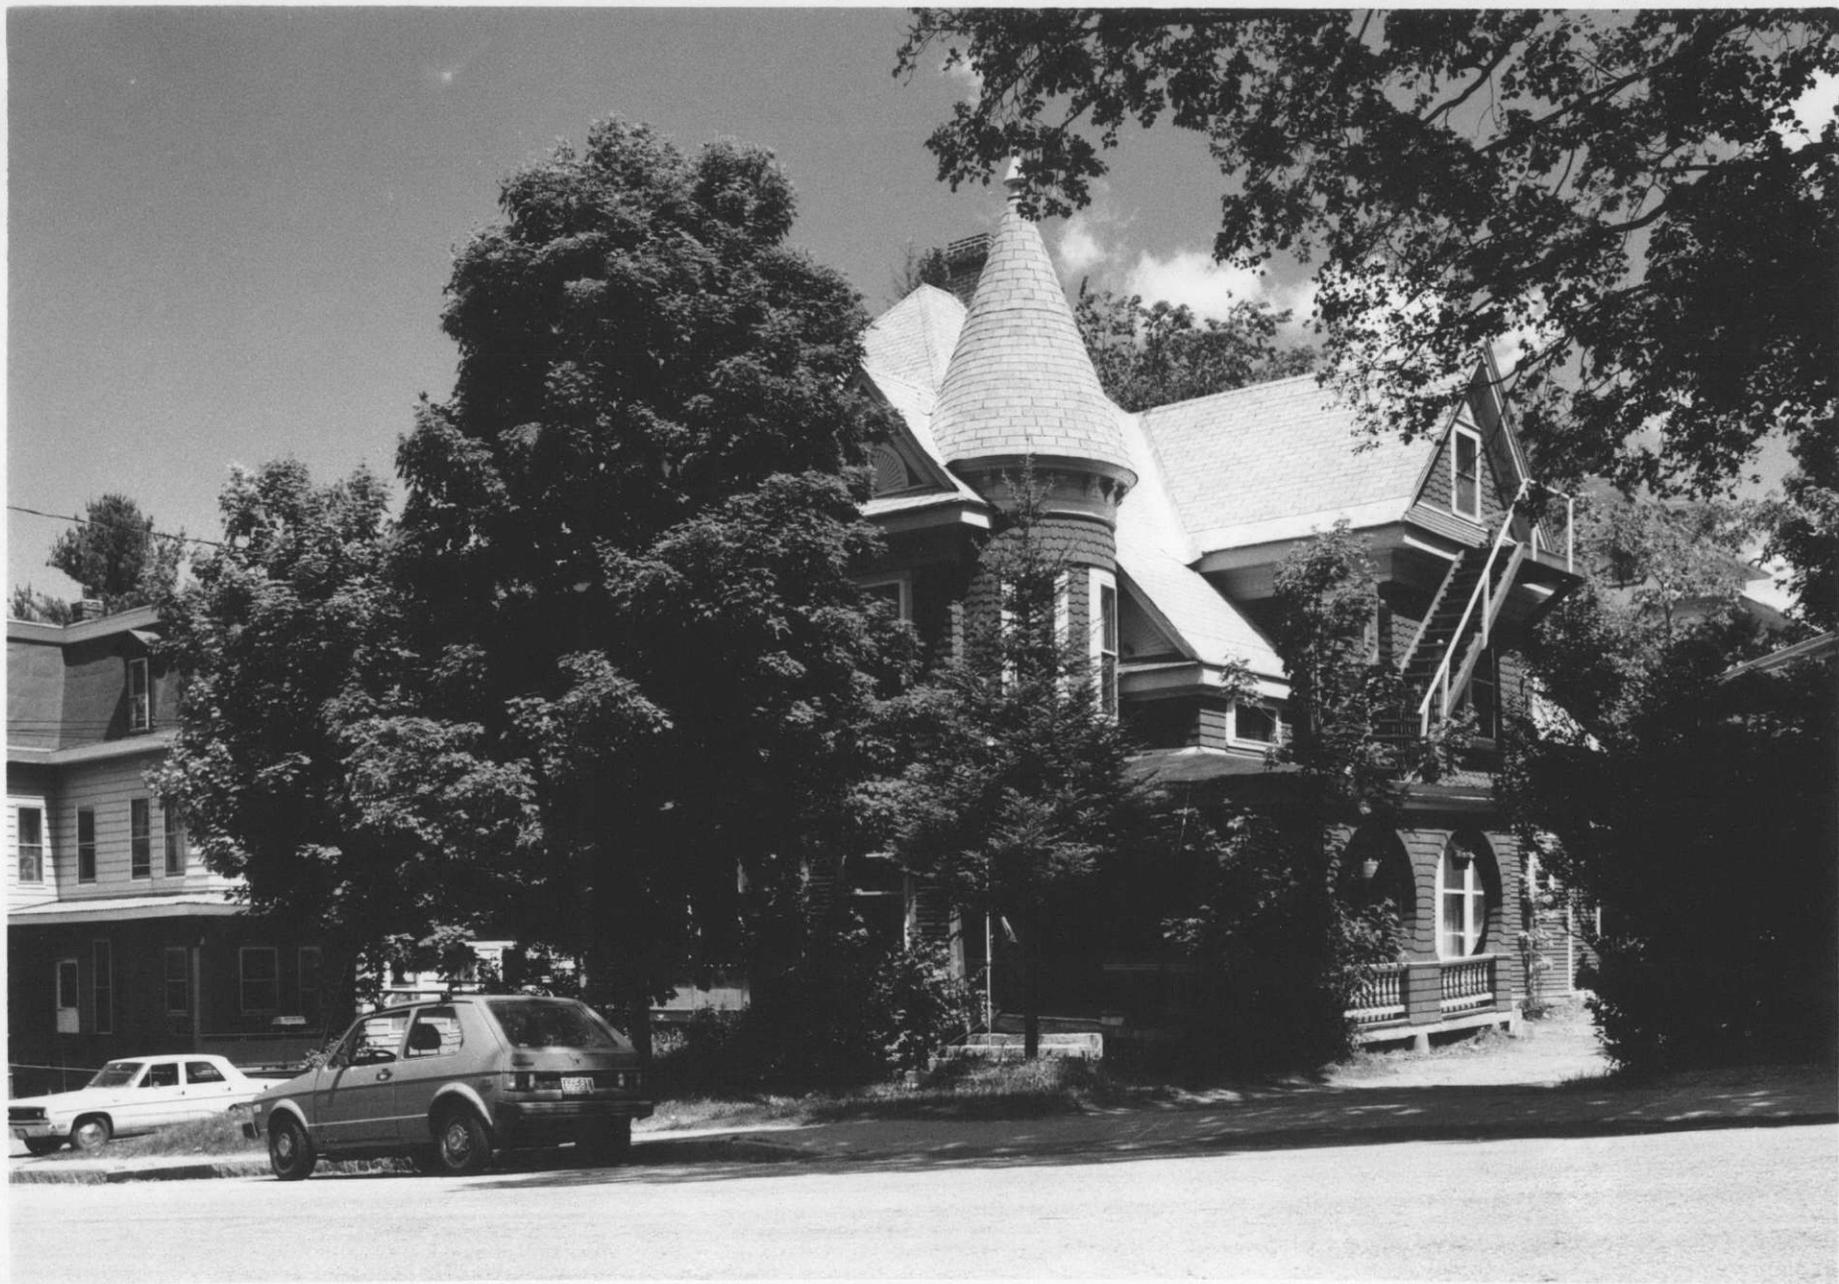
Montpelier Historic District Amendment (Boundary Increase)
East State Street, Montpelier, Vermont
Negative on file Vermont Division for Historic Preservation
Credit: Reid Larson
Date: June 1988
Description: #3. (74 East State St.), looking northwest
Photograph 6

3. Duplex (74 East State Street), c. 1897.

This 2 1/2 story, Queen Anne style house on the north side of East State Street has an irregular massing and generously reflects the vocabulary of the style. From the main, steeply-pitched hipped roof are projecting 2 1/2 story bays on the east, south (front), and west sides. These 1-by-1 bays are capped with pedimented gables which are separated from the wall below by pent eaves. A two-story, hipped-roofed wing extends along to the north with a single-story, hipped roofed entry room on its east end. A 3-by-2 bay, single-story porch, featuring horseshoe-shaped archs and turned balusters between shingled piers, extends around the southeast corner, with a cylindrical tower rising above the porch on the south facade. The tower is capped with a metal finial and has scrolled brackets below its overhanging eaves.

The walls of this wooden building are covered with clapboards on the first story and wooden shingles above. The shingles are laid in various patterns. On much of the second story, the shingles are laid in a square-edged staggered pattern, while a band at the top of the tower wall has a scalloped pattern. Quarter-round sunburst panels are located in the front projecting gable typanum and in the gable pediment formed by the main roof, just northeast of the tower.

Fenestration is irregular with single and paired 1-over-1 windows, except a 6-over-6 window on the first story of the north facade and a single pane horizontal window over the porch. The building rests on a granite foundation and a brick chimney rises from the ridge at the center of the main roof.

The main entrance opens onto the porch below the tower on the south facade, and a side entrance is located on the east near the rear corner. A recently constructed, wooden fire escape leads from the attic window on the east bay to the roof of the porch.

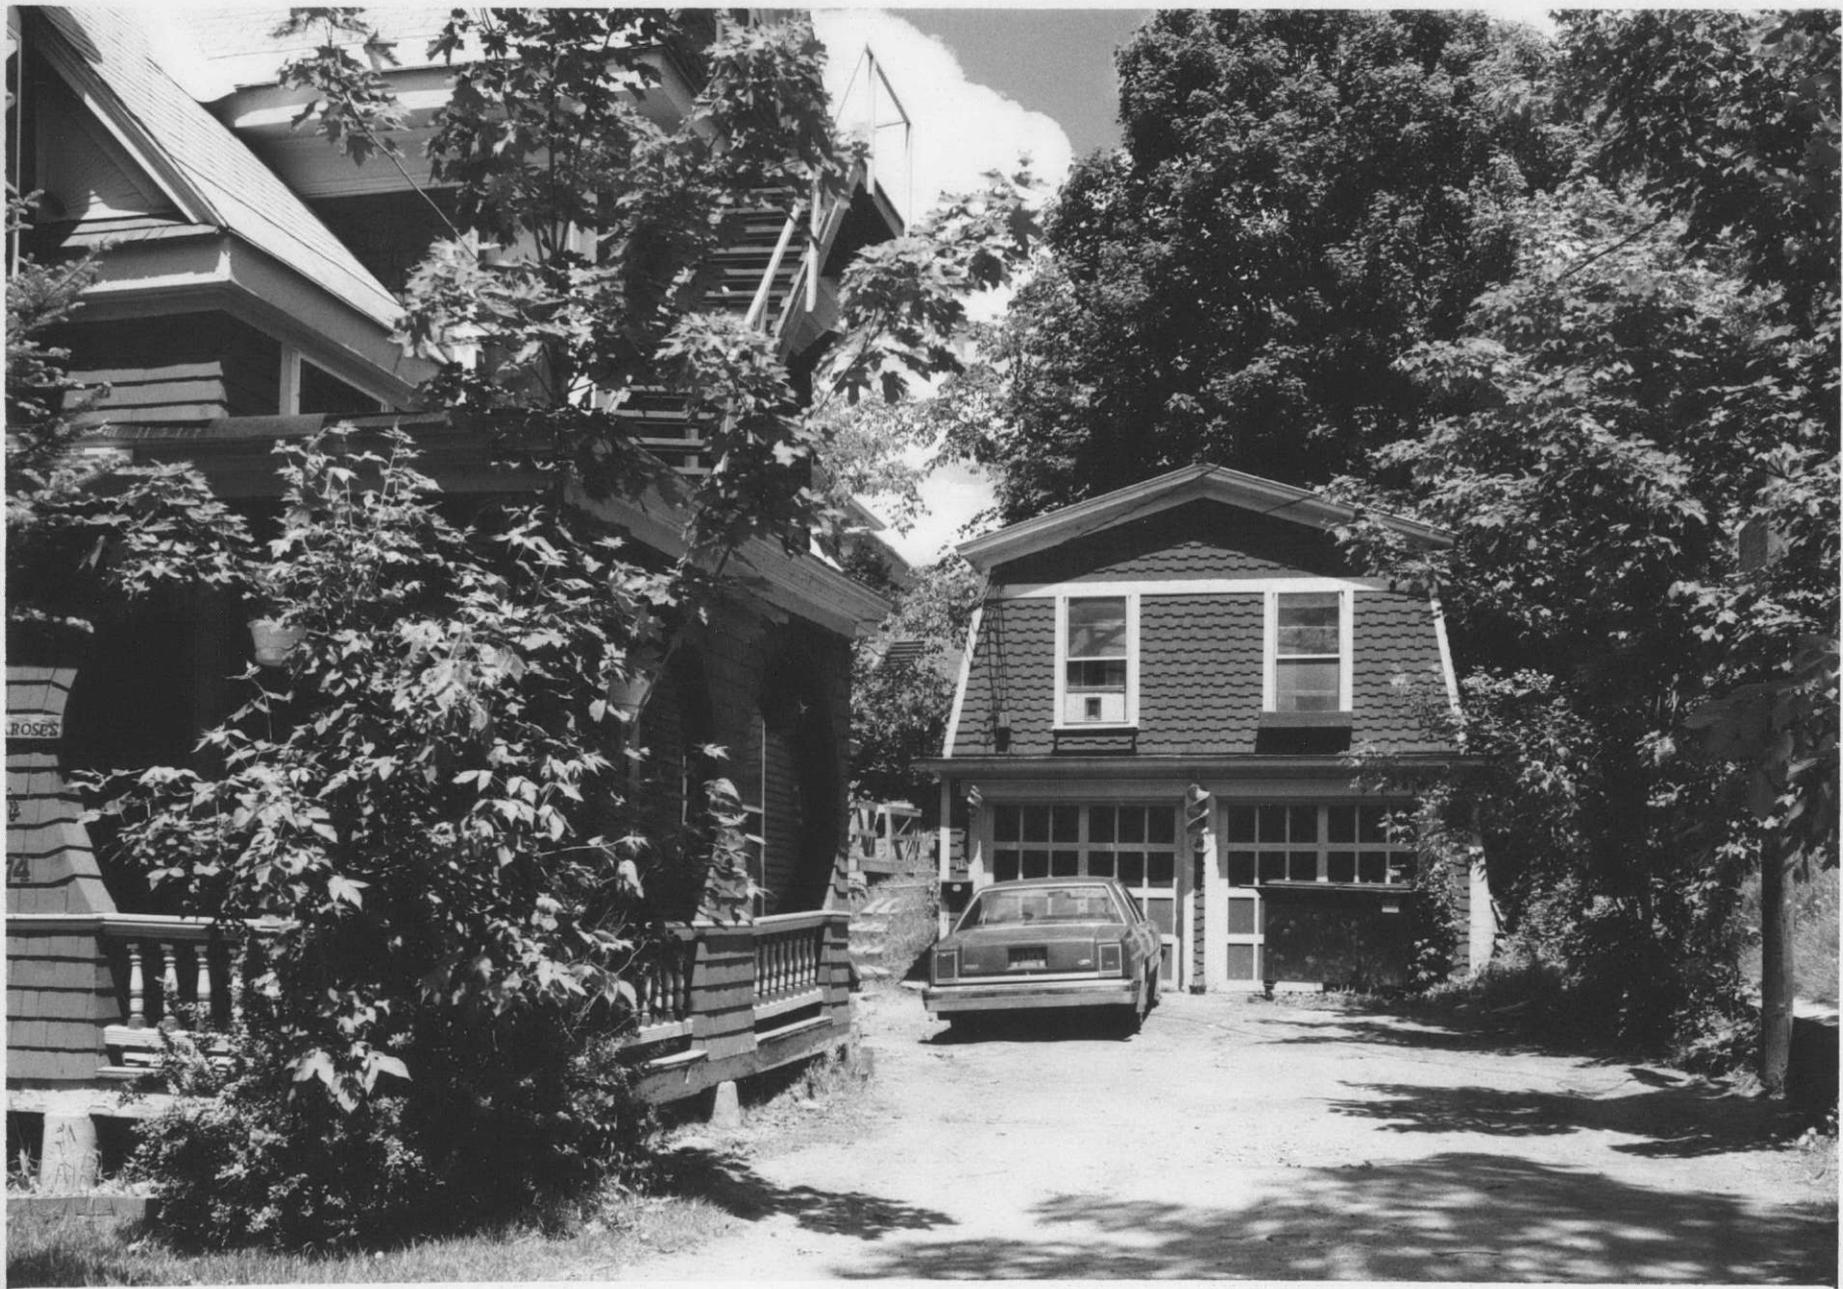
3A

Montpelier Historic District Amendment (Boundary Increase)
East State Street, Montpelier, Vermont
Negative on file Vermont Division for Historic Preservation
Credit: Reid Larson
Date: June 1988
Description: #3a. (74 1/2 East State St.), looking north
Photograph 7

3a. Garage/ Apartment (74 1/2 East State Street) c. 1925.

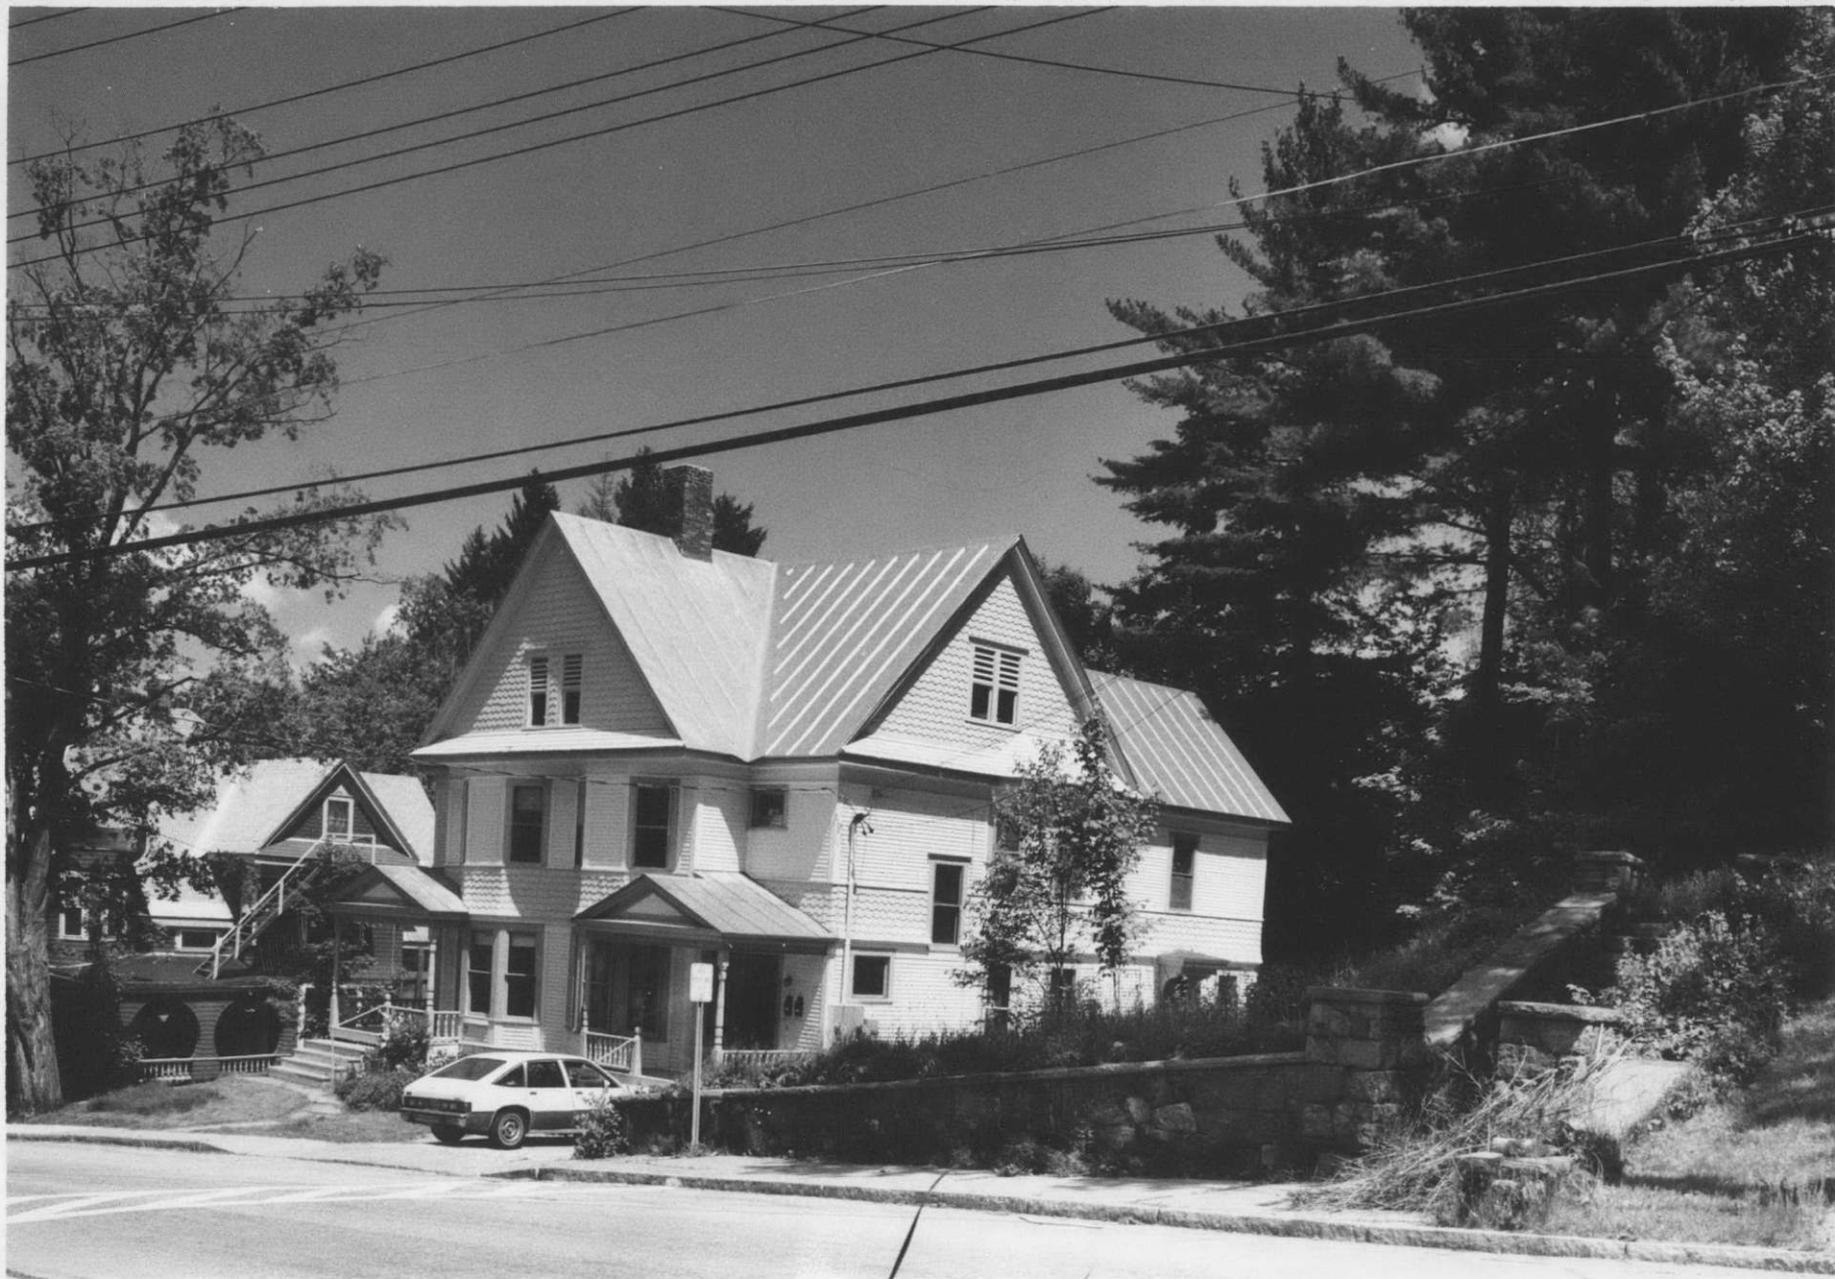
4

Description: #4. (76 East State St.), looking northwest; granite stairs at
right lead up to #5.

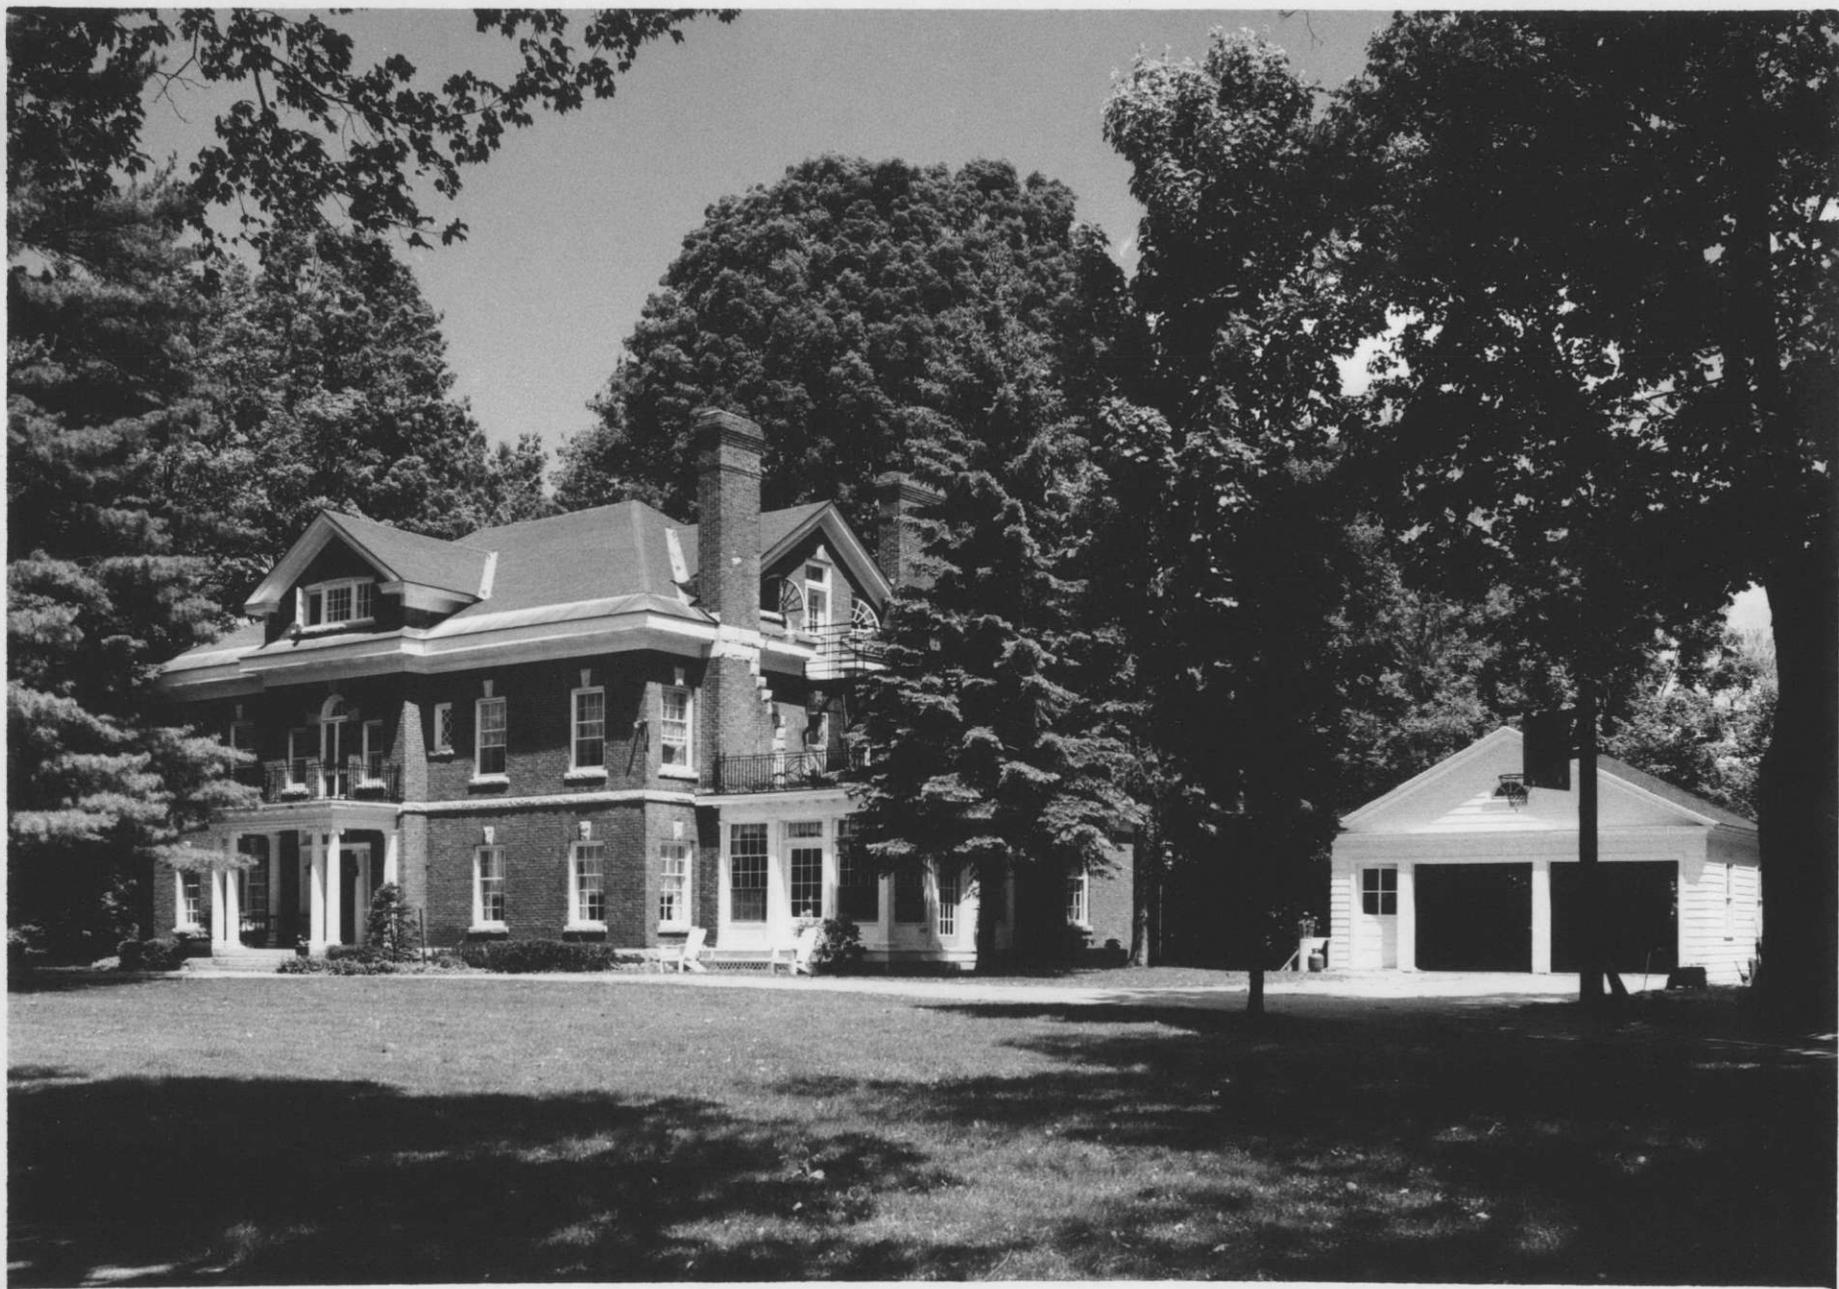
5, 5A

Description: #5. (100 East State St.), looking NW; #5a. Garage at right.

Set high above East State Street on one of the largest lots in the city, this 2 1/2 story, brick house, with a hipped roof and gabled dormers on all four sides, is an imposing example of the Colonial Revival style of architecture. Its rough-faced granite foundation, entry steps, belt course, and window sills, keystones, and corner blocks reinforce the substantial feeling of the building.

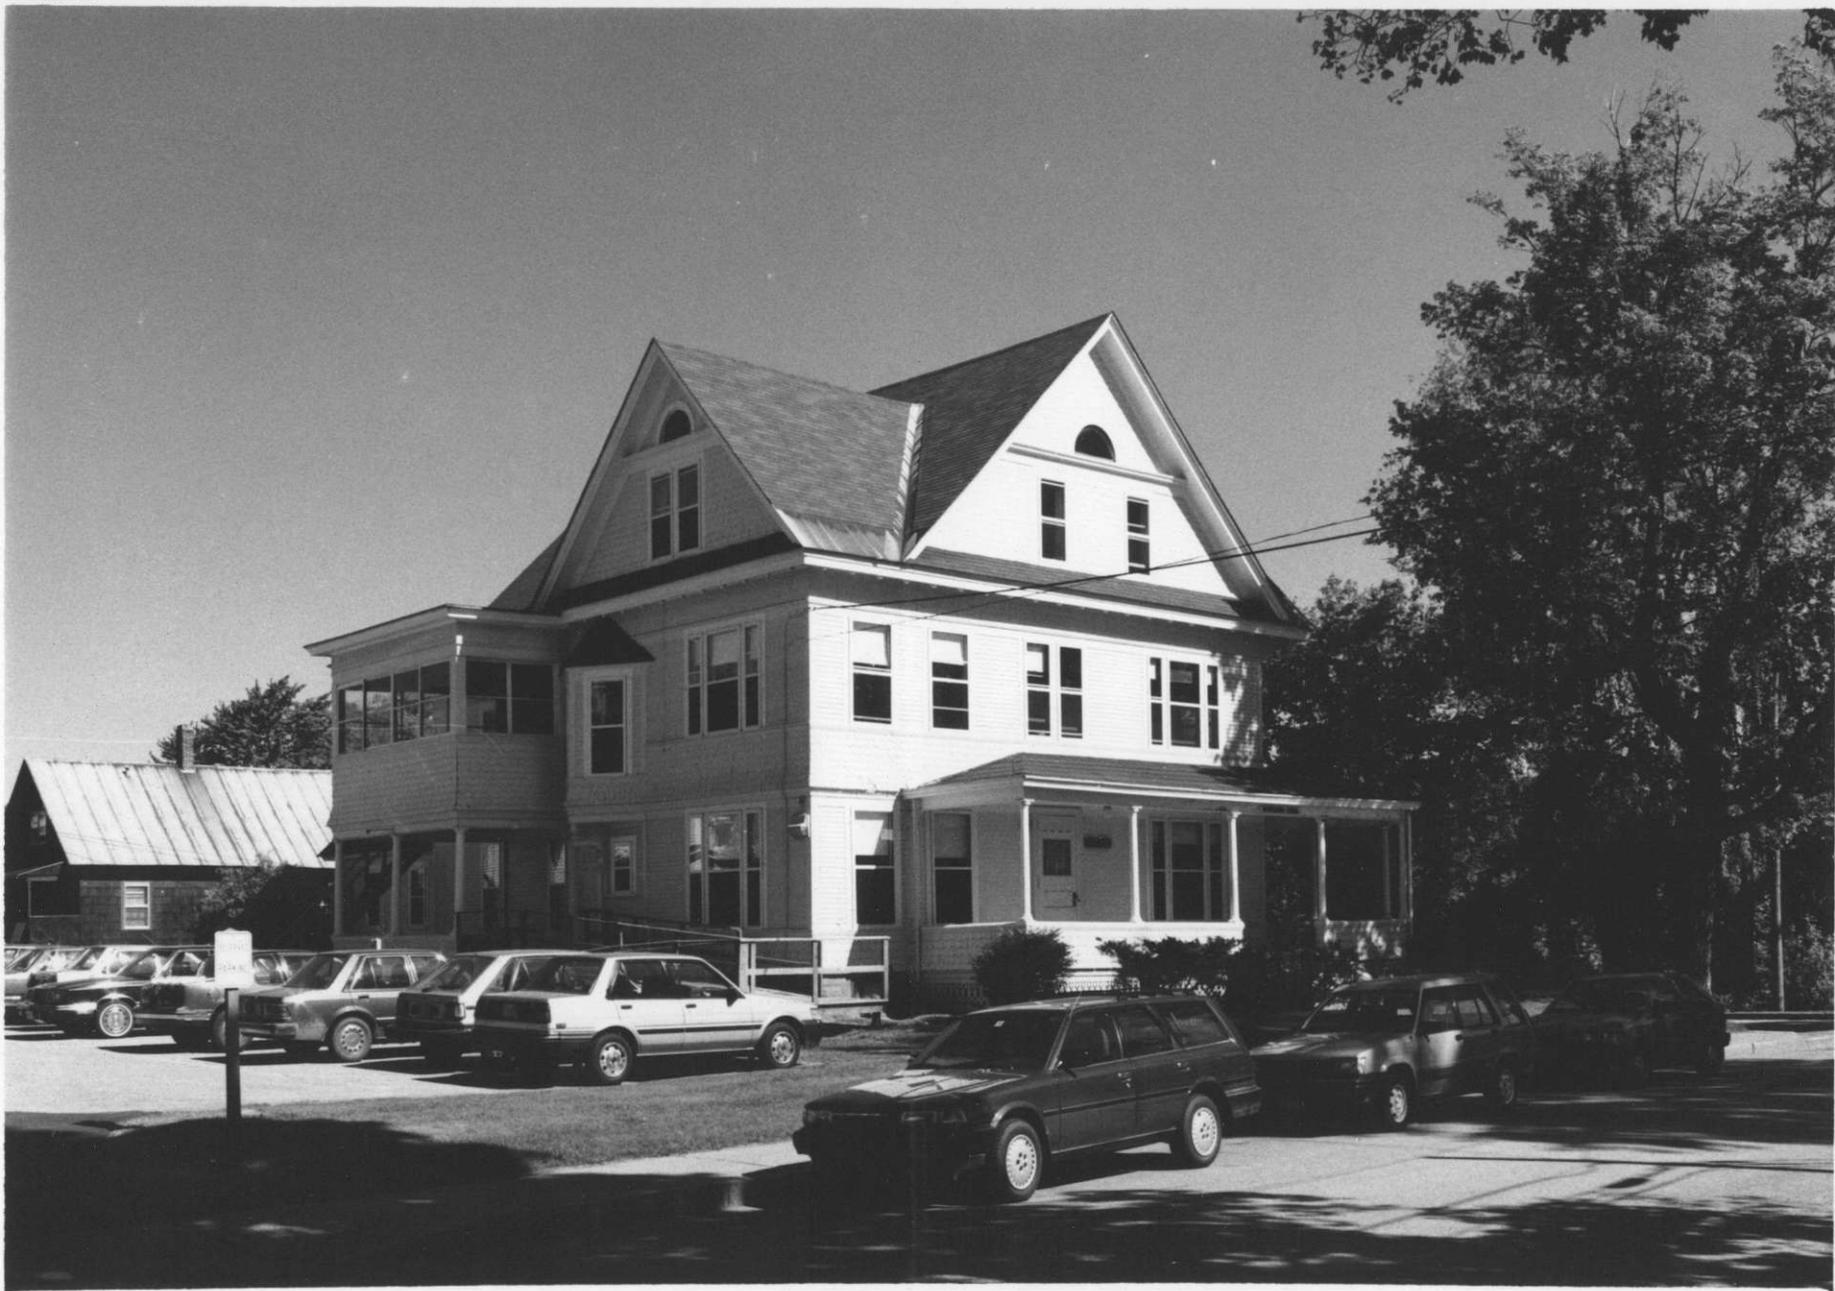
6

Montpelier Historic District Amendment (Boundary Increase)
East State Street, Montpelier, Vermont
Negative on file Vermont Division for Historic Preservation
Credit: Reid Larson
Date: June 1988
Description: #6. (1 West Street), looking northwest
Photograph 10

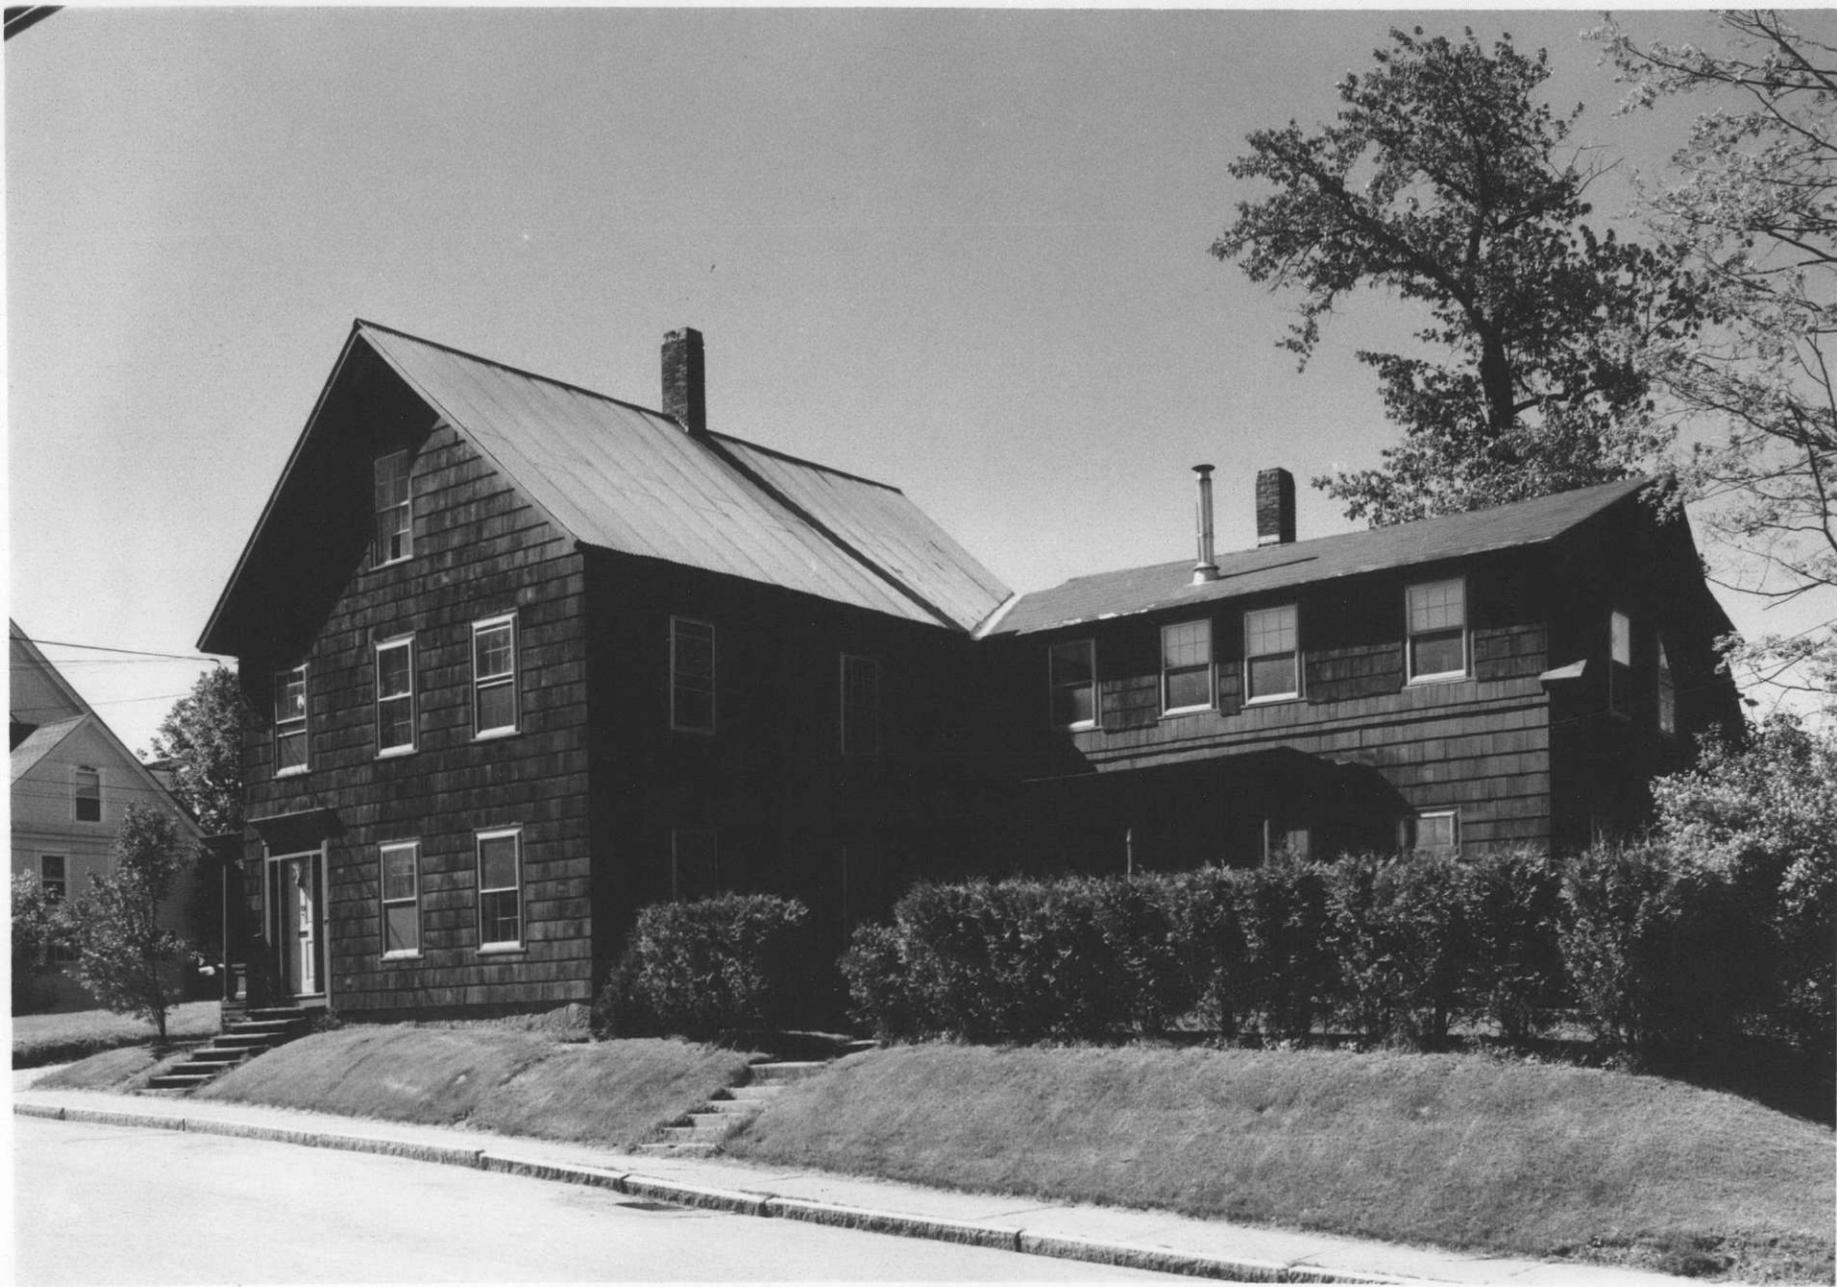
7

Montpelier Historic District Amendment (Boundary Increase)
East State Street, Montpelier, Vermont
Negative on file Vermont Division for Historic Preservation
Credit: Reid Larson
Date: June 1988
Description: #7. (99-101 East State St.), looking southeast
Photograph 11
