National Register of Historic Places Registration Form

historic name Montpelier Historic District Amendment (Boundary Increase)

street & number 70 to 101 East State Street and 1 West Street

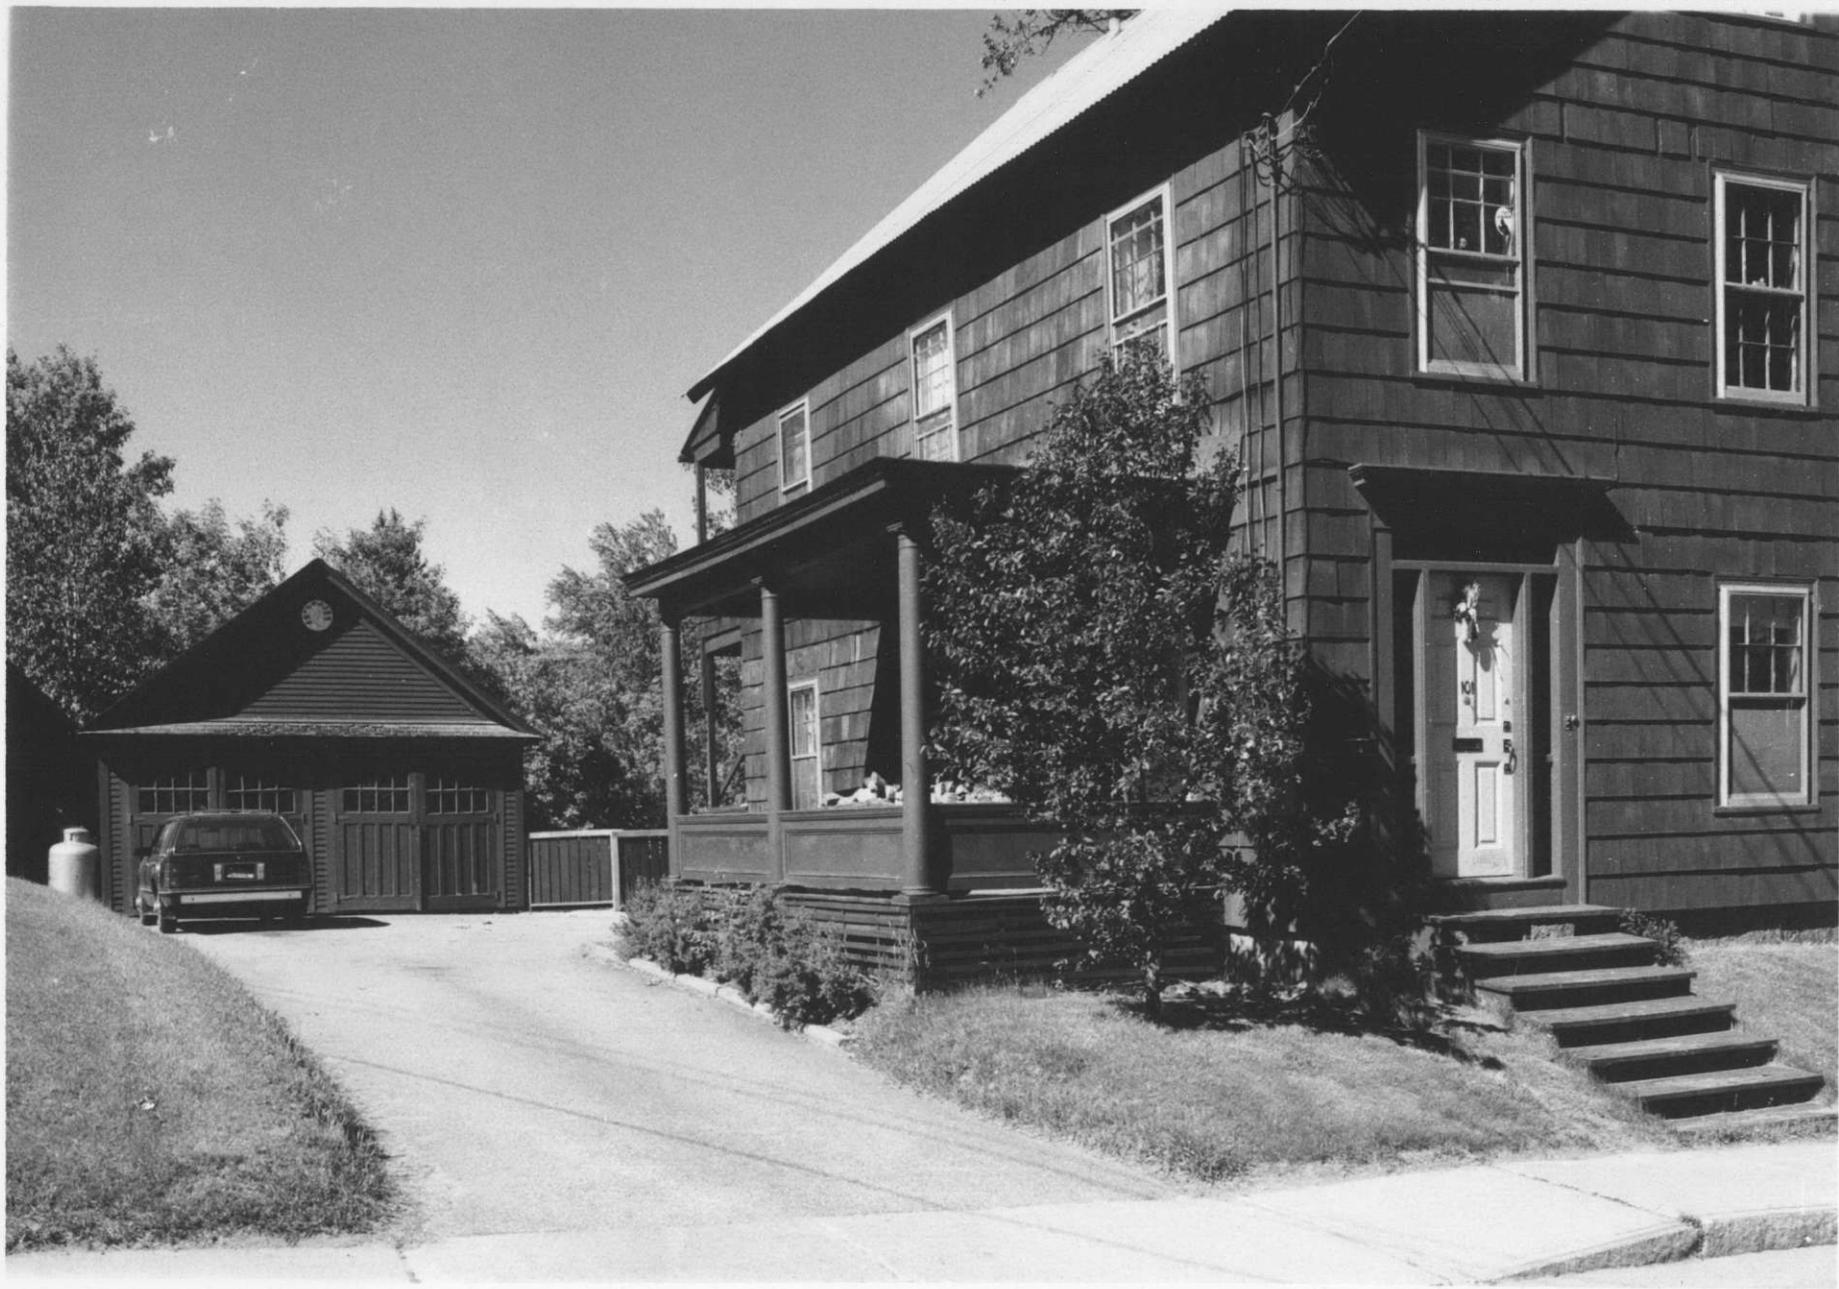
7A

Montpelier Historic District Amendment (Boundary Increase)
East State Street, Montpelier, Vermont
Negative on file Vermont Division for Historic Preservation
Credit: Reid Larson
Date: June 1988
Description: #7a. Garage (99-101 East State St.), looking south
Photograph 12

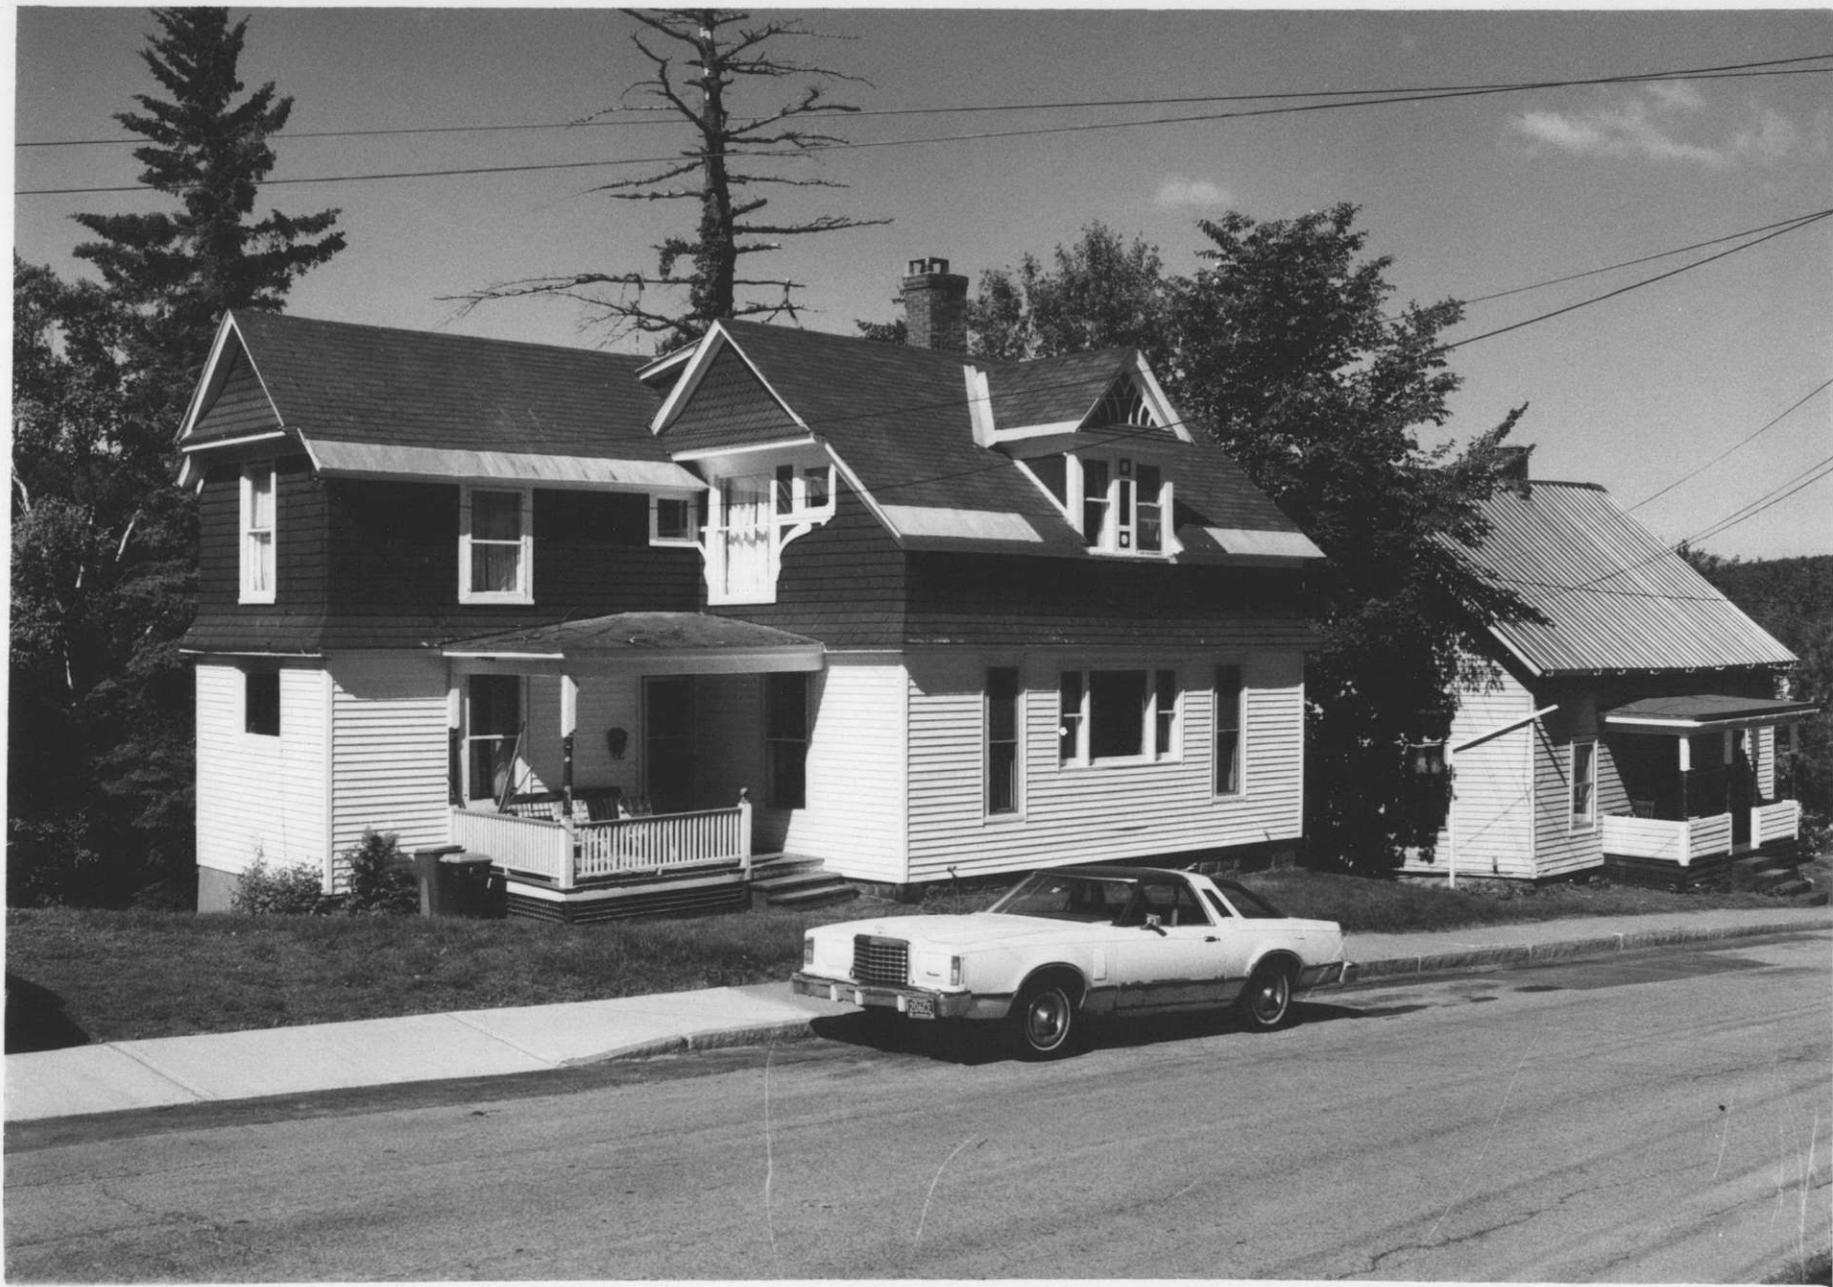
8

Description: #8. (95 East State St.), looking southwest

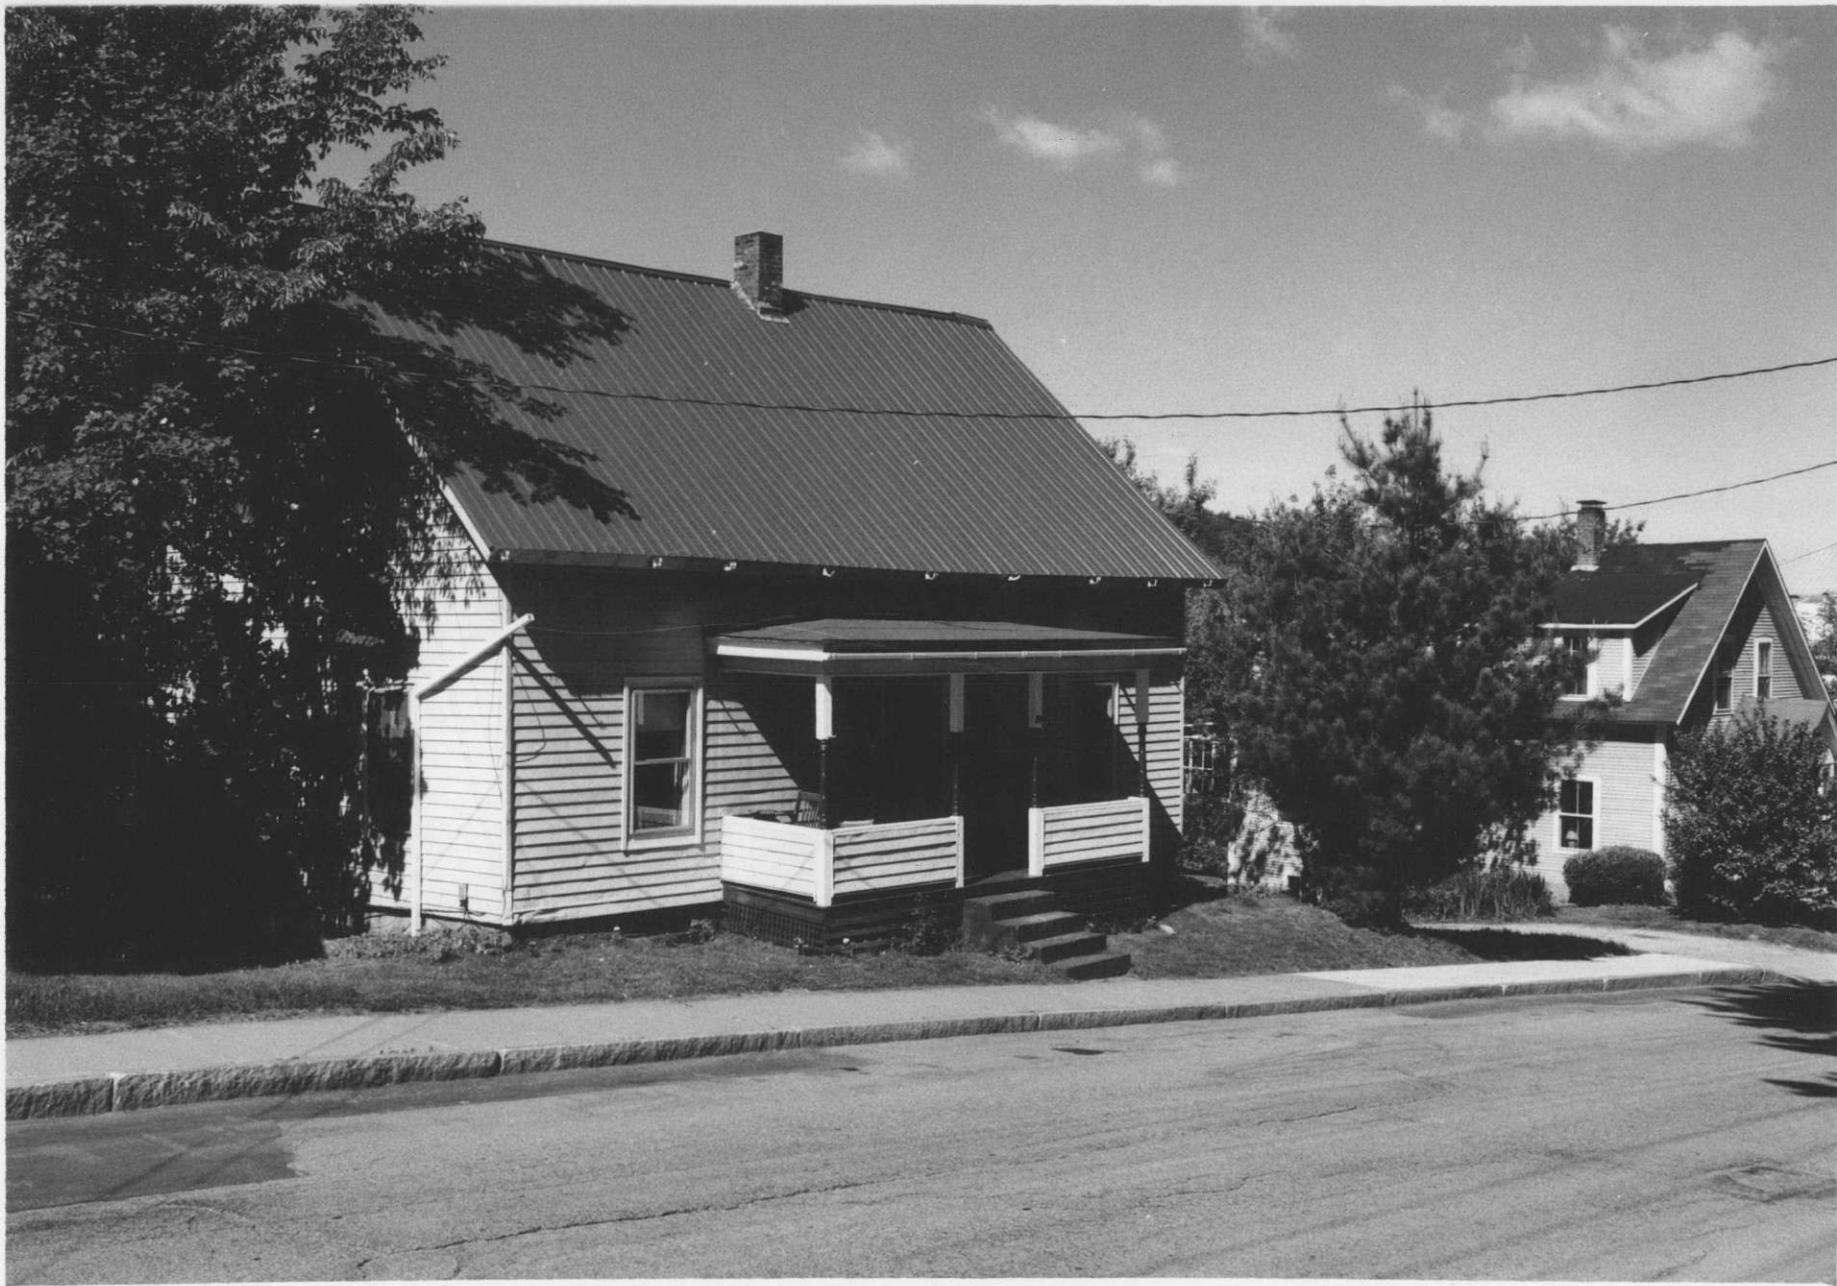
9

Description: #9. (89 East State St.), looking southwest

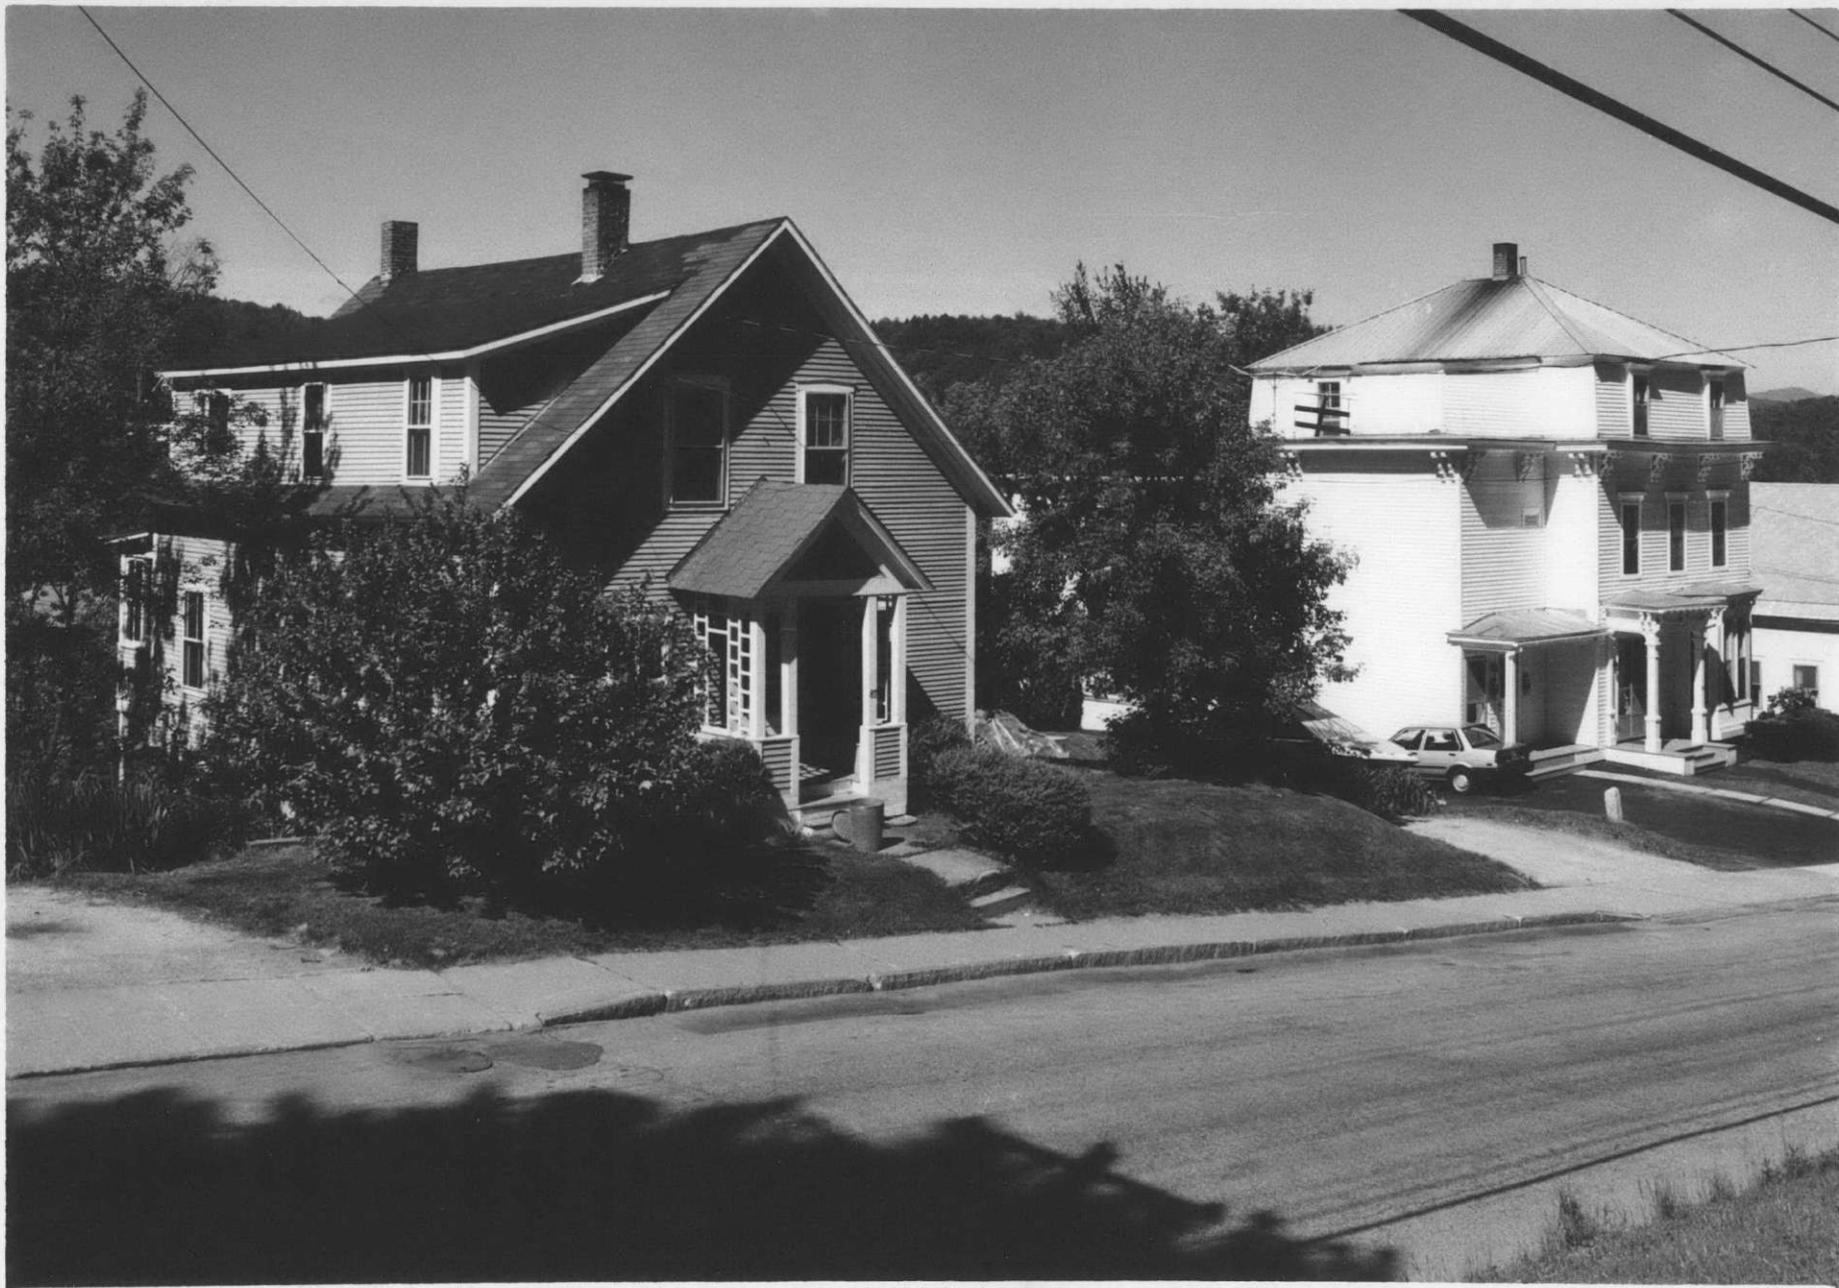
10, 11

Description: #10. (87 East State St.), looking southwest; #11 at right

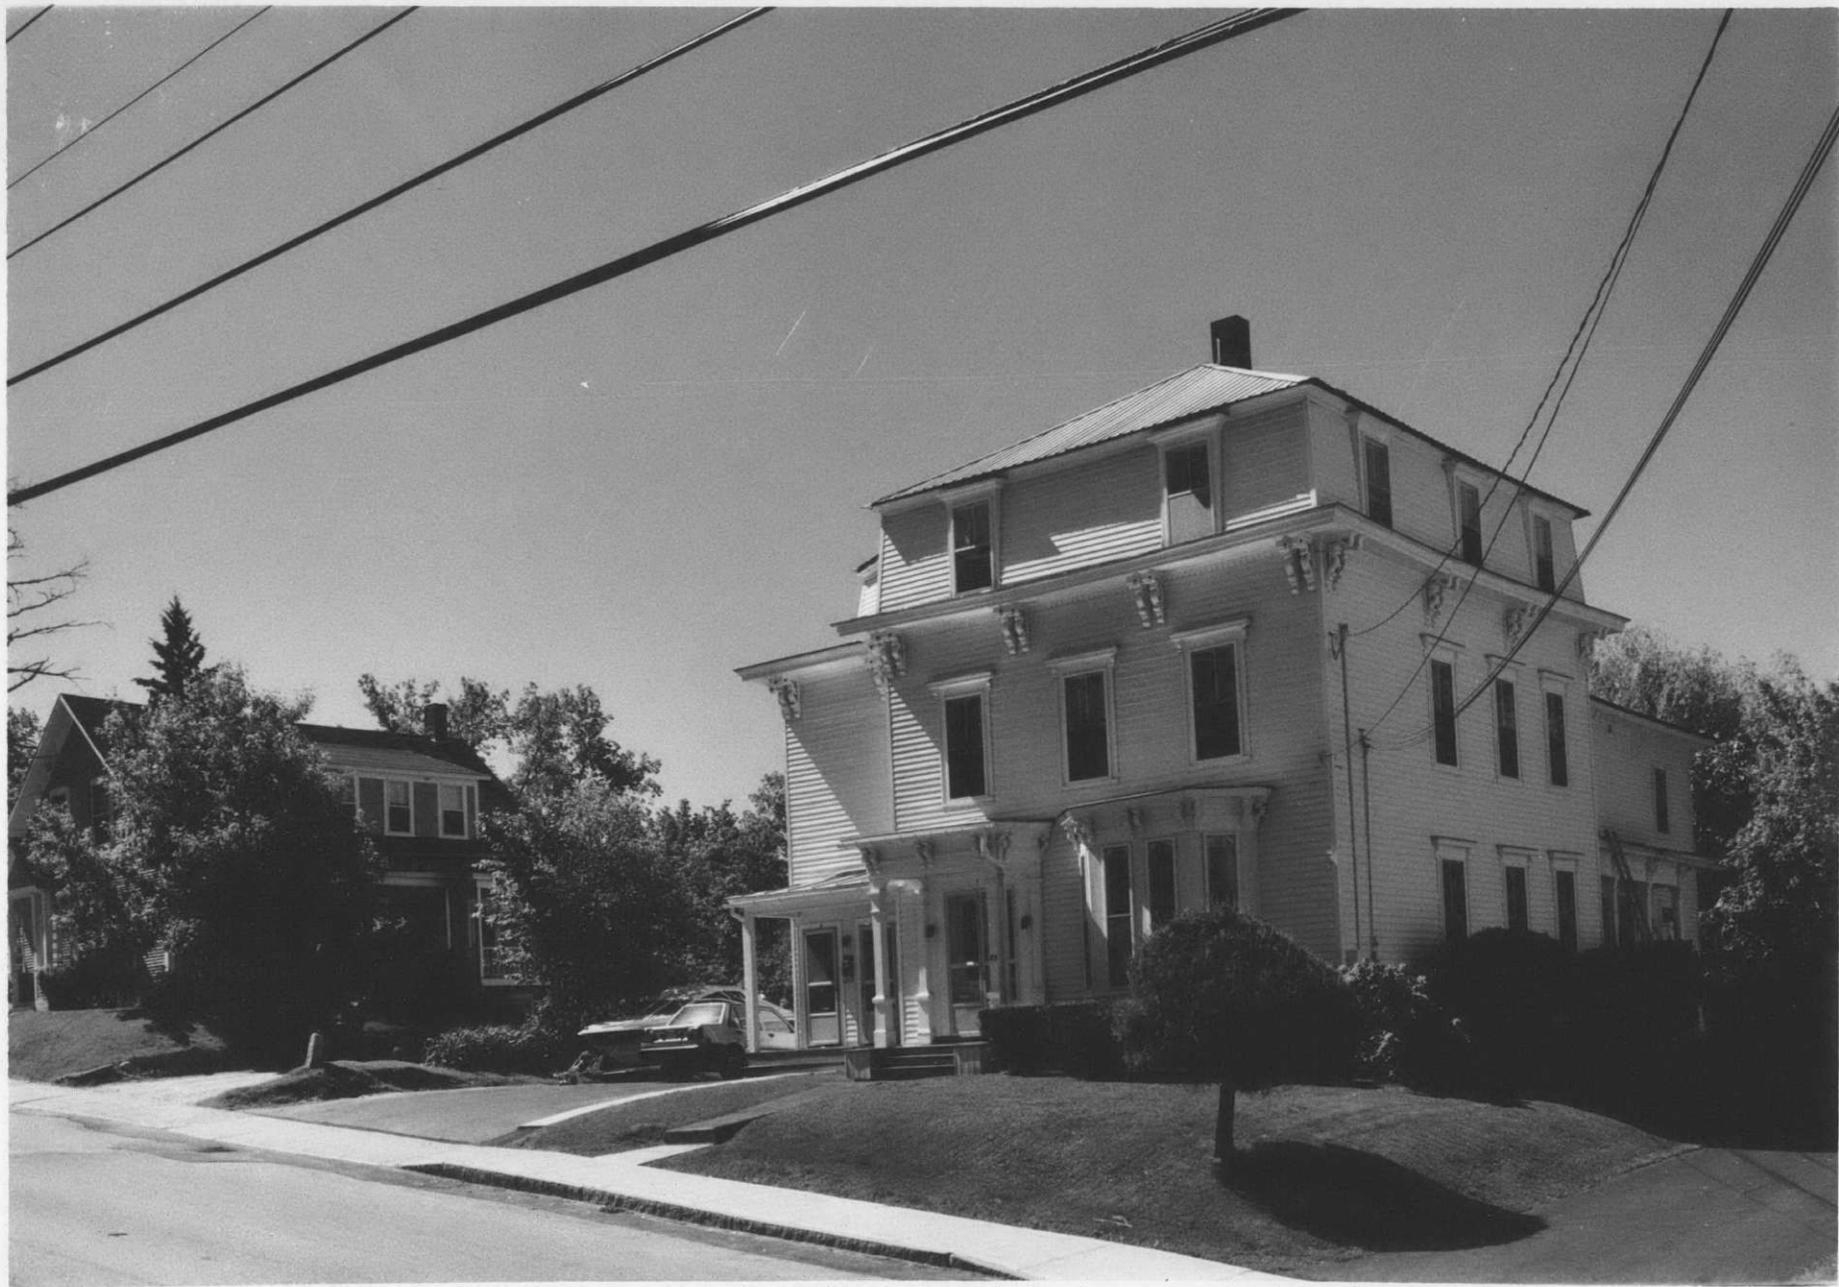
11

Montpelier Historic District Amendment (Boundary Increase)
East State Street, Montpelier, Vermont
Negative on file Vermont Division for Historic Preservation
Credit: Reid Larson
Date: June 1988
Description: #11. (83-85 East State St.), looking southeast
Photograph 16

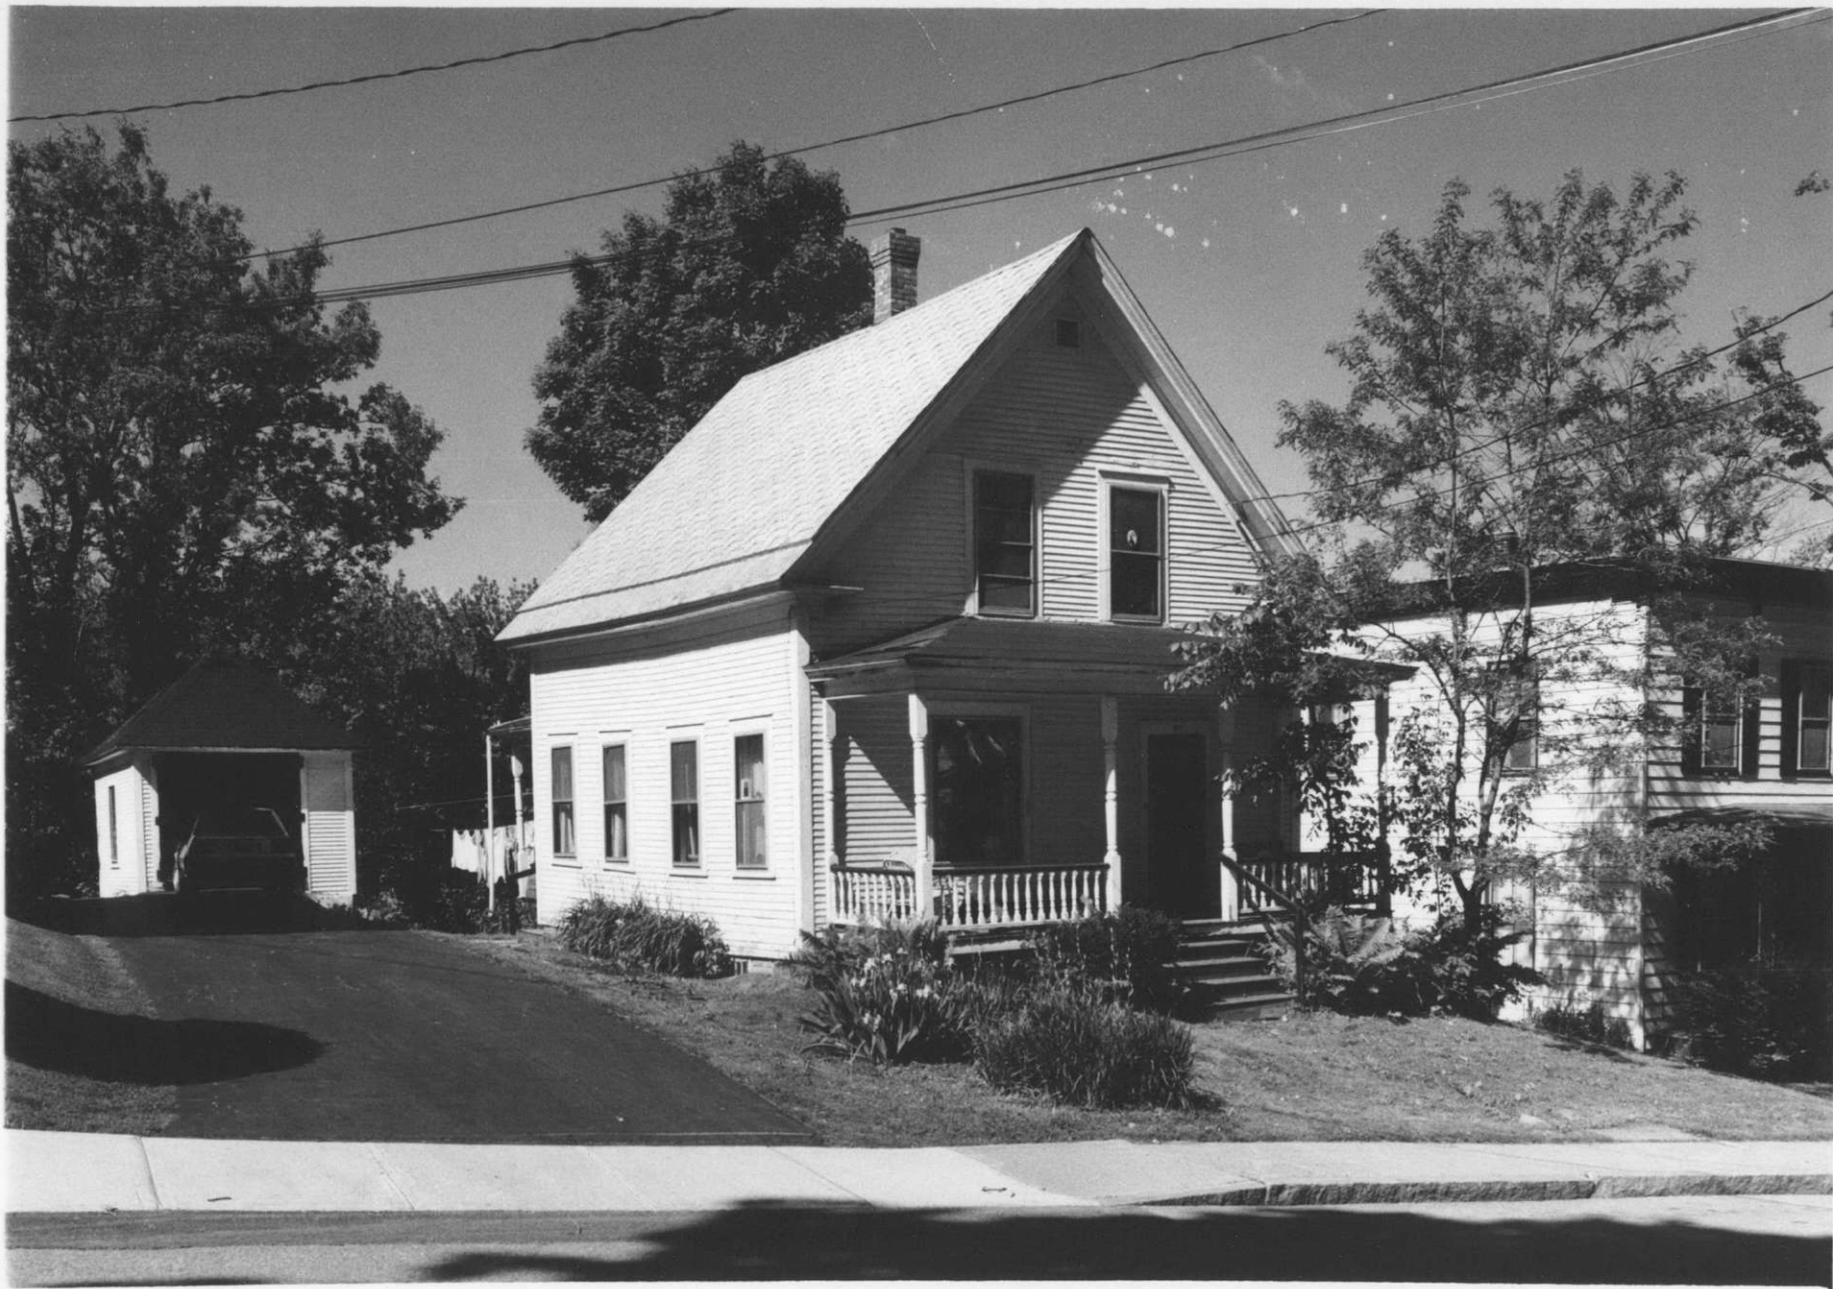
12

Montpelier Historic District Amendment (Boundary Increase)
East State Street, Montpelier, Vermont
Negative on file Vermont Division for Historic Preservation
Credit: Reid Larson
Date: June 1988
Description: #12. (81 East State St.), looking southwest
Photograph 17

Located behind #12 (81 East State Street), this small, 1-by-1 bay, clapboarded, single-car garage has an asphalt-shingled, hipped roof. The building rests on a concrete foundation. The hinged pair of garage doors are slightly offset. The building takes advantage of the steeply sloping terrain to allow a lower story on the rear (south) and west sides. The windows are 2-over-2, except a 9-pane sash is located on the west main story. A simple board door on the west side allows access to the lower level. This garage first appears on the 1925 Sanborn Insurance maps.

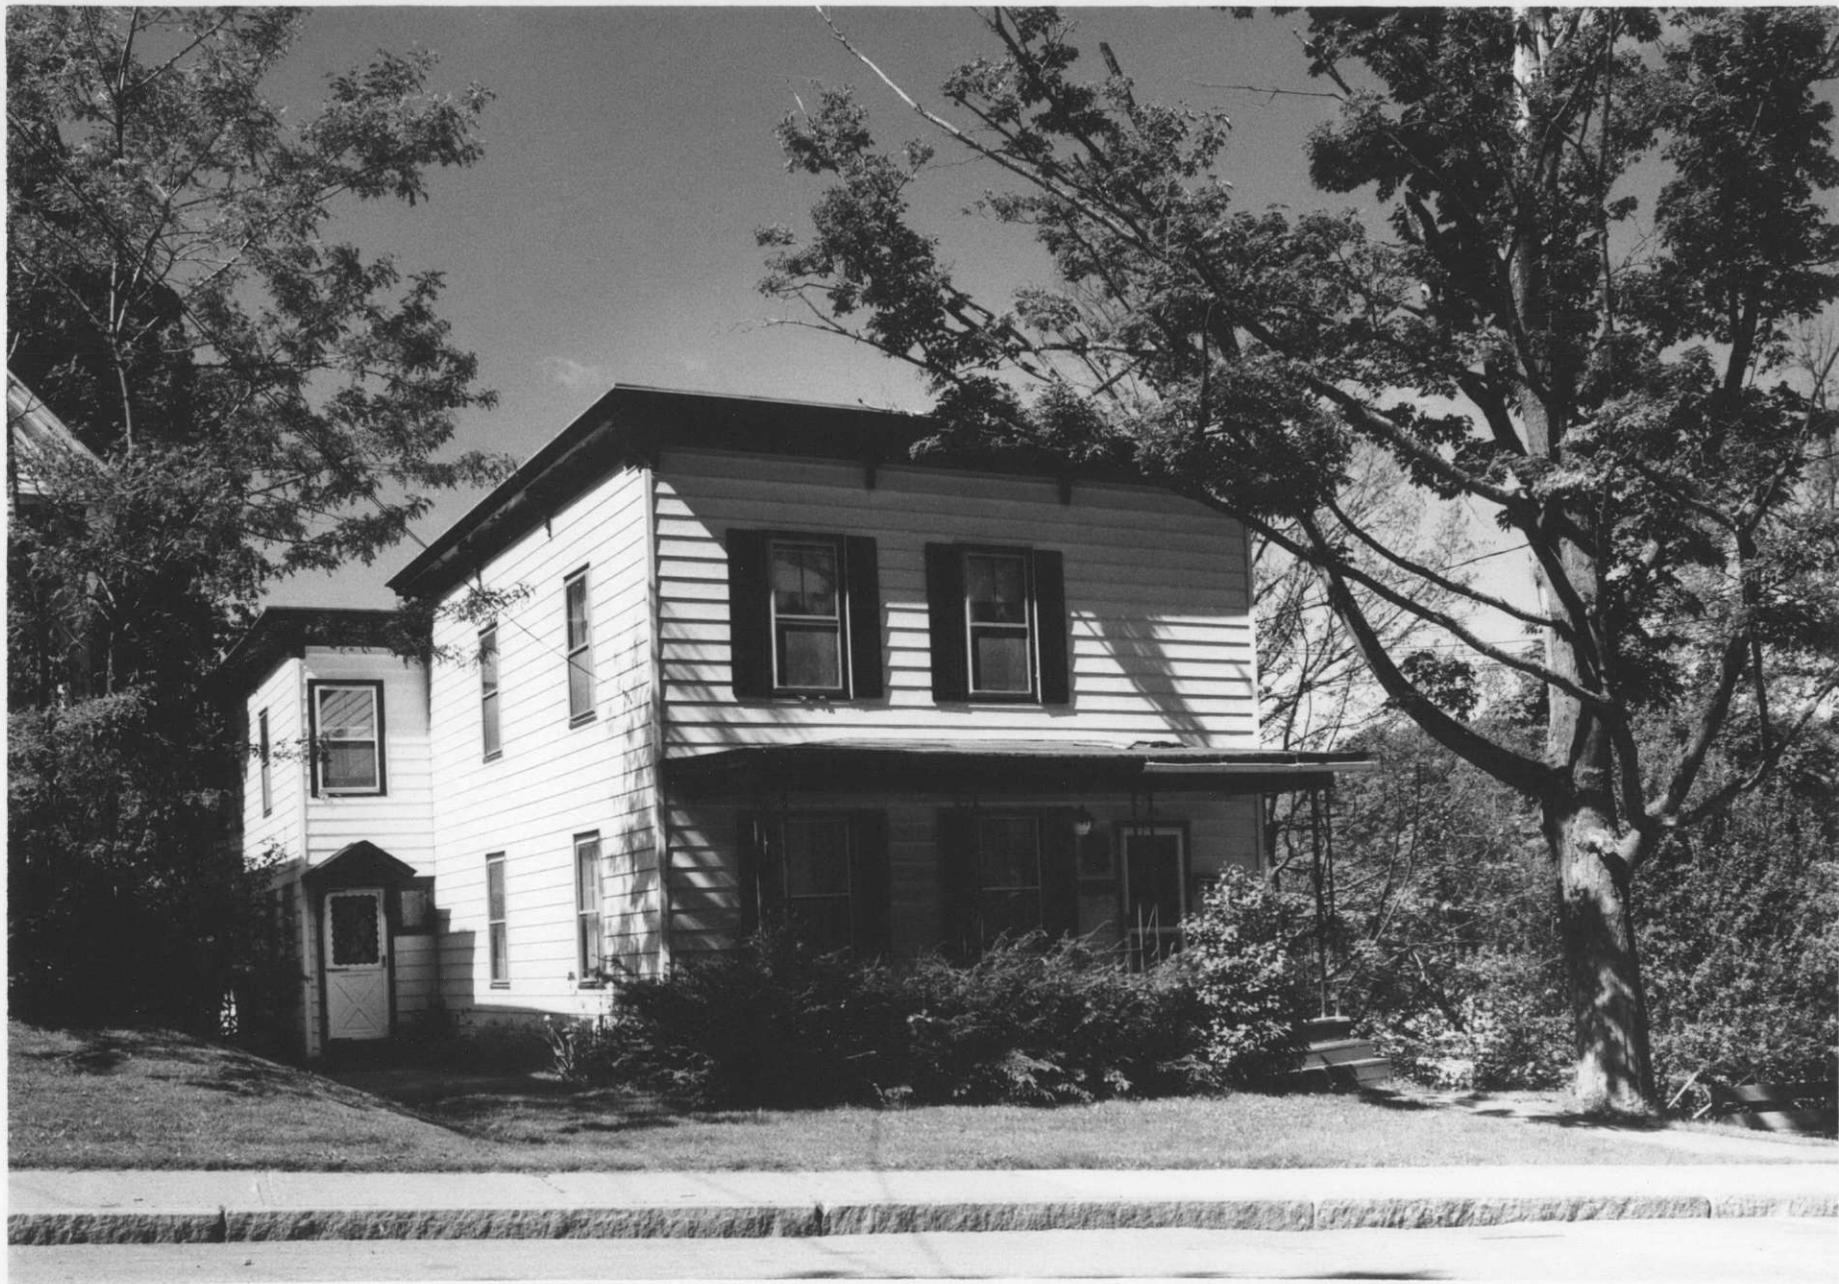
13

Montpelier Historic District Amendment (Boundary Increase)
East State Street, Montpelier, Vermont
Negative on file Vermont Division for Historic Preservation
Credit: Reid Larson
Date: June 1988
Description: #13 (79 East State St.), looking southwest
Photograph 18

This two-story, flat-roofed building, consists of a main, 2-by-2 bay, front section, with two wings on the rear. All windows are 2-over-2, except on the lower west basement wall, which has paired casements. An open porch along the front is supported by replacement wrought iron posts and surrounded by iron railings. The building is clad with wide aluminum siding.

The east rear wing steps down slightly from the front, but features a matching bracketed cornice. This wing also projects one bay to the east, allowing a rear entrance and window above. The rear entrance, with a modern replacement door, is capped by a pedimented hood. The west rear wing is 1-by-1 bay and 2 stories high, but lacks a cornice. The

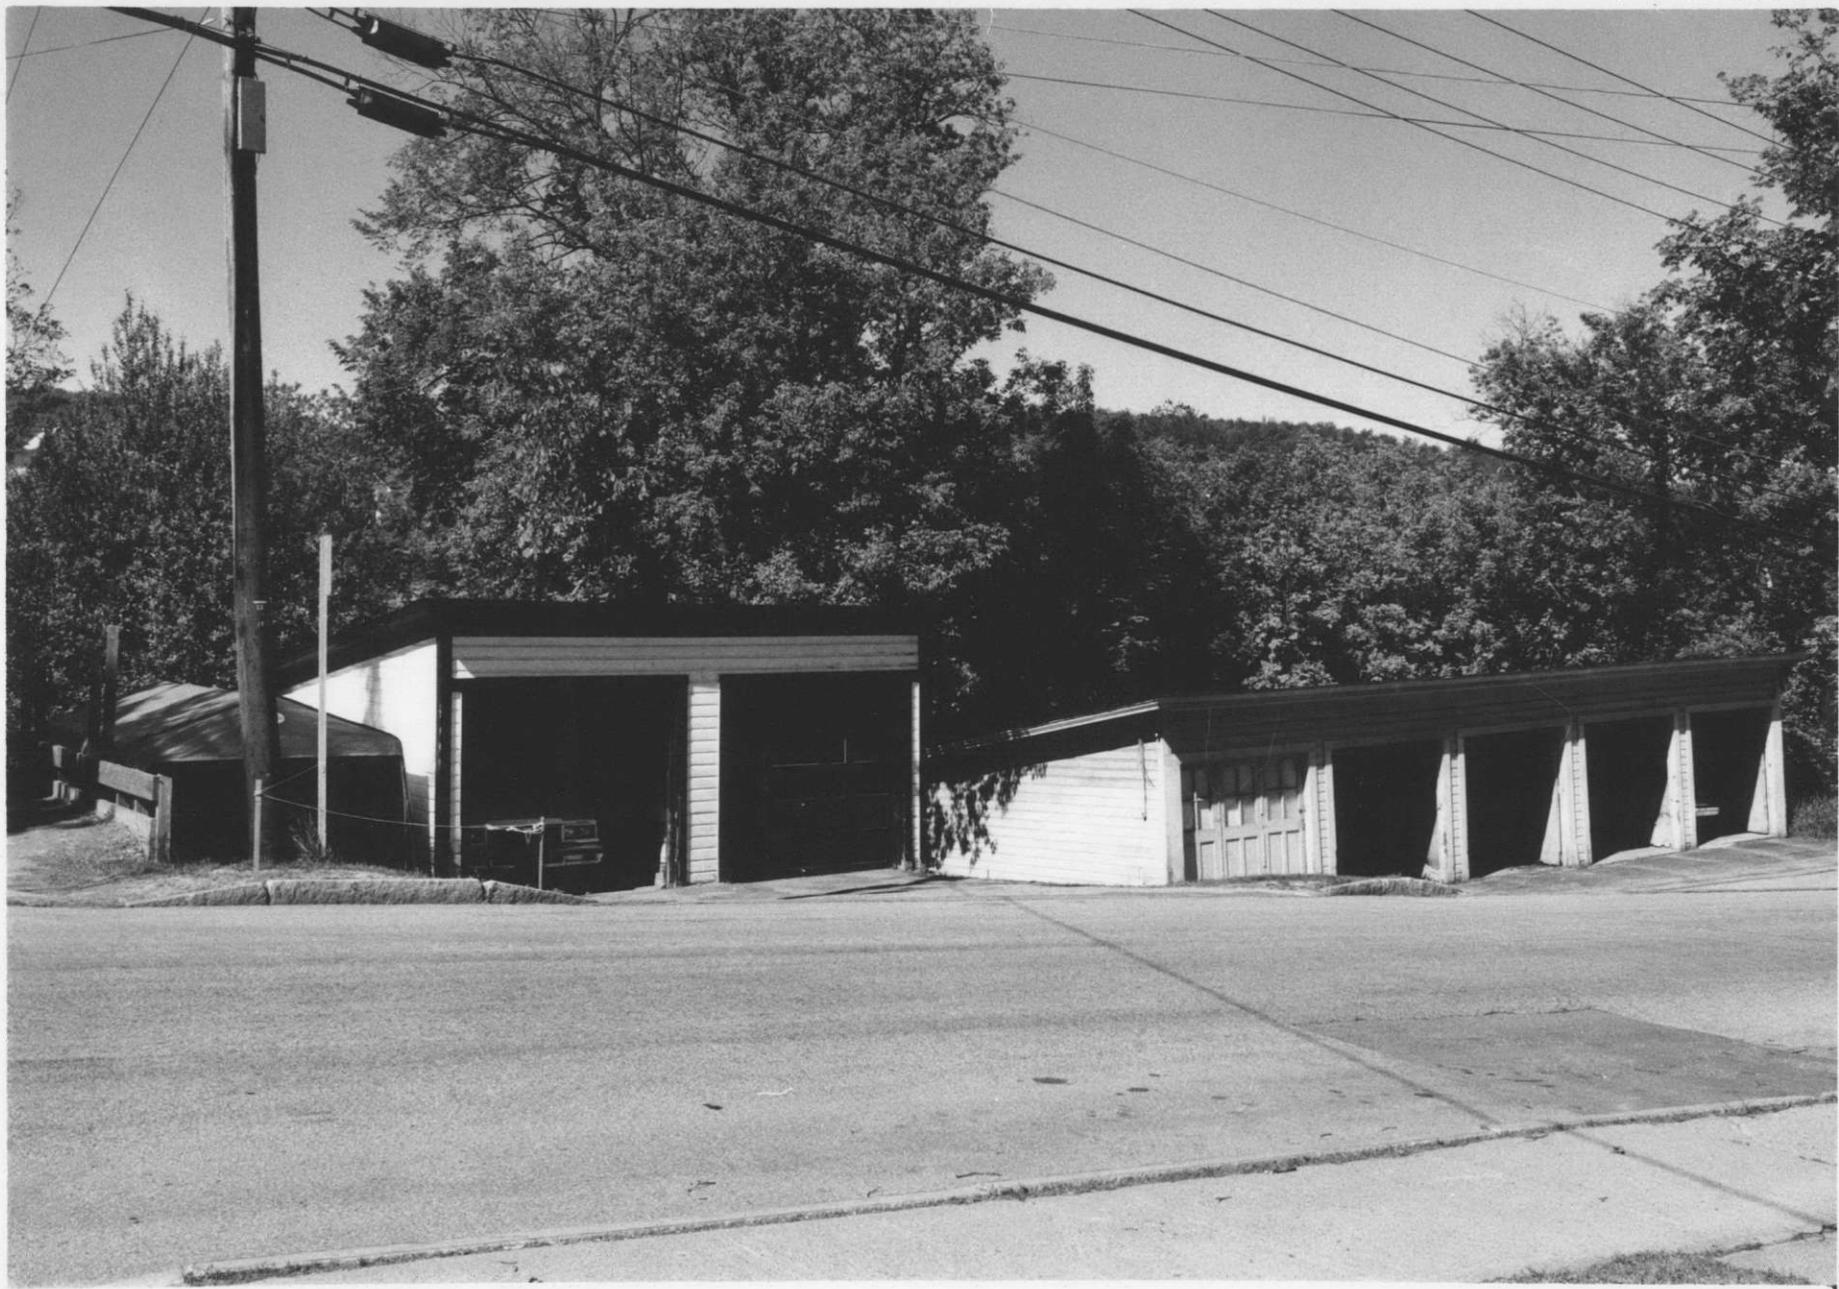
13A, 14

Montpelier Historic District Amendment (Boundary Increase)
East State Street, Montpelier, Vermont
Negative on file Vermont Division for Historic Preservation
Credit: Reid Larson
Date: June 1988
Description: #13a. (79 East State St.) and #14. (77 East State St.)
 looking southwest
Photograph 19

A small, single-story, two-bay garage, located just west of #13 (81 East State Street), this building has an asphalt-covered shed roof. The walls are sheathed with novelty siding and the floors are poured concrete. Two-over-two windows light each bay on the south (rear) elevation. The original doors have been replaced with 5-sectioned paneled overhead garage doors. Although smaller, and with fewer original features, this garage is significant in that it is very similar to its neighbor (#14) at 77 East State Street and was probably built at the same time, when automobile ownership was first becoming common in the district.
